Re: Arborist Findings at 200 Park Central Boulevard, Pompano Beach, FL

I visited the above-mentioned property on Saturday, February 4th, 2023 to evaluate +/- 121 trees, take photographs (Specimen sized trees only), perform relocation evaluations, calculate appraisal values (Rule 14-10 2020), and note any defects.

PZ23-12000034

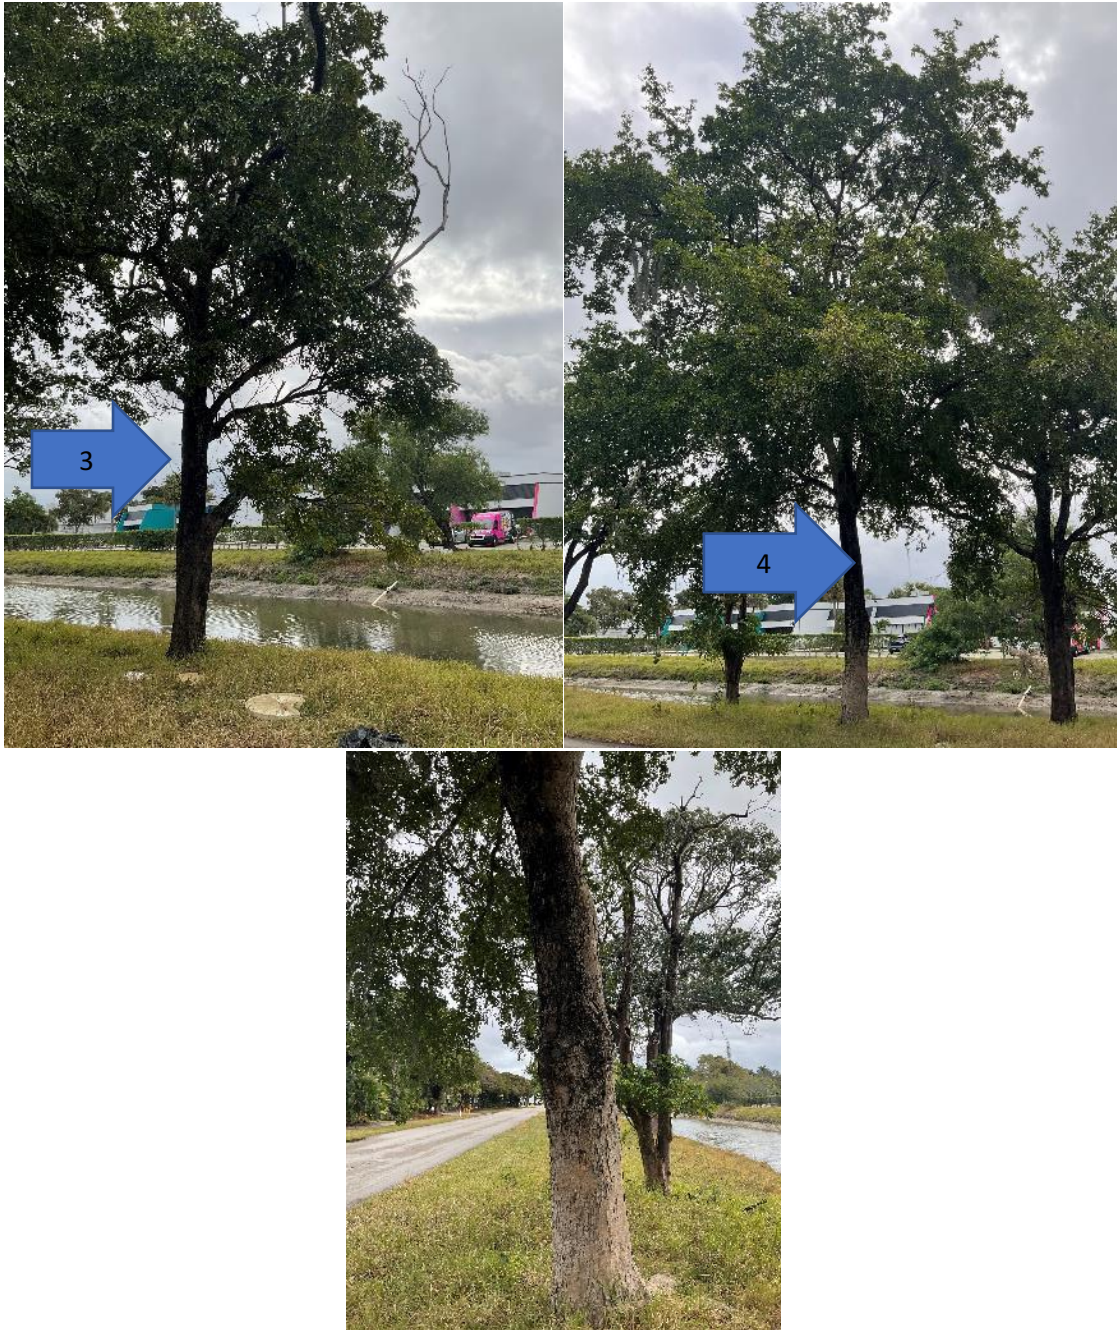
Trees Three & Four

Bishopwood (*Bischofia javanica*) Tree #3, and Black Olive (*Bucida buceras*) Tree #4, facing south. Note Tree #3 is a Florida Invasive Species Council Category I Invasive, and Tree #4 has poor structure, deadwood, flush cuts, and visual evidence of decay.

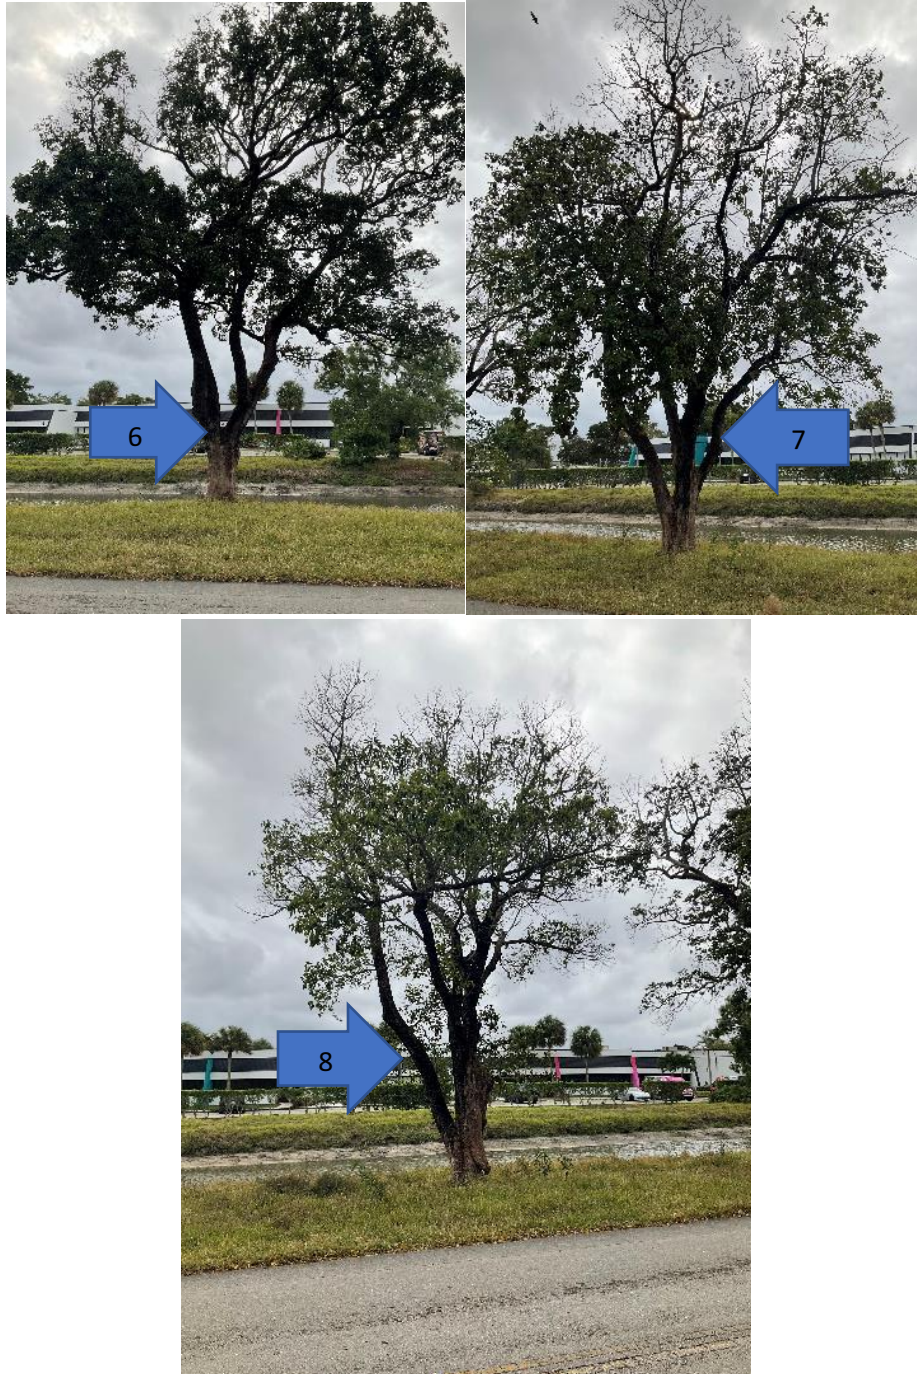
Trees Six, Seven, & Eight

Bishopwood trees (*Bischofia javanica*), facing south. Note all trees are Florida Invasive Species Council Category I Invasives.

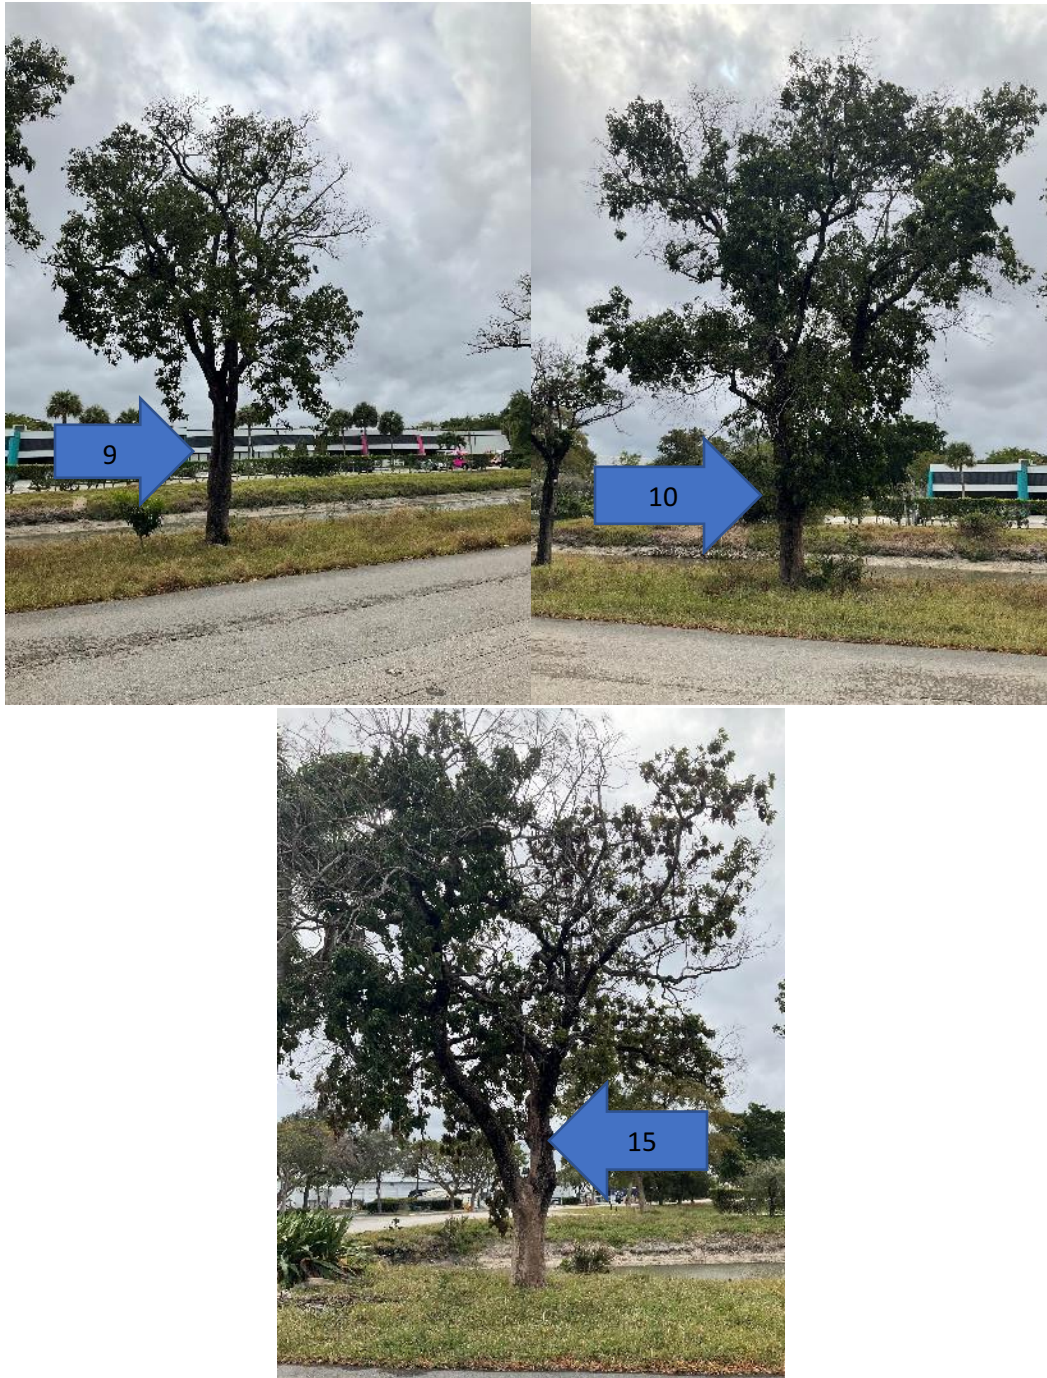
Trees Nine, Ten, & 15

Bishopwood trees (*Bischofia javanica*), facing south. Note all trees are Florida Invasive Species Council Category I Invasives.

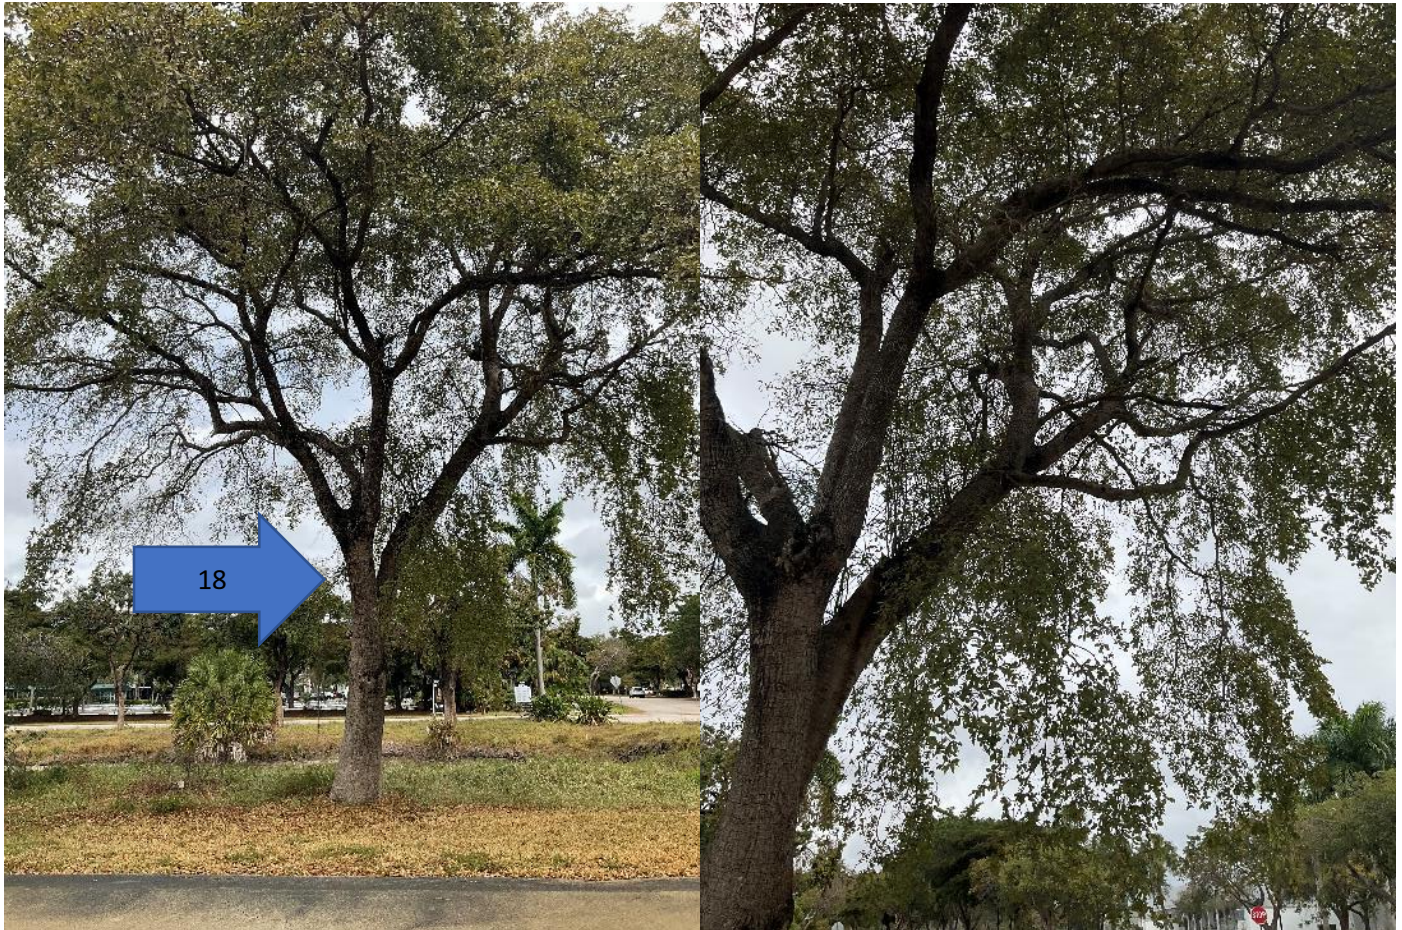
Tree 18

Black Olive (*Bucida buceras*), facing north. Note poor structure, canopy dieback, deadwood, visual evidence of decay, and water sprouts.

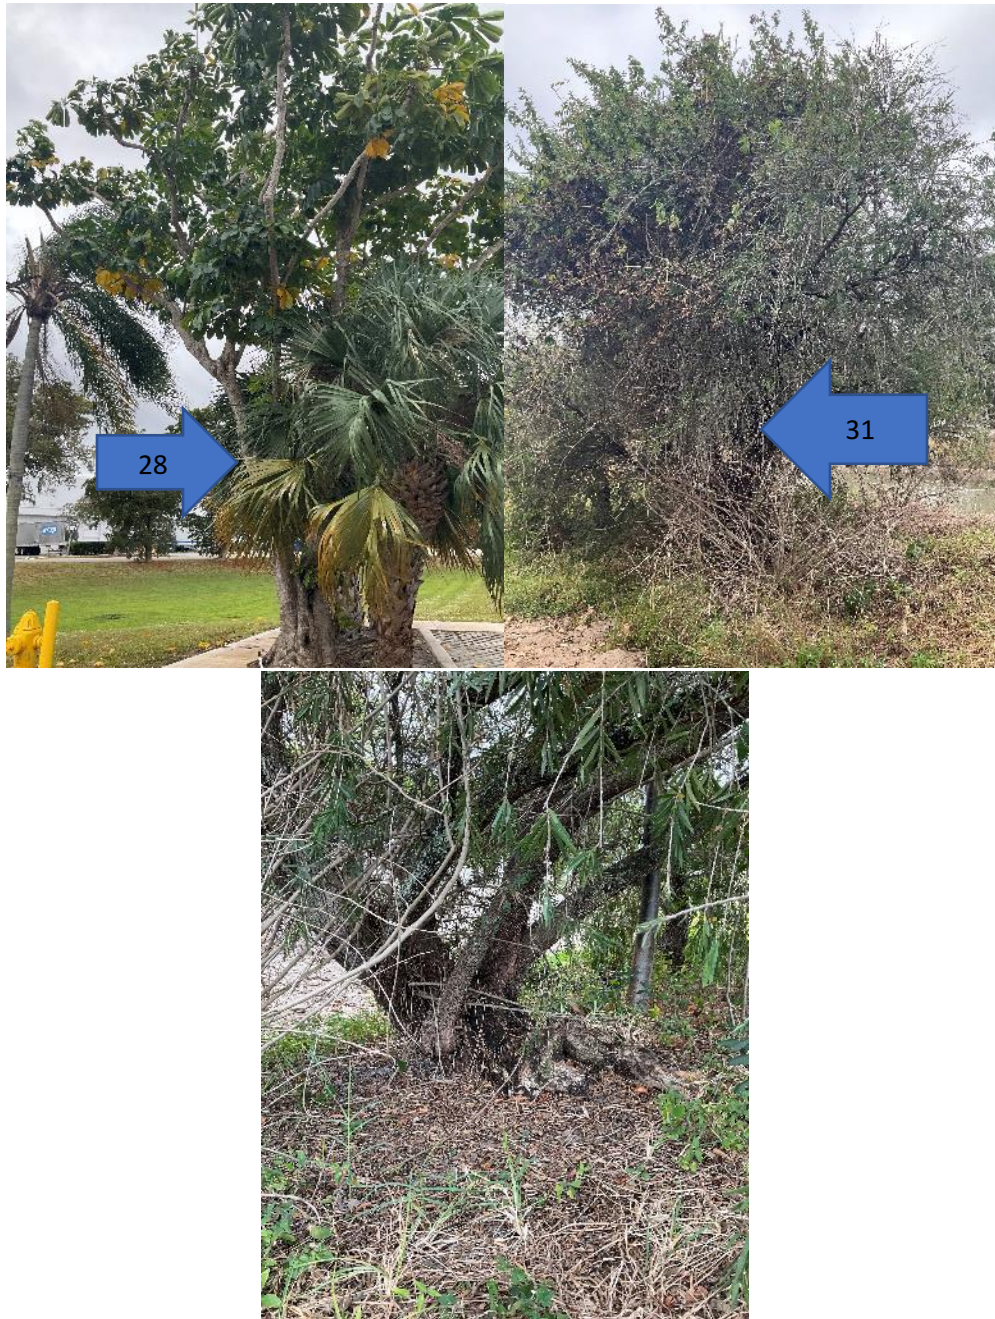
Trees 28 & 31

Umbrella Tree (*Heptapleurum actinophyllum*) Tree #28, and Bottlebrush (*Callistemon sp.*) Tree #31, facing west and north. Note Tree #28 is a Florida Invasive Species Council Category I Invasive, and Tree #31 has Poor structure, visual evidence of decay, and vines.

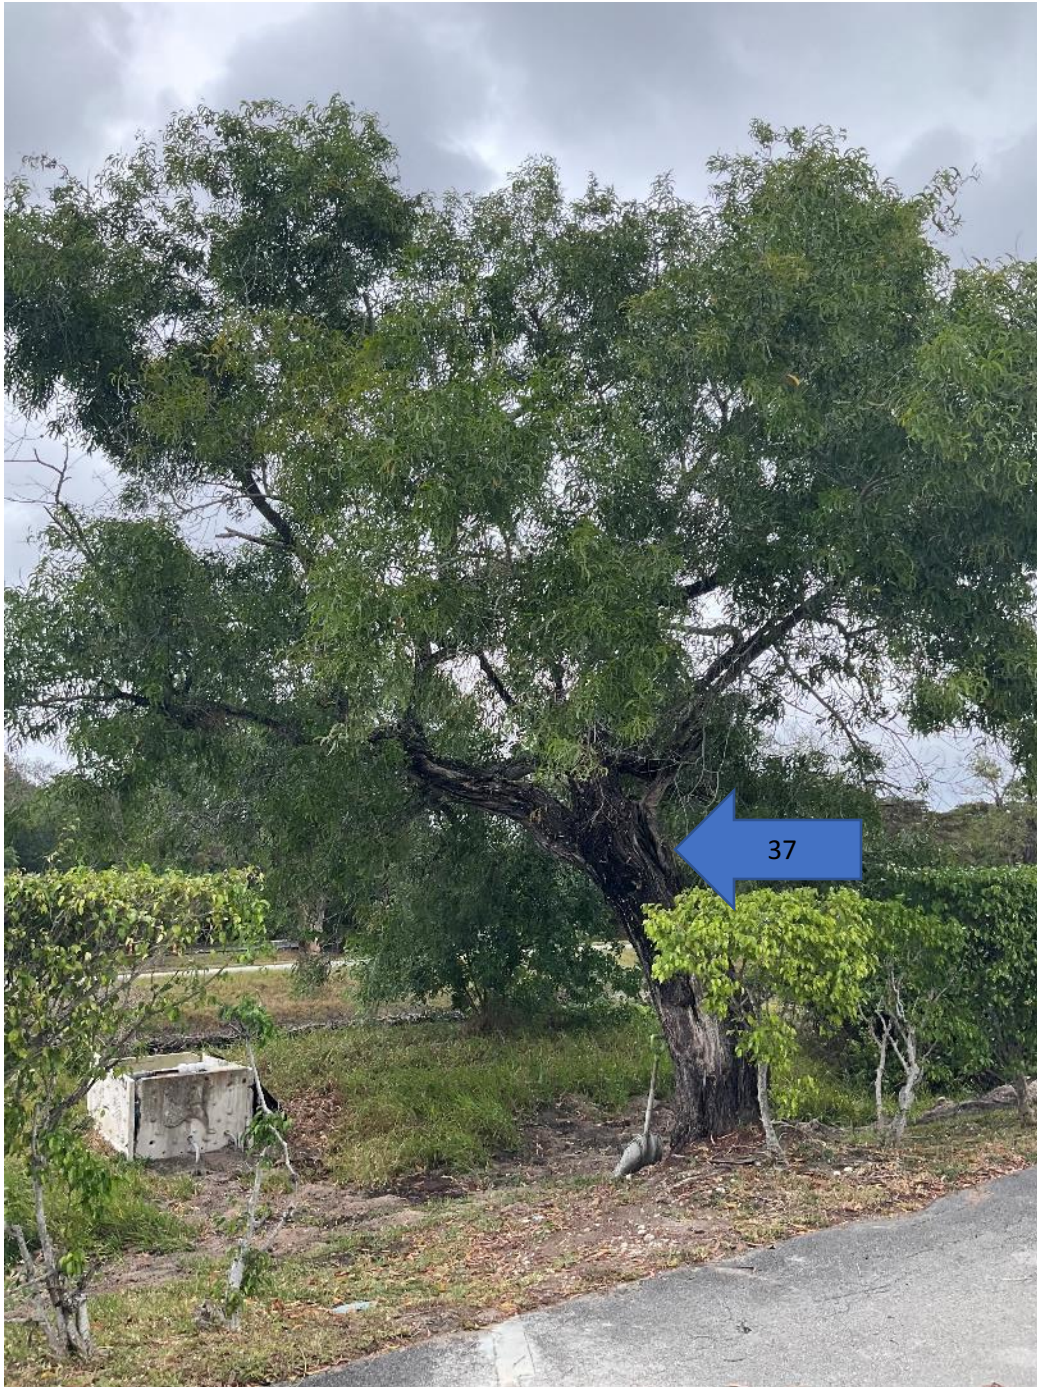
Tree 37

Earleaf Acacia (*Acacia auriculiformis*), facing north. Note tree is a Florida Invasive Species Council Category I Invasive.

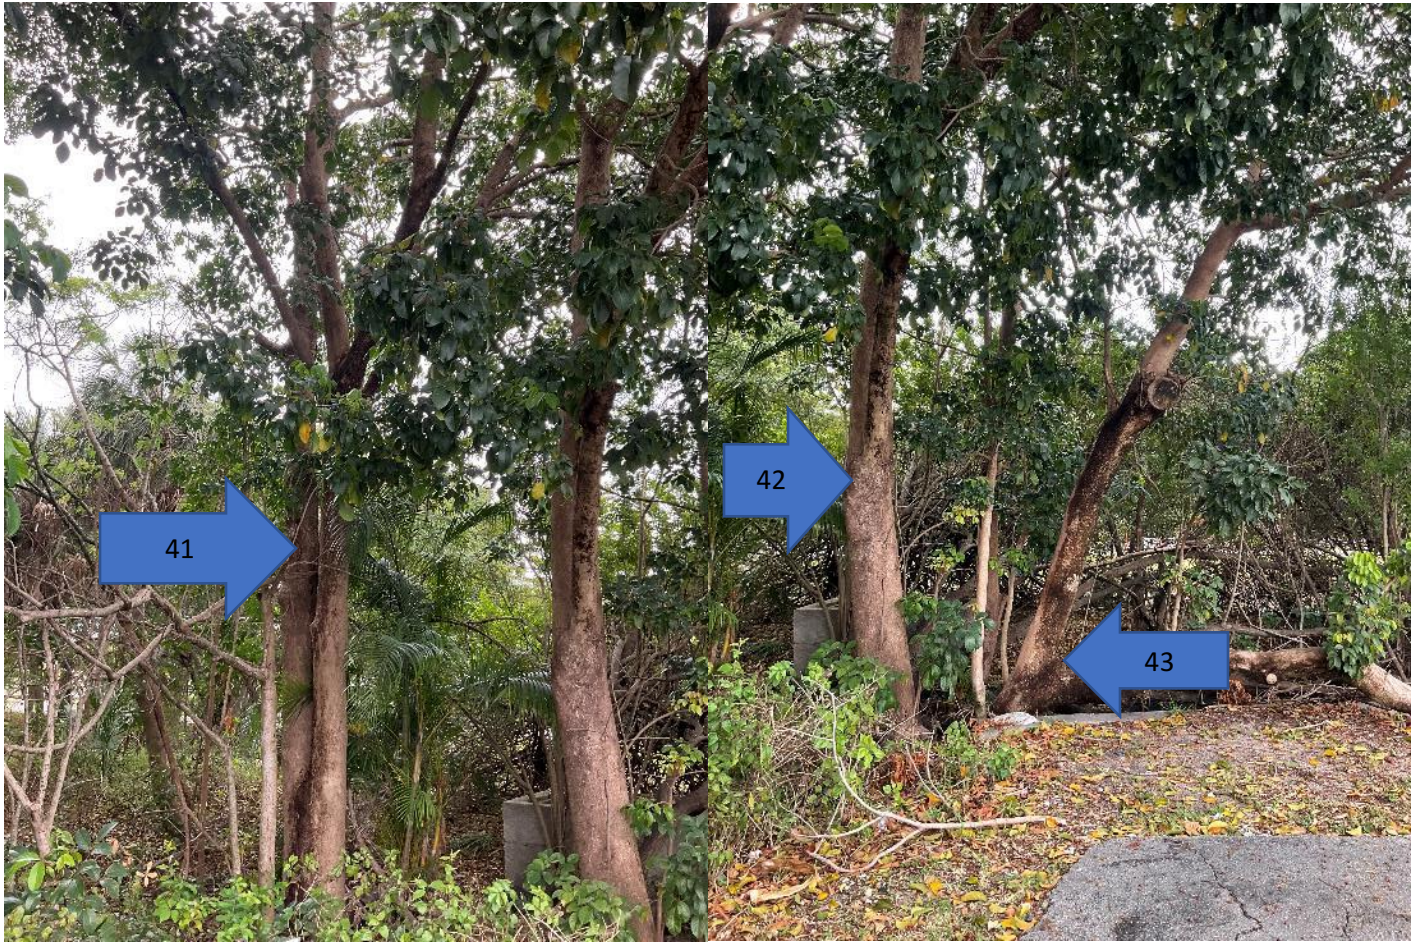
Trees 41, 42, & 43

Bishopwood trees (*Bischofia javanica*), facing north. Note all trees are Florida Invasive Species Council Category I Invasives.

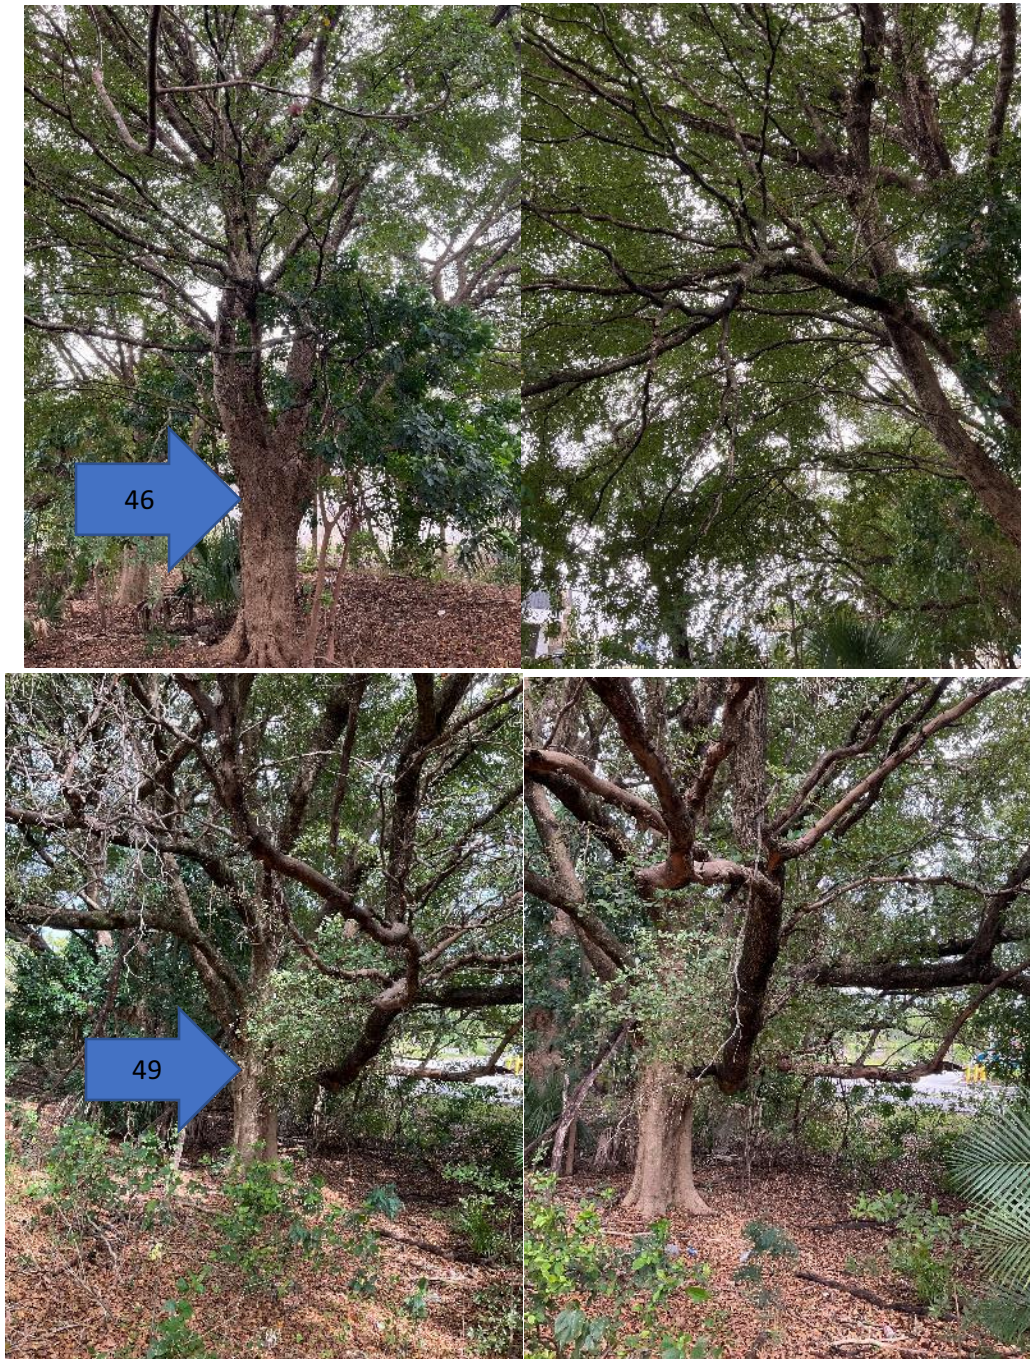
Trees 46 & 49

Black Olives (*Bucida buceras*), facing west. Note Poor structure, deadwood, visual evidence of decay for Tree #46, and poor structure, large diameter deadwood, visual evidence of decay, and canopy dieback for Tree #49.

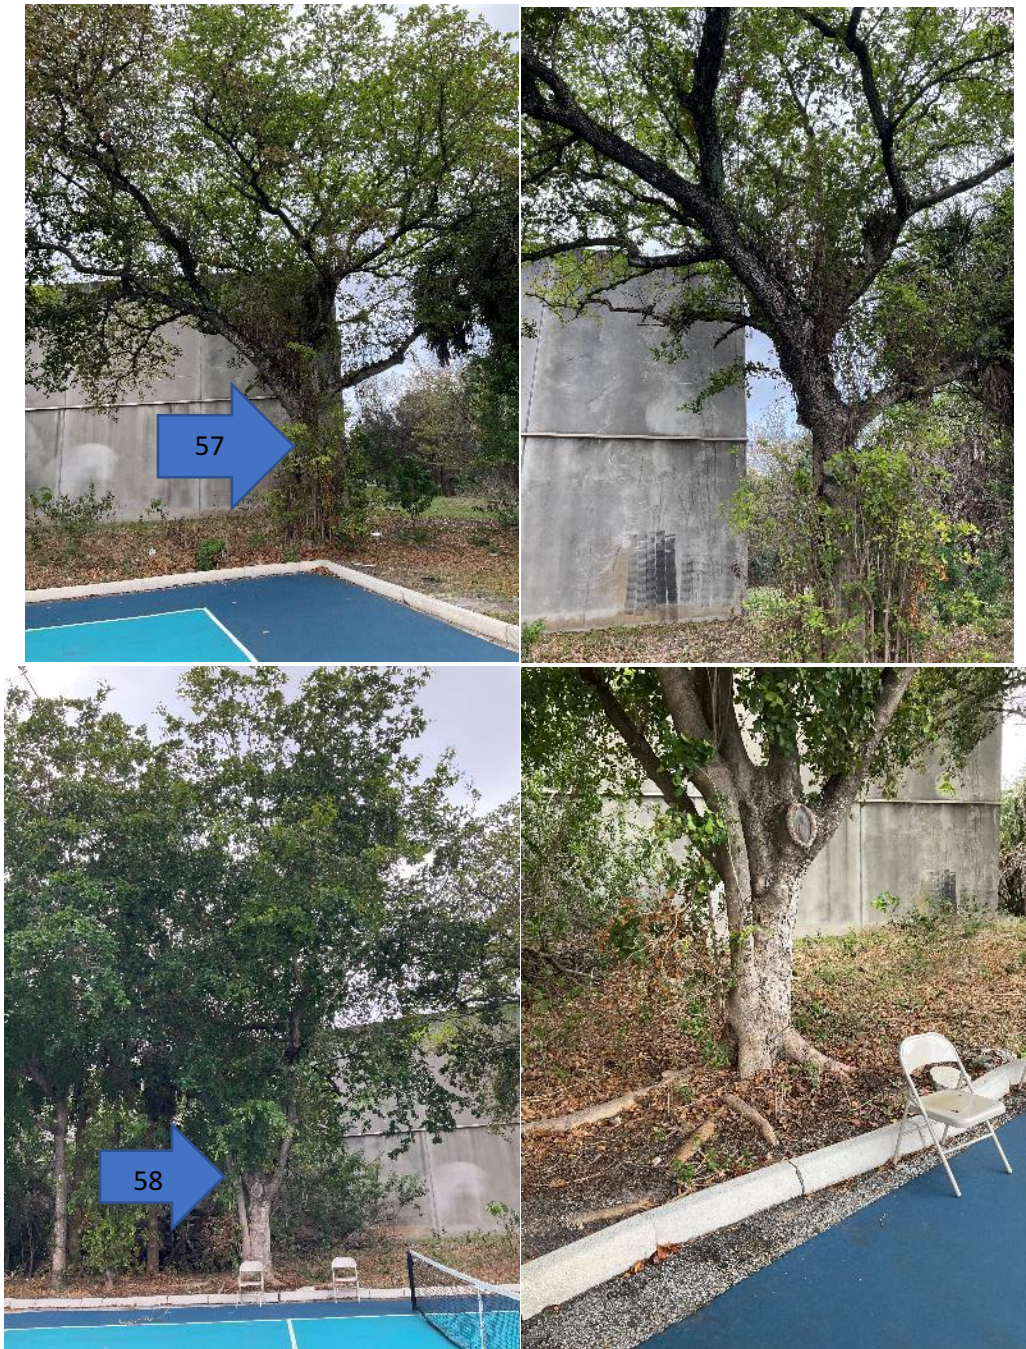
Trees 57 & 58

Black Olives (*Bucida buceras*), facing west. Note poor structure, water sprouts, chlorotic foliage for Tree #57, and poor structure, flush cuts, confined root space for Tree #58.

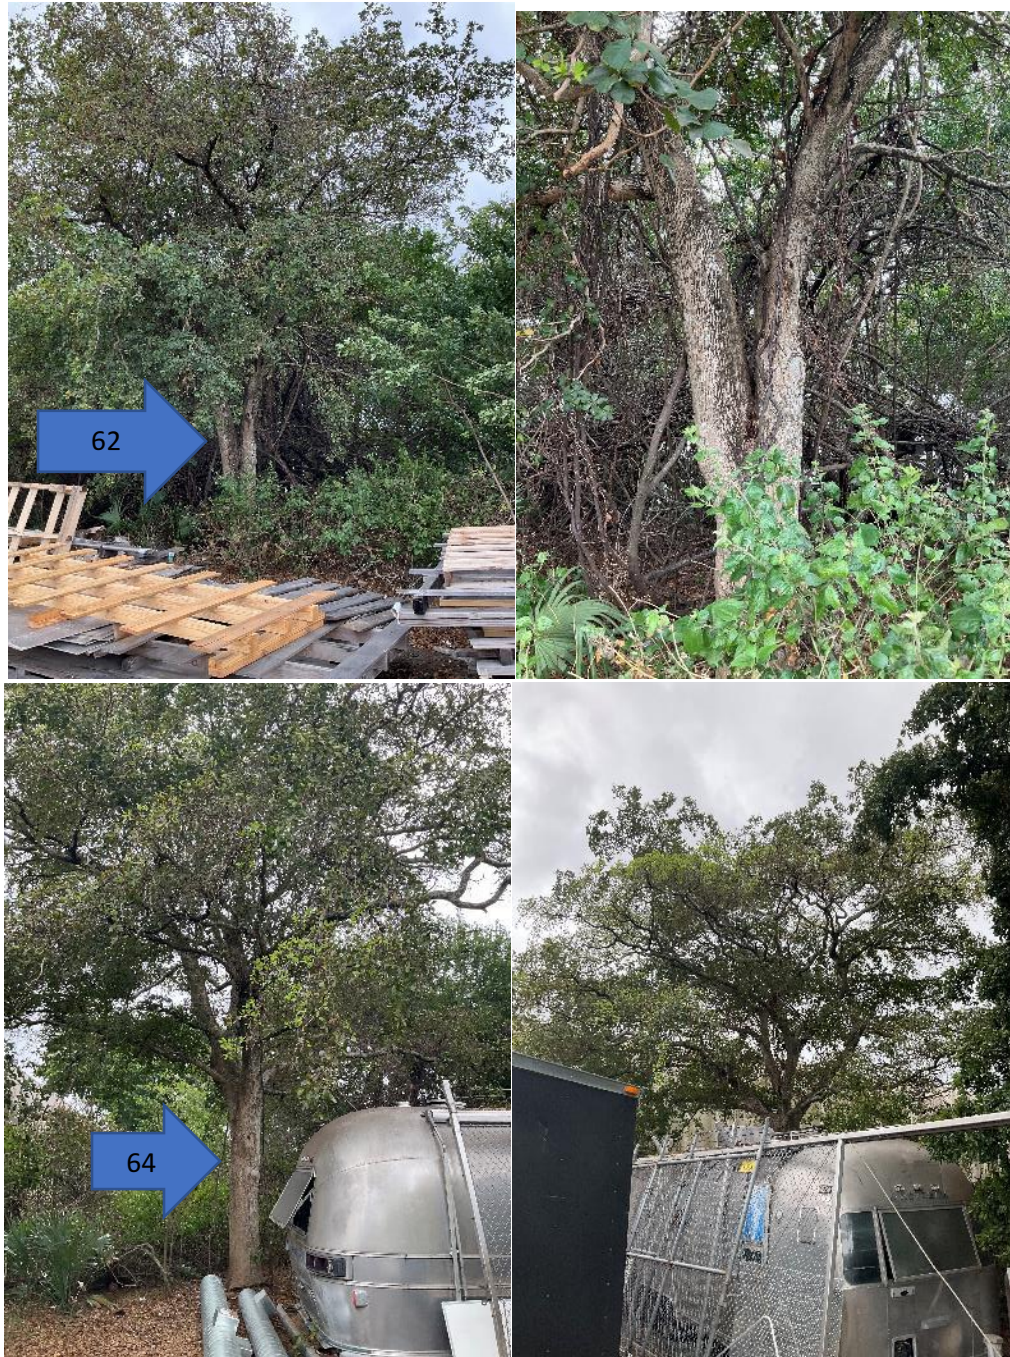
Trees 62 & 64

Black Olives (*Bucida buceras*), facing west. Note poor structure, flush cuts, deadwood, and vines for Tree #62, and poor structure, flush cuts, deadwood, and canopy dieback for Tree #64.

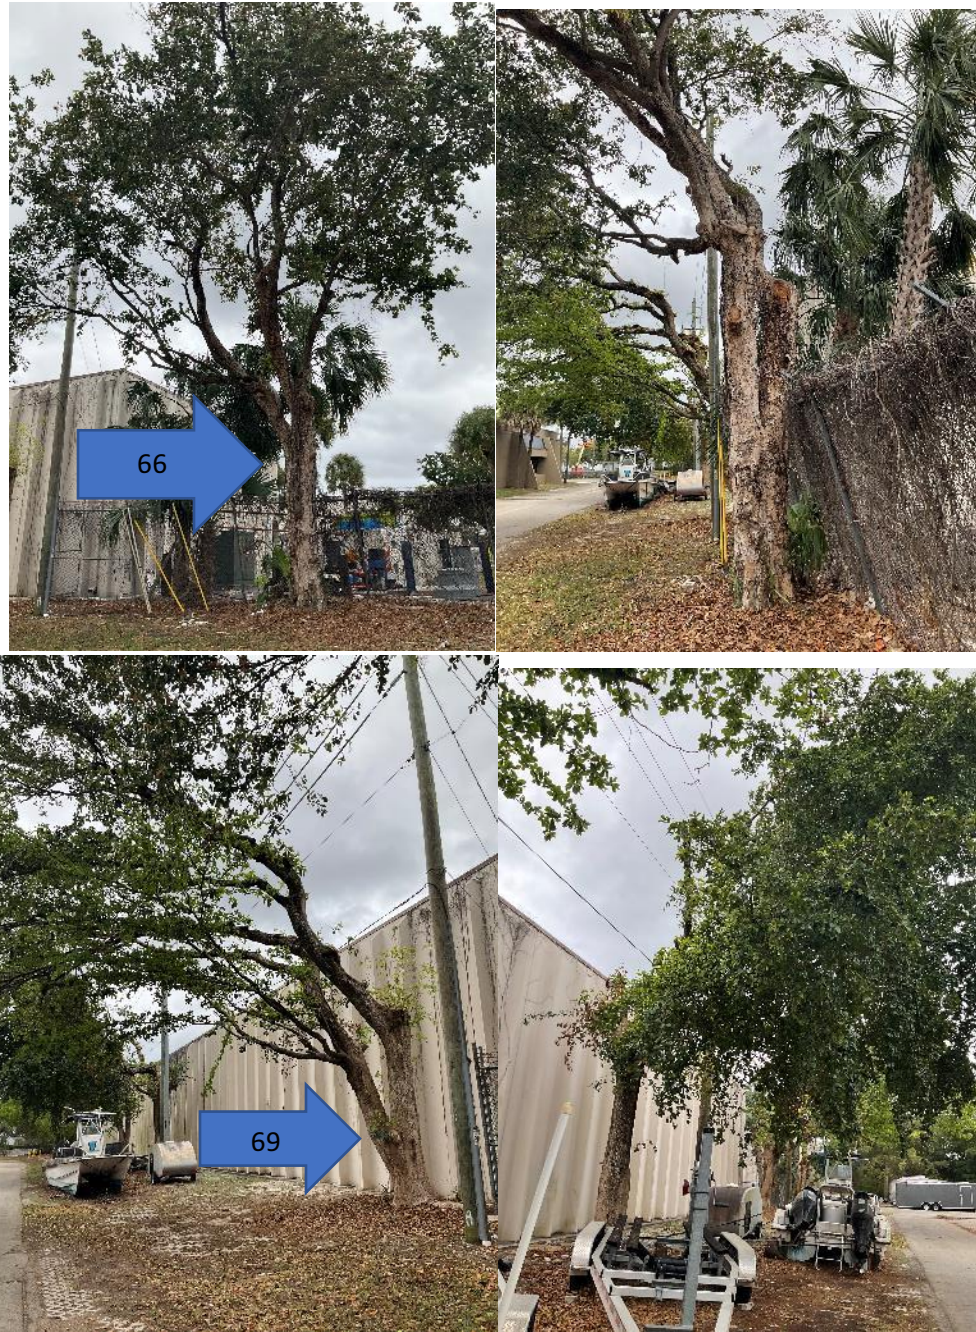
Trees 66 & 69

Black Olives (*Bucida buceras*), facing south. Note poor structure, unbalanced crown, severe utility pruning, bleeding cankers, and deadwood for Tree #66, and poor structure, unbalanced crown, severe utility pruning, canopy dieback for Tree #69.

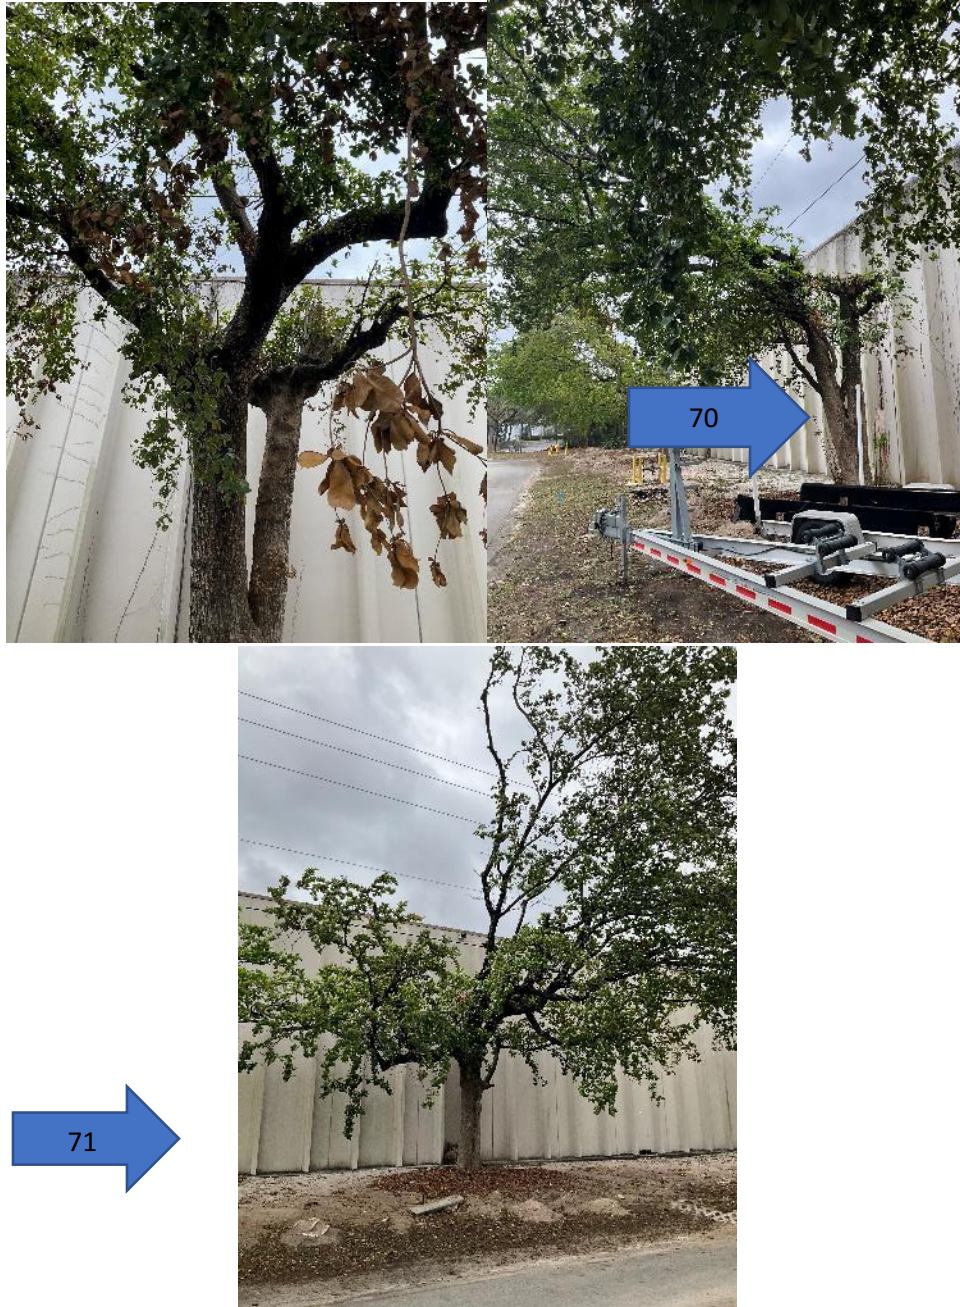
Trees 70 & 71

Black Olives (*Bucida buceras*), facing south. Note poor structure, unbalanced crown, severe utility pruning, and canopy dieback for Tree #70, and poor structure, unbalanced crown, severe utility pruning, and canopy dieback for Tree #71.

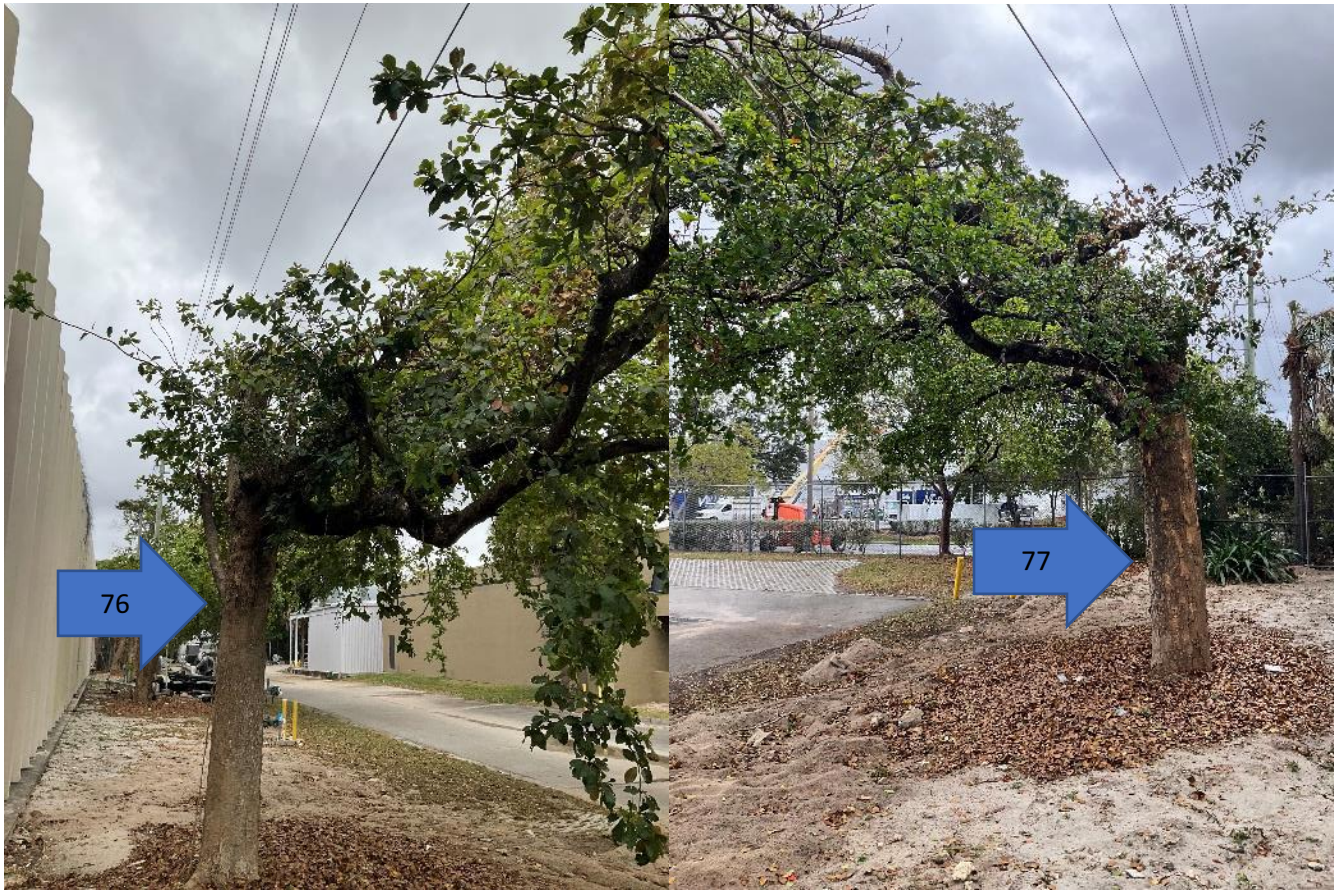
Tree 76 & 77

Black Olives (*Bucida buceras*), facing south. Note poor structure, unbalanced crown, severe utility pruning, and canopy dieback for Tree #76, and poor structure, unbalanced crown, severe utility pruning, and canopy dieback for Tree #77.

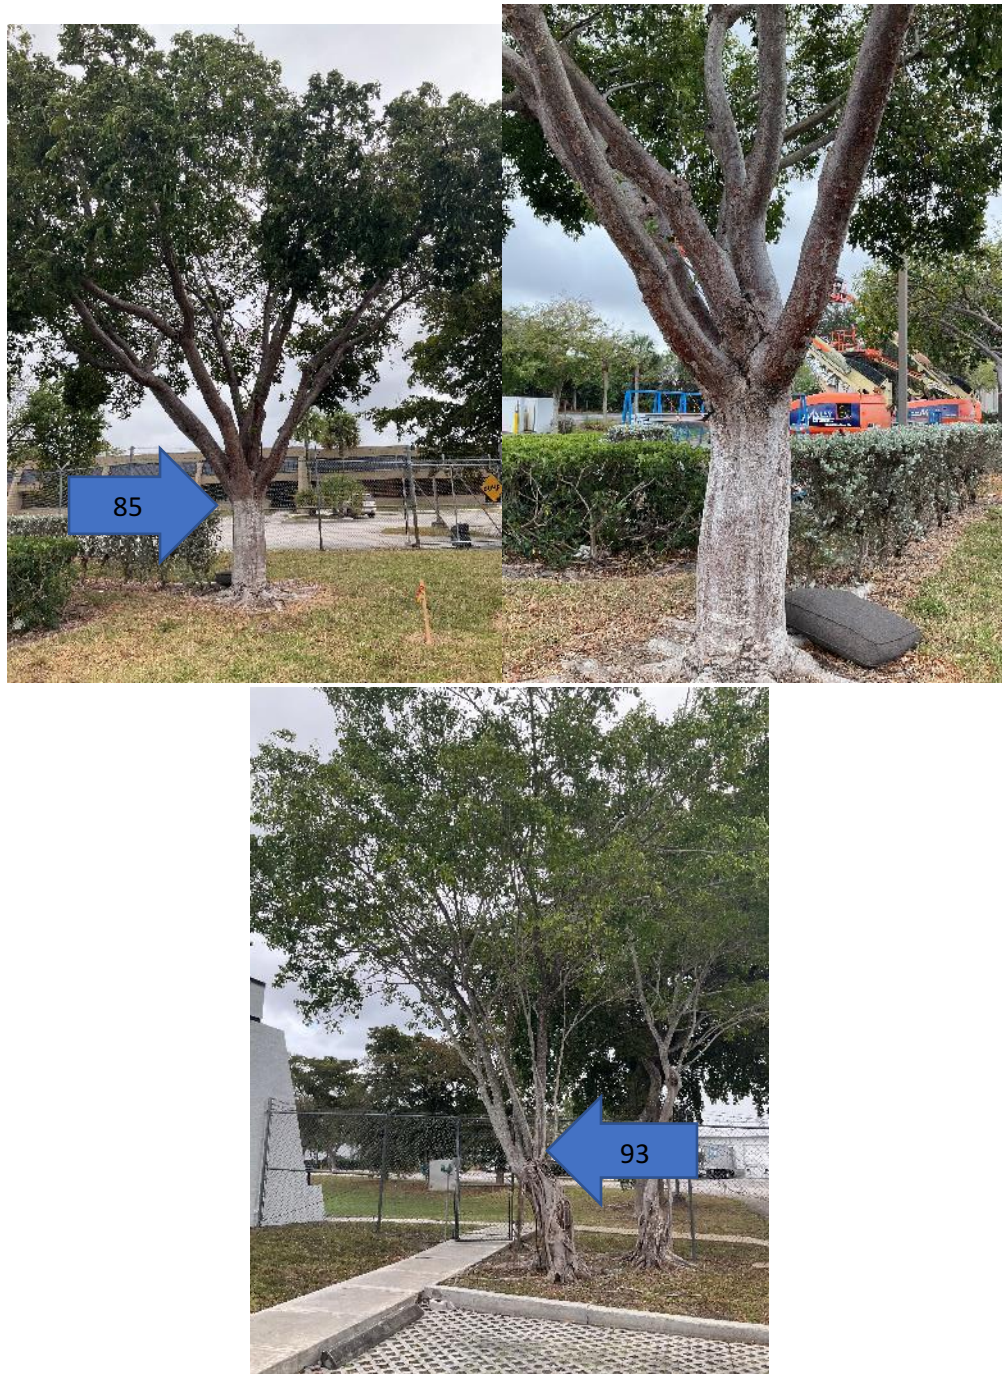
Trees 85 & 93

Gumbo Limbo (*Bursera simaruba*) Tree #85, and Weeping Fig (*Ficus benjamina*) Tree #93, facing north and east. Note poor structure, confined root space, and extensive visual evidence of decay for Tree #93.

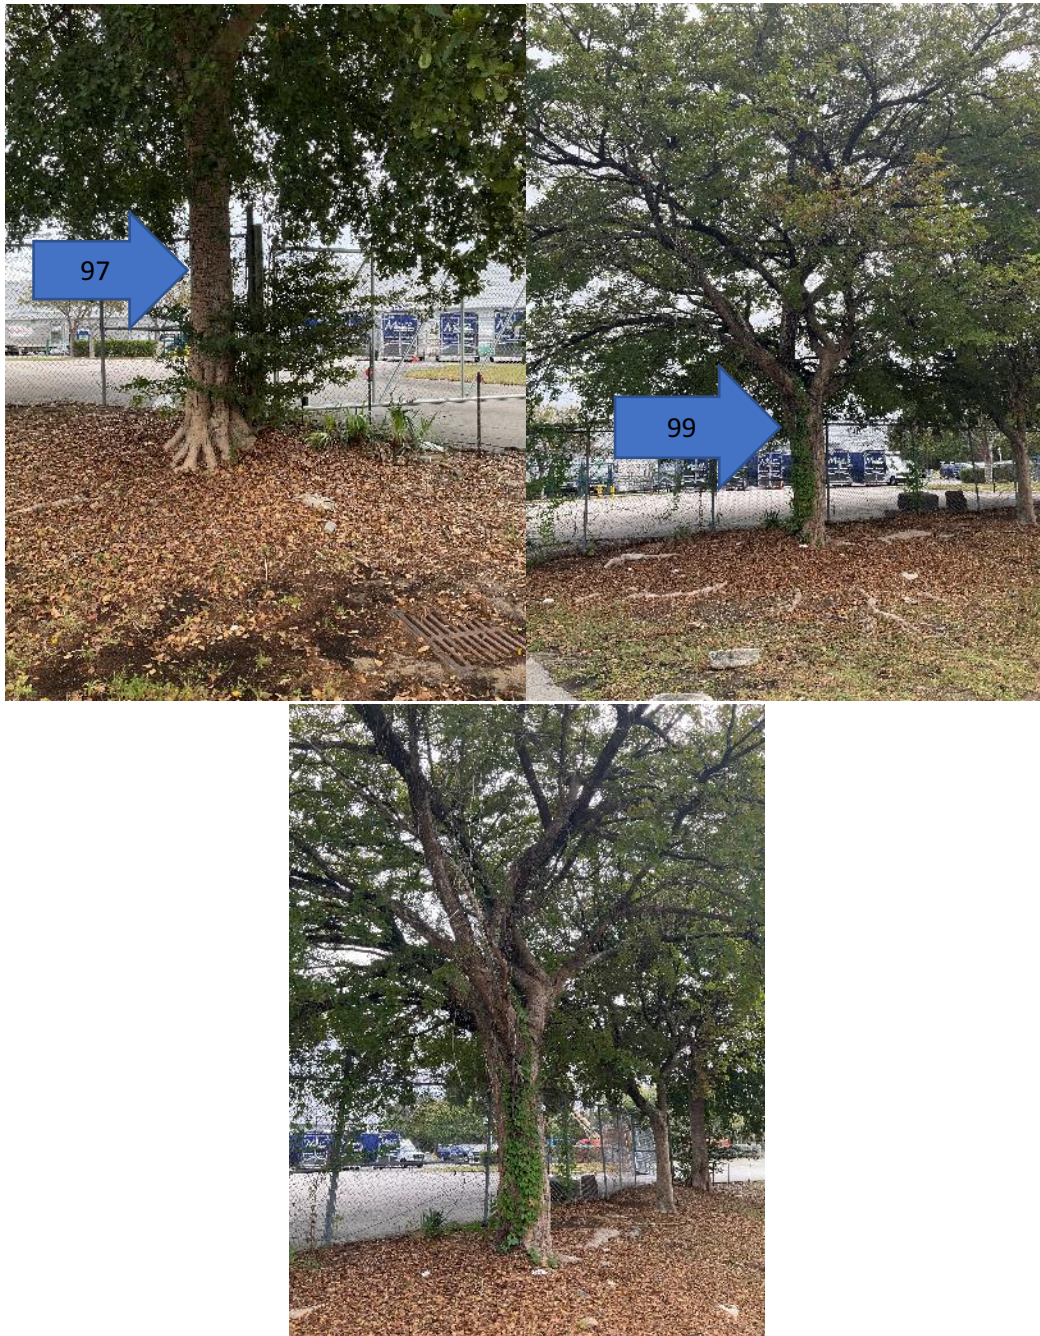
Trees 97 & 99

Black Olives (*Bucida buceras*) facing east. Note poor structure, confined root space, canopy crowding, insufficient rootball for relocation for Tree #97, and poor structure, vines, canopy dieback, confined root space, and deadwood for Tree #99.

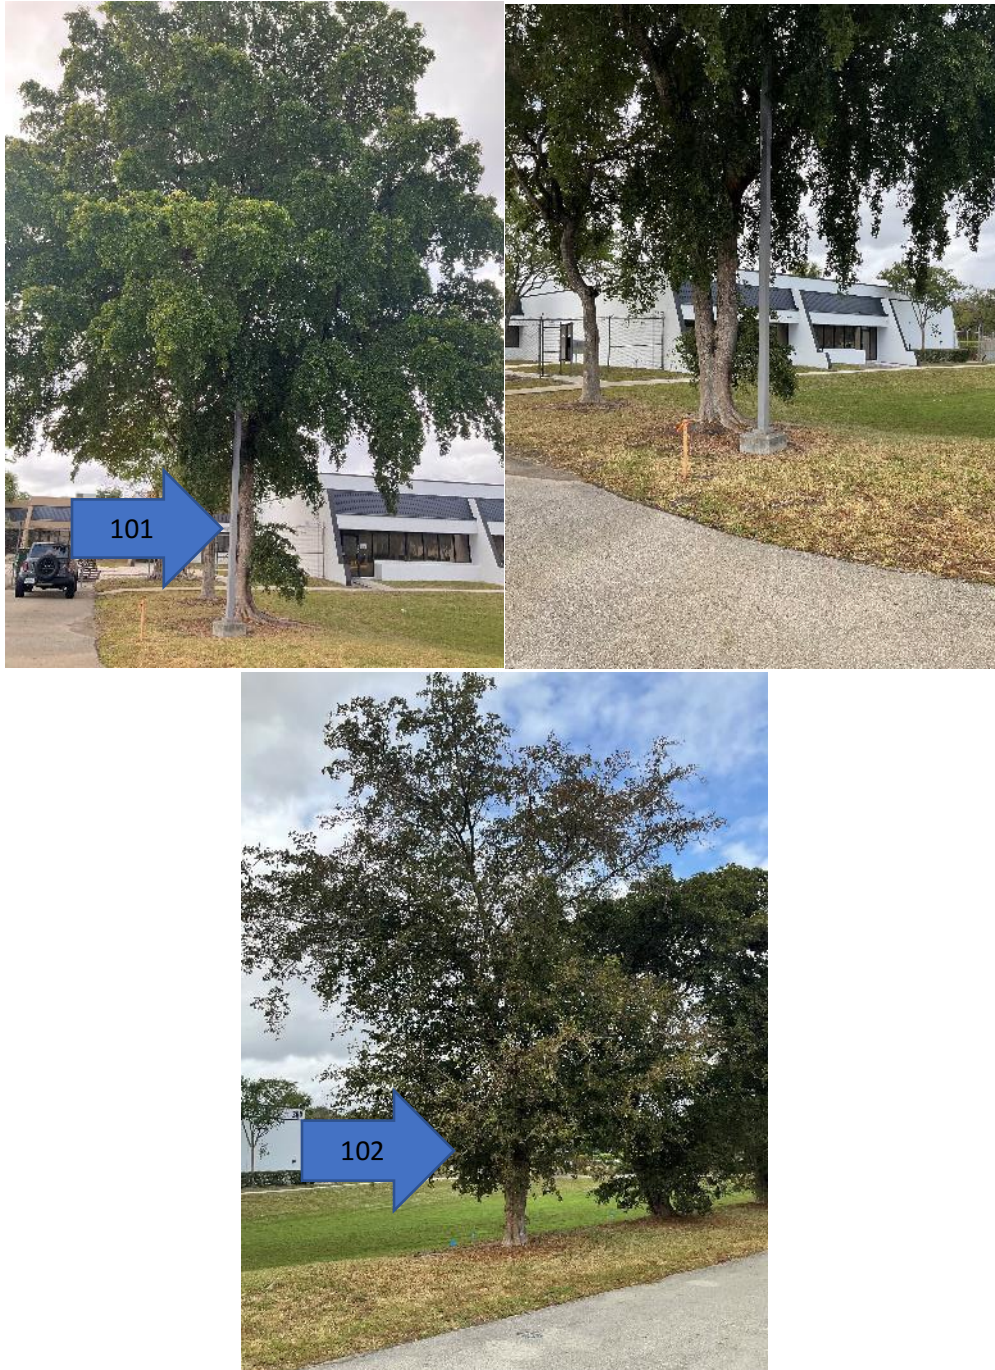
Trees 101 & 102

Black Olives (*Bucida buceras*) facing west. Note poor structure, girdling roots, and light pole conflict for Tree #101, and Poor structure, canopy crowding, flush cuts, and visual evidence of decay for Tree #102.
