Re: Arborist Findings at 200 Park Central Boulevard, Pompano Beach, FL

I visited the above-mentioned property on Saturday, February 4th, 2023 to evaluate +/- 121 trees, take photographs (Specimen sized trees only), perform relocation evaluations, calculate appraisal values (Rule 14-10 2020), and note any defects.

PZ23-12000034

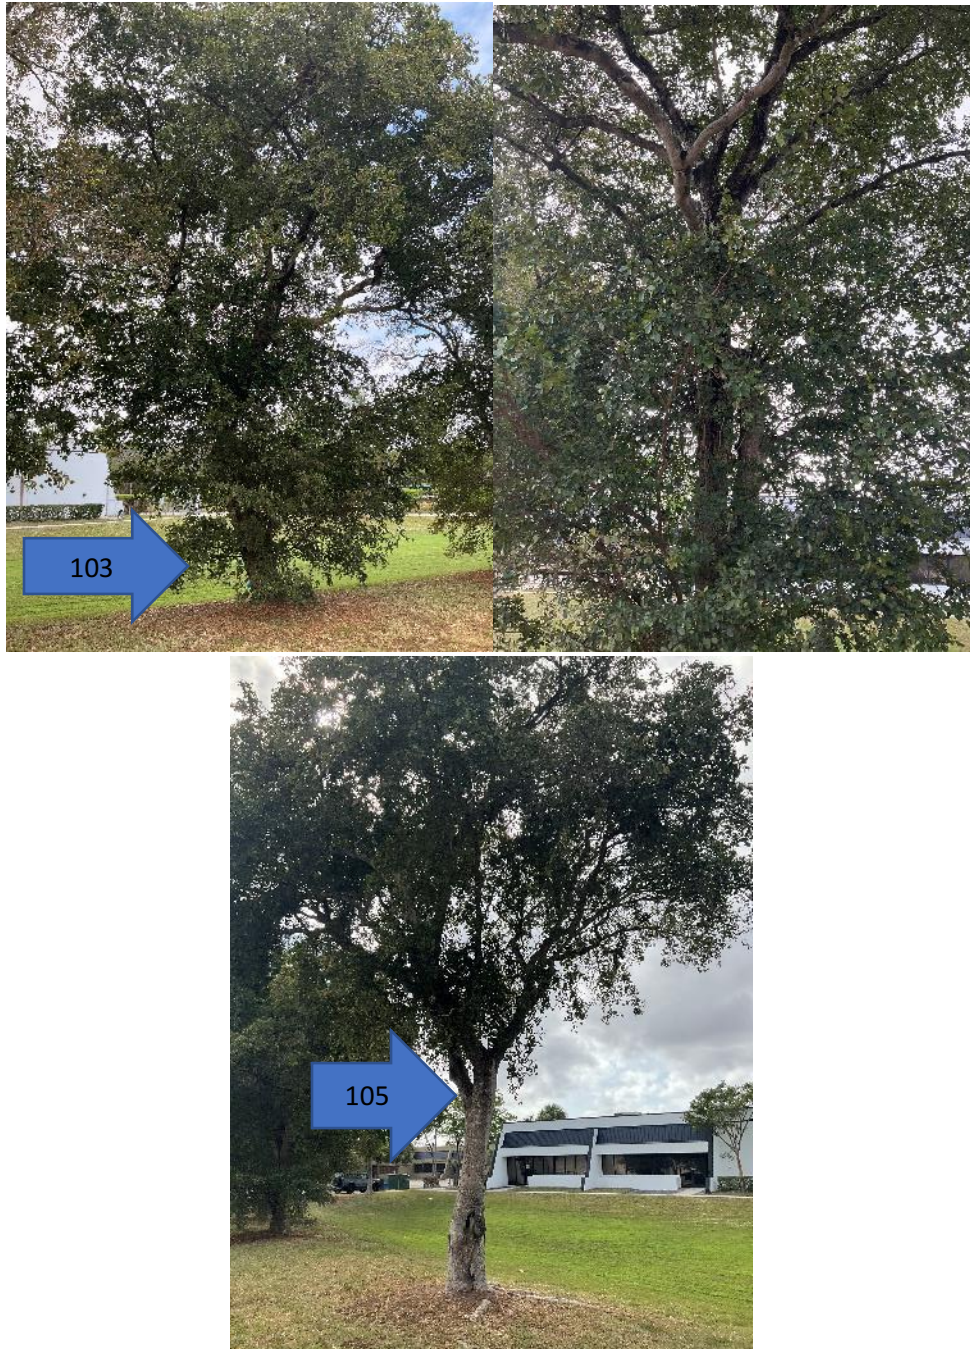
Trees 103 & 105

Black Olives (*Bucida buceras*) facing west. Note poor structure, canopy crowding, flush cuts, visual evidence of decay for Tree #103, and Poor structure, canopy crowding, flush cuts, visual evidence of decay, and over lifted canopy for Tree #105.
