ARBORIST REPORT

200 N. Federal Hwy.
Pompano Beach, Fl 33062

Assignment/Overview

Treage LLC was contacted by George Akirtava of Elit Group to do a Certified Arborist Report/Tree Assessment at 200 N. Federal Hwy. in Pompano Beach, FL.

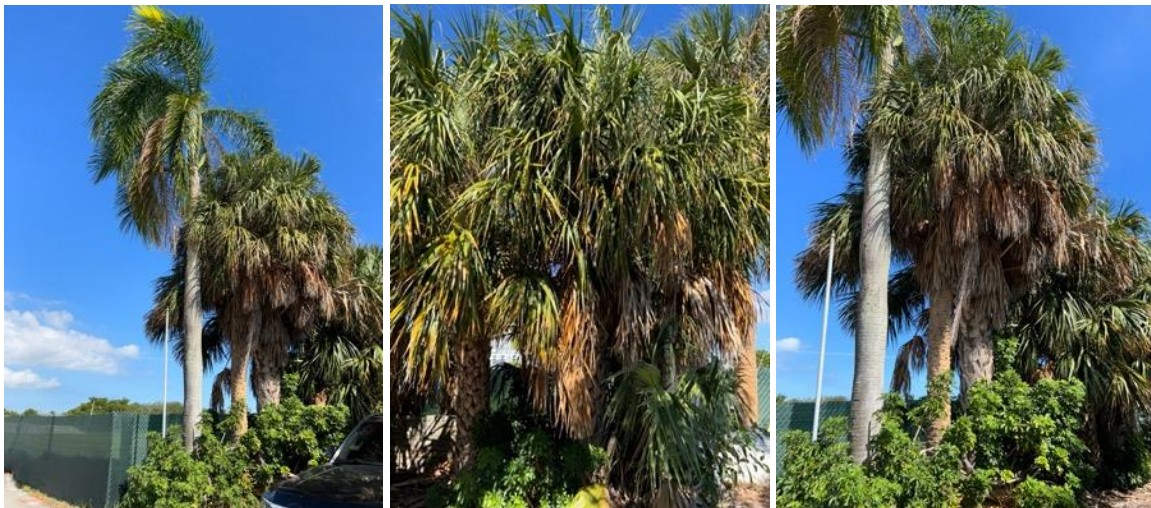
Tree #1 – *Roystonea regia*, Royal Palm – this tree is located in the northwest corner of the property adjacent to the parking lot and next to the ROW. It is crowded with minor chlorosis and a slightly undersized canopy. Overall, it is in fair condition and is proposed for removal.

Tree #2 – *Sabal palmetto*, Sabal Palm – this tree is located directly east of Tree #1. It is very crowded with a pronounced curve in the upper trunk due to the crowded conditions. It is in fair condition and is proposed for removal.

Tree #3 – *Sabal palmetto*, Sabal Palm – this tree is located directly east of Tree #2 on the northeast side of the property. It is very crowded and has live fronds only on one side of the trunk due to severe crowding. It is in poor condition and is proposed for removal.

Tree #4 – *Sabal palmetto*, Sabal Palm – this tree is located directly east of Tree #3. It is very crowded and overgrown but otherwise is in fair condition. This tree is proposed for removal.

Tree #5 – *Sabal palmetto*, Sabal Palm – this tree is located directly east of Tree #4. It is very crowded and overgrown but otherwise is in fair condition. It is proposed for removal.

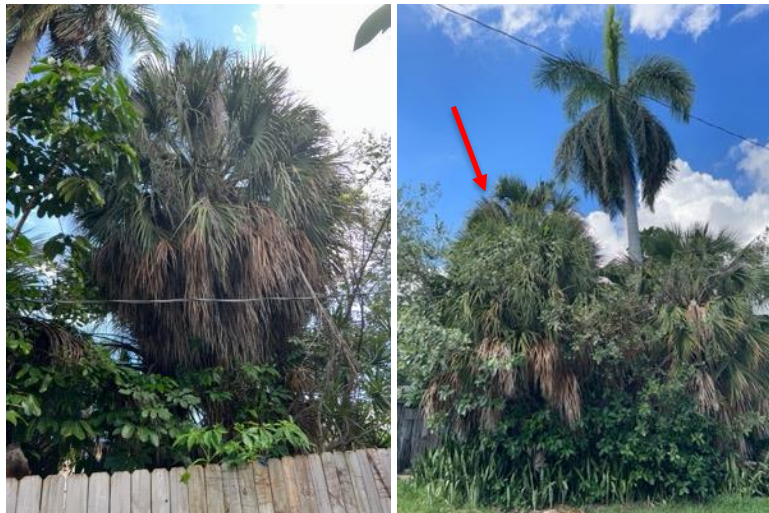
Tree #20 – *Roystonea regia*, Royal Palm – this tree is located in an overgrown cluster of vegetation on the east side of the property. It is very crowded and overgrown and could not be accessed due to its location within a fenced area. It shows signs of very minor nutrient deficiency. Overall it is in fair condition and is proposed for removal.

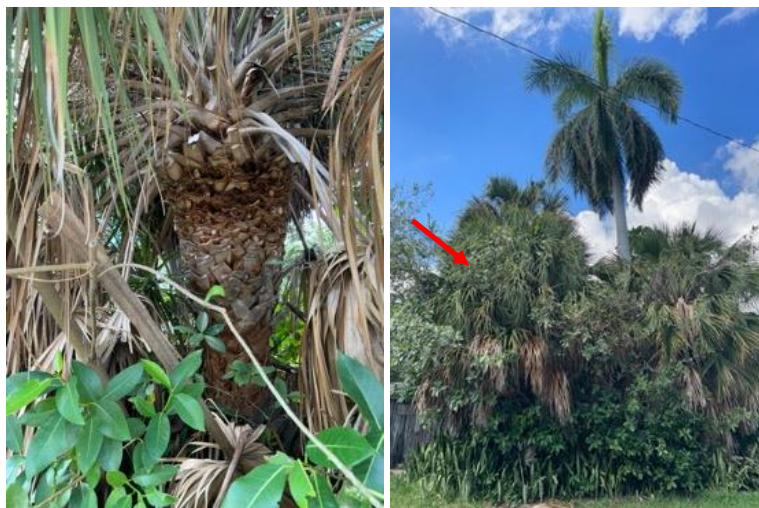
Tree #30 – *Sabal palmetto*, Sabal Palm – this tree is located directly in front of Tree #21 on the east side of the property. It is very crowded, overgrown with vines, and unmaintained. Overall, it is in fair condition and is proposed for removal.
