TREAGE LLC
Tree and Garden Experts

ARBORIST REPORT

872 McNab Rd.
Pompano Beach, FL 33030

Assignment/Overview

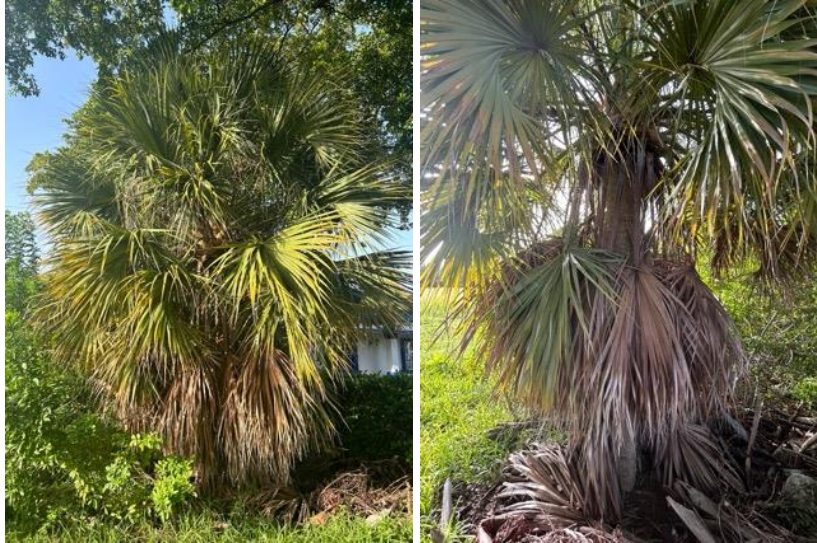
Tree #1 – *Sabal palmetto*, Sabal Palm – this tree is located on the northwest side of the site near the property line. It is crowded, overgrown, and unmaintained, but overall is in fair condition. It will require a permit if it is to be removed, or protection during construction per measures below. As an alternative, it is a decent candidate for relocation.

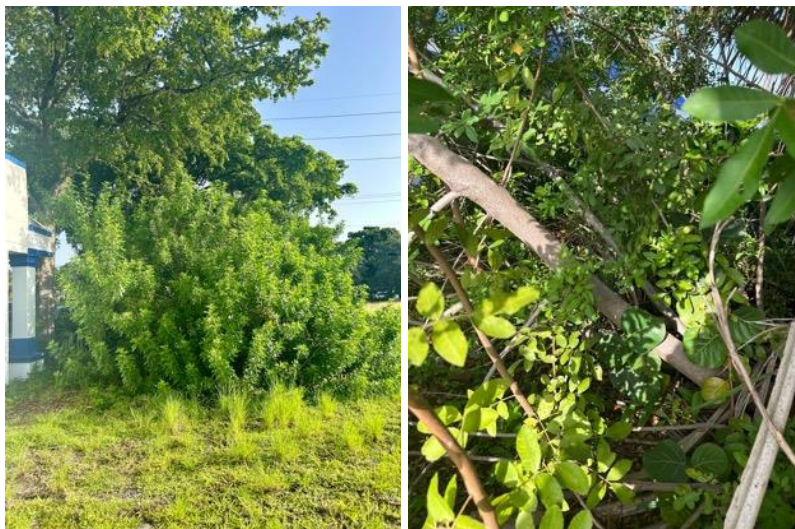
Tree #2 – *Schinus terebinthifolia*, Brazilian Pepper – this tree is growing directly south of Tree #1. It consists of multiple small trunks/sprouts and is very overgrown. This is considered a Nuisance Species that must be removed with a no-fee permit.

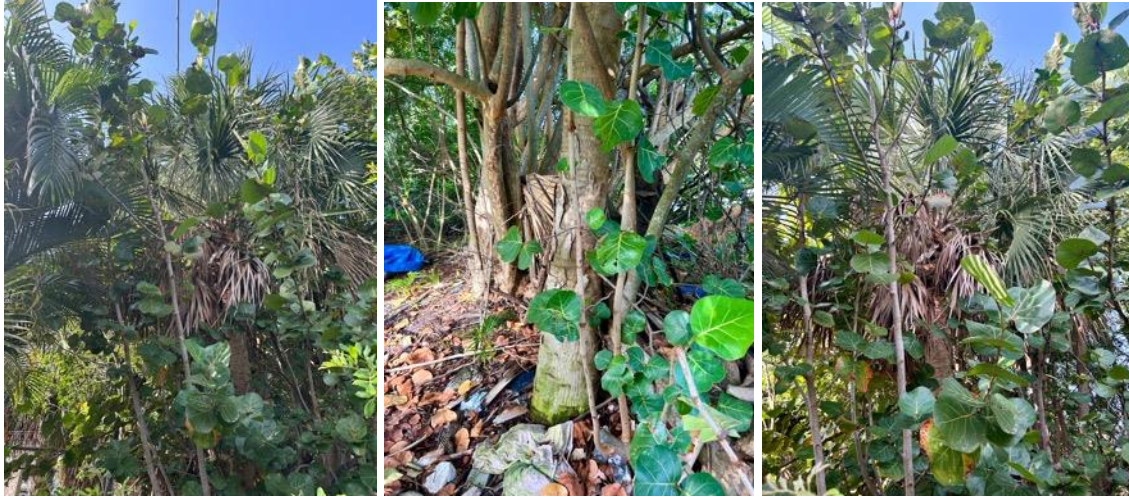
Tree #3 – *Sabal palmetto*, Sabal Palm – this tree is located on the southeast side of the property within 4' of the chain link fence separating the adjacent property. It is very crowded and overgrown but otherwise in fair condition. It will require a permit if it is to be removed, or protection during construction per measures below. As an alternative, it is a possible candidate for relocation.

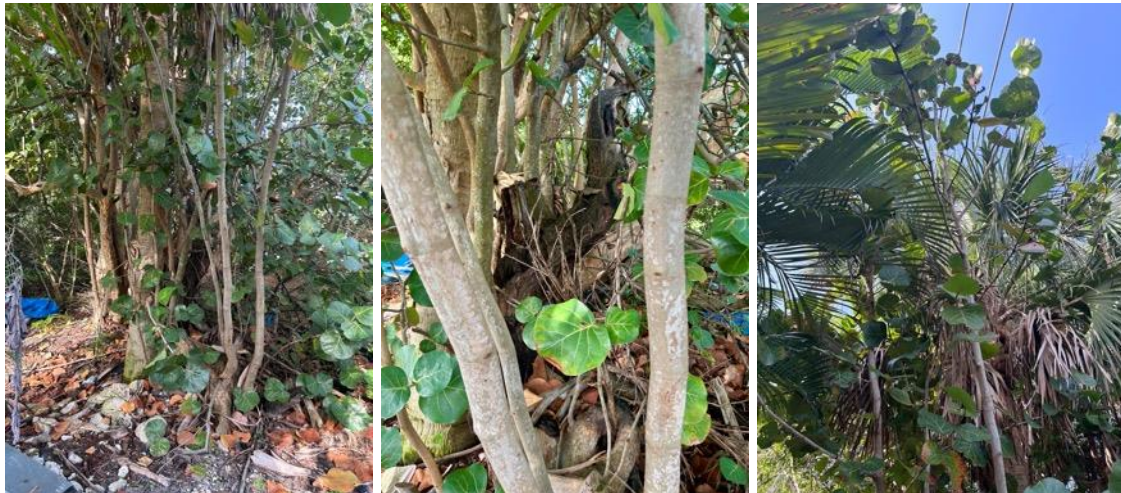
Tree #4 – *Coccoloba uvifera*, Seagrape – this tree is growing directly west of Tree #3. It has a large dead/decayed trunk that terminates at approximately 5' height and only small upright sprouts remaining. This tree is very crowded and overgrown and it has a poor branching structure. Overall, it is in moderate to poor condition.

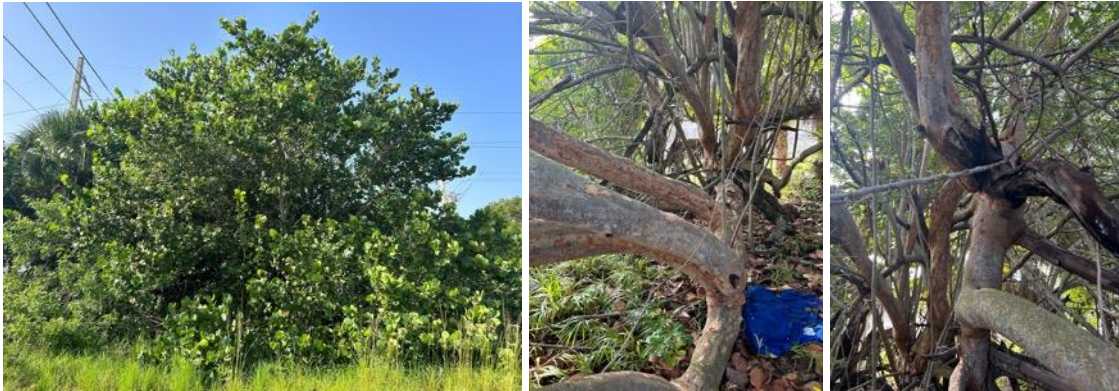
Tree #5 – *Coccoloba uvifera*, Seagrape – this tree is growing slightly southwest of Tree #4. There are 6 upright trunks on the east side of the tree and 2 large trunks that are leaning heavily to the west. This is assumed to be 1 tree that fell horizontally and is resprouting vertically from the base, although it could possibly be 2 separate trees growing against each other. It is very crowded and overgrown with areas of significant decay. Overall, this tree is in moderate condition. It is recommended for canopy cleaning/maintenance pruning and further evaluation to determine its disposition.

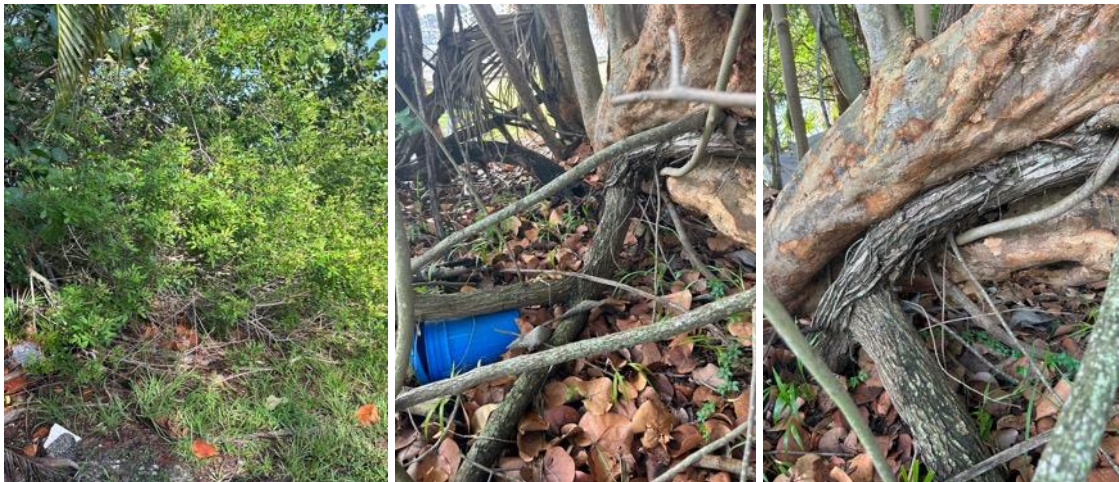
Tree #6 – *Schinus terebinthifolia*, Brazilian Pepper – this tree is growing next to and against/in contact with Tree #5. It is very overgrown, crowded, and in poor condition. It is a Nuisance Species that will require removal with a no-fee permit.

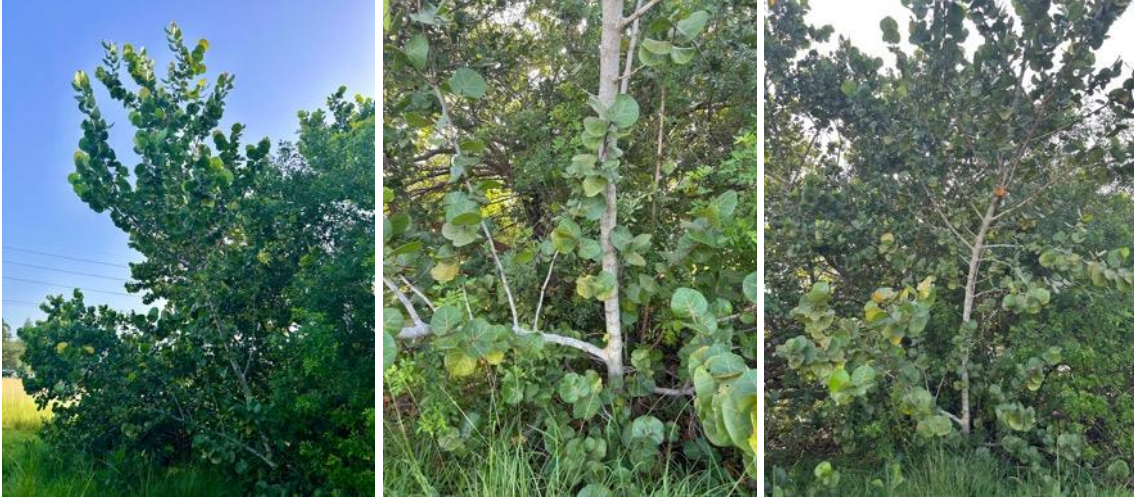
Tree #7 – *Coccoloba uvifera*, Seagrape – this is a small volunteer growing on the west side of the overgrown cluster of vegetation containing Trees #4-6. It is crowded and leaning as a result with an overall weak structure/growth habit. This tree is in moderate condition. It will require a permit if it is to be removed, or protection during construction per measures below. As an alternative, it is a possible candidate for relocation.

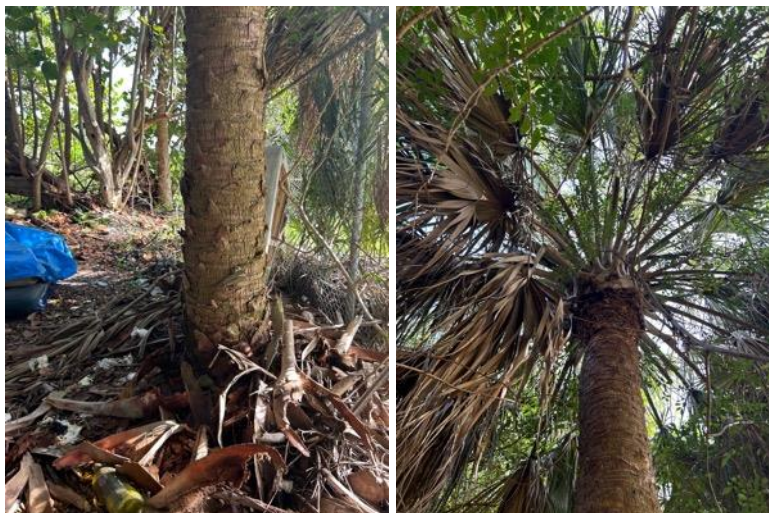
Tree #8 – *Sabal palmetto*, Sabal Palm – this palm is growing within 3.5' of the chain link fence slightly south of Tree #3. It is very crowded and overgrown, but otherwise in fair condition. It will require a permit if it is to be removed, or protection during construction per measures below. As an alternative, it is a possible candidate for relocation.

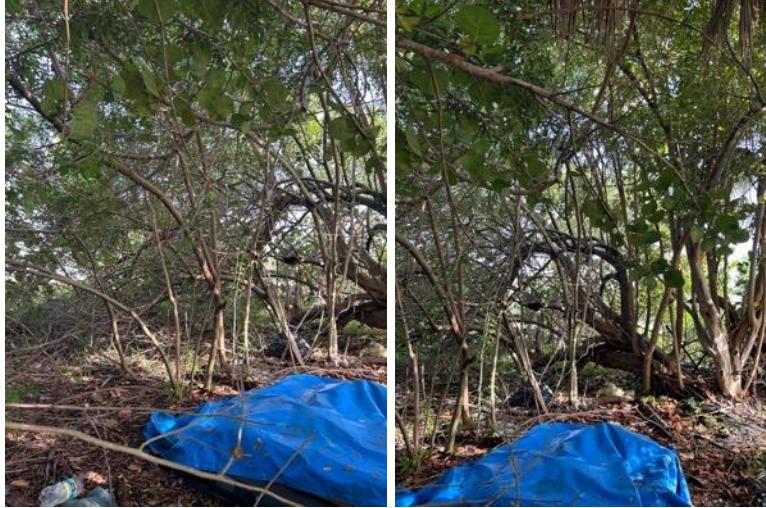
Note: there are several small Brazilian Pepper volunteers, all under 3" DBH, growing under the canopy of Tree #5. They are under regulation size and were not individually counted. These are Nuisance Species that should be eligible for removal without a separate permit (to be confirmed by the City).

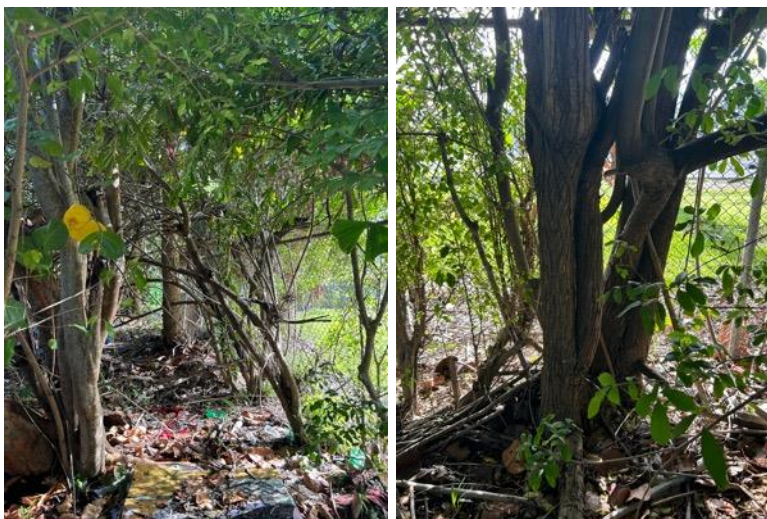
Tree #9 – *Schinus terebinthifolia*, Brazilian Pepper – this tree is growing slightly south of Tree #8 along the fence line. It is very overgrown, crowded, and in moderate condition. It is a Nuisance Species that will require removal with a no-fee permit.

Tree #10 – *Schinus terebinthifolia*, Brazilian Pepper – this tree is growing slightly south of Tree #9 along the fence line. It is very overgrown, crowded, and in moderate condition. It is a Nuisance Species that will require removal with a no-fee permit.

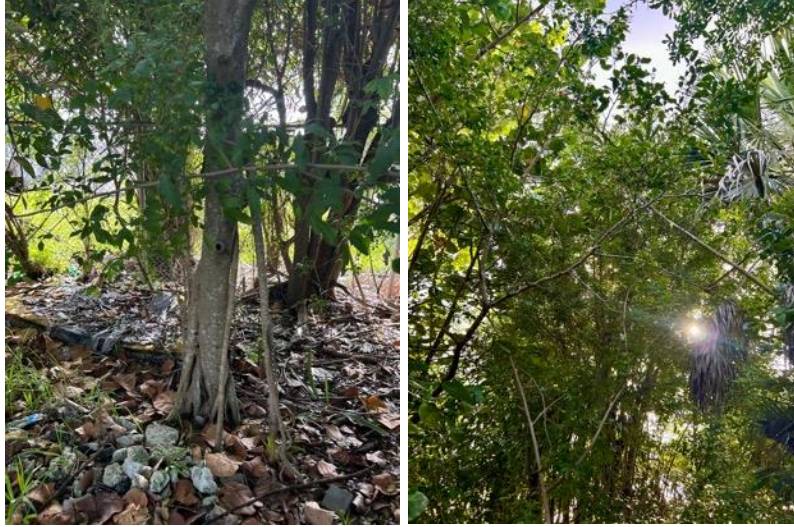
Tree #11 – *Ficus benjamina*, Weeping Fig – this tree is located slightly west of Tree #10. It is very crowded and overgrown and leaning somewhat as a result. Overall, it is in moderate condition. It will require a permit if it is removed, or protection during construction per measures below if it remains.

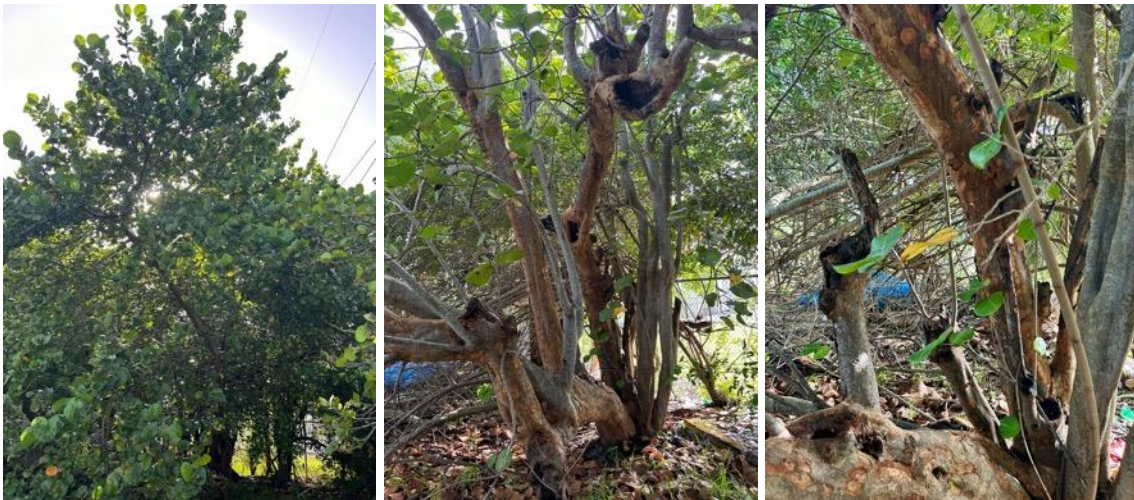
Tree #12 – *Coccoloba uvifera*, Seagrape – this large tree is growing slightly northwest of Tree #10 near the southeast corner of the property. It consists of multiple trunks, the majority of which have poor cuts and tears with deadwood and decay present. Overall, this tree is in borderline fair condition. It is recommended for canopy cleaning/maintenance pruning and further evaluation to determine its disposition.

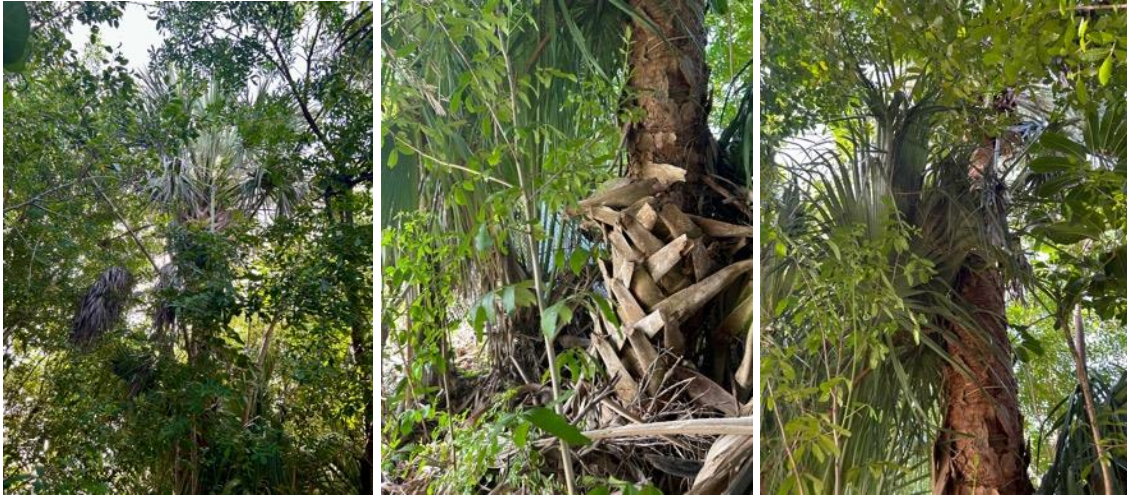
Tree #13 – *Sabal palmetto*, Sabal Palm – this palm is growing in the southeast corner of the property. It is very crowded and overgrown and difficult to access, and it has partial boots remaining, so the DBH had to be estimated. Overall, this tree appears to be in fair condition. It is a decent candidate to remain with protection due to its location along the fence. Otherwise, it will require a permit if it is to be removed. There is a small seedling/volunteer Sabal next to it that is under regulation size.

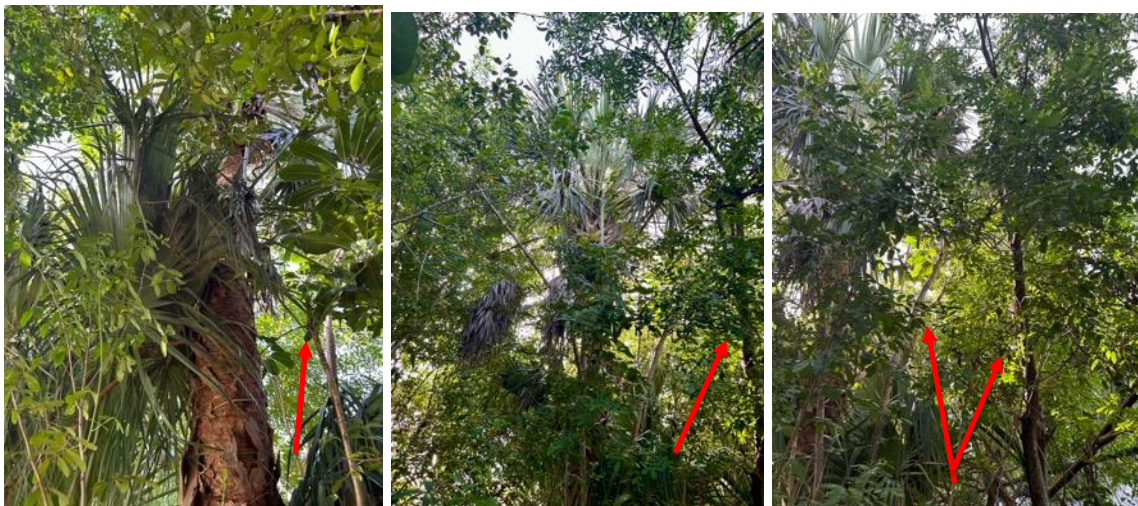
Tree #14 – *Schefflera actinophylla*, Umbrella Tree – this tree is growing on the west side of, and against, Tree #13. It is very crowded with a weak structure as a result. This is a Nuisance Species that requires removal with a no-fee permit.

Tree #15 – *Schinus terebinthifolia*, Brazilian Pepper – this tree is growing slightly west of Trees #13-14 along the west fence line. It is crowded, overgrown, and in moderate condition. It is a Nuisance Species that will require removal with a no-fee permit.

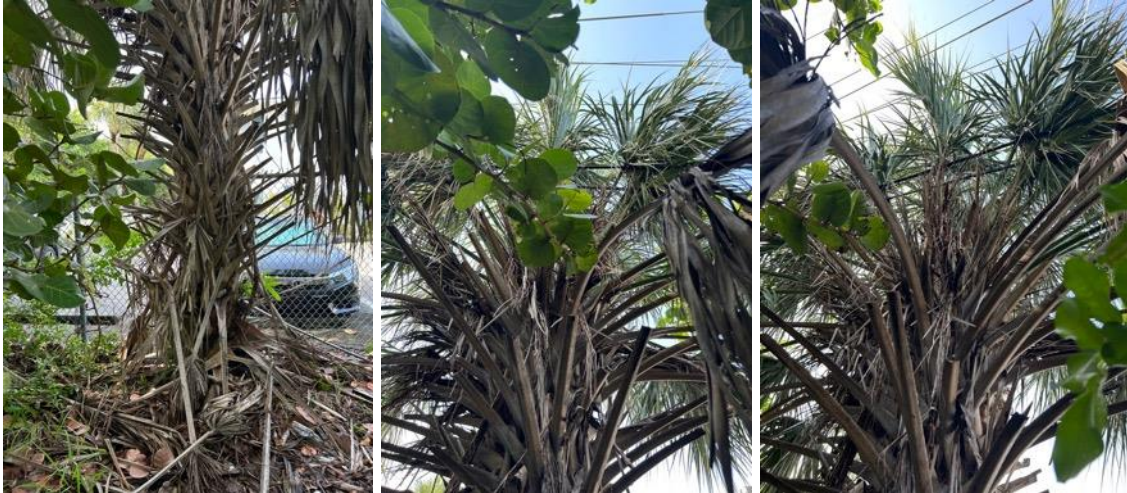
Tree #16 – *Sabal palmetto*, Sabal Palm – this tree is located along the south fenceline slightly west of Tree #15 and south of Tree #12. It is crowded and overgrown and in close proximity to the utility lines. Overall, it is in fair condition. It is a decent candidate to remain with maintenance pruning/canopy cleaning, however it is in proximity of utility lines so this should be taken into account. If it is removed, it will require a permit and mitigation.

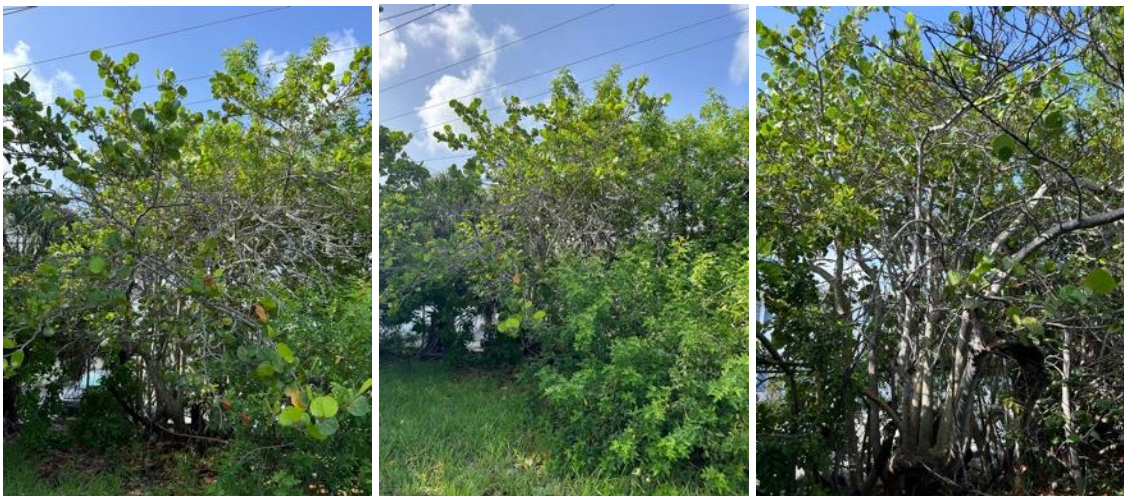
Tree #17 – *Coccoloba uvifera*, Seagrape – this refers to an overgrown cluster of Seagrape located slightly west of Tree #16 along the fence line. It consists of multiple small diameter trunks/sprouts. It has a poor branching structure with moderate deadwood and significant decay present, and it is growing in close proximity to utility wires. This tree is recommended for maintenance pruning/canopy cleaning and subsequent further evaluation to determine its disposition. It will require a permit and mitigation if it is removed.

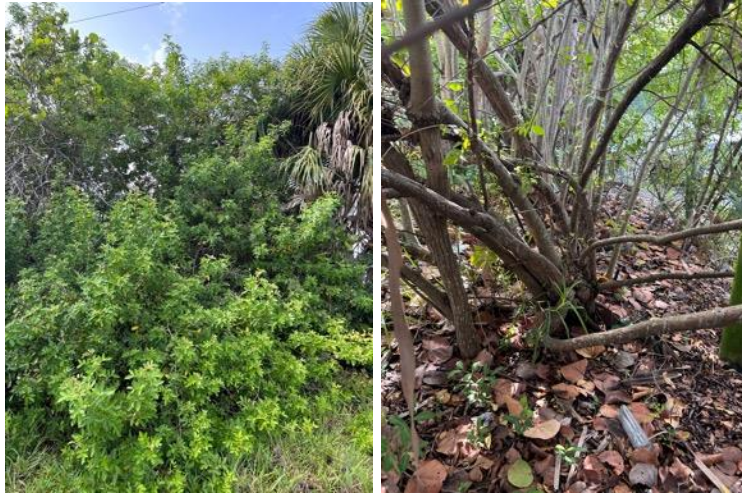
Tree #18 – *Schinus terebinthifolia*, Brazilian Pepper – this tree is growing just west of Tree #17. It is overgrown, unmaintained, and is a Nuisance Species that must be removed with a no-fee permit.

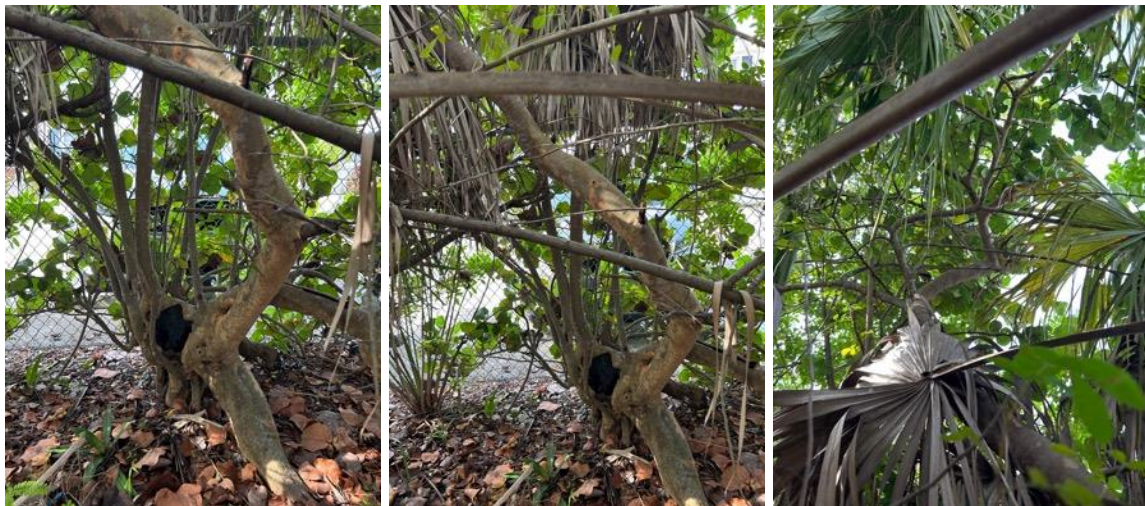
Tree #19 – *Coccoloba uvifera*, Seagrape – this tree is growing against the fence just west of Tree #18. There is one limb that bends and extends backward over the neighboring property and otherwise there are only small sprouts originating above a decay cavity at the base of the trunk. Overall, this tree is in poor condition. It is most likely a good candidate for removal due to its condition.

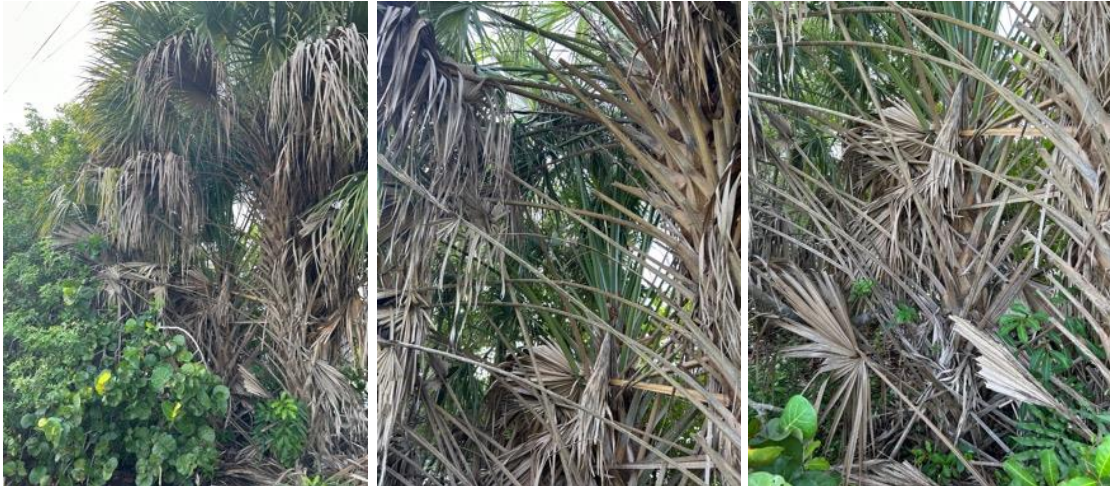
Tree #20– *Sabal palmetto*, Sabal Palm – this tree is growing against Tree #19 in a cluster of Sabal Palms. It is extremely crowded. It does not appear to have any clear trunk at 4.5' height, so it may be eligible for removal without a permit, to be confirmed by the City.

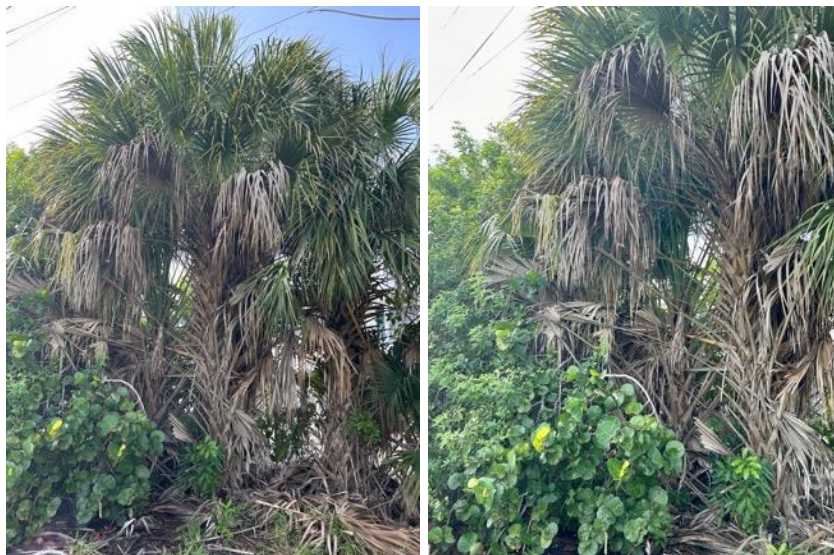
Tree #21 – *Sabal palmetto*, Sabal Palm – this tree is growing in the middle of a cluster of Sabals along the fence line with Trees #19-20. Its trunk is barely visible due to extreme crowding. It does have its boots still present. This tree could remain with protection during construction, but it is growing in close proximity to utility lines. As an alternative, it may be a decent candidate for relocation onsite per specifications below. Otherwise, it will require a permit and mitigation if it is removed.

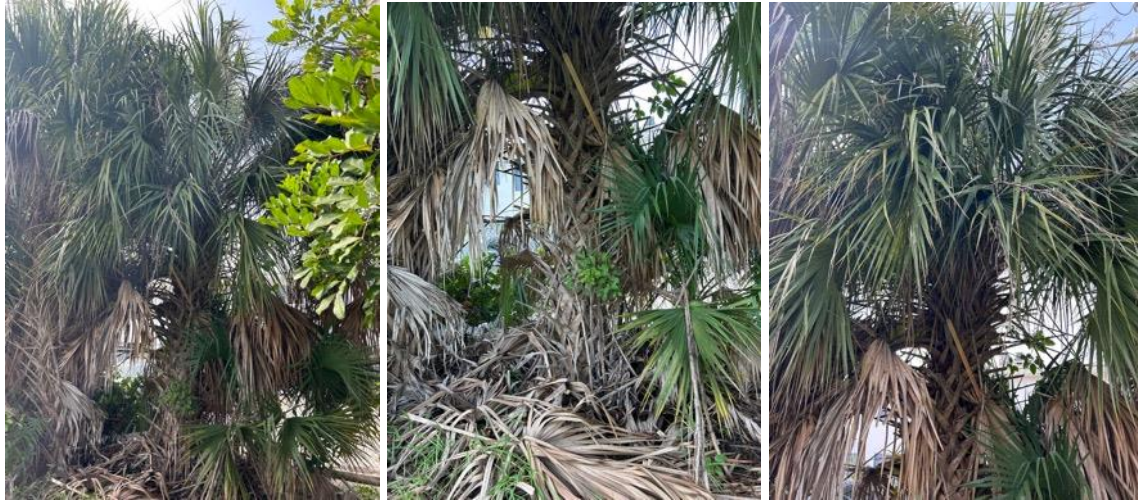
Tree #22 – *Sabal palmetto*, Sabal Palm – this palm is growing on the west side of the cluster with Trees #20-21. It is very crowded, overgrown and unmaintained. It is in borderline fair condition. This tree could remain with protection during construction, but it is growing in very crowded conditions and very close to utility lines. As an alternative, it may be a decent candidate for relocation onsite; see relocation specifications below. Otherwise, it will require a permit and mitigation if it is removed.

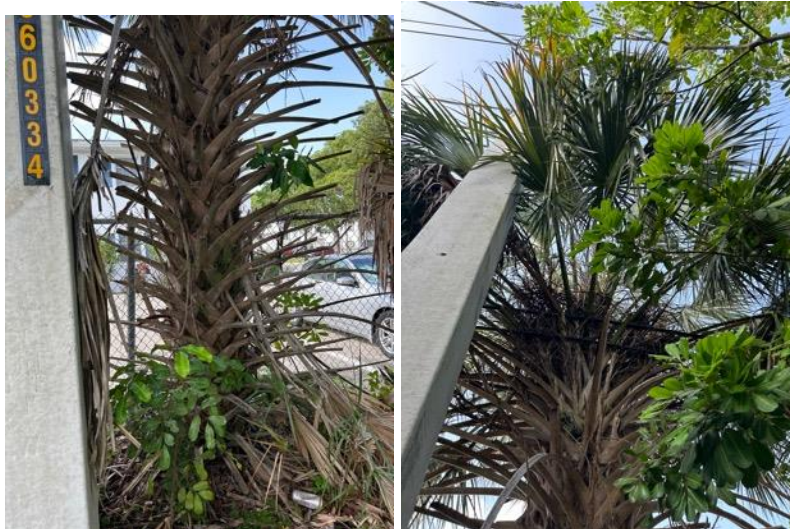
Tree #23 – *Sabal palmetto*, Sabal Palm – this tree is growing just west of Tree #22 and a utility pole near the south fence line. It is very crowded but otherwise in fair condition. It is growing among the adjacent utility lines. It still has its boots present. This tree could remain with protection during construction, but it is growing in very close proximity to a utility pole/utility lines. As an alternative, it may be a decent candidate for relocation onsite per specifications below. Otherwise, it will require a permit and mitigation if it is removed.

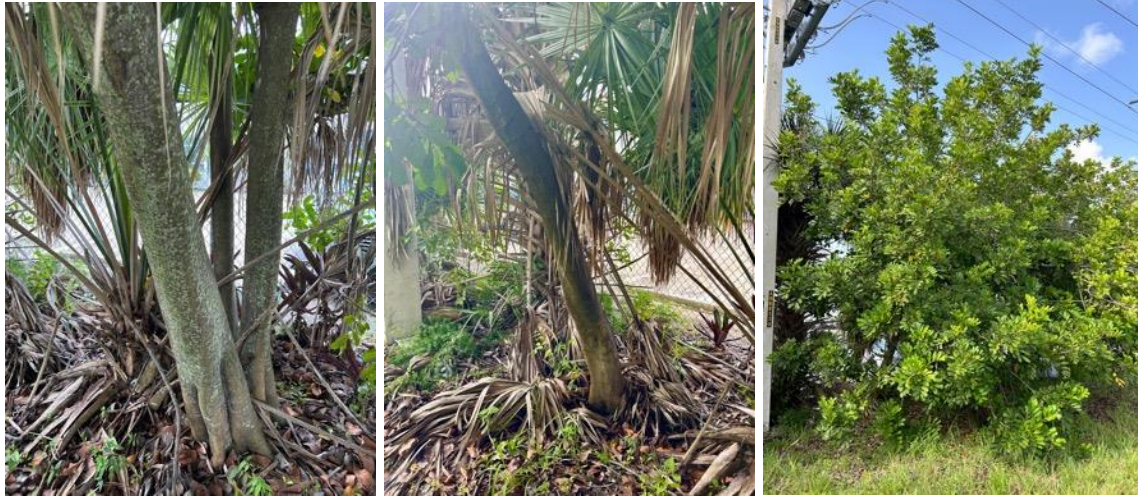
Tree #24 - *Cupaniopsis anacardioides*, Carrotwood – this tree is growing against the south fence line just west of Tree #23. It is crowded, overgrown, leaning and in poor condition. This is a Nuisance Species that requires removal with a no-fee permit.

Tree #25 - *Cupaniopsis anacardioides*, Carrotwood – this tree is growing against the south fence line just west of Tree #24. It consists of multiple trunks and is crowded, overgrown and leaning. This is a Nuisance Species that requires removal with a no-fee permit.

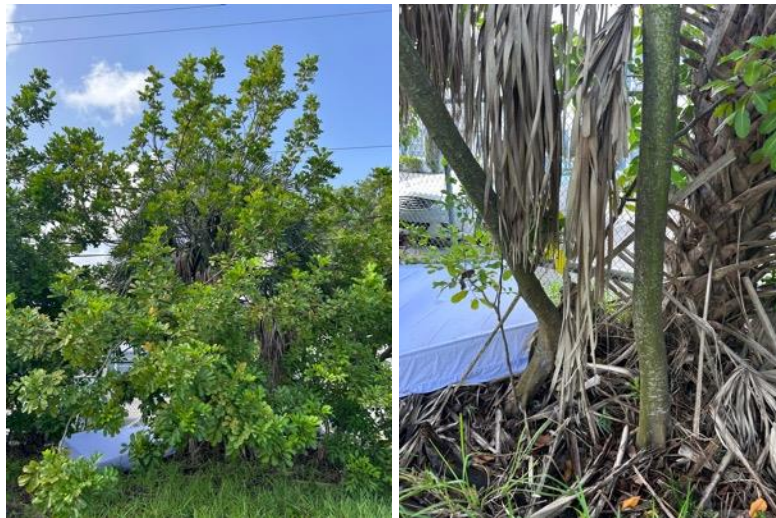
Tree #26-27 - *Cupaniopsis anacardioides*, Carrotwood – this refers to 2 small Carrotwood trees growing just west of Tree #25. They are crowded and leaning as a result. These are a Nuisance Species that require removal with a no-fee permit.

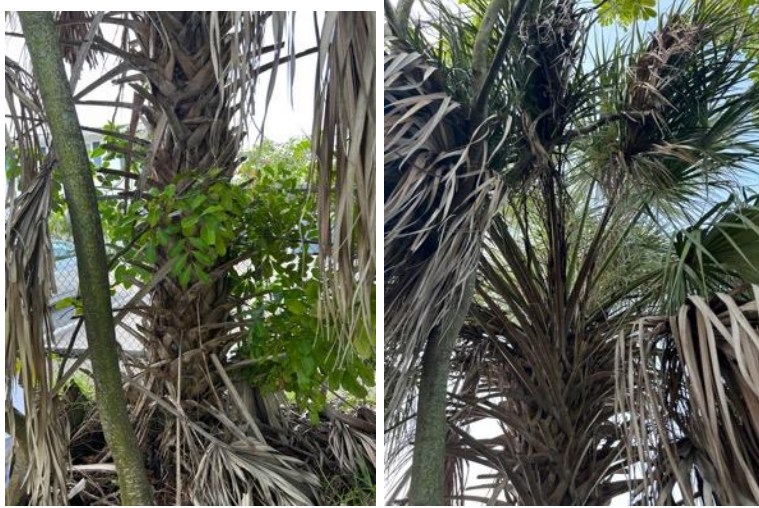
Tree #28 – *Sabal palmetto*, Sabal Palm – this tree is growing against the fence just west of Tree #27. It is crowded, overgrown, and unmaintained, and it still has its boots intact, but overall it is in fair condition. It is a decent candidate to remain due to its location and compact root zone. If it is removed, it will require a permit and mitigation.

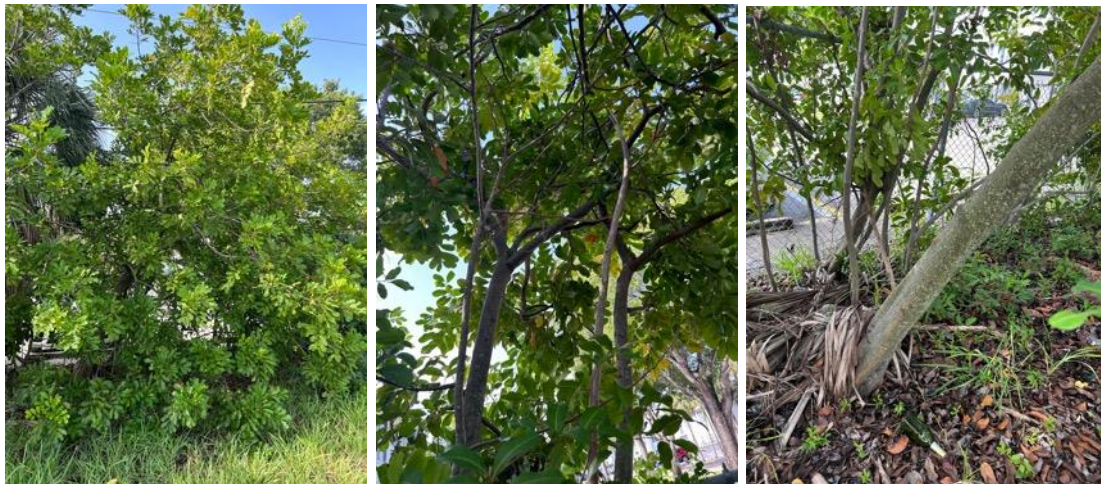
Tree #29 - *Cupaniopsis anacardioides*, Carrotwood – this tree is growing just west of Tree #28 near the property line. It is crowded and leaning in poor condition. This is a Nuisance Species that requires removal with a no-fee permit.

Tree #30 - *Cupaniopsis anacardioides*, Carrotwood – this tree is growing just behind Tree #29 near the property line. It is crowded and in poor condition with small tears present. This is a Nuisance Species that requires removal with a no-fee permit.

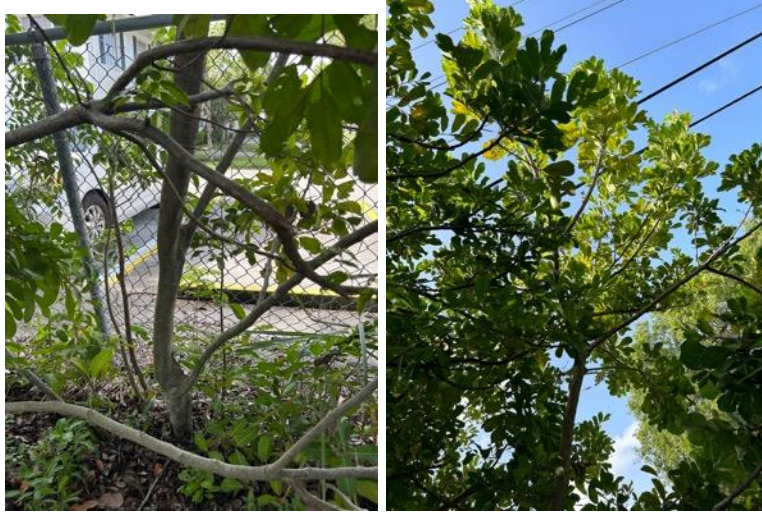
Tree #31 - *Cupaniopsis anacardioides*, Carrotwood – this tree is growing just west of Tree #30 near the property line. It is crowded and in poor condition. This is a Nuisance Species that requires removal with a no-fee permit.

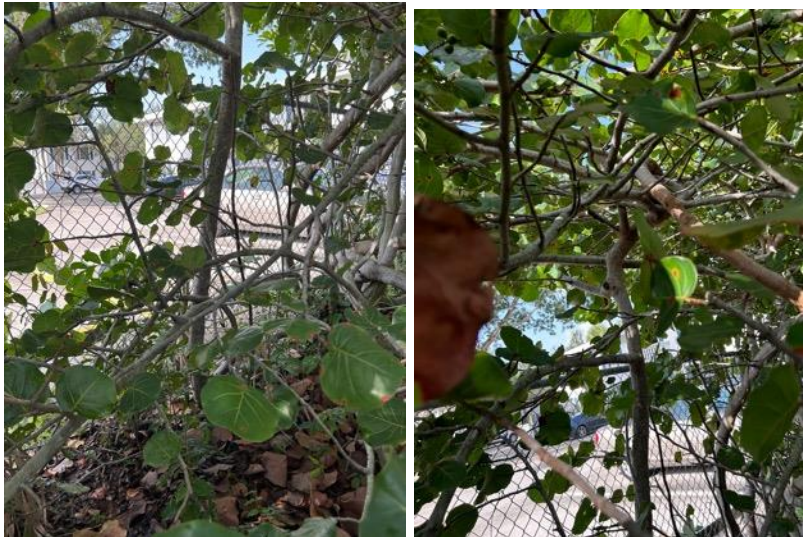
Tree #32 – *Coccoloba uvifera*, Seagrape – this is a small individual that is likely a volunteer. It has a poor branching structure and weak growth habit due to very crowded conditions. It has a single trunk that bends at nearly a 90 degree angle at approximately 5' height and its maximum height is 10'. This tree is just over regulation size, so it will most likely require a permit and mitigation for removal.

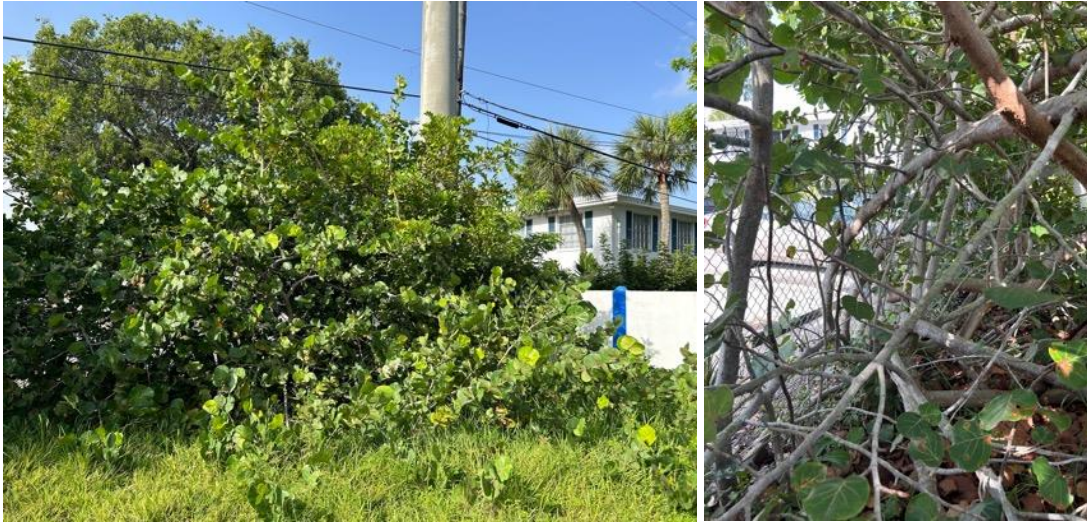
Tree #33 – *Coccoloba uvifera*, Seagrape – this cluster is located near the southwest corner of the property just west of Tree #32. It consists of multiple small diameter sprouts growing mostly horizontally due to crowding; there are only 2 sprouts over regulation height. It is crowded, overgrown and unmaintained. Overall, it is in moderate condition. It will require protection during construction and is recommended for maintenance pruning/cleaning if it remains; otherwise, it will require a permit and mitigation if it is removed.

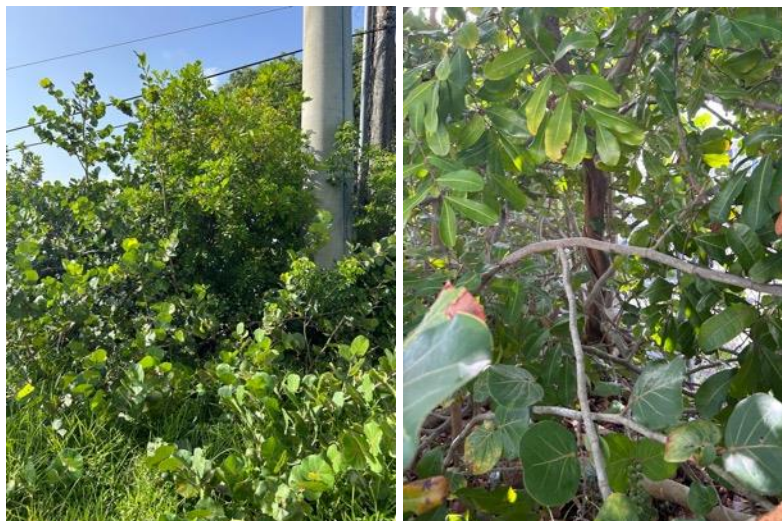
Tree #34 - *Cupaniopsis anacardioides*, Carrotwood – this tree is growing on the southwest side of the property near the fence line. It is crowded and overgrown with a weak structure. This is a Nuisance Species that requires removal with a no-fee permit.

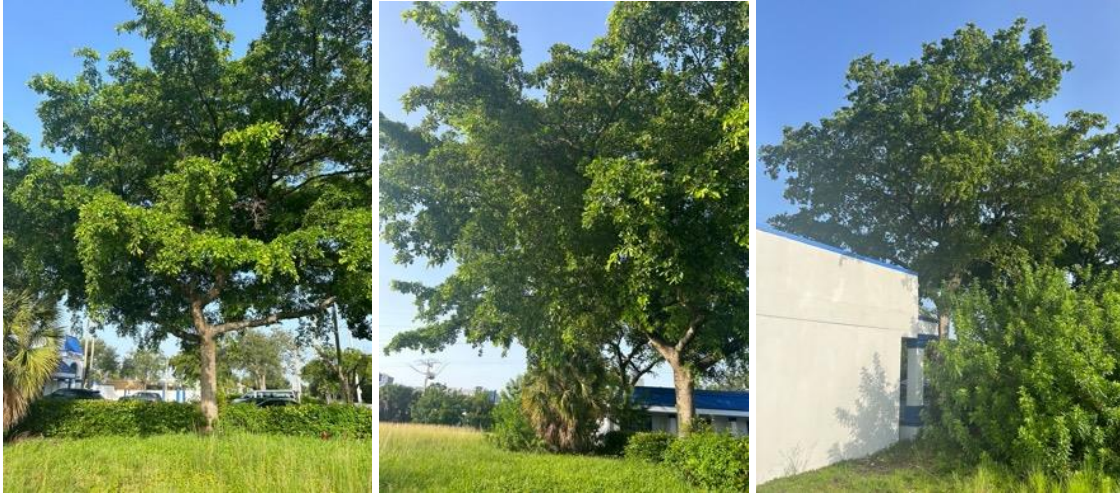
***Bucida buceras*, Black Olive** – there are 2 Black Olive trees located on the property to the west adjacent to the northwest side of this property. Both trees are within 10' or less of the property line, so it is likely that their CRZ's extend approximately 5' or more over the property line. They are not expected to be impacted but protection measures below apply during any work, including staging and access, within their TPZs. If any canopy pruning is required for clearance, it must be in accordance with ANSI Standards and pruning specifications below.

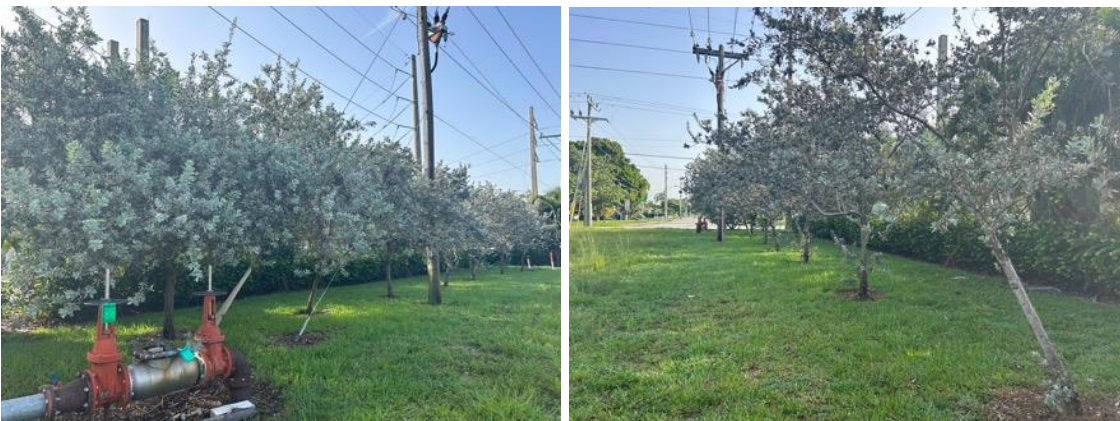
***Conocarpus erectus* var. *sericeus*, Silver Buttonwood** – this refers to a row of 7 somewhat recently planted Silver Buttonwoods located on the property to the east. They are not expected to be impacted and their TPZ's should not extend over the property line, but protection measures below apply.
