Prepared by: Trea Jones
International Society of Arboriculture Certified Arborist

Report

This is a residential property. My assignment is to evaluate all trees and palms on site for health, appraisal, and condition.

The property involved is known as 400 Sunset Dr, Pompano Beach, FL 33062. I arrived on site 03-19-2024. The trees/palms are located throughout the property.

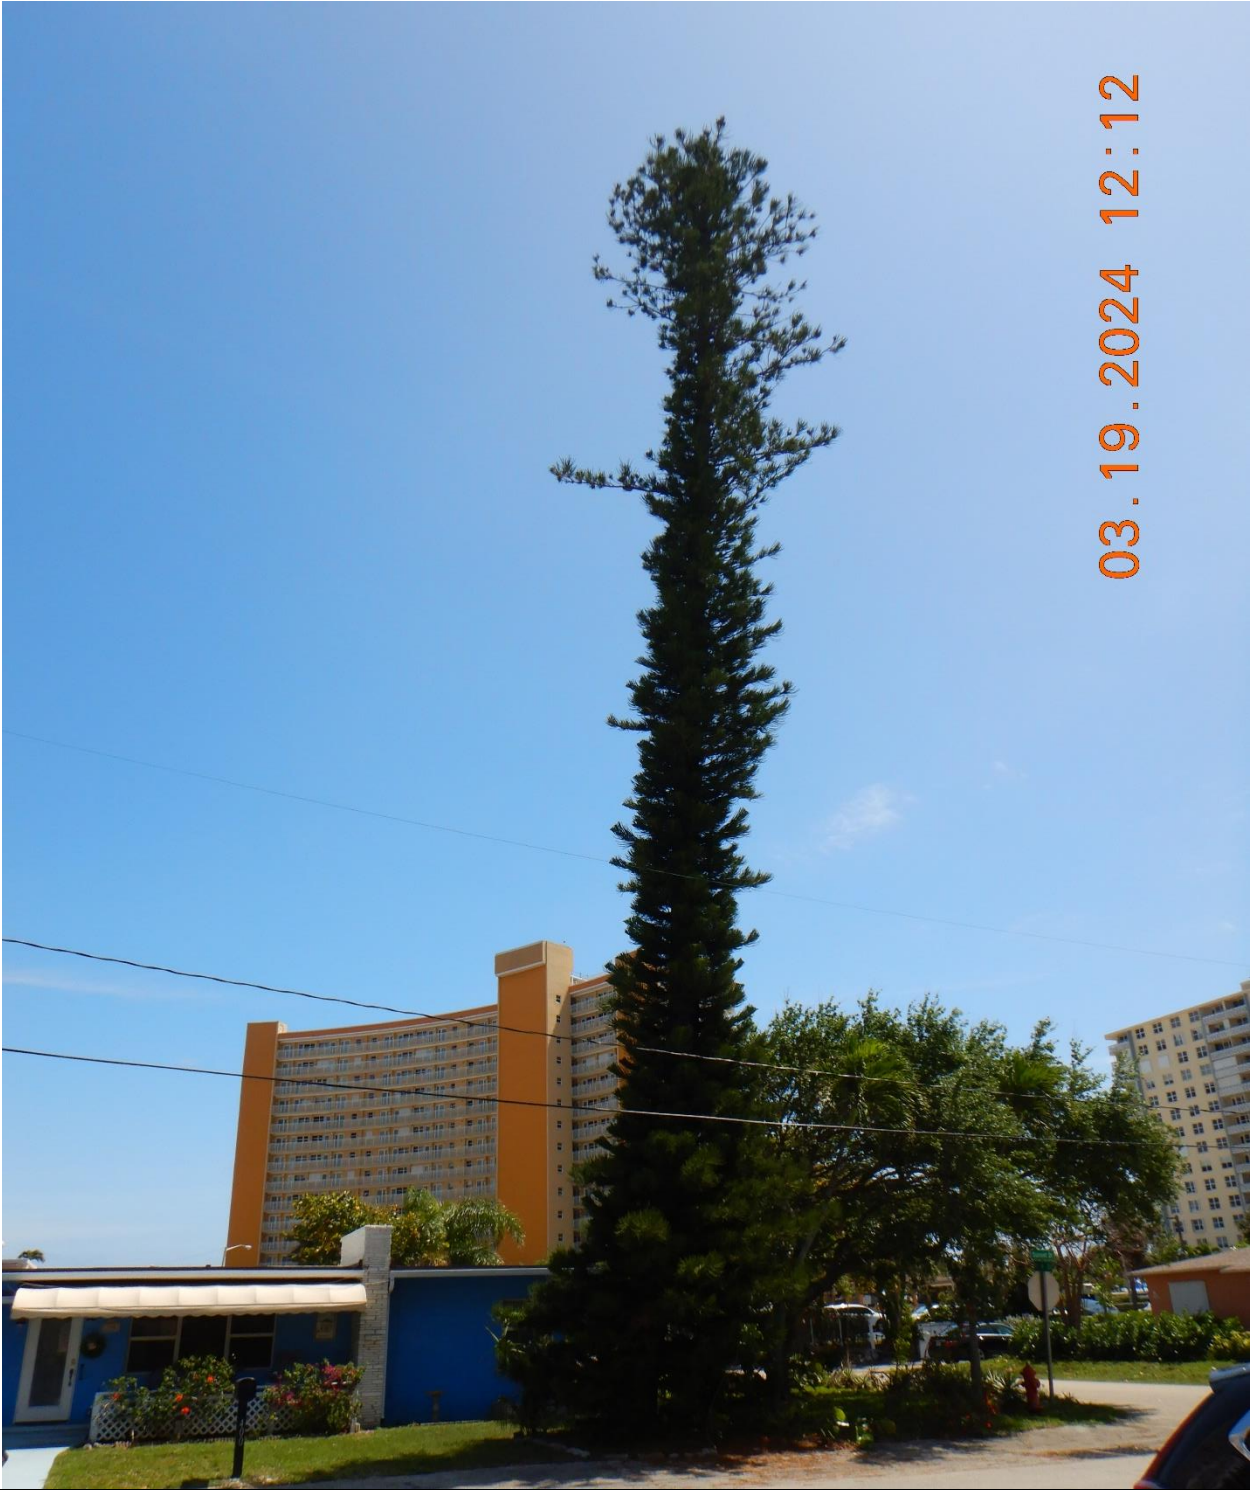
Tree #	Common name	Botanical name	DBH	Height OA	Height clt	Canopy size	Condition	Price per in / ft	Value before diminution	Value	Notes
1	Norfolk Island Pine	Araucaria heterophylla	22	60		12x12	60%	\$85.00	\$1,800.00	\$1,120.00

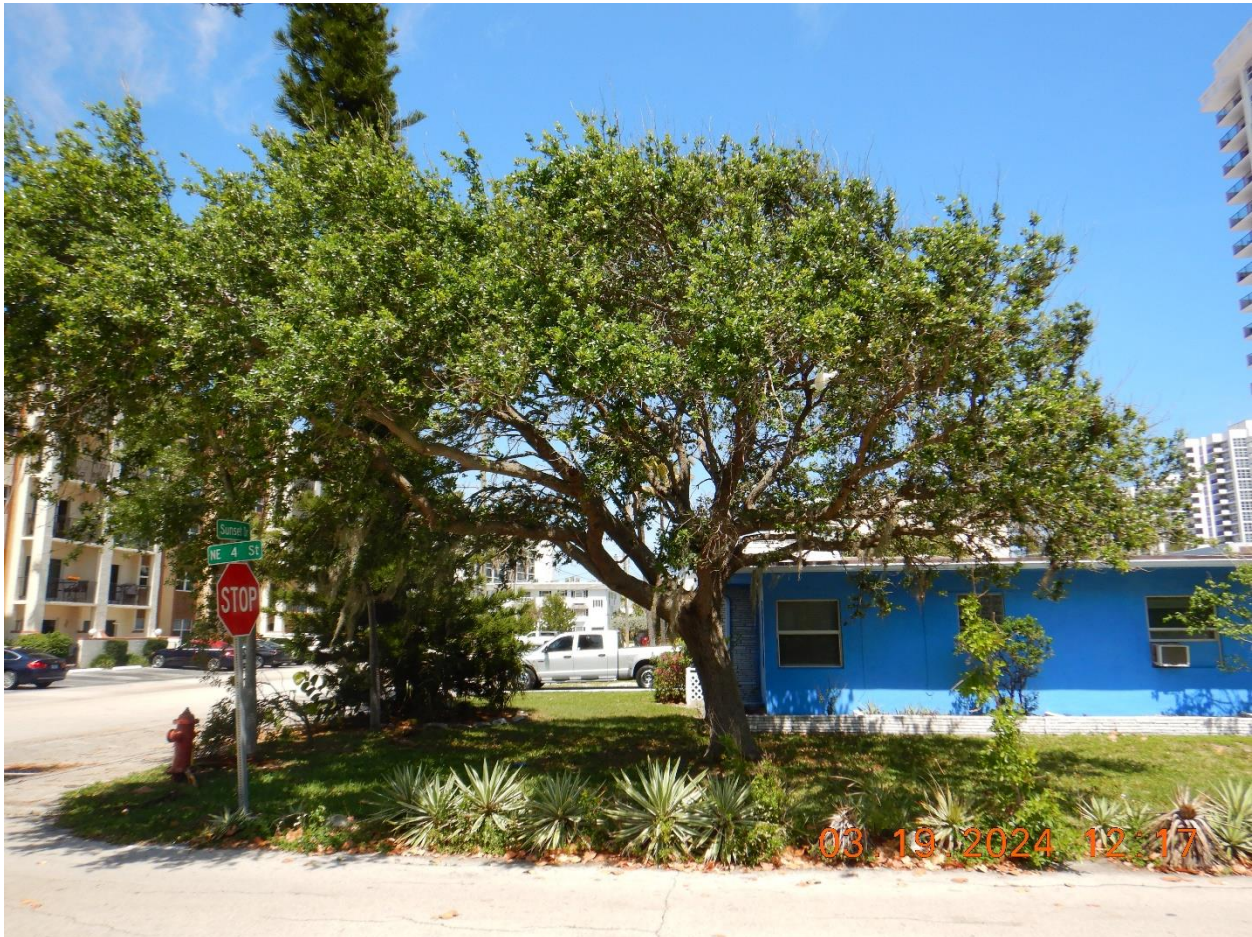
Tree #	Common name	Botanical name	DBH	Height OA	Height c/t	Canopy size	Condition	Price per in / ft	Value before Diminution	Value	Notes
2	Live oak	<i>Quercus virginiana</i>	19	25		40x35	60%	\$177.08	\$3,364.52	\$2,018.71	Co-dom branch union, tip decline

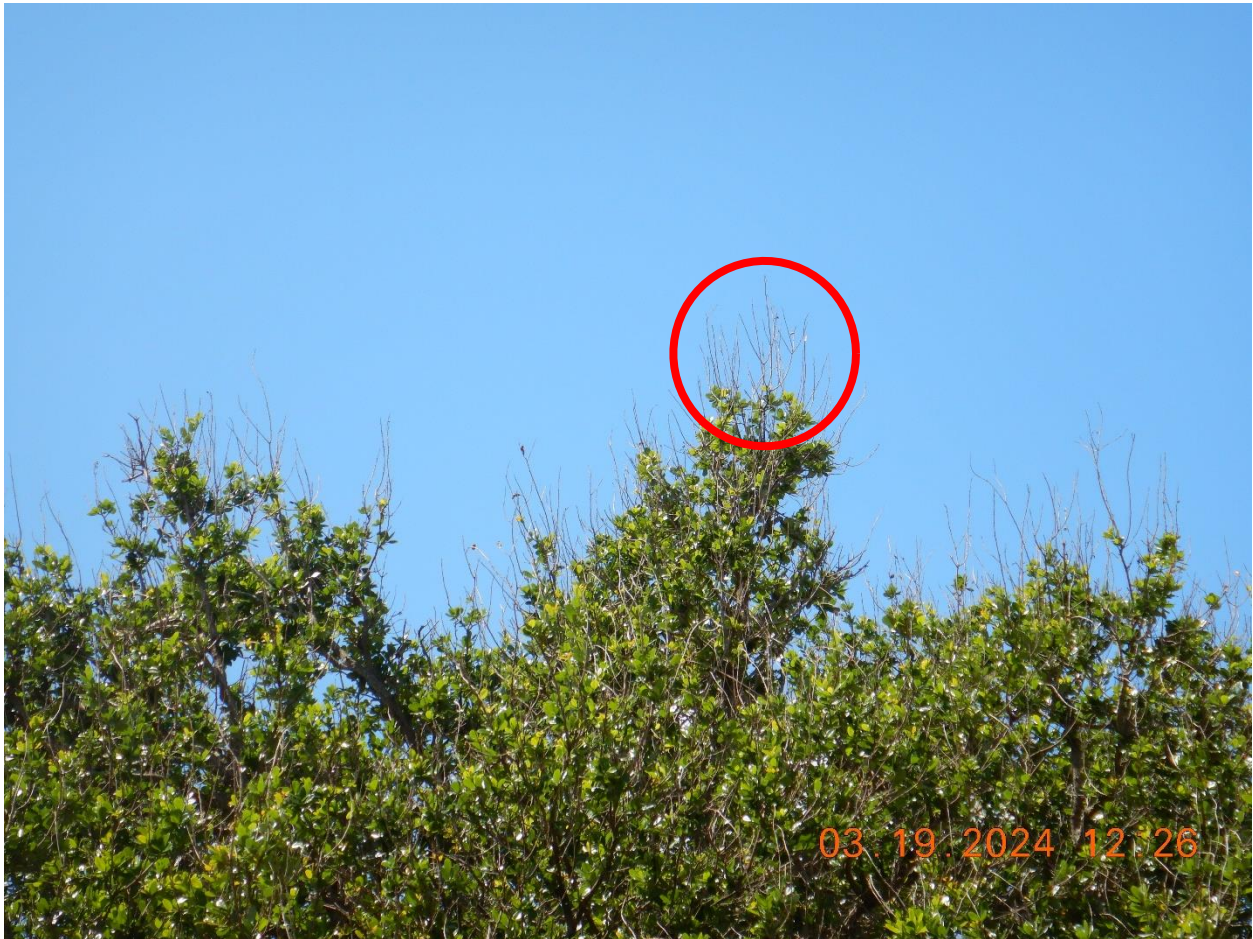
#2

Slight tip decline, an indication of a potential root-related problem.

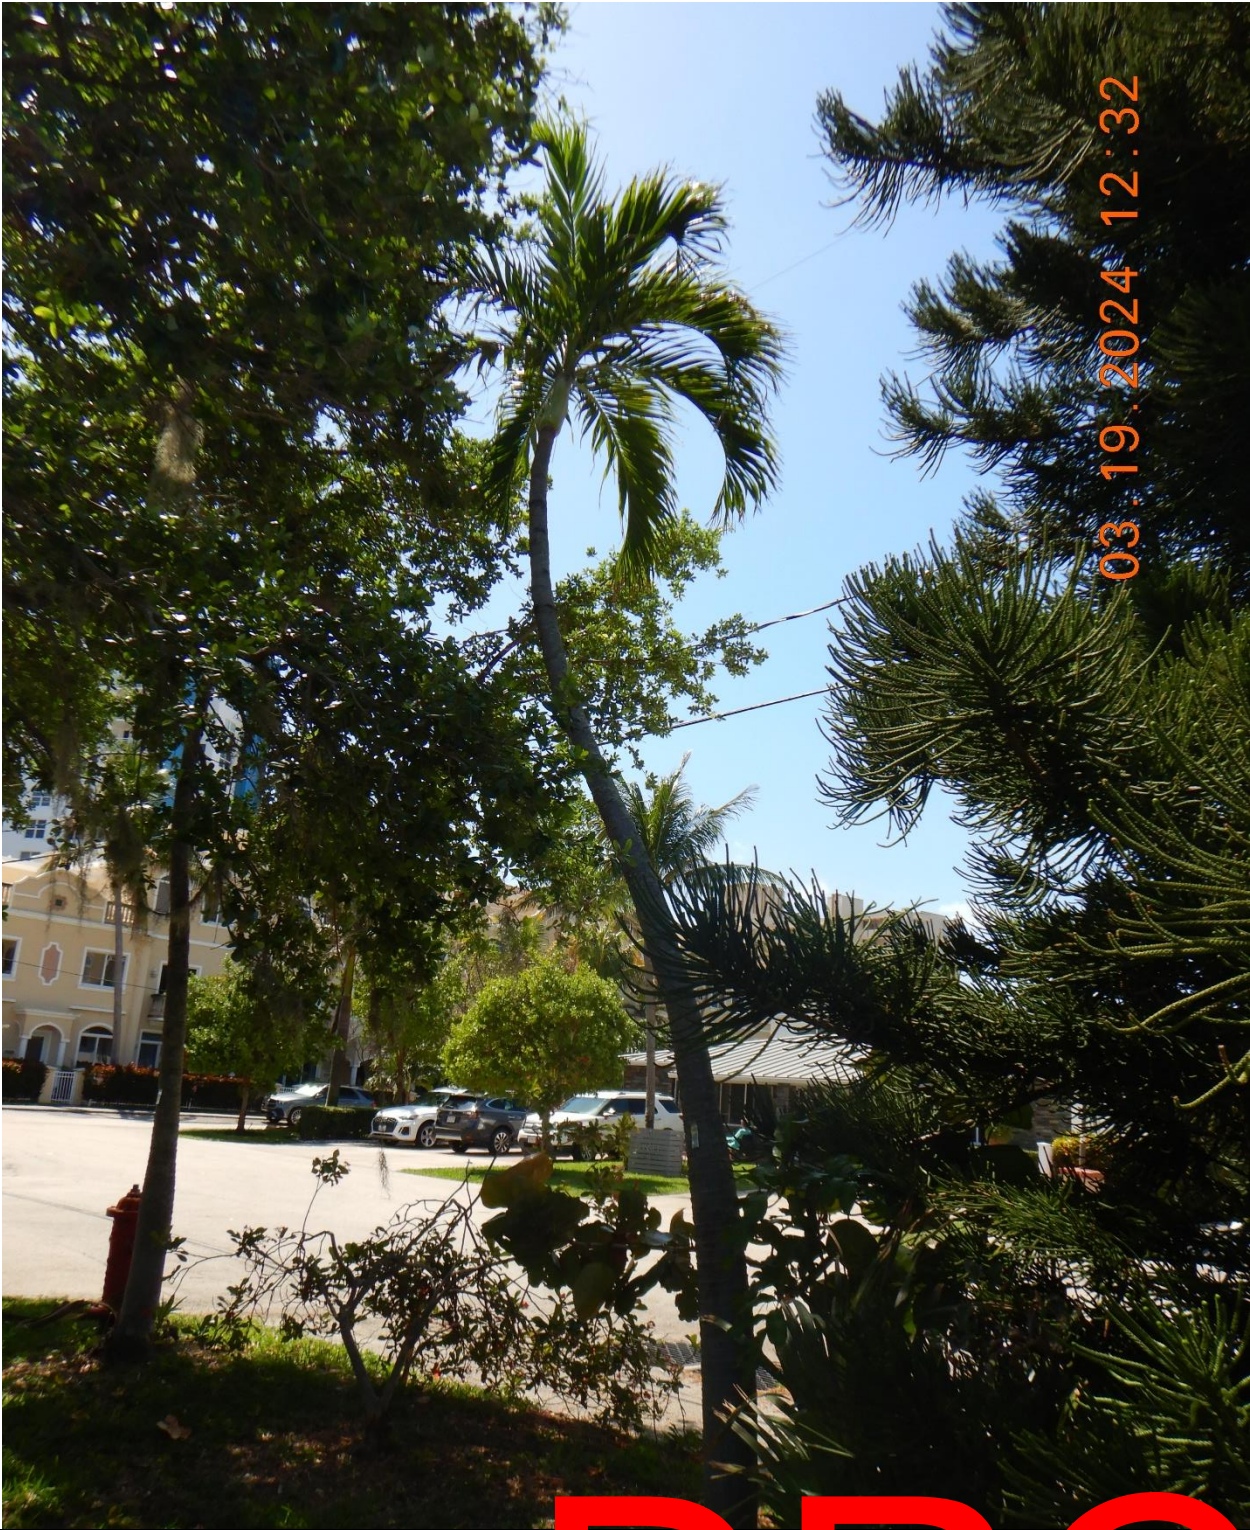
Tree #	Common name	Botanical name	DBH	Height OA	Height c/t	Canopy size	Condition	Price per in /	Value before Diminution	Value	Notes
3	Christmas palm	Adonidia merrillii			12		70%	\$32.74	\$392.8	\$253.02

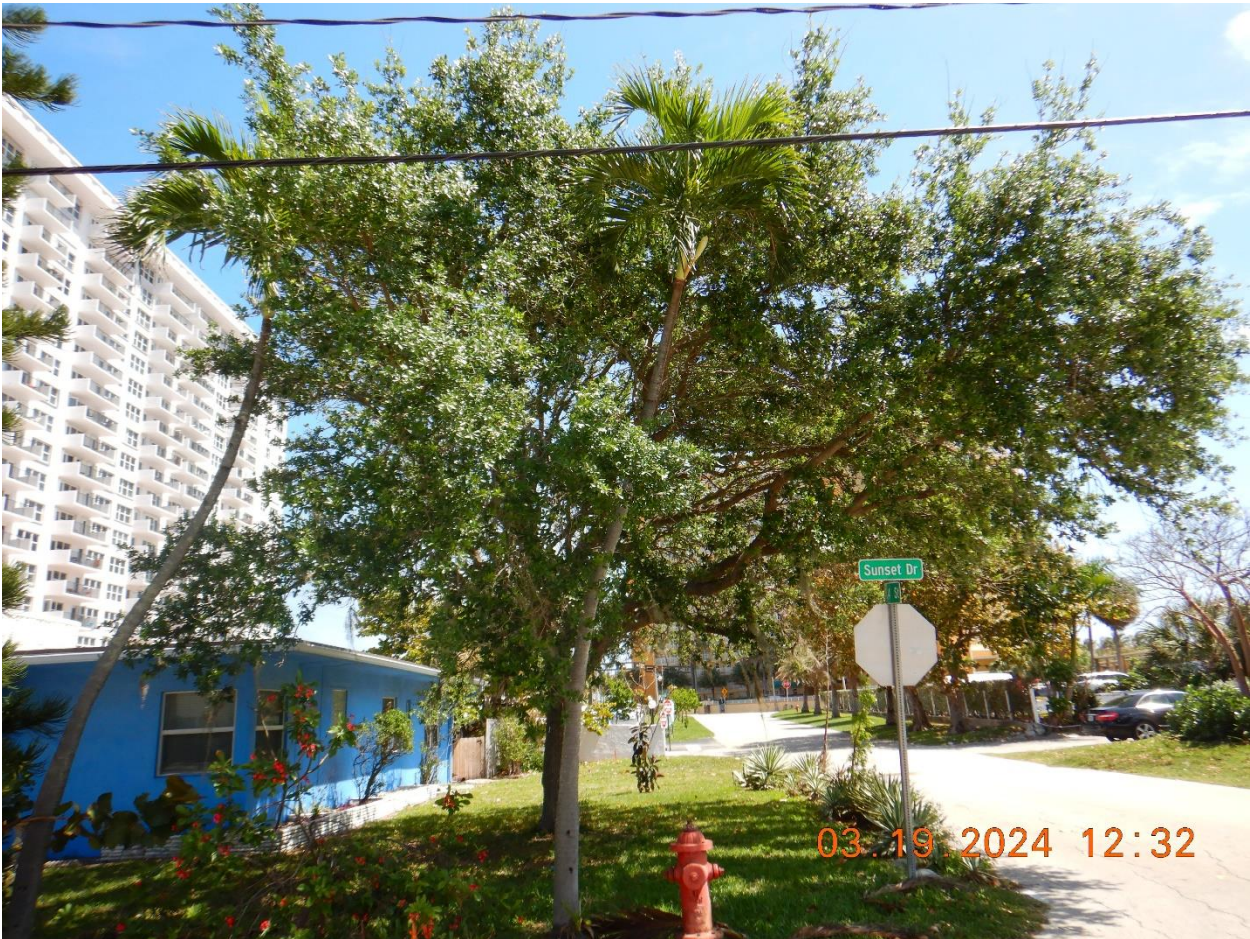
Tree #	Common name	Botanical name	DBH	Height OA	Height c/t	Canopy size	Condition	Price per in / ft	Value before Diminution	Value	Notes
4	Christmas palm	Adonidia merrillii			12	8x8	60%	\$32.74	\$392.88	\$235.73

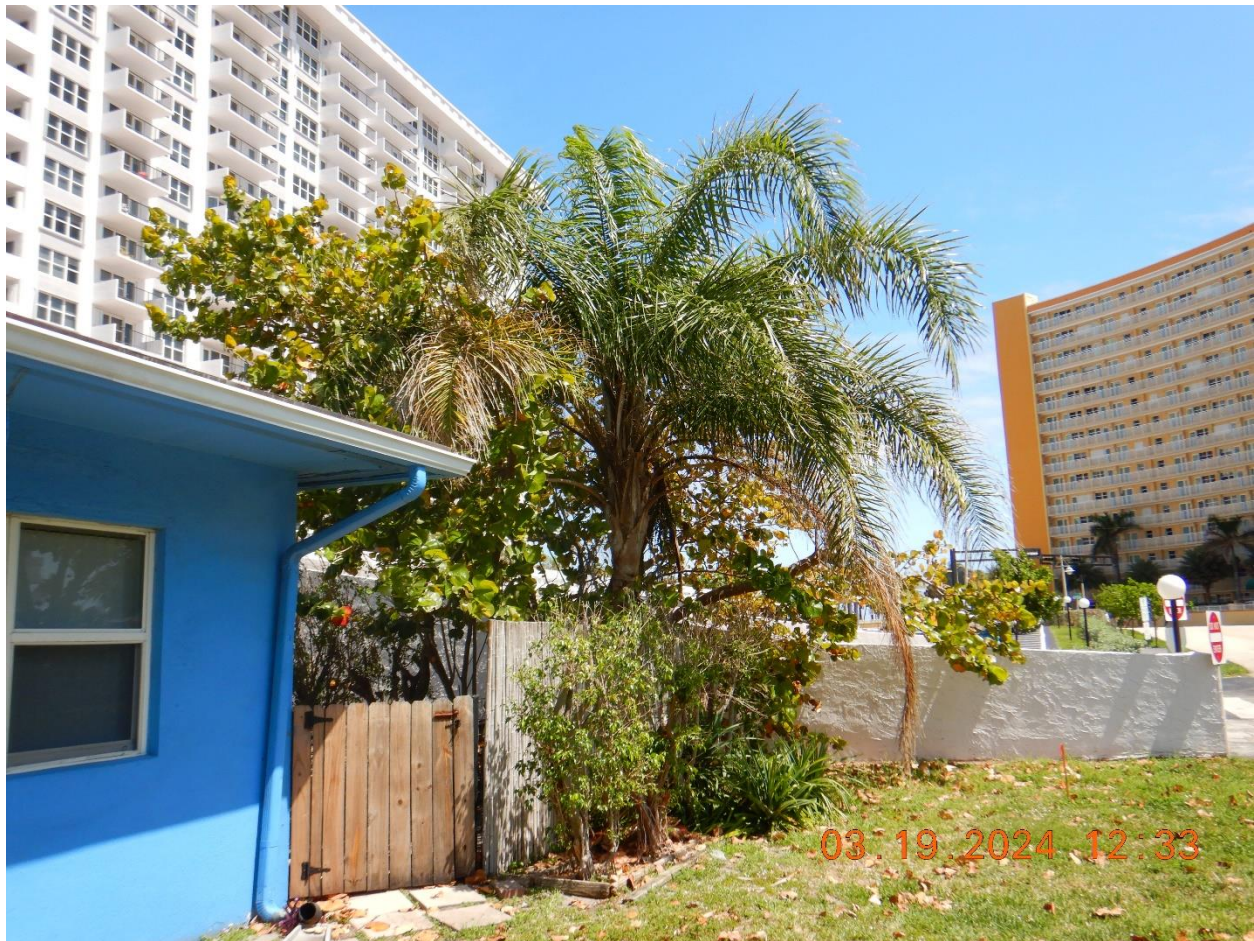
Tree #	Common name	Botanical name	DBH	Height OA	Height c/t	Canopy size	Condition	Price per in / ft	Value before Diminution	Value	Notes
5	Queen palm	<i>Syagrus romanzoffiana</i>			7	24x24	60%	\$25.83	\$180.81	\$108.49

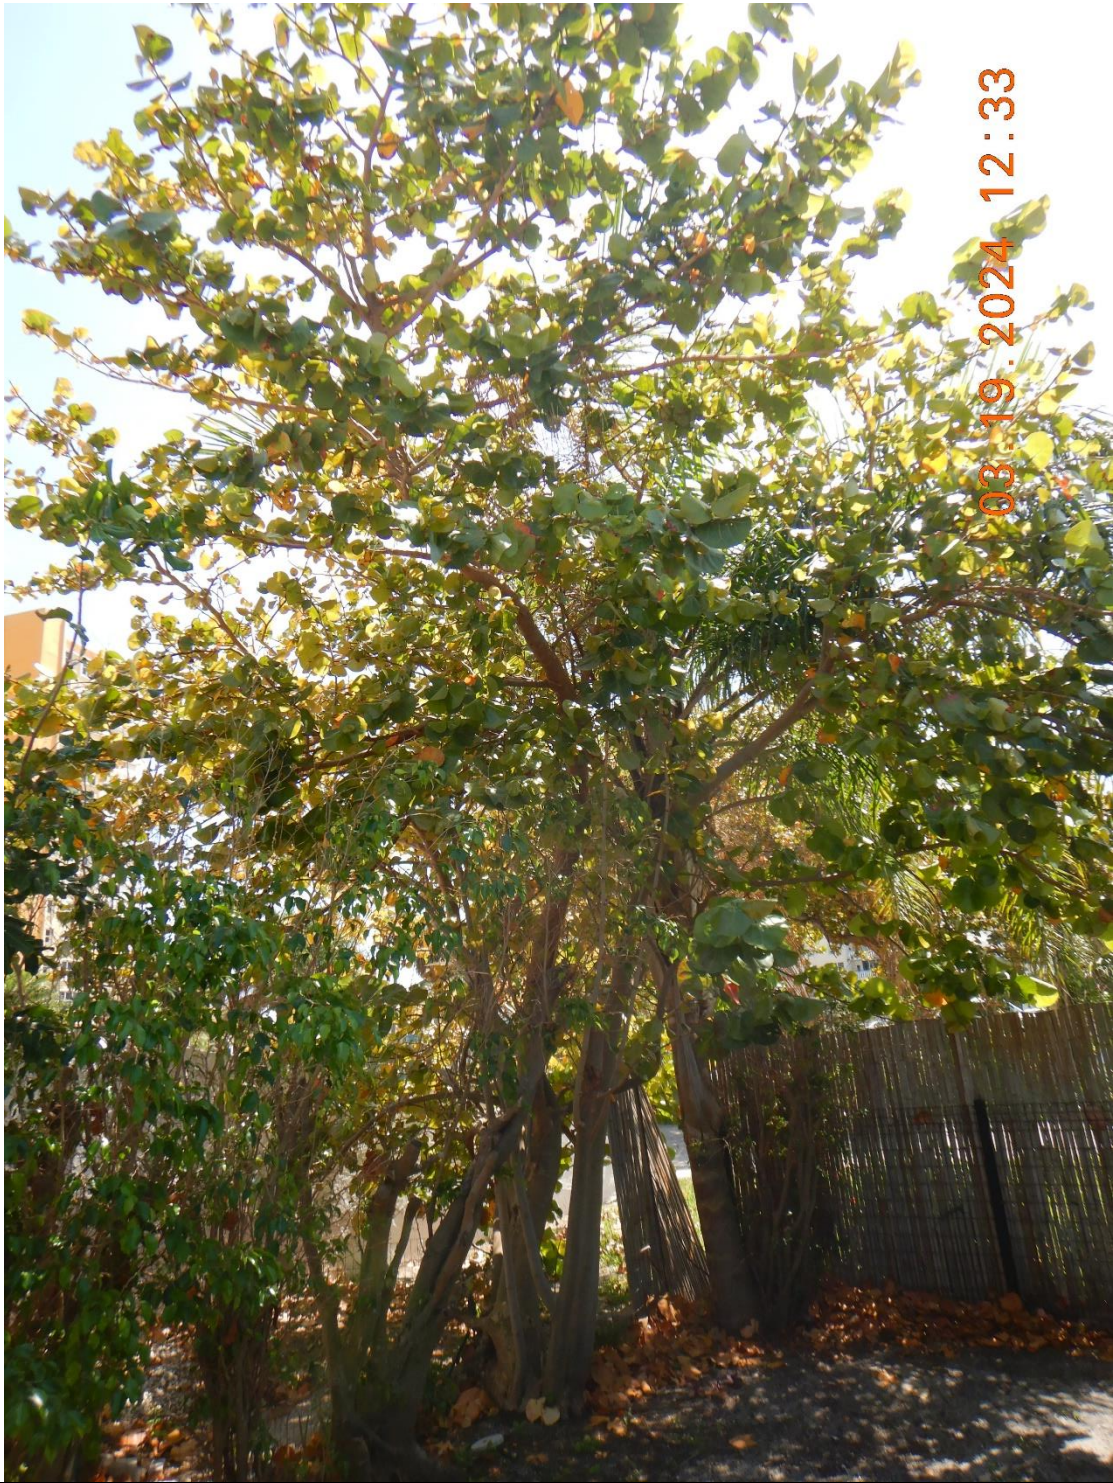
Tree #	Common name	Botanical name	DBH	Height OA	Height c/t	Canopy size	Condition	per in / ft	Value before Diminution	Value	Notes
6	Sea grape	Coccoloba uvifera	14	17		25-35'	40%	\$229.17	\$3,208.35	\$1,335.35	Very poor structure, co-canopy

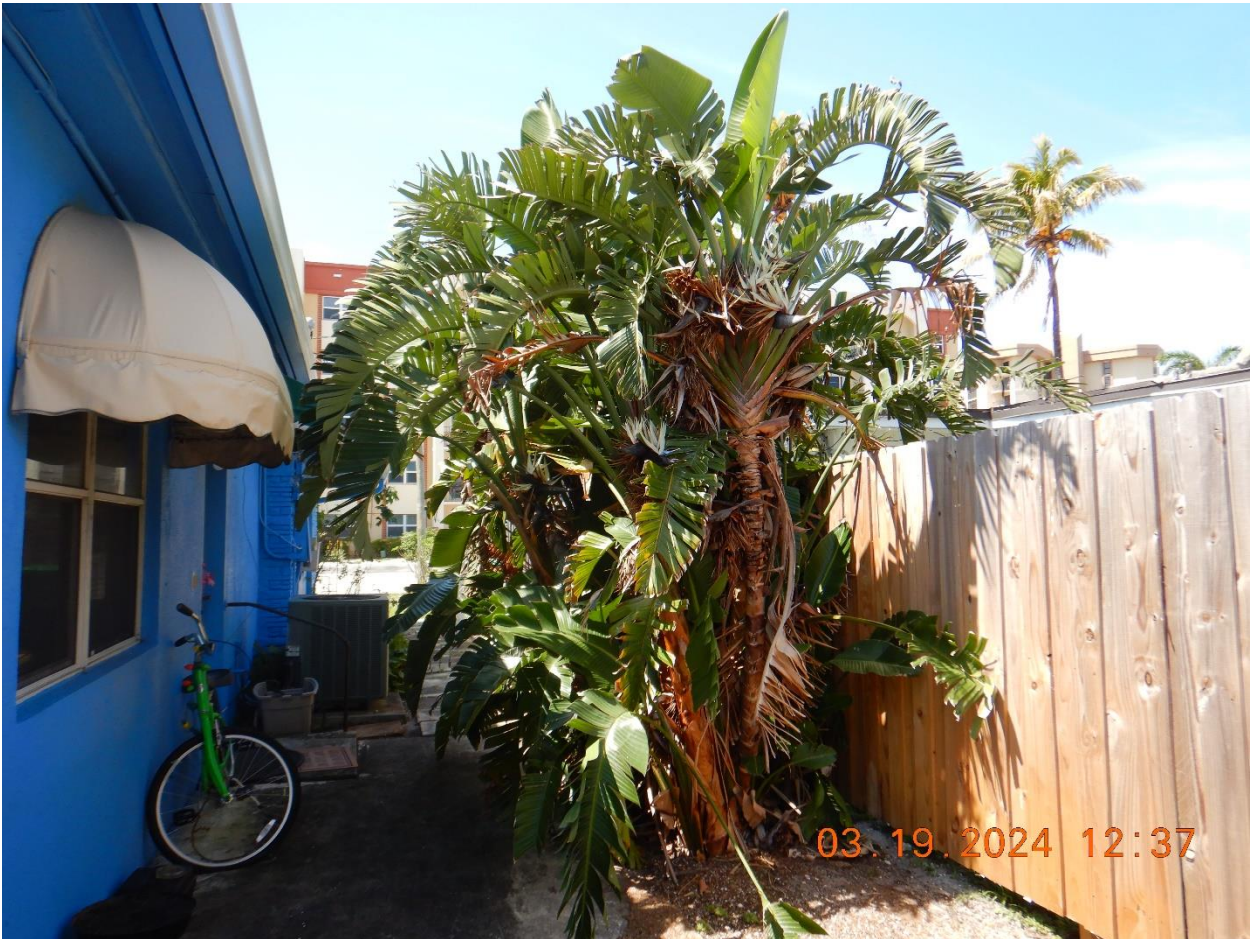
Tree #	Common name	Botanical name	DBH	Height OA	Height c/t	Canopy size	Condition	Price per in / ft	Value before Diminution	Value	Notes
7	White bird of paradise	Strelitzia nicolai			6	12x12	80%	\$30.95	\$185.70	\$148.56	Multi trunk cluster
