Enclosed please find the updated Certified Arborist Report/Tree Assessment for the property located at 200 N. Federal Hwy. in Pompano Beach, FL conducted on November 16, 2022.

# ARBORIST REPORT

200 N. Federal Hwy.  
Pompano Beach, Fl 33062

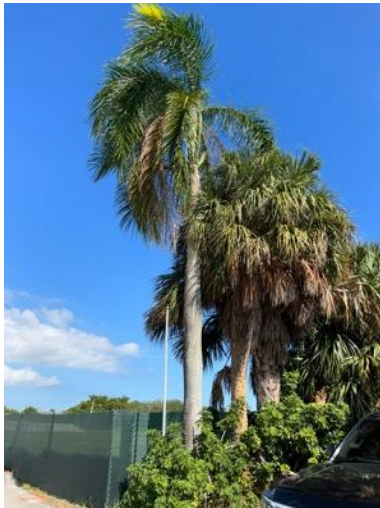
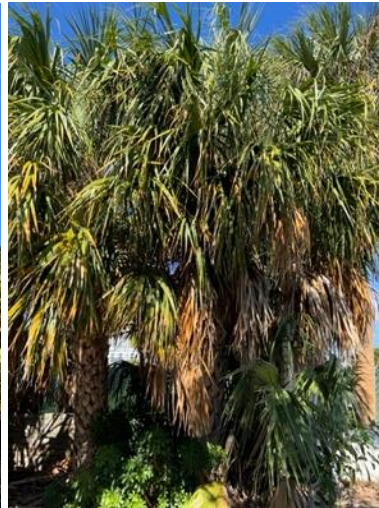
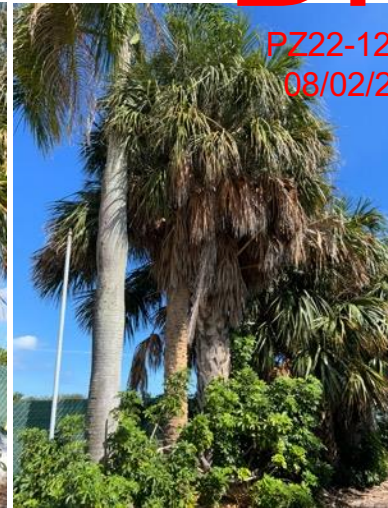
**Tree #1 – *Roystonea regia*, Royal Palm** – this tree is located in the northwest corner of the property adjacent to the parking lot and next to the ROW. It is crowded with minor chlorosis and a slightly undersized canopy. Overall, it is in fair condition and is proposed for removal.

**Tree #2 – *Sabal palmetto*, Sabal Palm** – this tree is located directly east of Tree #1. It is very crowded with a pronounced curve in the upper trunk due to the crowded conditions. It is in fair condition and is proposed for removal.

**Tree #3 – *Sabal palmetto*, Sabal Palm** – this tree is located directly east of Tree #2 on the northeast side of the property. It is very crowded and has live fronds only on one side of the trunk due to severe crowding. It is in poor condition and is proposed for removal.

**Tree #4 – *Sabal palmetto*, Sabal Palm** – this tree is located directly east of Tree #3. It is very crowded and overgrown but otherwise is in fair condition. This tree is proposed for removal.

**Tree #5 – *Sabal palmetto*, Sabal Palm** – this tree is located directly east of Tree #4. It is very crowded and overgrown but otherwise is in fair condition. It is proposed for removal.

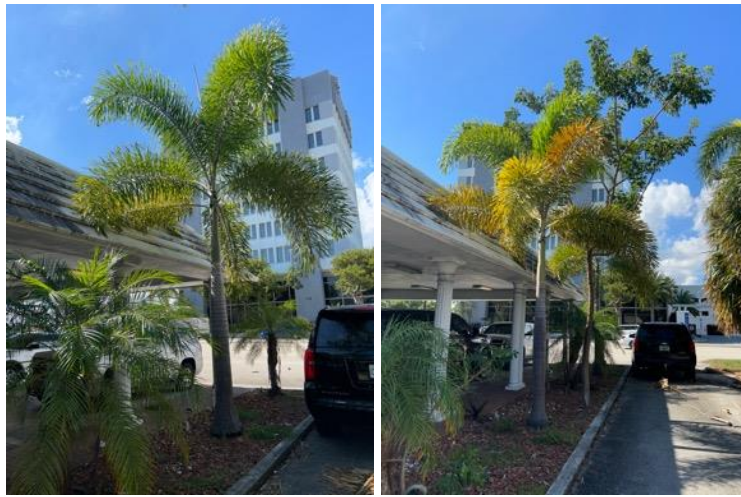
**Tree #6 – *Wodyetia bifurcata*, Foxtail Palm** – this tree is located in a small planting island on the north side of a covered valet area. It has minor chlorosis and is slightly crowded but otherwise is in fair condition with no significant defects. It is proposed for removal.

**Tree #7 – *Wodyetia bifurcata*, Foxtail Palm** – this tree is located near the east end of the planting island. It has moderate to severe chlorosis and is in overall moderate condition. This palm is proposed for removal.

**Trees #8-10 – *Phoenix roebellini*, Pygmy Date Palm** – this refers to 3 Pygmy Date palms located in the planting island with Trees #6-7. They are all under regulation size, so they should not require a permit or mitigation for their removal.

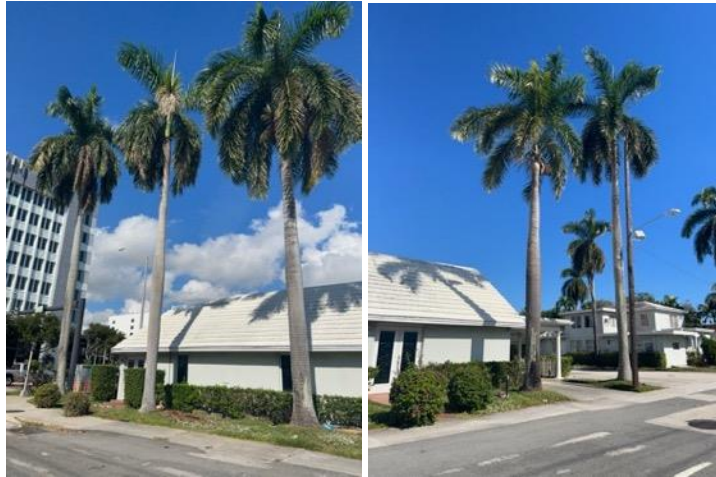
**Tree #14 – *Roystonea regia*, Royal Palm** – this tree is located on the south side of the property east of Trees #11-13 and just west of the concrete walkway to the covered porch area. It shows signs of minor chlorosis/nutrient deficiency, but otherwise is in good condition with no significant defects. It is proposed for removal.

**Tree #15 – *Roystonea regia*, Royal Palm** – this tree is located on the south side of the property east of the covered walkway to the covered porch area. It shows signs of very minor nutrient deficiency, but otherwise is in good condition with no significant defects. It is proposed for removal.

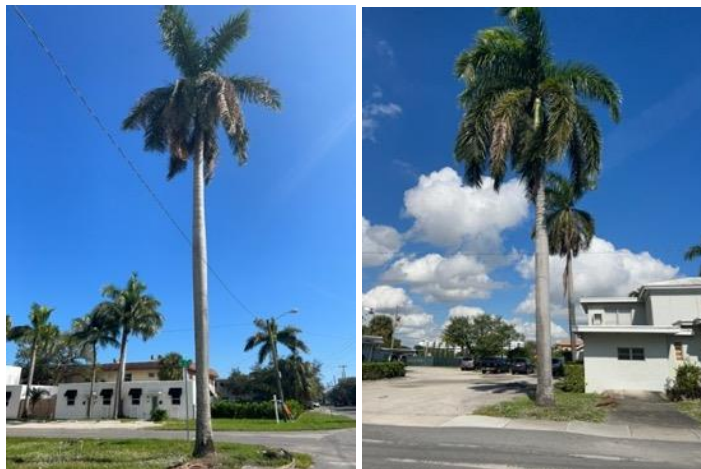
**Tree #16 – *Roystonea regia*, Royal Palm** – this tree is located near the southeast corner of the property. It shows very minor signs of nutrient deficiency but otherwise is in good condition. It is proposed for removal.

**Tree #17 – *Roystonea regia*, Royal Palm** – this tree is located on the south side of the property just east of the entrance to the asphalt parking lot. It is in good condition with no significant defects. It is proposed for removal.

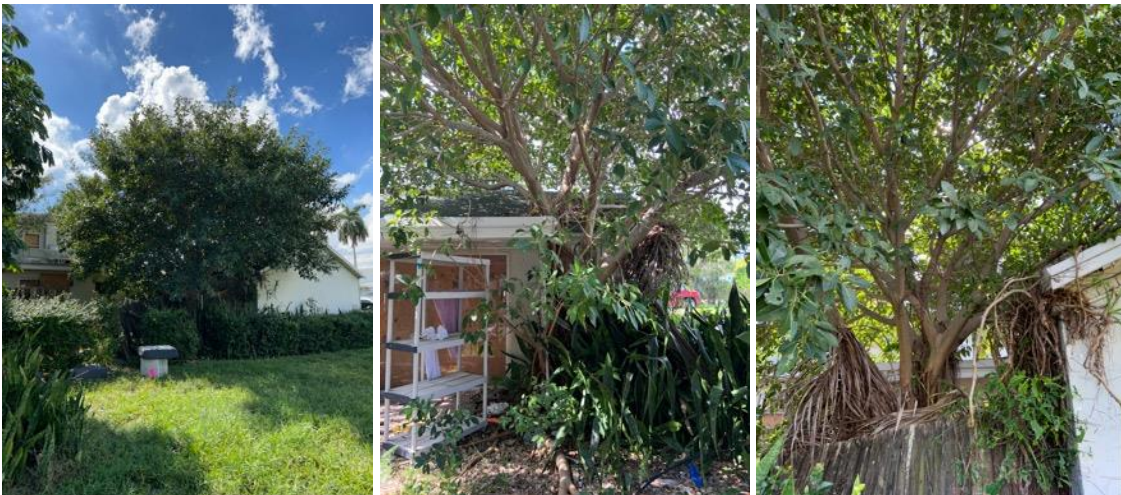
**Tree #19 – *Ficus aurea*, Strangler Fig** – this tree is located on the northeast side of the existing building on the east side of the property. It is crowded, overgrown, and unmaintained with minor deadwood present, but overall it is in fair condition. This tree is proposed for removal.

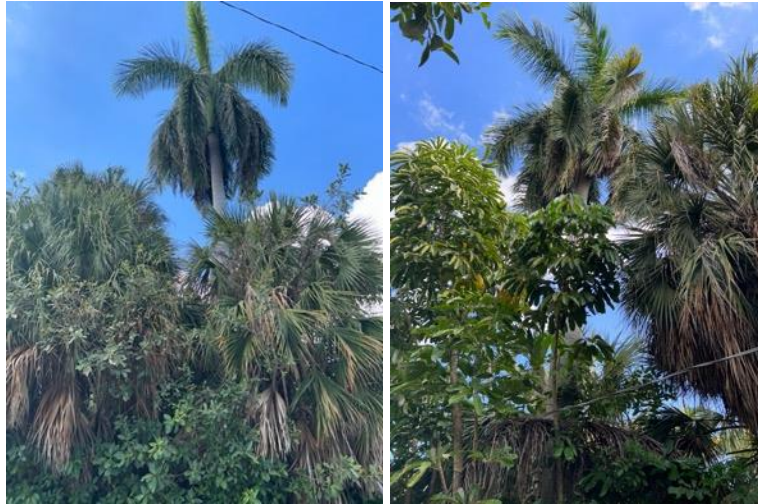
**Tree #20 – *Roystonea regia*, Royal Palm** – this tree is located in an overgrown cluster of vegetation on the east side of the property. It is very crowded and overgrown and could not be accessed due to its location within a fenced area. It shows signs of very minor nutrient deficiency. Overall it is in fair condition and is proposed for removal.

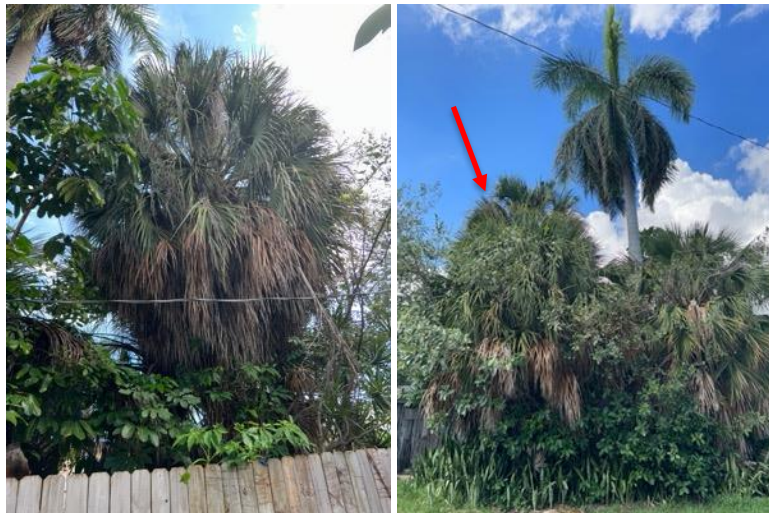
**Tree #21 – *Sabal palmetto*, Sabal Palm** – this tree is located on the south side of the overgrown cluster of vegetation on the east side of the property. It is very crowded and overgrown, and was inaccessible, but otherwise it is in good condition. It is proposed for removal.

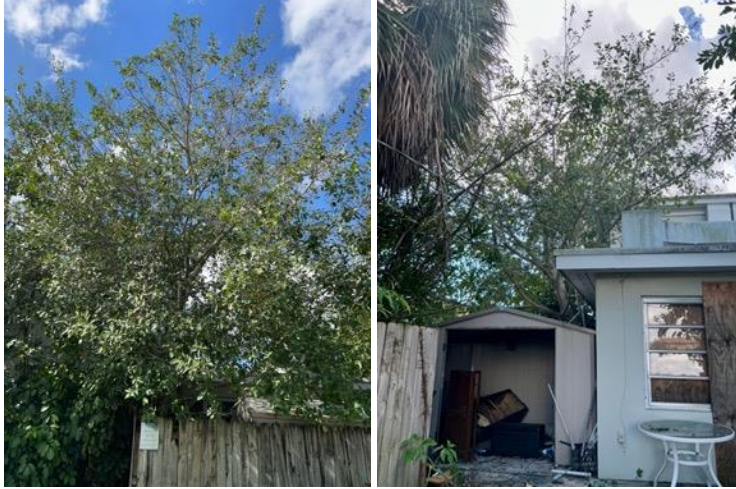
**Tree #22 – *Ficus aurea*, Strangler Fig** – this tree is located on the east side of the building on the east side of the property. It is inaccessible due to its location inside a fenced area. It appears to be crowded, overgrown and unmaintained with areas of slightly sparse foliage. Overall, it is in fair condition and will be removed.

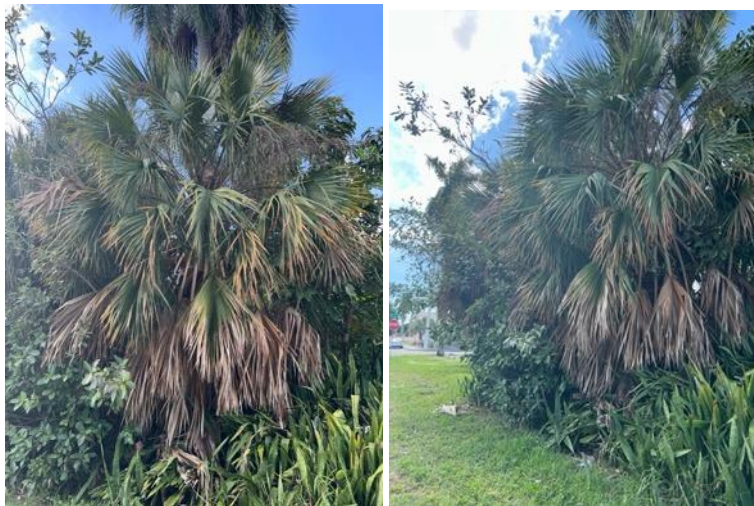
**Tree #23 – *Sabal palmetto*, Sabal Palm** – this tree is located on the north side of the overgrown cluster of vegetation on the east side of the property. It is very crowded, and overgrown. Overall it is in fair condition and is proposed for removal.

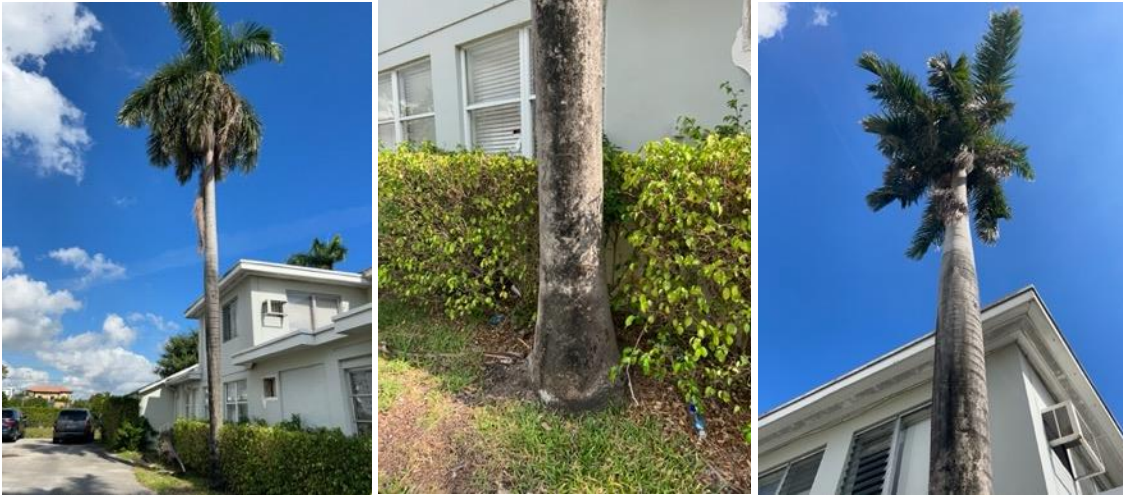
**Tree #24 – *Roystonea regia*, Royal Palm** – this tree is located on the west side of the back building that is on the east side of the property. It is growing within 3.5' of the existing building. It shows very minor signs of nutrient deficiency and is in overall good condition.

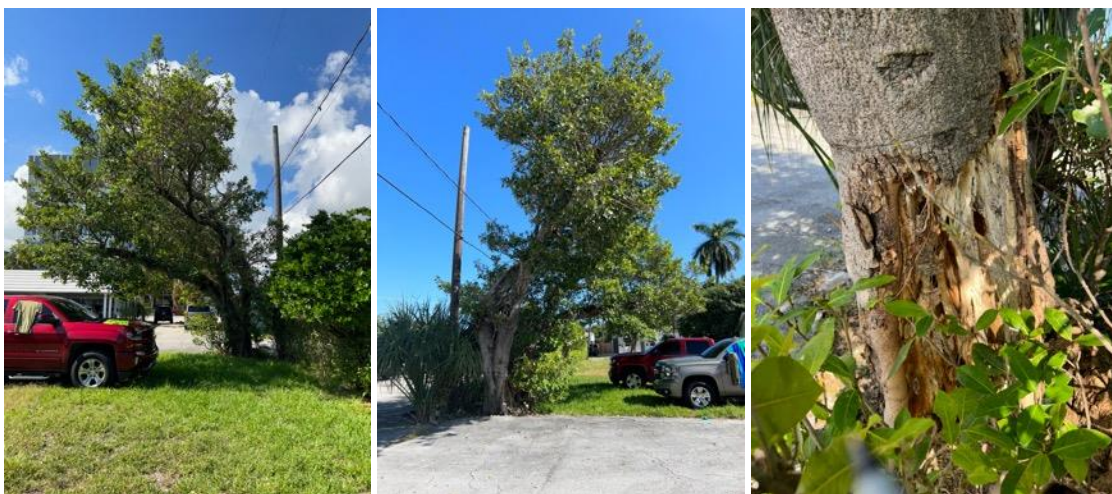
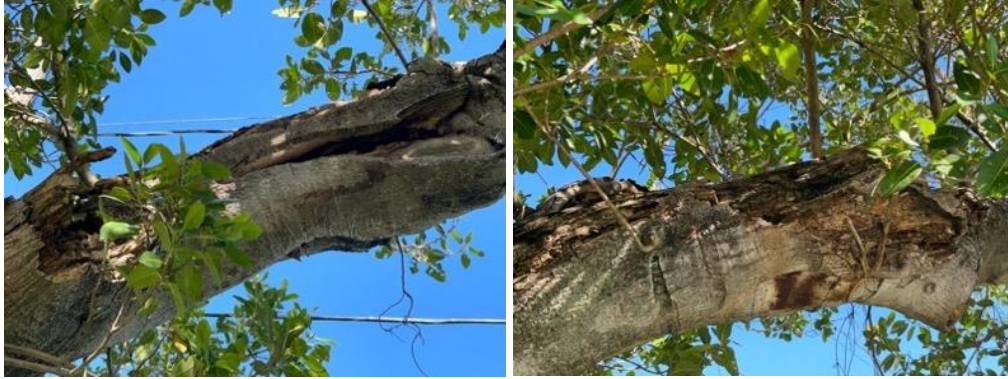
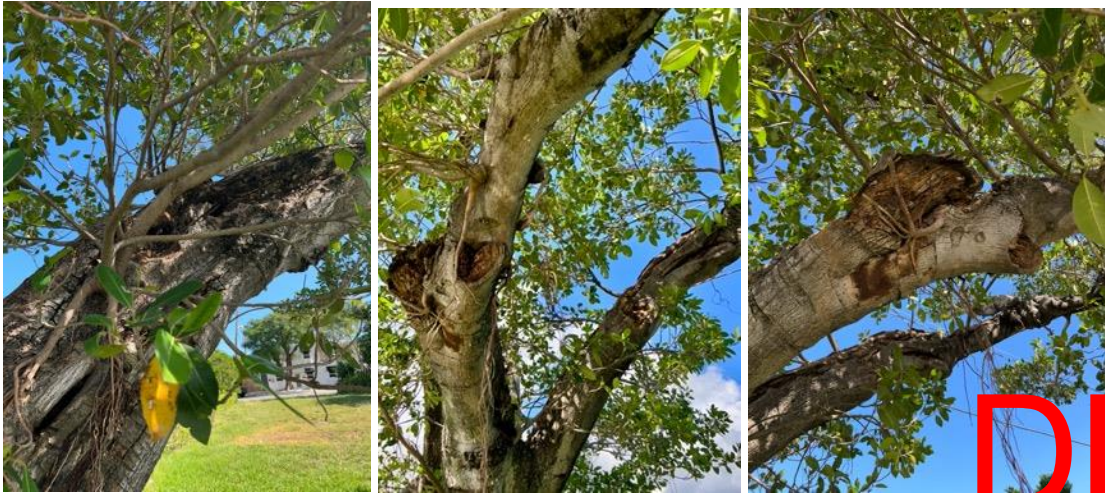
**Tree #25 – *Ficus aurea*, Strangler Fig** – this tree is located on the north side of the main parking lot near the entrance to the small parking lot (Lot 17, Block ). It has extensive internal decay at the base of the trunk and in all remaining scaffold limbs. There is decayed wood, apparent termite damage, and fruiting fungal bodies present. Based on a Level 2 inspection and using the ISA Risk Rating matrix, this tree constitutes a high risk and there are no mitigation options that can reduce its risk to moderate or less; therefore, it is recommended for consideration for removal without a permit or mitigation per FS 163.045.

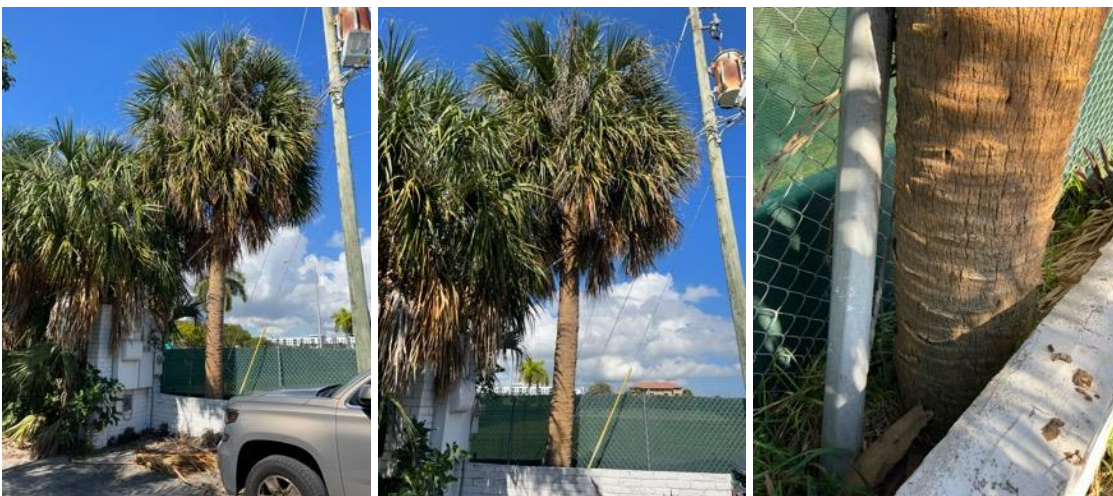
**Tree #26 – *Sabal palmetto*, Sabal Palm** – this tree is located just east of Trees #1-5 on the northeast side of the property/parking lot. It is somewhat crowded but otherwise is in good condition. It is proposed for removal.

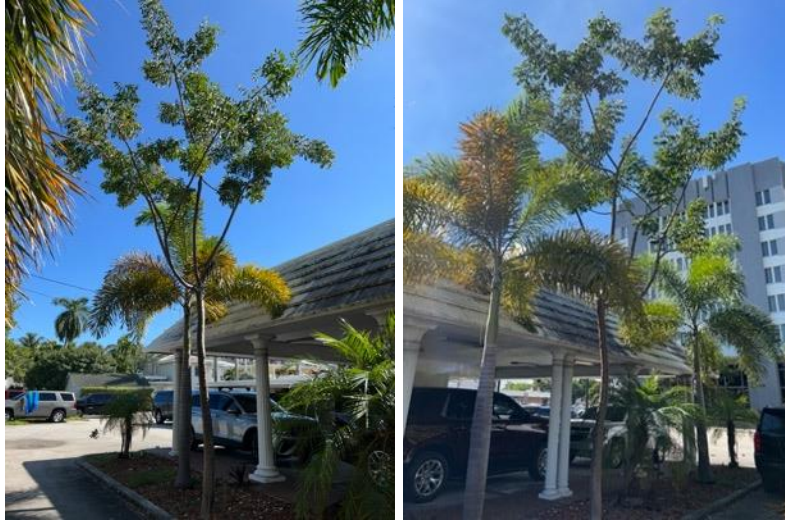
**Tree #27 – *Bursera simarouba*, Gumbo Limbo** – this tree is located east of Tree #6 in the planting island on the north side of the covered valet drop off area. It is a relatively young tree in fair condition with a slightly weak growth habit but no other significant defects. It is proposed for removal.

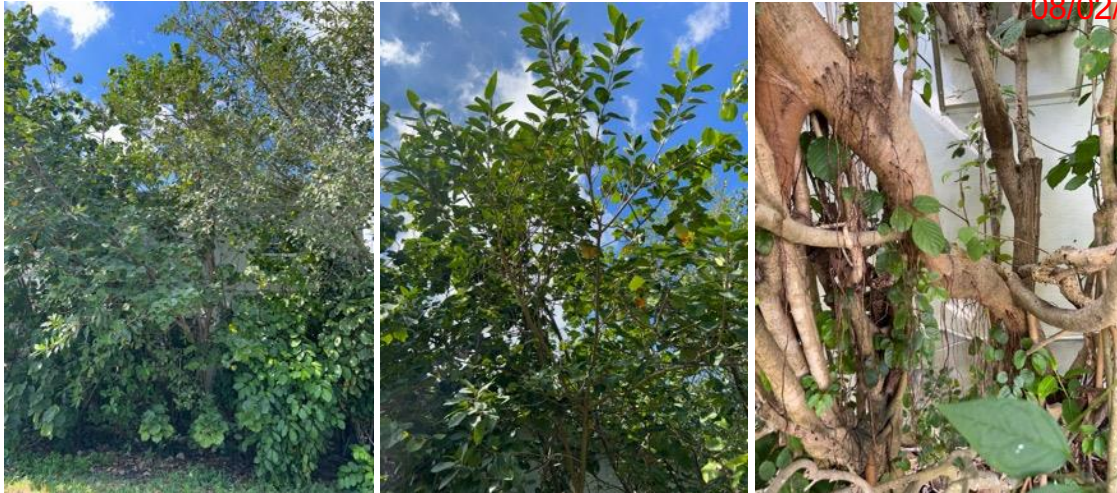
**Tree #28 – *Ficus aurea*, Strangler Fig** – this is a small volunteer that is growing in an overgrown cluster of Sea Hibiscus on the east side of the existing back building. It is crowded and leaning and has a weak growth habit/structure as a result. It is in poor condition and will be removed.

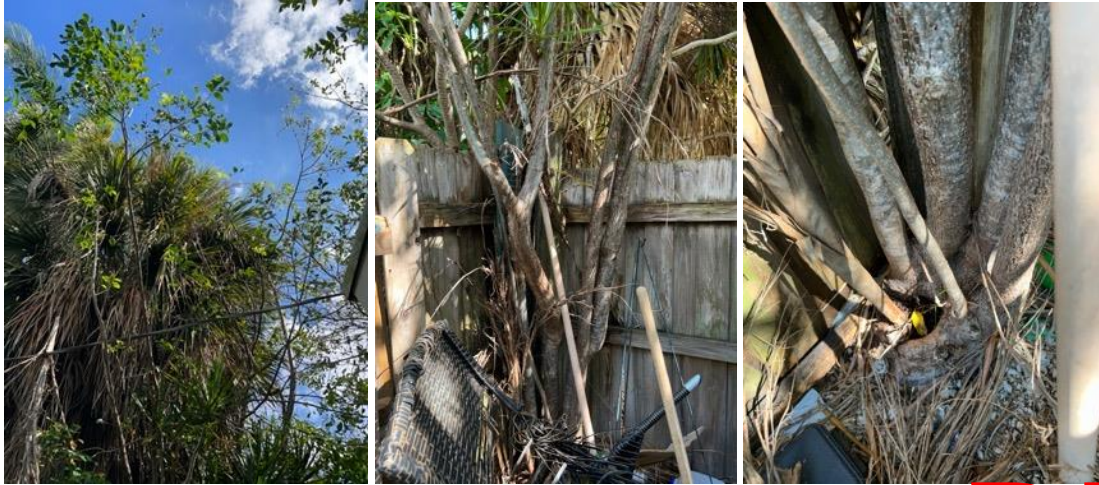
**Tree #29 – *Bursera simarouba*, Gumbo Limbo** – this tree is growing on the southwest corner of the cluster of overgrown vegetation on the east side of the existing back building; it is likely a volunteer. It is growing against a wooden fence and appears to have been trimmed multiple times near ground level so that it consists of multiple sprouts. There is a decay cavity near the base of the trunk. The canopy is small and sparse. Overall, this tree is in poor condition. It is proposed for removal.

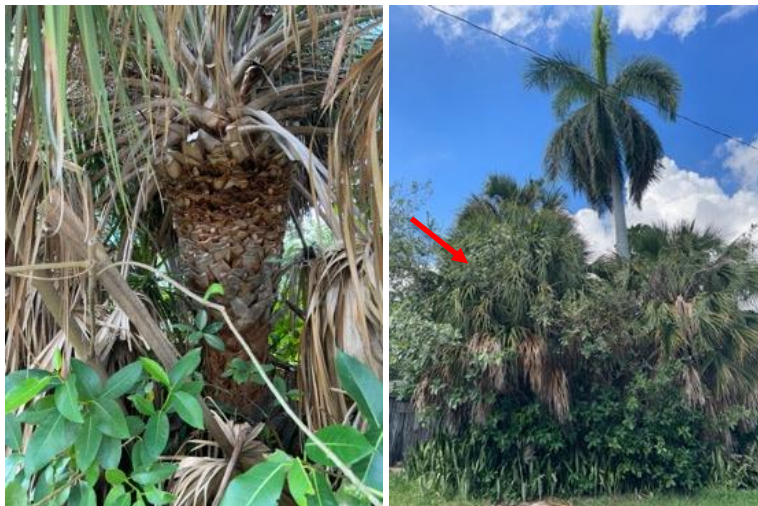
**Tree #30 – *Sabal palmetto*, Sabal Palm** – this tree is located directly in front of Tree #21 on the east side of the property. It is very crowded, overgrown with vines, and unmaintained. Overall, it is in fair condition and is proposed for removal.

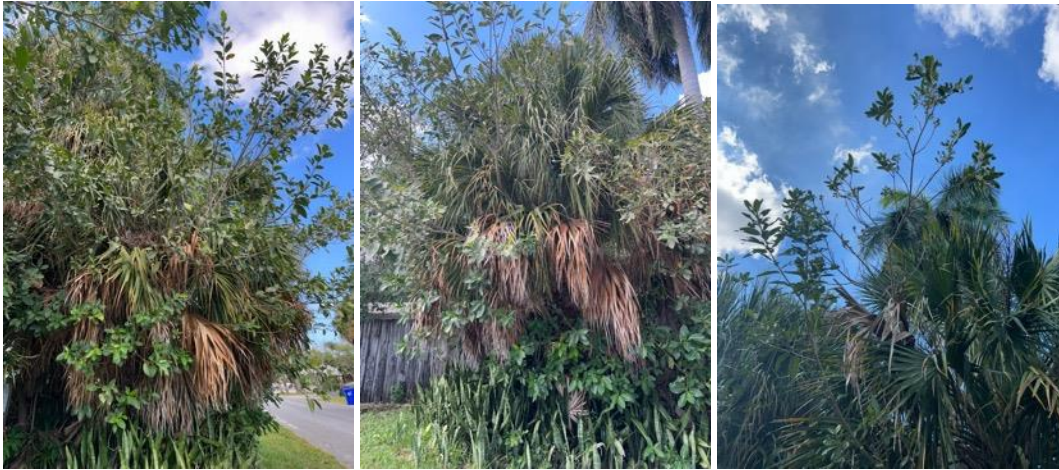
**Tree #31 – *Ficus aurea*, Strangler Fig** – there is at least one Strangler Fig growing in the middle of the overgrown cluster of vegetation containing Trees #20-21. It is very crowded, overgrown, inaccessible and difficult to see, but at least 3 individual trunks, each 2-3" DBH, were observed with minimal amounts of foliage visible as well. For the sake of this assessment, it is assumed that this is one tree. It is in poor condition and will be removed.

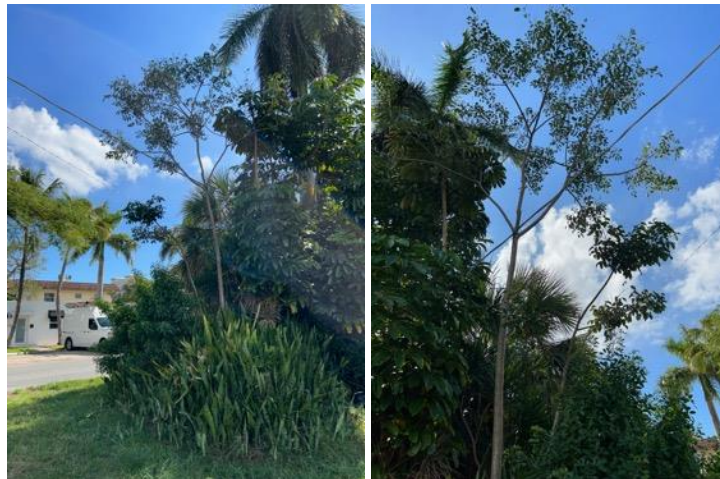
**Tree #32 – *Bursera simarouba*, Gumbo Limbo** – this tree is located on the north side of the cluster of overgrown vegetation on the east side of the property (north of Trees #20 and 23). It is crowded and overgrown with a slightly weak structure, and it is growing among utility wires. Overall, it is in fair condition and is proposed for removal.

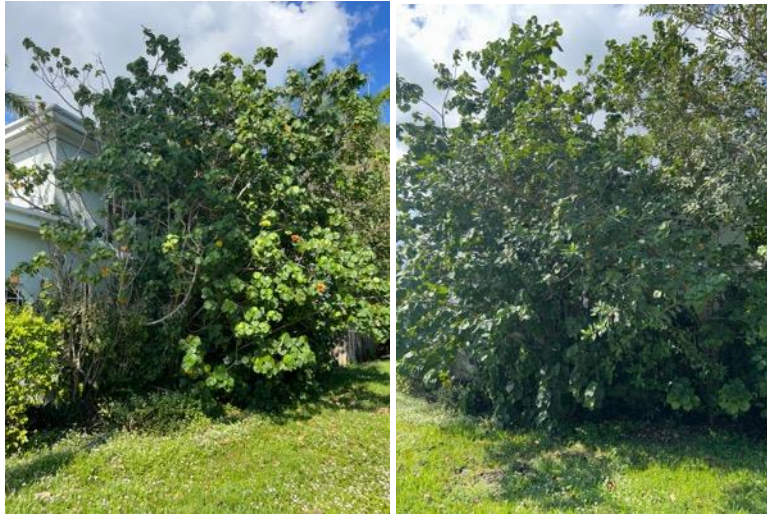
***Hibiscus tiliaceus*, Sea Hibiscus** – this refers to a large overgrown cluster of Sea Hibiscus located on the east side of the property against the southeast side of the back building. There appear to be 2 distinct individual clusters present. They are crowded, overgrown and unmaintained, and in overall moderate condition. This is more of an overgrown shrub than a tree, so it is recommended for removal without mitigation to be confirmed by the City.

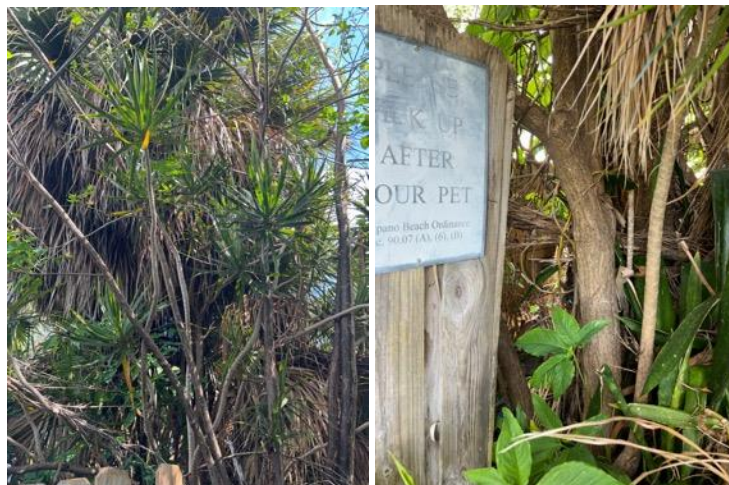
***Dracaena reflexa*, Dracaena** – there is a small cluster of Dracaena located on the southwest side of the cluster of vegetation on the east side of the property (adjacent to Tree #21). It is crowded and overgrown. It is more of an overgrown shrub than a tree, so it is recommended for removal without a permit or mitigation, to be confirmed by the City.

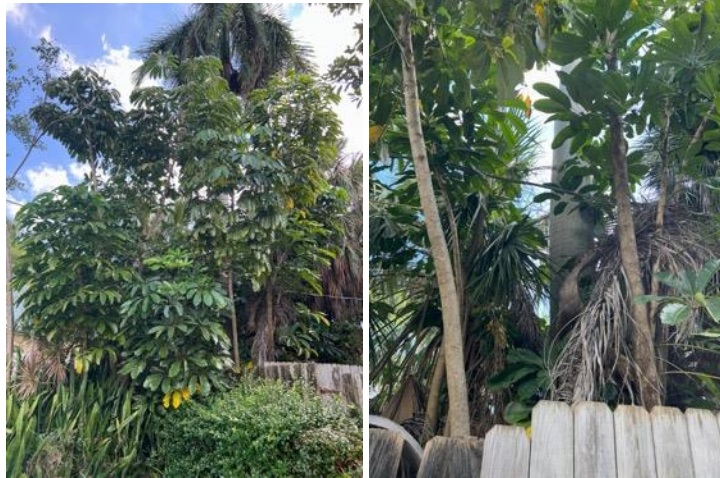
***Schefflera actinophylla*, Umbrella tree** – there are 2 clusters of Umbrella tree located on the northwest side of the overgrown cluster of vegetation on the east side of the property (adjacent to Tree #20). This is considered a nuisance species that should not require a permit or mitigation for removal, to be confirmed by the City.
