ATLAS SAFETY &amp; SECURITY DESIGN, INC.

RE: Oldcastle Coastal Facility – 1200 NW 18<sup>th</sup> St., Pompano Beach, CPTED/Security Public Safety Plan

I have been contracted to review the drawings for security and Crime Prevention Through Environmental Design (CPTED) features in the proposed Oldcastle Bonsal Facility site plan update that is being considered for permitting by the City of Pompano Beach.

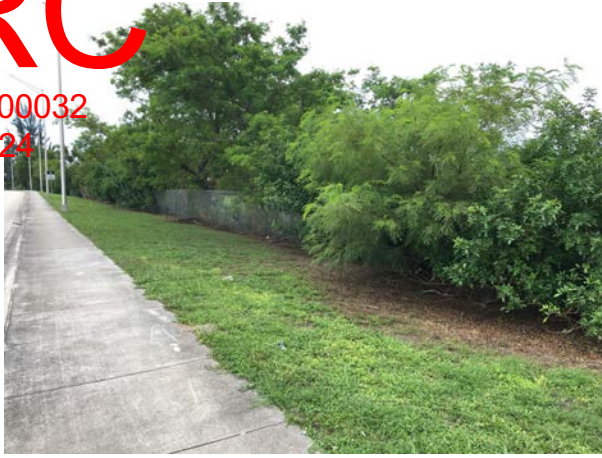
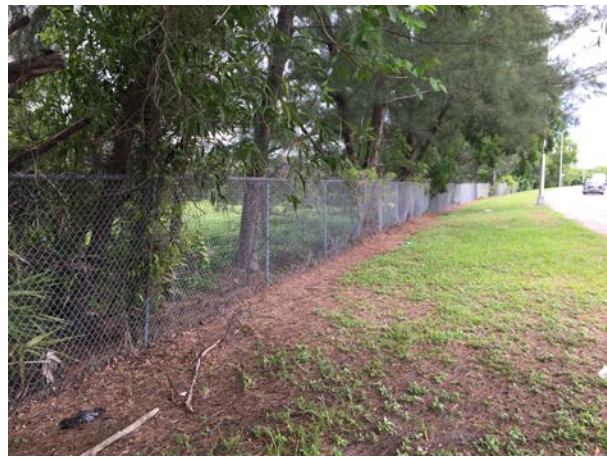
The west boundary on Andrews Avenue is chain link fencing and overgrown shrubs and non-native Australian Pine.

The west border definition will be improved with an attractive picket metal code compliant fencing with plantings, and a vehicle gate. It is recommended that as the site is improved to accommodate a sidewalk connection, and new monumental sign, and additional stripping at the entrance of onto Andrews Avenue will be added to direct the heavy trucks and rigs.

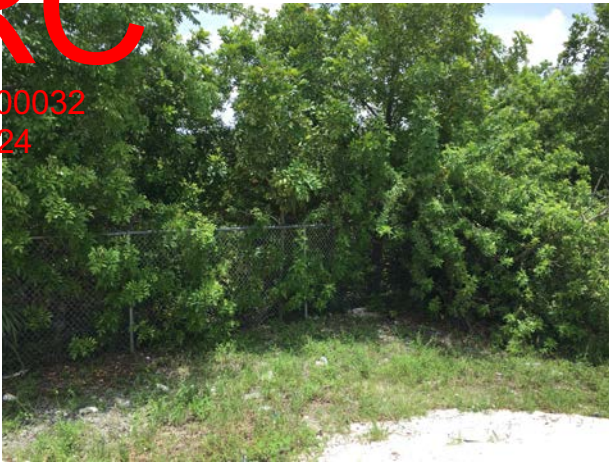
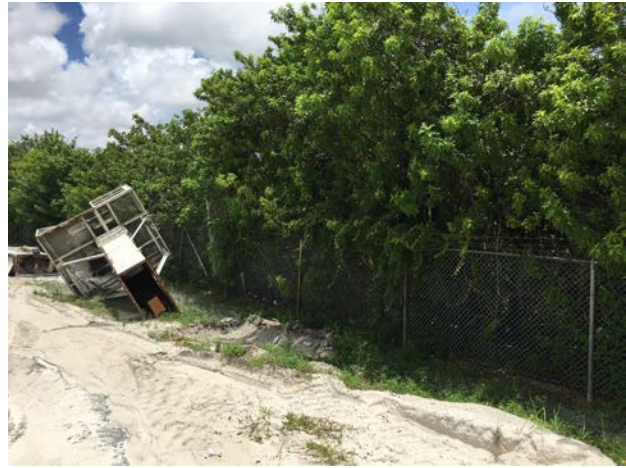
The East boundary is six-foot chain link with overgrown shrub.

Territorial Reinforcement /Boundary definition – Fencing and Plantings – The existing six-foot high chain link fencing requires extensive repair and maintenance on the north, south, and east sides. Plantings should be maintained to be no higher than the fence line and the boundaries. Tree canopies should be maintained clear under 8 feet, with a tree trunk six inches in diameter or greater. If new saplings are planted, do not mutilate them to comply with the canopy requirement until they are mature trees with a six inch diameter trunk or greater, and if the tree canopies are blocking the field of vision.

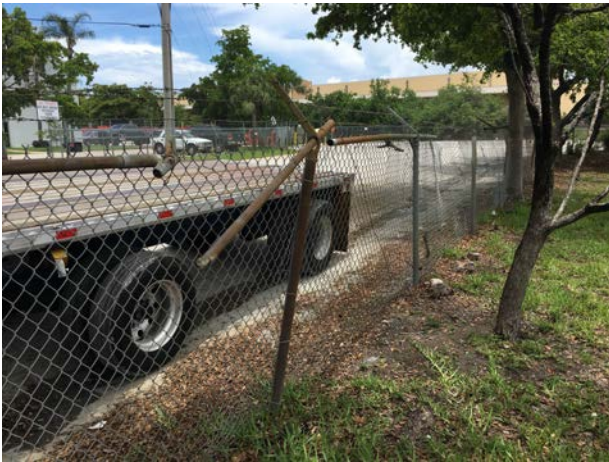
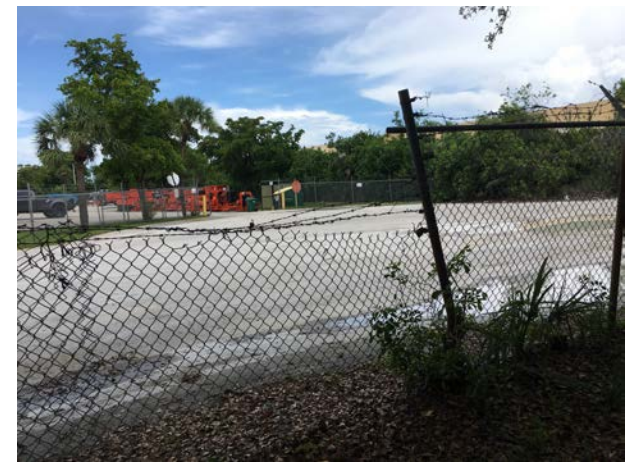
The North boundary is presently the primary access and egress points to the plant on NW 18<sup>th</sup> Street. There are two gates openings. Both gates are left open and have been damaged and non-operational. The barbed wire on the top of the chain link fencing has been damaged and not consistent.

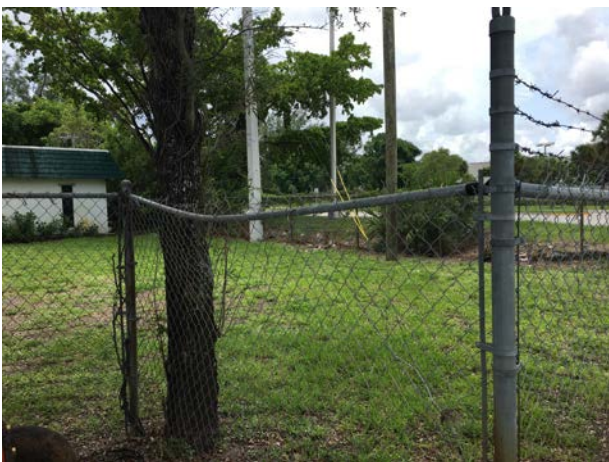
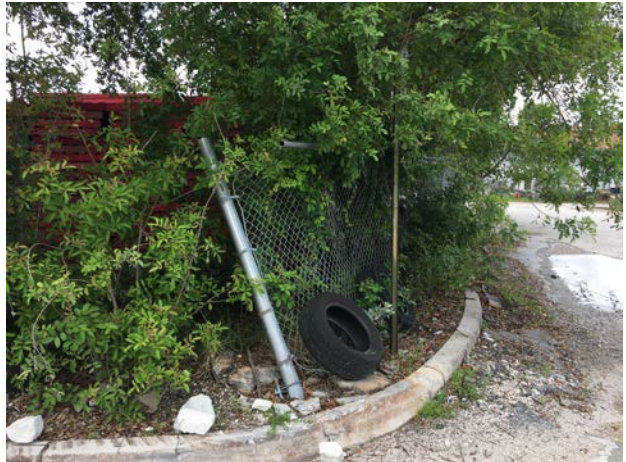
The north boundary fencing is heavily damaged.

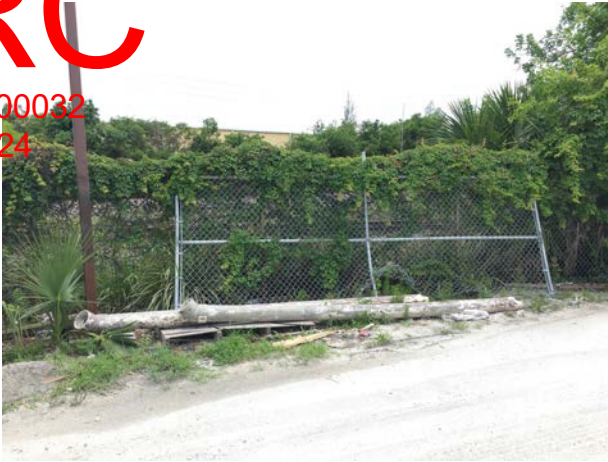
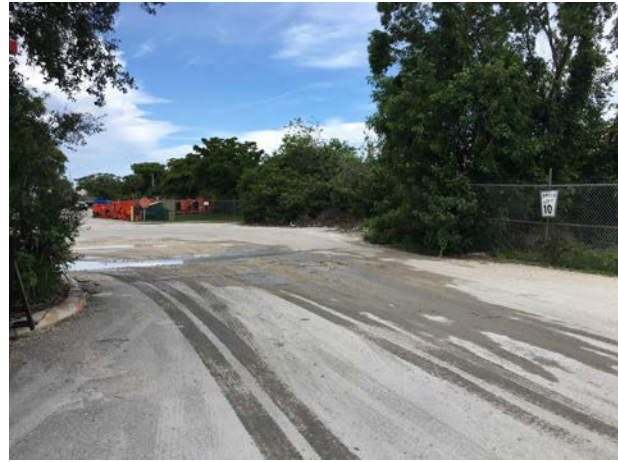
The northeast gate has been knocked off the tracks and lays against the east perimeter fence. The open access allows trucks with aggregate product to enter in the site, but also has no barriers to keep trespassers out.

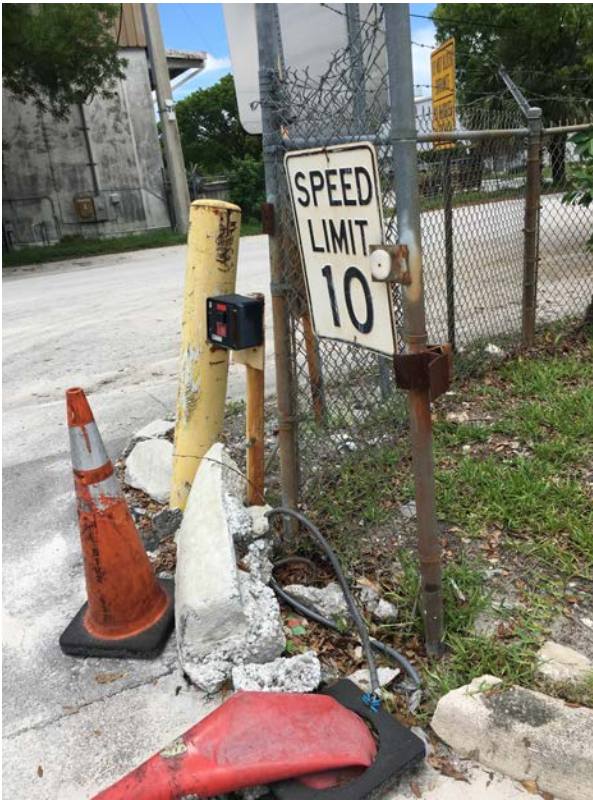
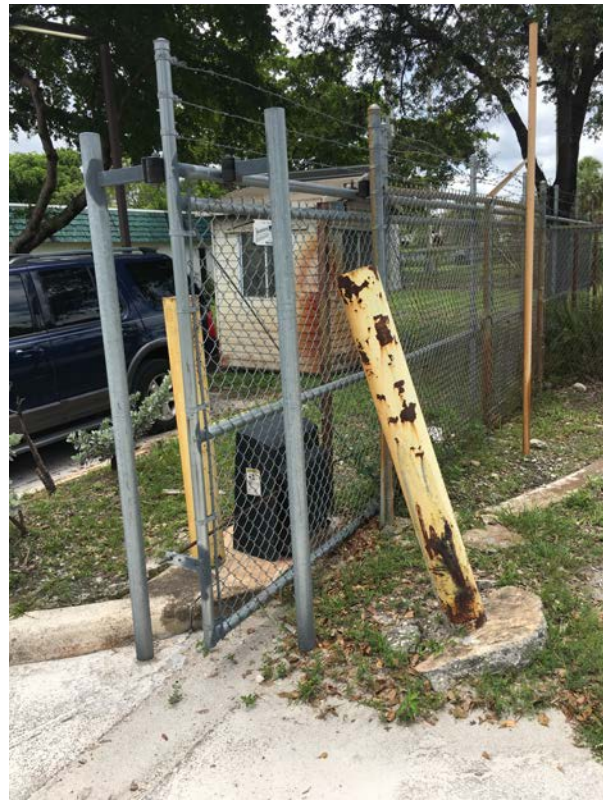
The Northwest gate is the primary entrance for administration, employee vehicles. The gate is non-functional and is in disrepair.

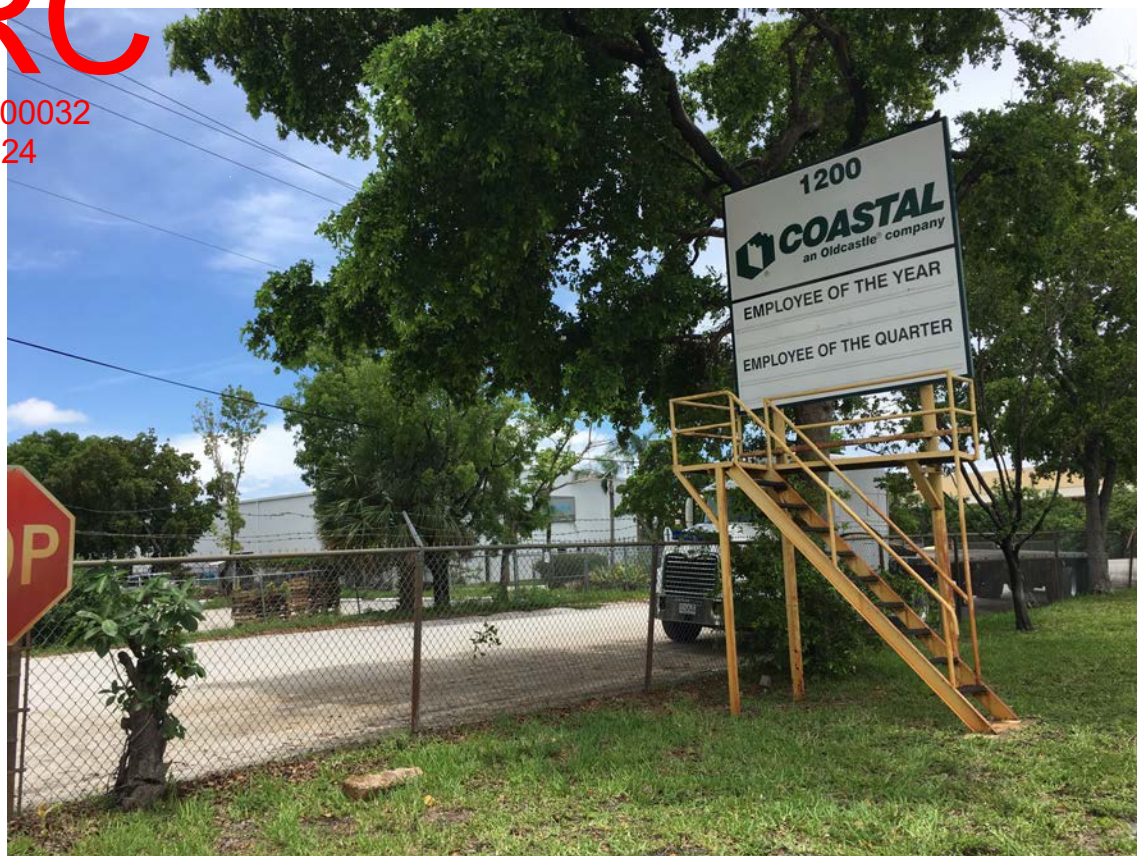
The north boundary on NW 18<sup>th</sup> Street has the marquee sign for the plant. It is difficult to see from the main road, Andrews Avenue.

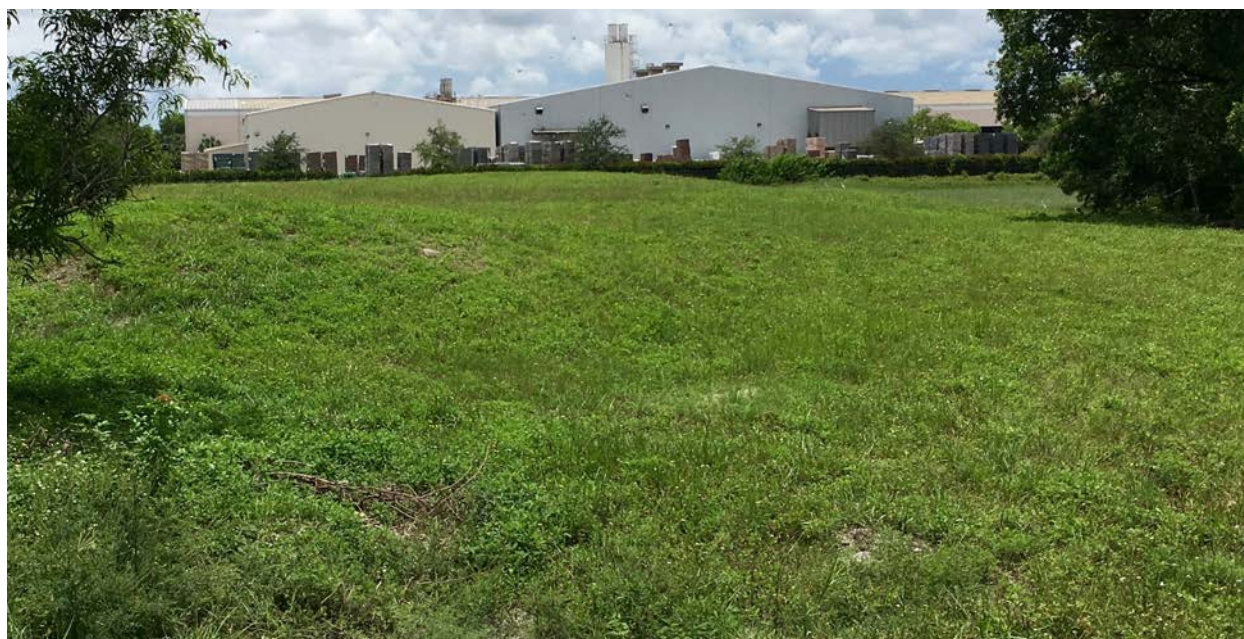
The South boundary is open real estate between the Bonsal Plant and the Oldcastle Distribution Center.

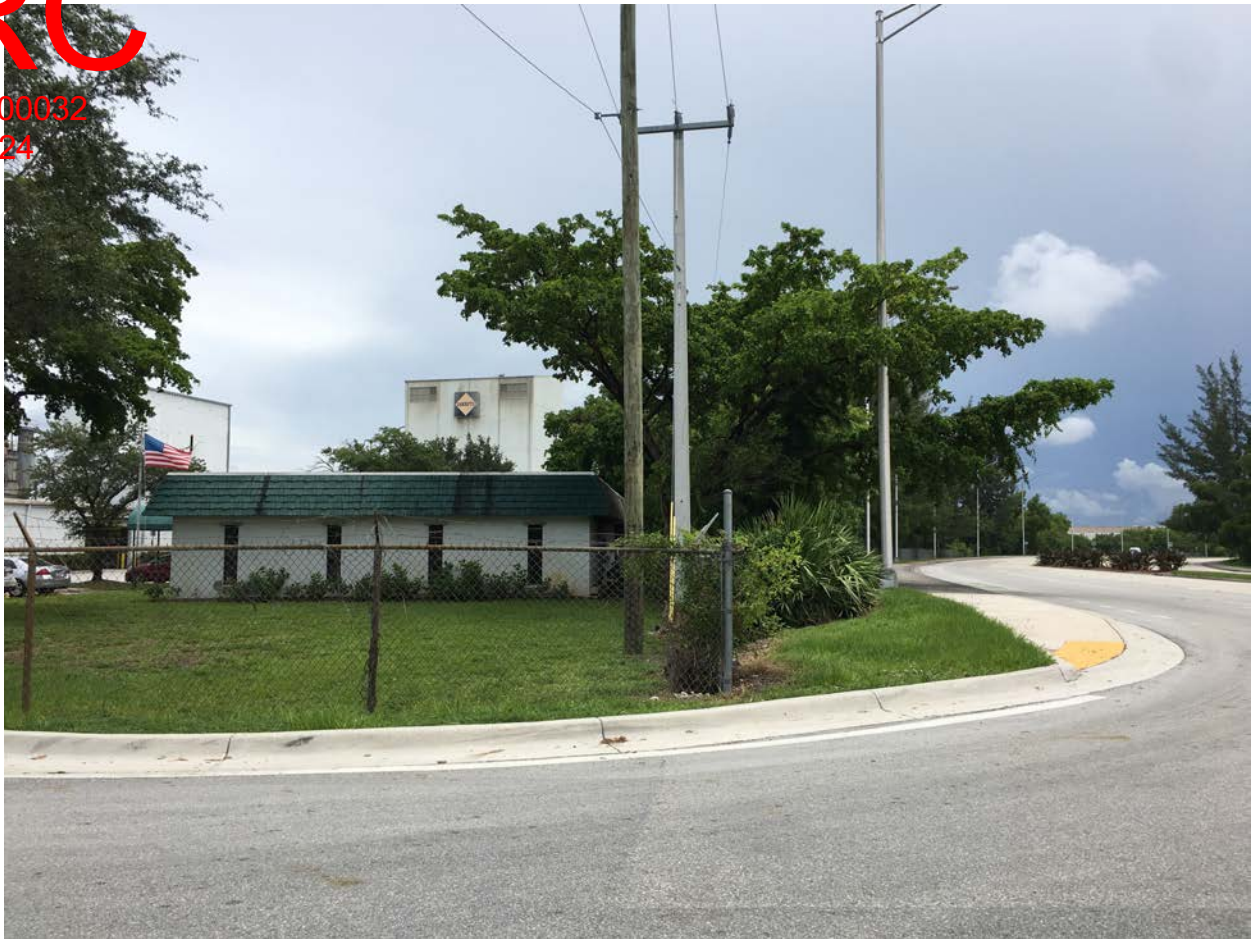
There are no controls for vehicles once trucks turn on 18<sup>h</sup> Street. There are no barriers controlling access to the parking lot and site on the north side.

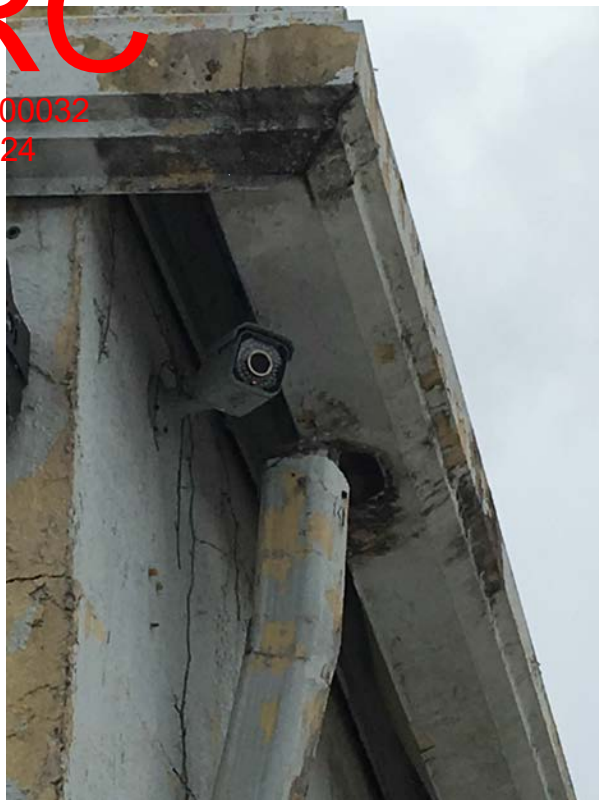
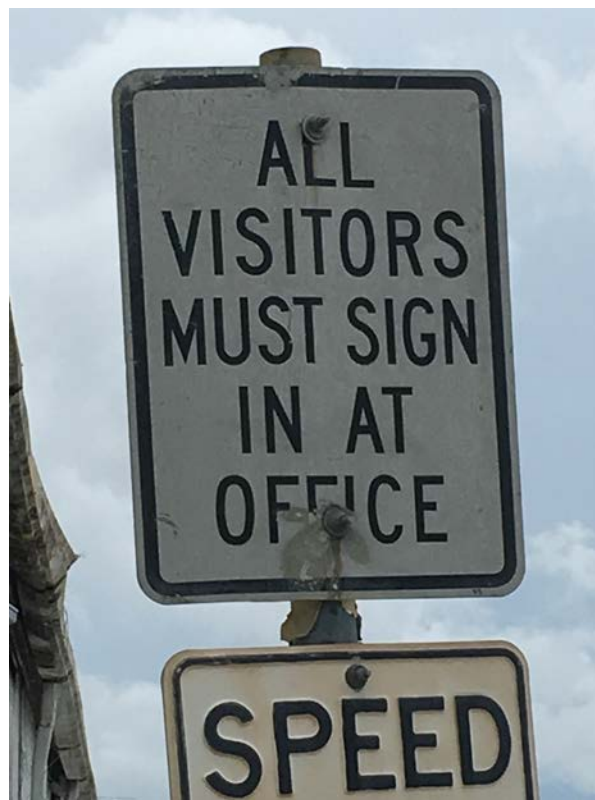
Natural surveillance of the north parking lot and northwest vehicle entrance is achievable from the windows of the administrative offices if staff is present. There is no mechanical surveillance being used on the property, on the site or inside the plant or administrative spaces. While remnants of an old CCTV system were there, it is not functional. Access to the site are not controlled by gates because of the high volume of truck traffic daily, so to prevent theft, vandalism, pilferage, or illegal dumping, vehicles and persons entering the site should be under mechanical surveillance.

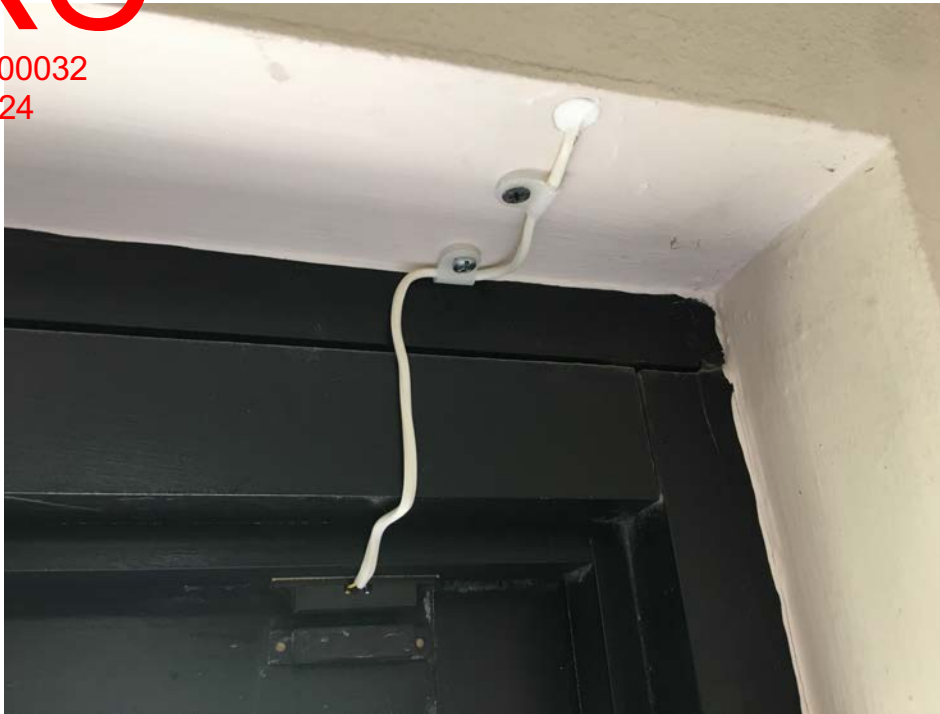
The office has a make shift security system that is monitored but needs to be updated. There is no exterior light along the east side of the business office.

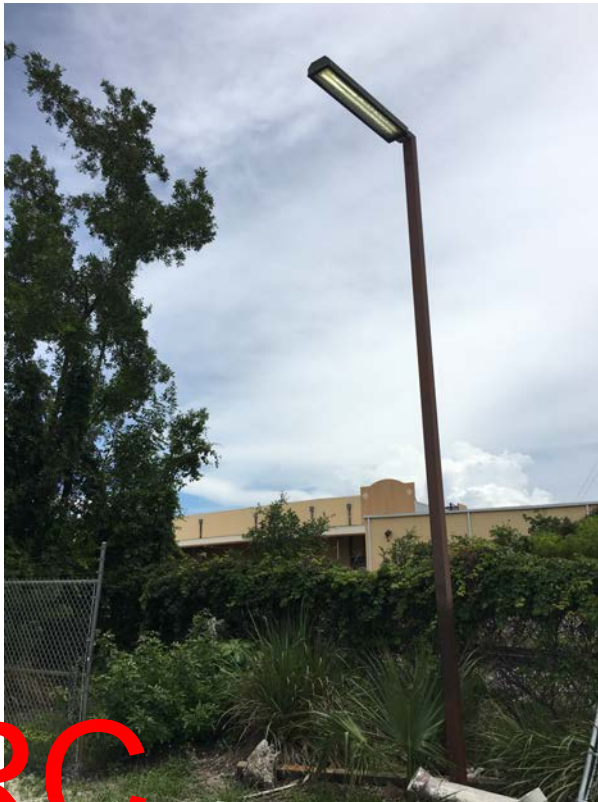
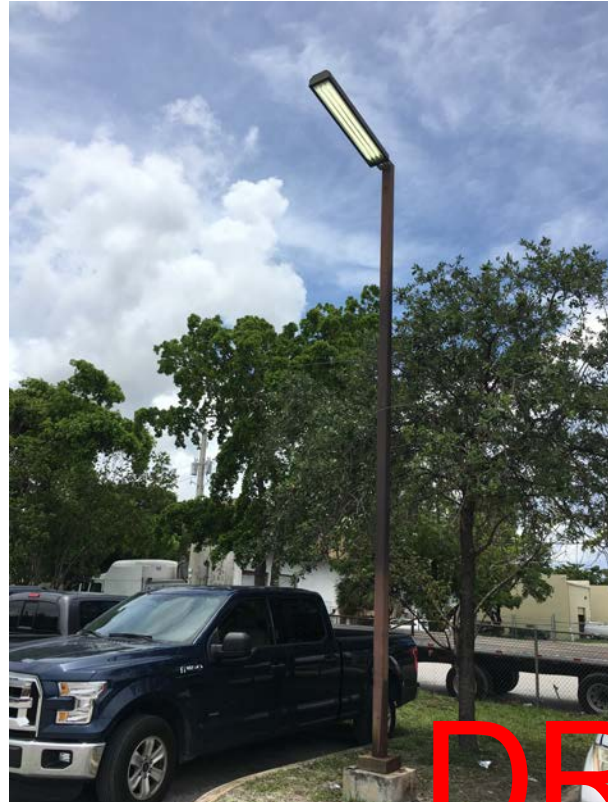
The pole lighting actually uses florescent tubes, and was turned on during daylight hours.

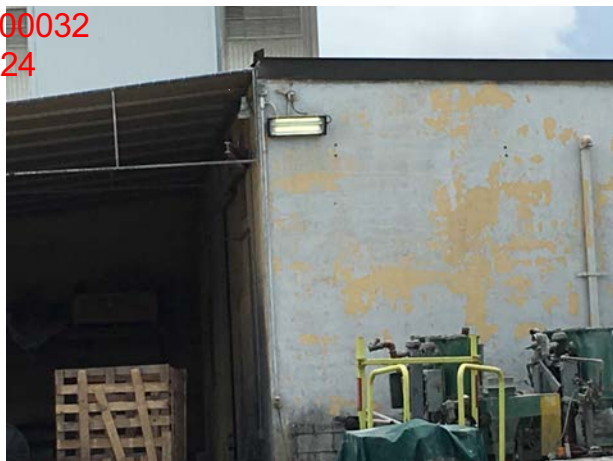
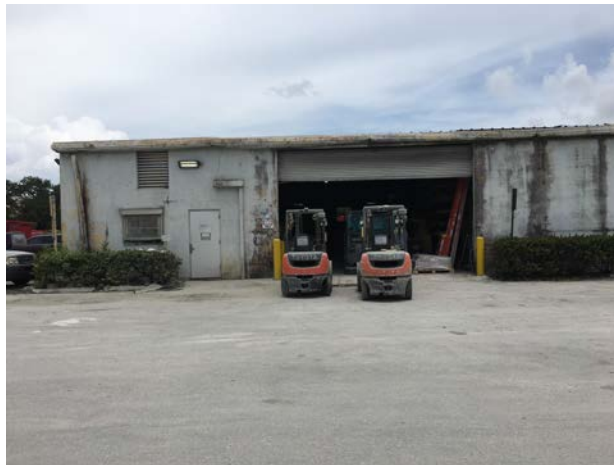
The exterior building lighting is florescent tubes, which are inadequate to properly light the grounds.

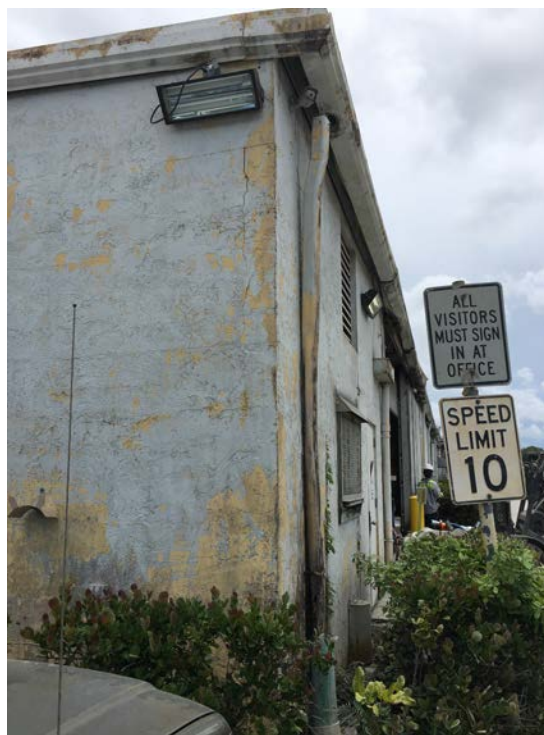
The exterior lighting using florescent tubes as the light source was inefficient and not effective to evenly light the site and building exterior.

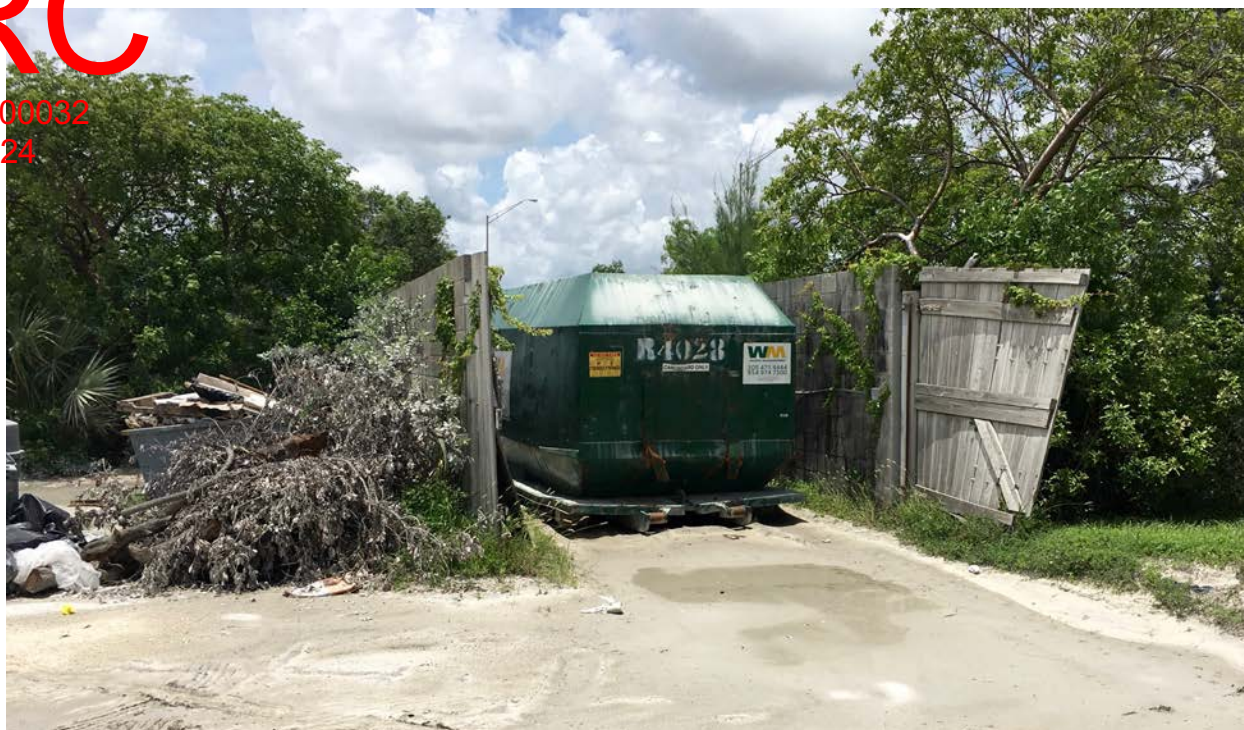
The exterior dumpster area is located in the south part of the yard area across from the Plant. The screening needs to be in working order, and lockable, and the area cleaned up. The dumpster is not set down on a concrete pad. There is no drainage capacity. The wooden gates and shielding are damaged and does not close properly. There is no locking capability to prevent outsiders from outside persons dumping trash.

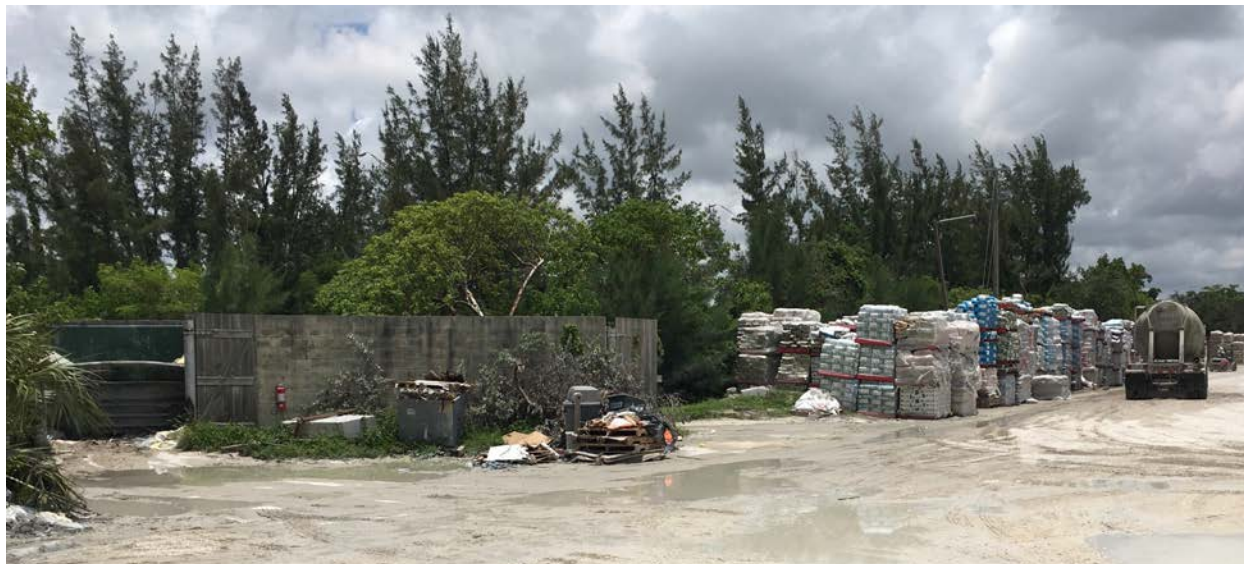
There appears to be some dumping just adjacent to the dumpster. In the new site plan the dumpster will be designed to have compliant surrounding shielding and be secured.

The new proposed dumpster area should be on a concrete pad that can withstand picking up and dropping down by a garbage truck. There should be bollards/bumpers to prevent the truck from hitting the dumpster enclosure. The dumpster should be shielded on three sides with a screening that complies with zoning regulations. Swing gates that are locked should be used to protect the dumpster from illegal or unwanted dumpster diving or dumping. The front screening should be raised so that a person in the dumpster area can be observed from the outside. The gates should be lockable so they can be secured when not being used. If there is any trespassing in the exterior site areas, the person will stand out and be observed and challenged.
