PZ23-12000051  
05/15/2024

Foliage Expressions LLC

## Arborist Report

325 NW 10th St & 324 NW 11St  
Pompano Beach, FL 33060, USA

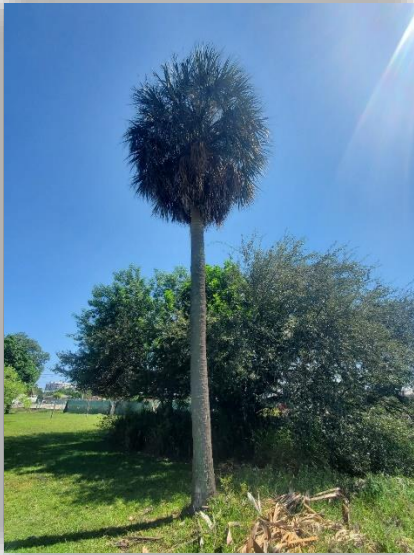
Tree # 1

Condition – Fair

Tree #1 is a large size sable palm located north side of parcel #5 and it is in a fair condition its upper canopy shows interveinal chlorosis and extreme burning on lower of fronds. This palm has been severely neglected over the years due to lack of care, trimming, fertilization and watering. This palm is currently proposed to be removed as part of the upcoming new construction activities and will be mitigated on site.

Disposition – To be removed

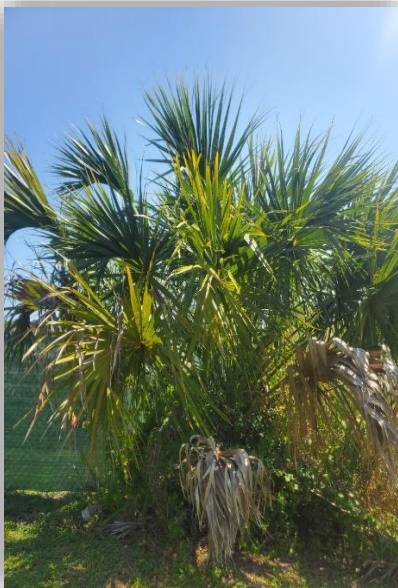
Tree # 2

Condition – Fair

Tree #2 is a young volunteer sable palm in a fair condition located inside parcel 4 east side of the lot. This palm upper canopy shows interveinal chlorosis and extreme burning on lower of fronds. This palm has been severely neglected over the years due to lack of care fertilization and watering. This palm is currently proposed to be removed as part of the upcoming new construction activities and will be mitigated on site.

Disposition – To be removed

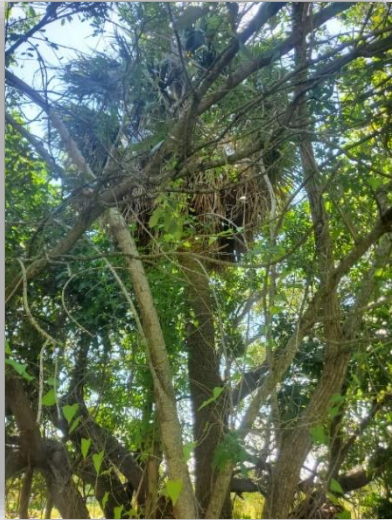
## Tree #3

Condition – Poor

Tree #3 is a large size sable palm located on parcel #5 in the middle of the lot. This palm is in a poor condition its upper canopy shows interveinal chlorosis and extreme burning on lower of fronds. In addition, this palm grew in a very tight space intertwined with adjacent tree Live oak tree #4. This palm has been severely neglected over the years due to lack of care fertilization and watering. This palm is currently proposed to be removed as part of the upcoming new construction activities and will be mitigated on site.

Disposition – To be removed

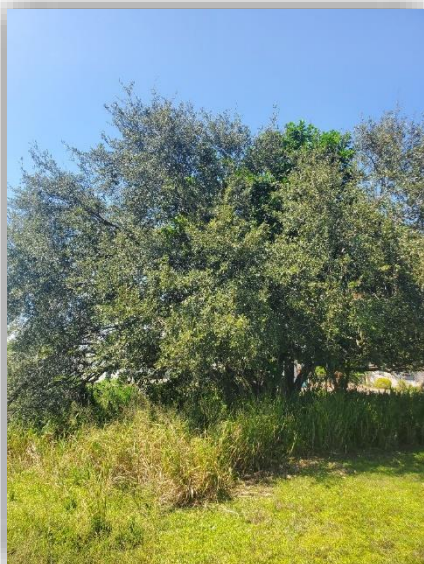
## Tree #4

Condition – Fair

Tree #4 is a multi-trunk native Live oak probably a seed spread Oak that grew in the middle of parcel #5. This Live Oak tree has an overall condition of 50% has several co-dominant leaders an multi trunk weakly attached and poor compartmentalization due to lack of maintenance and past hurricane storm events. This tree is currently in conflict with proposed new development and will be removed and mitigated on site.

\$14,444.16 x diminution of 50% condition = \$7,222.08

Mitigation cost = \$7,222.08

Disposition – To be removed
