PZ24-12000009

March 13, 2024
500 NW 12th Ave
Pompano Beach, FL

An Arborist Report/Appraisal was requested for the above referenced property regarding the condition of Live Oaks on site. See Below for a detailed report.

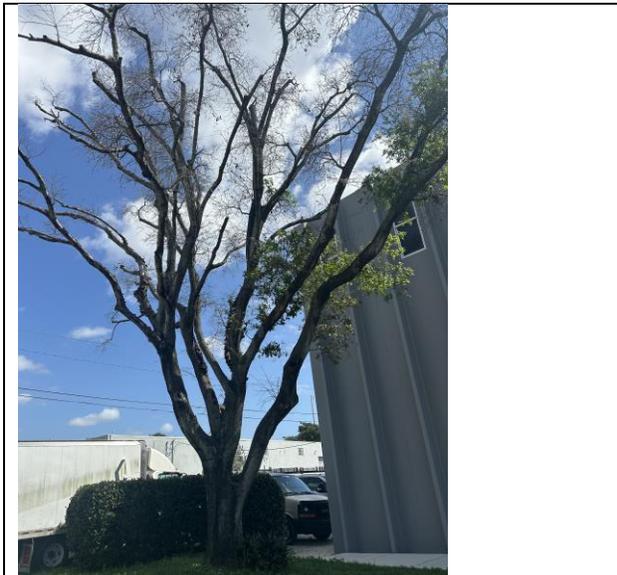
Tree #1 Live Oak (*Quercus Virginiana*) DBH 28", HT 25', SP 15', Cond Dead

This tree is on the Northwest side of the property. This tree is dead with Ganoderma visible on the stems.

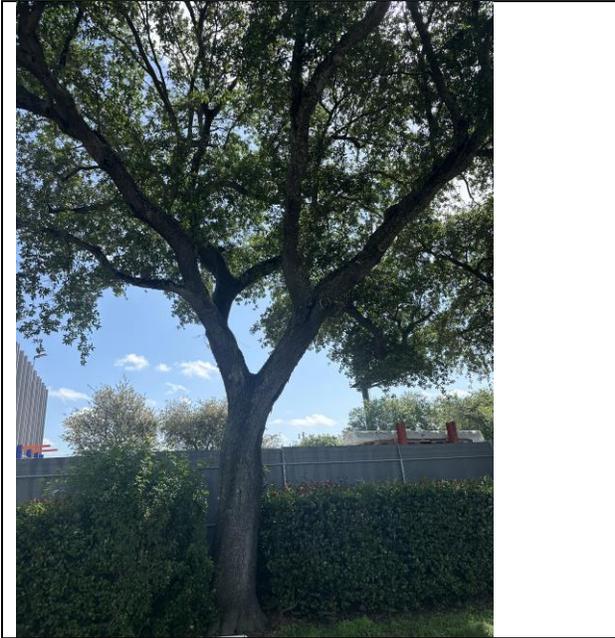
Tree #2 Live Oak (*Quercus Virginiana*) DBH 24", HT 28', SP 20', Cond 72% appraisal \$5,163

This tree is on the North side of the property. This tree has a dense canopy which appears to not have been pruned for a while with many cross, dead and rubbing branches. Some bark peeling was noticed. Stem bleeding was also visible this is an indication internal bacterial issues

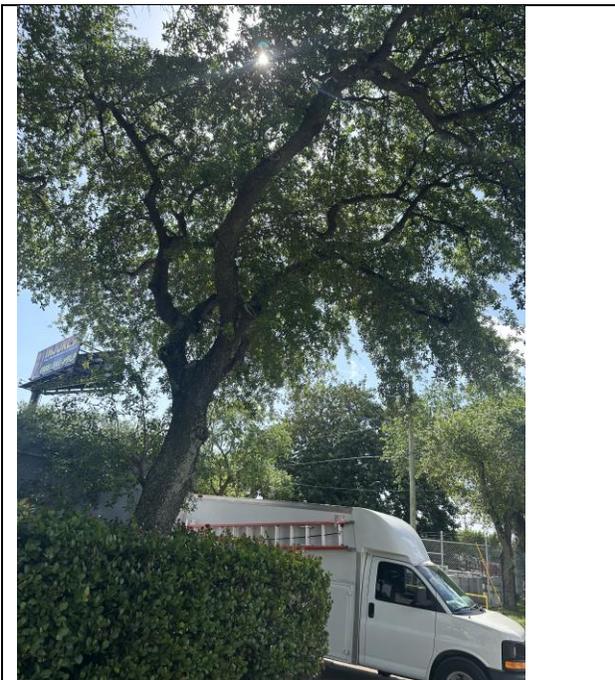
Tree #3 Live Oak (*Quercus Virginiana*) DBH 15", HT 28', SP 20', Cond 70% appraisal \$3,137.4
This tree is on the North side of the property. This tree has a dense canopy which appears to not have been pruned for a while with many cross, dead and fused branches.

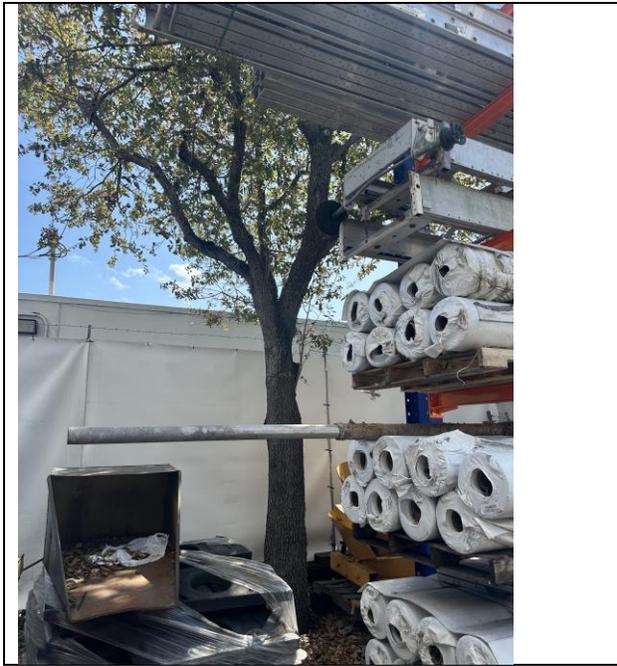
Tree #4 Live Oak (*Quercus Virginiana*) DBH 13", HT 25', SP 16', Cond 56% appraisal \$2,175.26

This tree is on the east side of the property in a small landscape planter about three feet in width. This tree has a sparse canopy with chlorotic leaves. Materials are being stored on and around the tree root system. The tree appears to be stressed and is the cause for the sparse canopy and nutritional deficiencies.

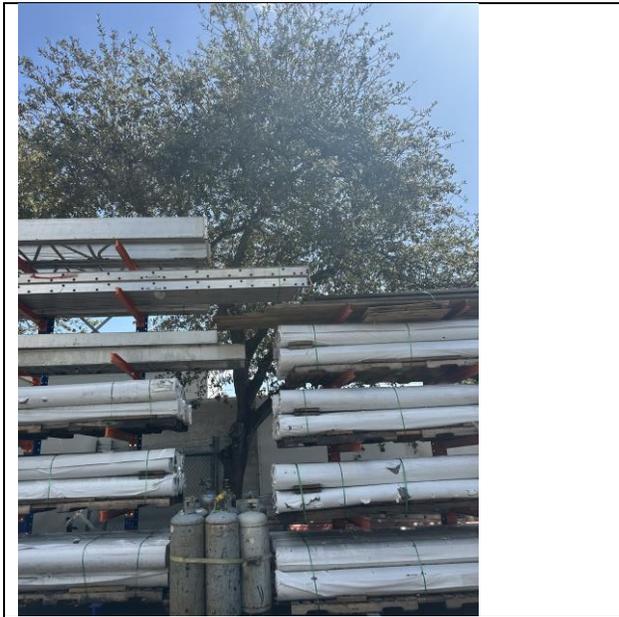
Tree #5 Live Oak (*Quercus Virginiana*) DBH 13", HT 25', SP 16', Cond 56% appraisal \$2,175.26

This tree is on the east side of the property in a small landscape planter about three feet in width. This tree has a sparse canopy with majority of the tree's canopy being concentrated on the east side. Materials are being stored on and around the tree root system.

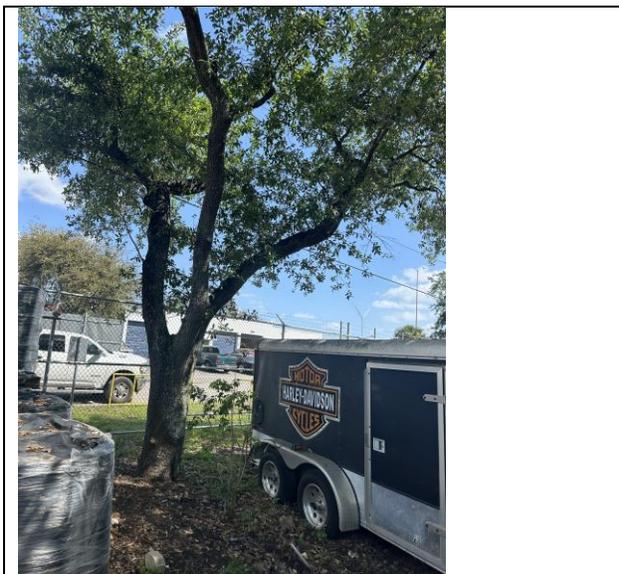
Tree #6 Live Oak (*Quercus Virginiana*) DBH 18", HT 25', SP 18', Cond 54% appraisal \$2,904.33

This tree is on the south side of the property. One portion of the tree has been hatracked due to the overhead powerline. Tree has codominant stems with a slight bark inclusion. Bark Inclusion occurs when two branches or stems of a tree grow too close together, this can result in cracked trunks and a broken limb. The trunks have fused together this is cause weak attachment and eventually one of these trunks will snap.

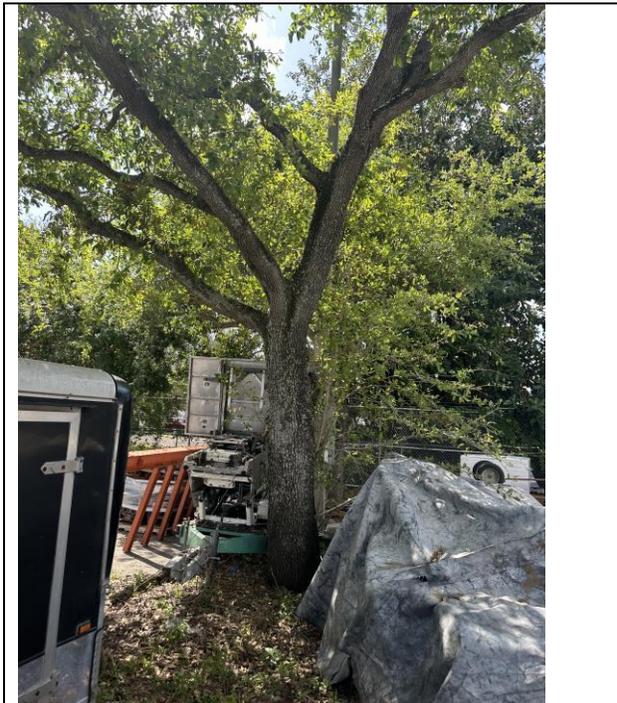
Tree #7 Live Oak (*Quercus Virginiana*) DBH 18", HT 25', SP 18', Cond 56% appraisal \$3,011.00

This tree is on the south side of the property. This tree has a lopsided canopy with all the canopy on the southside has been removed. Tree has codominant stems with a slight bark inclusion. Bark inclusion occurs when two branches or stems of a tree grow too close together, this can result in cracked trunks and a broken limb. The trunks have fused together this is cause weak attachment and eventually one of these trunks will snap. Equipment has been stored on the tree root system. This could cause the tree stress and slowly decline.

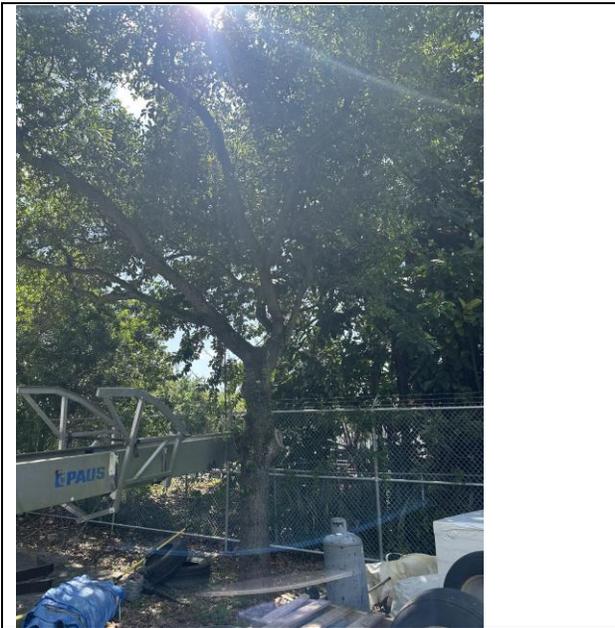
Tree #8 Live Oak (*Quercus Virginiana*) DBH 18", HT 25', SP 18', Cond 50% \$2,689.2

This tree is on the south side of the property. This tree has a lopsided canopy with all the canopy on the southside has been removed. This tree has a spar canopy with stunted growth. Equipment has been stored on the tree root system. This could cause the tree stress and slowly decline.

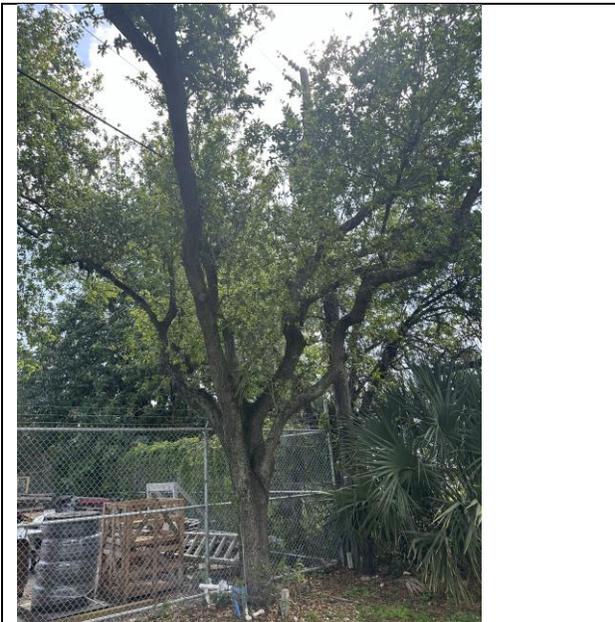
Tree #9 Live Oak (*Quercus Virginiana*) DBH 12", HT 25', SP 18', Cond 50% appraisal \$1,792.8

This tree is on the south side of the property. Tree has codominant stems with a slight bark inclusion. Bark Inclusion occurs when two branches or stems of a tree grow too close together, this can result in cracked trunks and a broken limb. Many dead, decayed and broken branches can be seen throughout the trees canopy.

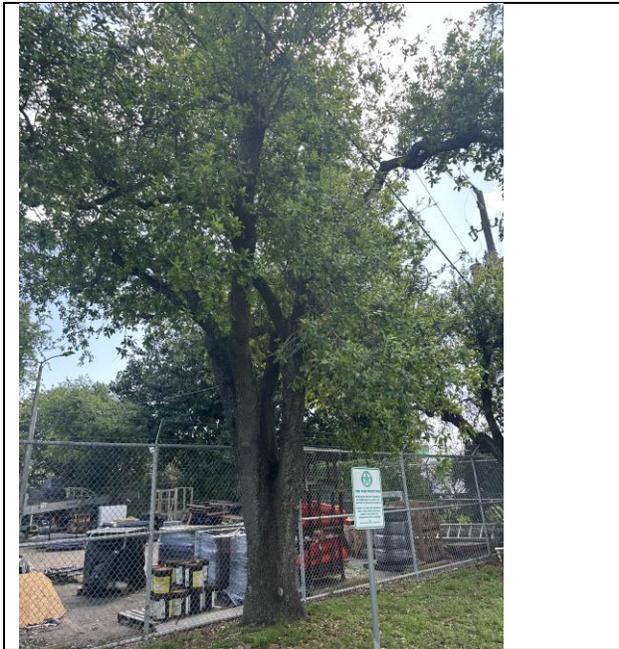
Tree #10 Live Oak (*Quercus Virginiana*) DBH 20", HT 25', SP 18', Cond 52% appraisal \$3,675.2

This tree is on the south side of the property. Tree has codominant stems with a slight bark inclusion. Bark Inclusion occurs when two branches or stems of a tree grow too close together, this can result in cracked trunks and a broken limb. Many dead, decayed and broken branches can be seen throughout the trees canopy.

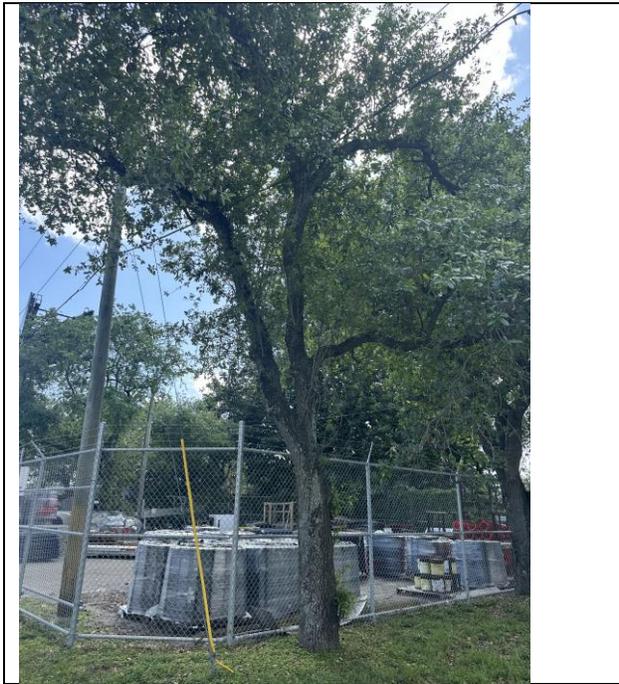
Tree #10 Live Oak (*Quercus Virginiana*)

Tree #11 Live Oak (*Quercus Virginiana*) DBH 12", HT 25', SP 18', Cond 50% appraisal \$1,792.8

This tree is on the southwest side of the property. This tree has a lopsided canopy growing into the powerlines. Many dead, decayed and broken branches can be seen throughout the trees canopy. Old pruning wounds were observed where the tree has failed to properly compartmentalize. This will allow disease rot and decay to set in.
