City of Pompano Beach Water Treatment Plant Building Hurricane Hardening Study – Final Technical Memorandum

June 30, 2016

**City of Pompano Beach
Utilities Department
1205 NE 5th Ave
Pompano Beach, FL 33060**

**Tetra Tech
450 N. Park Rd., Suite 502
Hollywood, FL 33021**

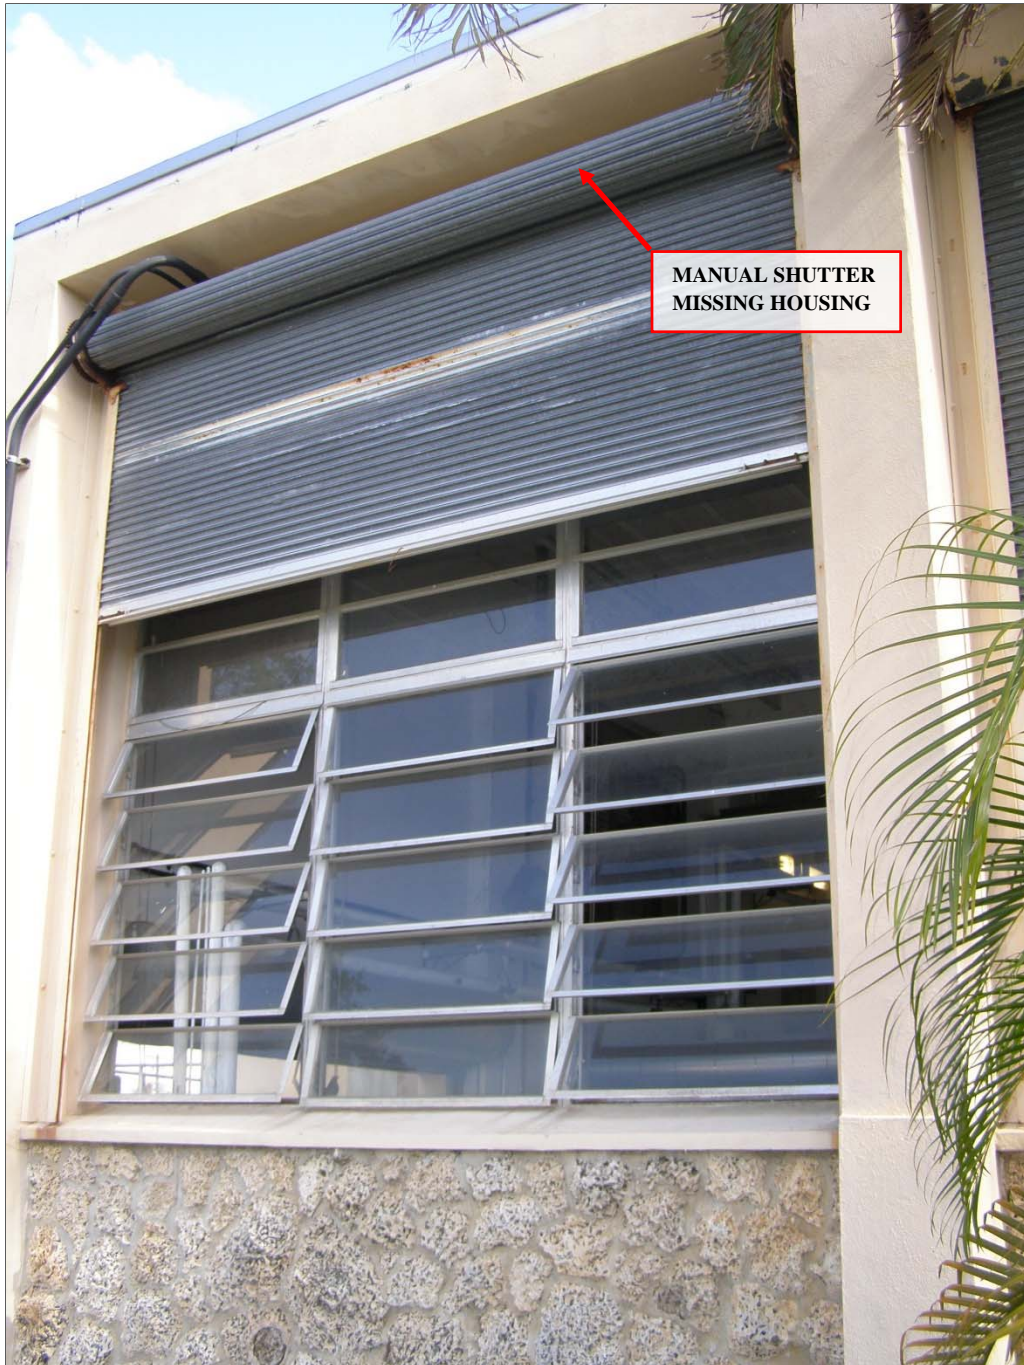
1. Six (6) approximately 12' x 12' operable window assemblies that are protected by manually operated roll down shutters doors mounted to the exterior of the building. The opening enclosures are original to the construction of the facility and provided ventilation to the HSP room.

Photo 5: Exterior View of Window and Shutter

1. Add #5 vertical reinforcement in grout filled cells at 48" o.c. to unreinforced CMU. ROM \$43,000.
2. Replace five (5) of six (6) approximately 12' x 12' operable window assemblies with HVHZ reinforced aluminum window frames and glazing rated for small and large missile impact and wind loads. Replace northern most 12'x12' window with HVHZ rated air intake fan and louver designed to meet code required for make-up air intake requirements and provide controlled ventilation of the HSP room. ROM \$60,000.

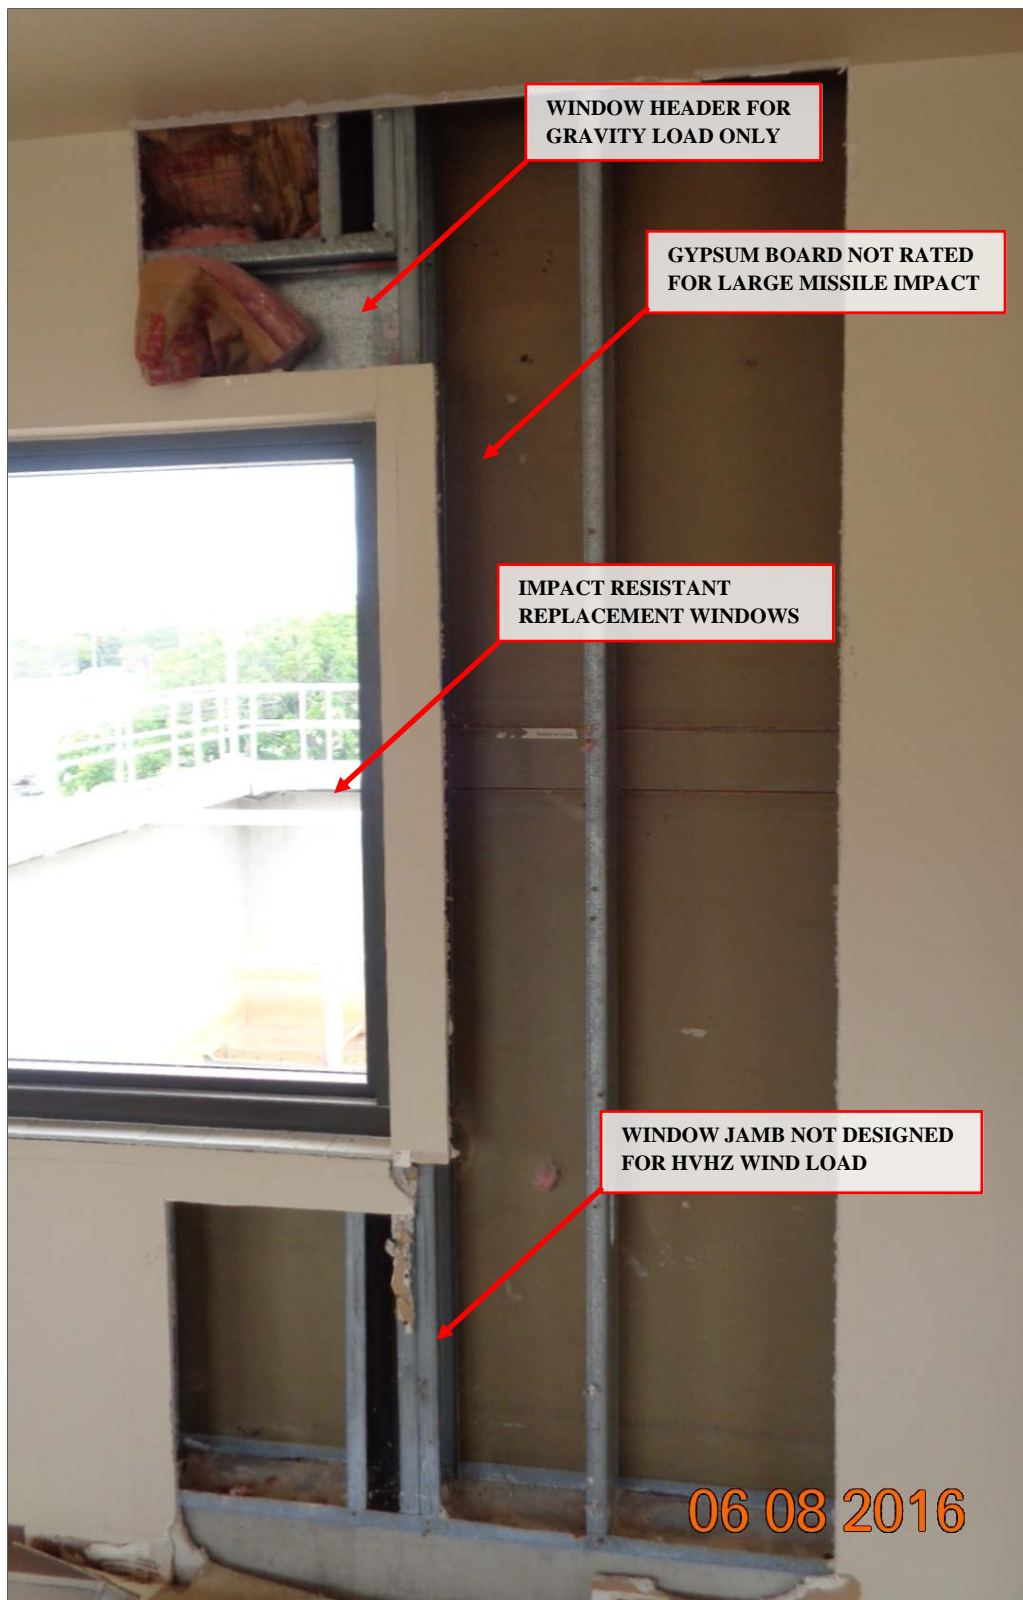
When the plant was expanded in 1983, the operation gallery was extended to the north but built with steel framing and metal stud cladding. Roof members are 8" deep wide flange beams with 1 ½" metal deck. Wall construction is 6" cold formed steel studs with stucco on metal lath over gypsum board. When analyzed for current wind loads, the structural framing and typical metal studs were verified as adequate. However, there are several deficiencies, including: metal roof deck attachment, metal stud construction/strength around large openings, lack of structural sheathing on the metal studs, and gypsum board attachment and wind/impact rating. Information regarding all three of these items is based on the record drawings and limited observation by removing sections of drywall from the building interior.

Photo 10: Filter Gallery Expansion - Stud Wall Assembly

1. Remove and replace metal stud wall assembly on Filter Operation Gallery addition with code compliant, engineered metal stud wall assembly. It is assumed that the recently replaced HVHZ rated windows can be reused. ROM \$75,000.

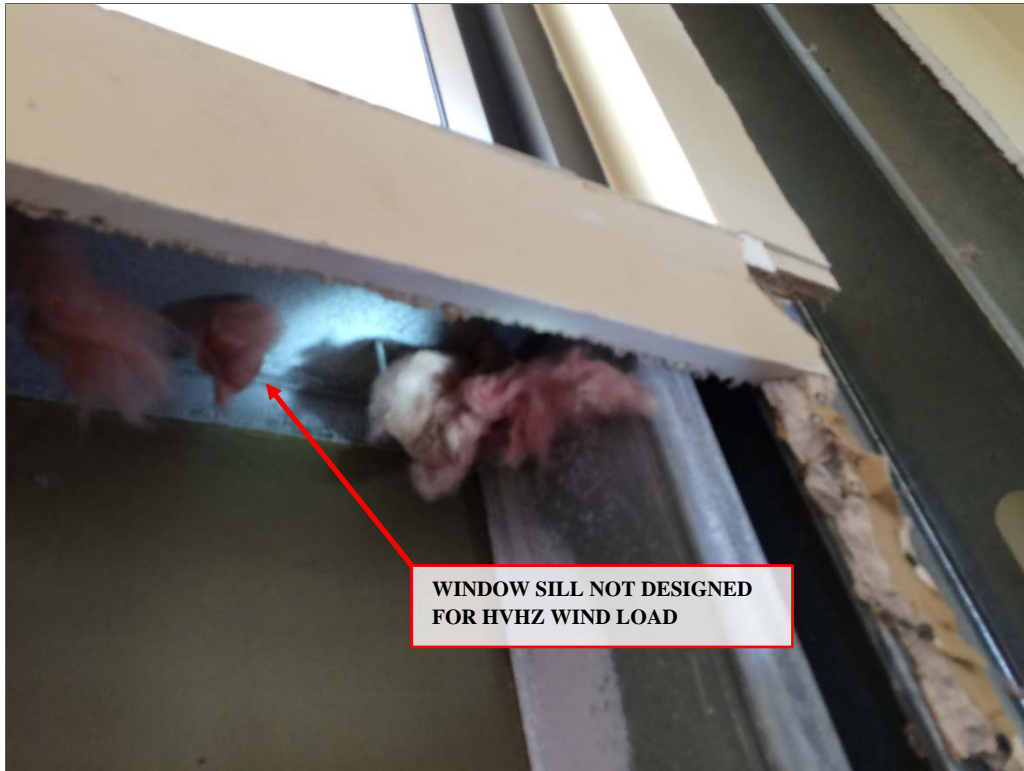
Photo 11: Filter Gallery Expansion - Window Sill Framing

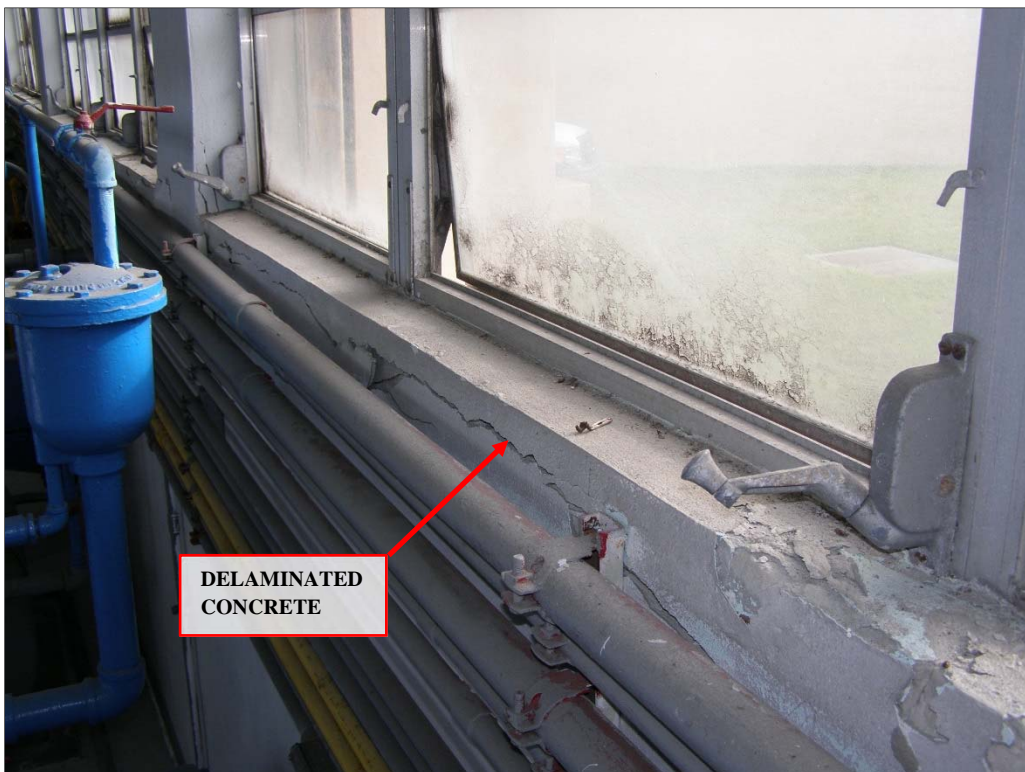
1. Seven (7) approximately 13' x 5' operable window assemblies that are protected by manually operated roll down shutters doors mounted to the exterior of the building. The openings are original to the construction of the facility and provide ventilation to the High Service Pump room. The windows are not currently operable, and water damage is evident where windows are stuck in the open position.

Photo 18: Window Sill Deterioration in Pump Room

2. Replace seven (7) approximately 13' x 5' operable window assemblies with HVHZ reinforced aluminum window frames and glazing rated for small and large missile impact and wind loads. Install louvers as required by mechanical for ventilation compliance. Remove roll shutters and repair exterior wall. ROM \$50,000.

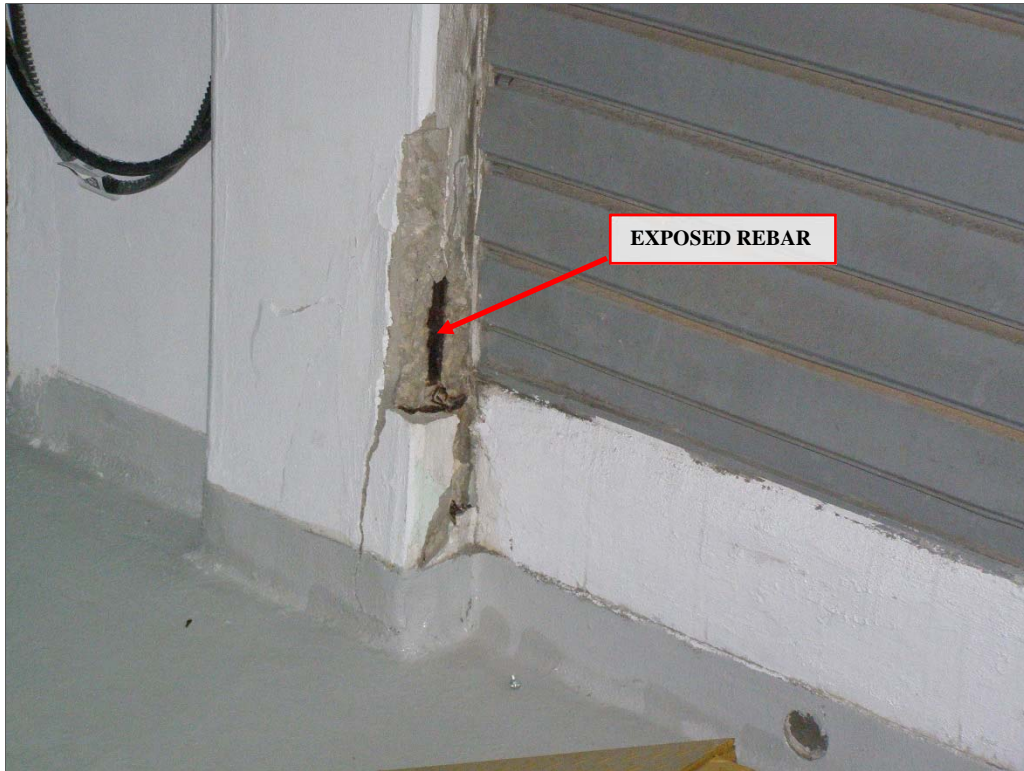
Photo 19: Column Damage in Generator Room

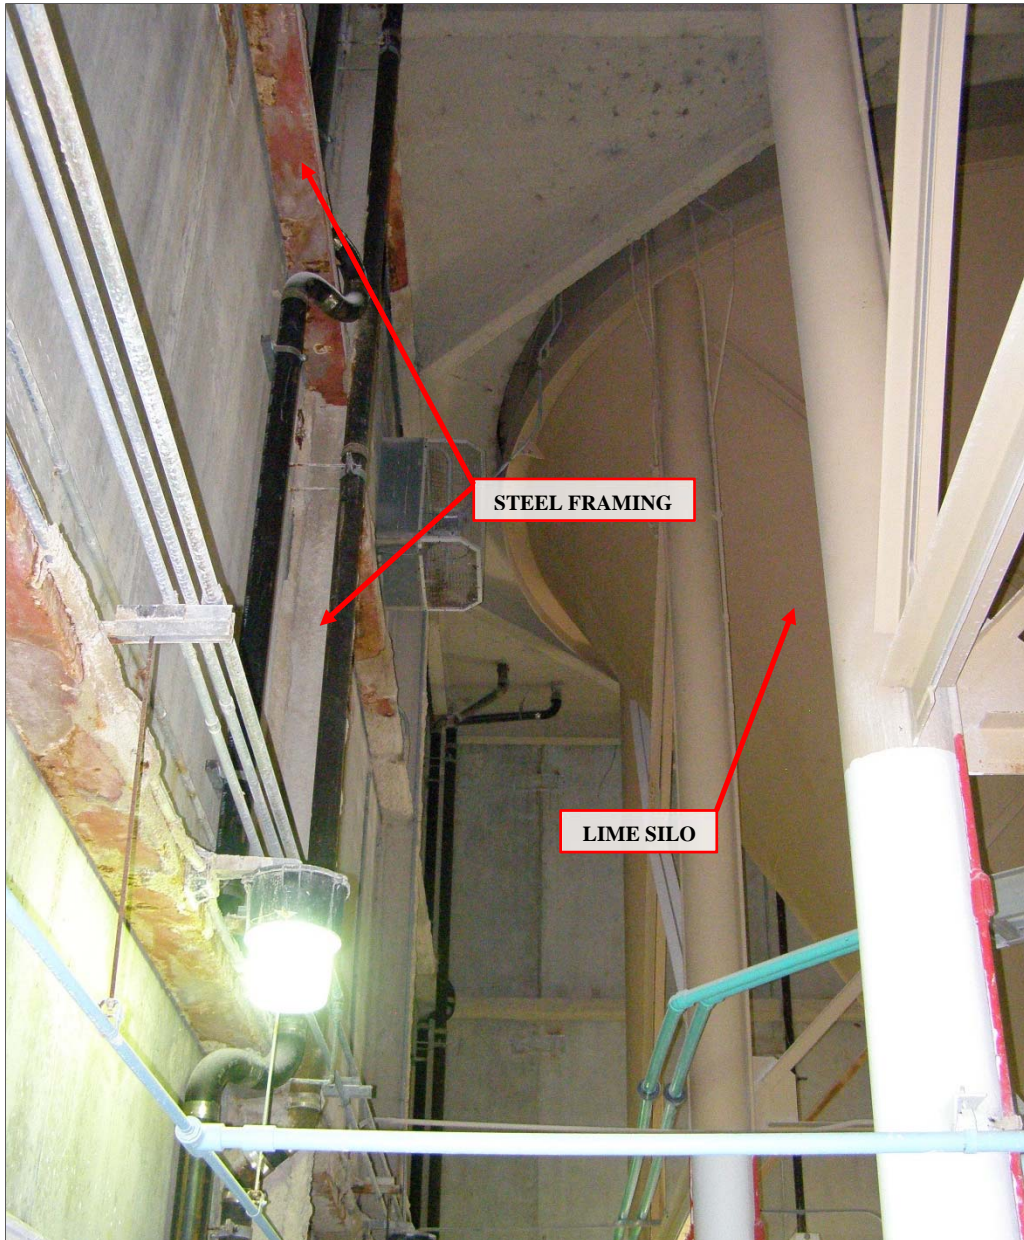
Building construction is primarily steel framing and exterior precast concrete wall panels that rest on top of the floor slab. The precast wall panel connections are detailed to transfer out-of-plane and in-plane loads only. Gravity loads from the roof and floor are carried by the steel framing. Roof framing over the shop and second floor is a combination of W-shape steel beams and H-series bar joists that support metal roof deck. The roof framing around the Lime silos is W-shape steel beams that act compositely with a 6" concrete slab. The second floor is a 6½" composite metal deck slab that is supported by a combination of CMU walls and W-shape beams. The concrete foundations are comprised of piers and stem walls on monolithically poured column and wall footings. Most structural members and components were observed to be in good condition overall, with the exception of some of the steel framing that has started corroding due to loss of sprayed-on fire protection.

Photo 25: Steel Framing with Corrosion and Loss of Fire Protection

1. Clean steel framing that is corroded and respray with fire protection. ROM \$8,000.
2. Retrofit metal deck attachment over shop area and 2nd floor by adding mechanical fasteners. Roofing replacement would be required for this retrofit. ROM \$50,000.

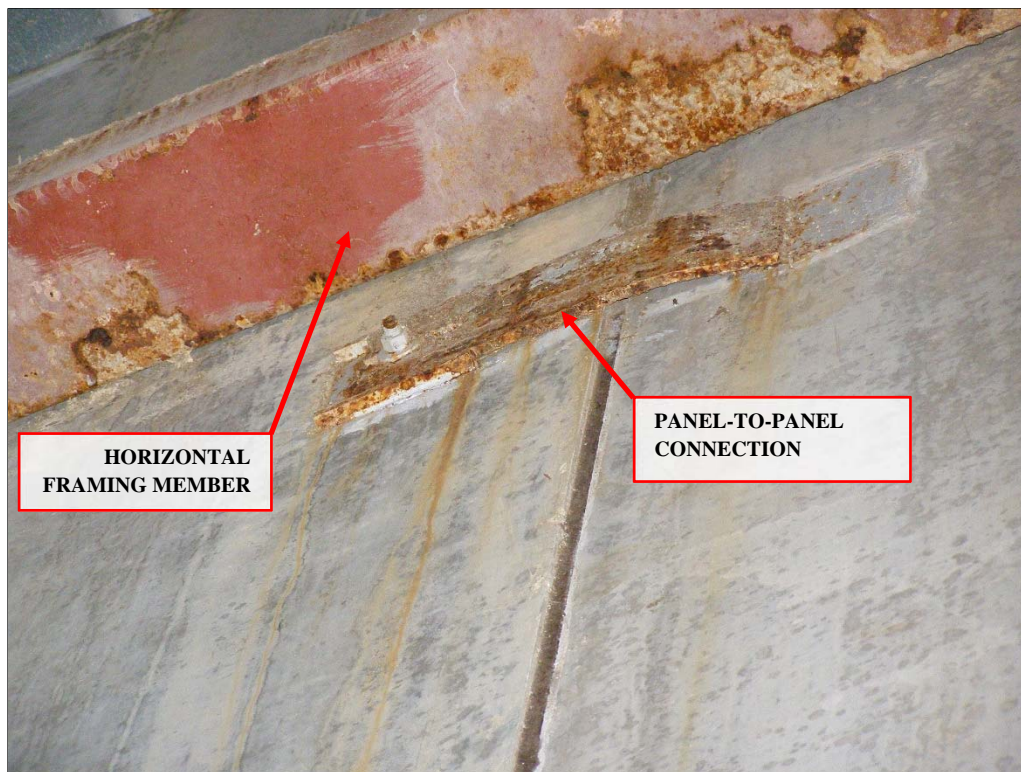
**HORIZONTAL
FRAMING MEMBER**

**PANEL-TO-PANEL
CONNECTION**

Photo 26: Steel Framing and Connection Corrosion

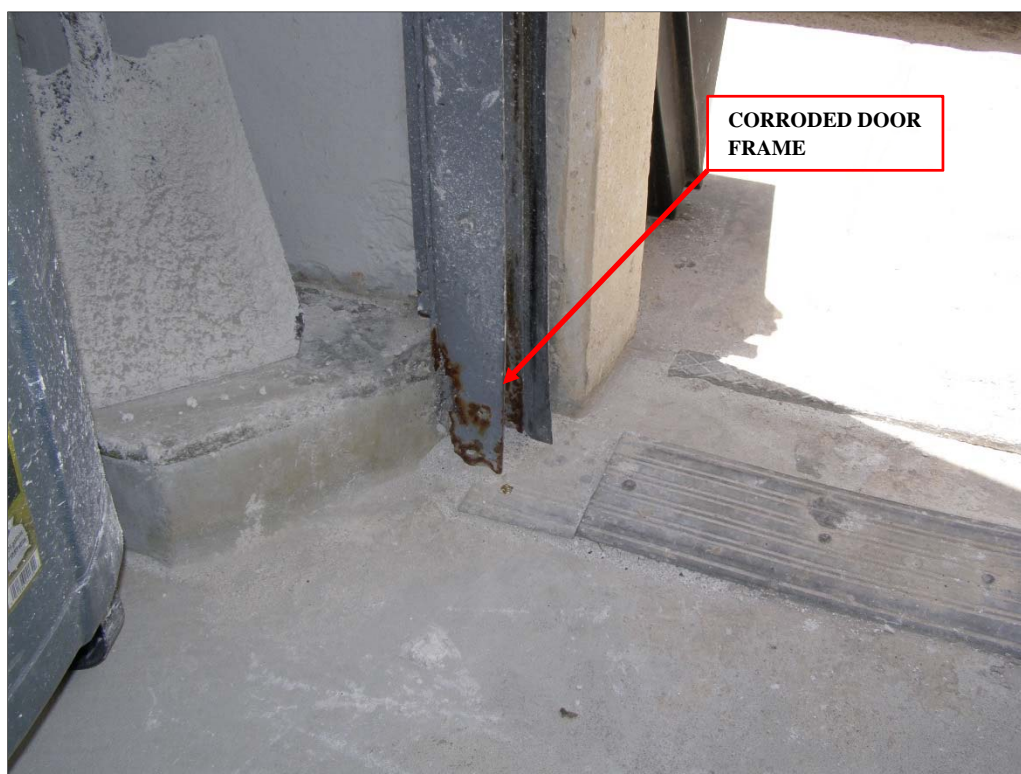
2. One (1) 10' x 14' and two (2) 12' x 9' manually operated overhead coil door provide service access to the Shop Area and the Lime Feed areas. The doors appears to be original to the construction of the facility and are showing advanced corrosion around the base of the tracks.

**CORRODED DOOR
FRAME**

Photo 27: Overhead Door Frame Corrosion

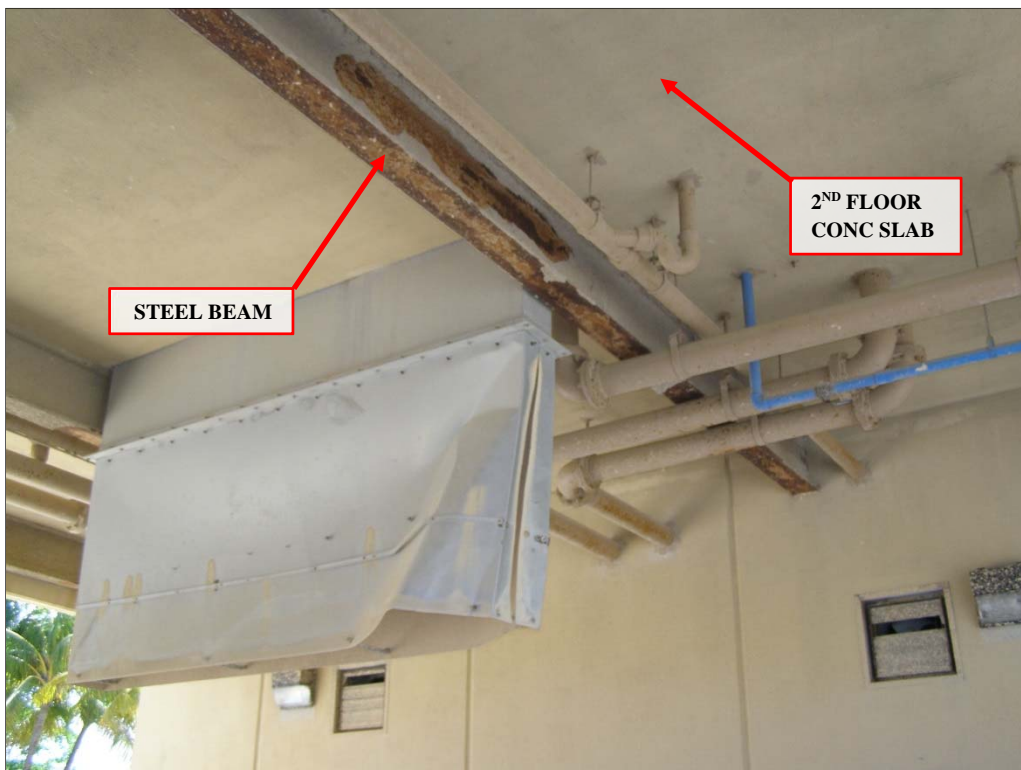
Building construction is steel framing with precast concrete wall panels. The precast wall panel connections are detailed to transfer out-of-plane and in-plane loads only. Gravity loads from the roof and floor are carried by the steel framing. Roof framing is a combination of W-shape steel beams and H-series bar joists that support metal roof deck. The second floor is an 8" concrete slab that acts compositely with the W-shape floor framing. The concrete foundations are mostly isolated column footings with some continuous wall footings to support the precast panels that extend to the ground level. Most structural members and components were observed to be in good condition overall, with the exception of some of the second floor steel framing that has started corroding due to loss of sprayed-on fire protection.

Photo 29: 2nd Floor Framing Corrosion

1. Clean steel framing that is corroded and respray with fire protection. ROM \$8,000.
2. Retrofit metal deck attachment by adding mechanical fasteners. Roofing replacement would be required for this retrofit. ROM \$42,000.
