Foliage Expressions LLC

## Arborist Report

3225 NE 5th St,  
Pompano Beach, FL  
33062

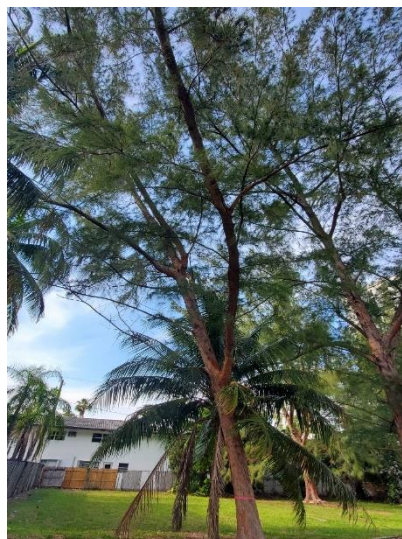
## Tree # 2

Condition – Poor

Tree #2 is an Australian Pine is an invasive exotic tree species as per FLEPPC Category I list of species. Tree is located south side of the property on site. This Australian pine is in poor condition with two main co-dominant leaders compromising tree stability and risk of failing. This tree is in conflict as well with the proposed new development and is proposed to be removed with no mitigation required.

Disposition – To be removed

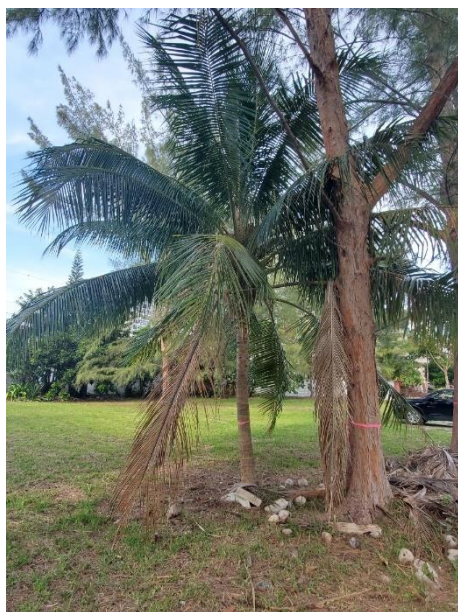
## Tree # 3

Tree #3 is a Coconut palm. This palm is in fair condition its upper canopy shows interveinal chlorosis and extreme burning on lower of fronds. The trunk shows clear signs of tapering reducing its girth on the top and slightly vent sideways due to severe nutritional deficiencies. This palm has been severely neglected over the years due to lack of care fertilization and watering. This palm is currently proposed to be removed as part of the upcoming new construction activities and will be mitigated on site.

Disposition – To be removed

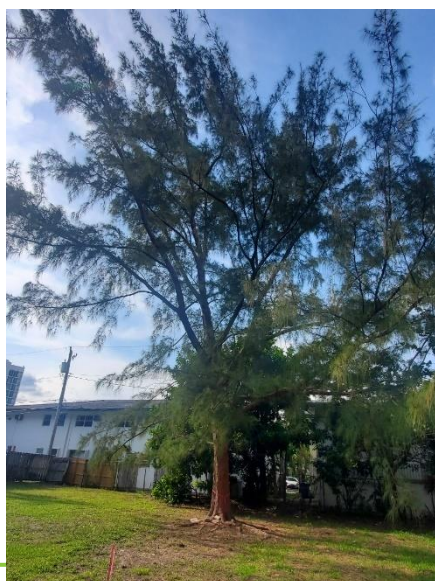
## Tree # 4

Condition – Poor

Tree #4 is an Australian Pine is an invasive exotic tree species as per FLEPPC Category I list of species. Tree is located in the middle of the lot north side of the property on site. This Australian pine is in poor condition with three main co-dominant leaders compromising tree stability and risk of failing. This tree is in conflict as well with the proposed new development and is proposed to be removed with no mitigation required.

Disposition – To be removed

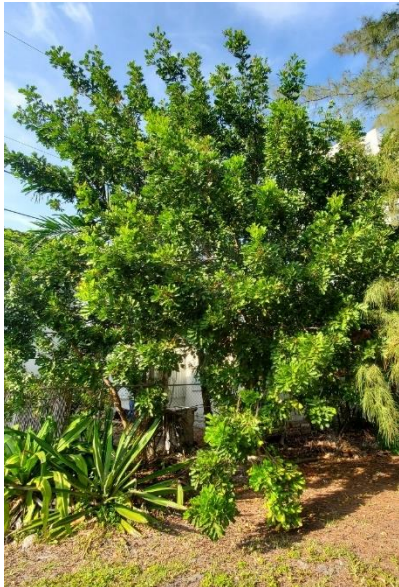
Tree #5 is a Carrotwood tree a very highly invasive exotic tree category 1 as per FLEPPC latest list. This tree is located N side of the property. This tree is probably a seedling of other invasive exotics found in this property or adjacent neighbors. Therefore, immediate removal is recommended and current disposition as per site development is to be removed with no mitigation required.

Disposition - To be removed

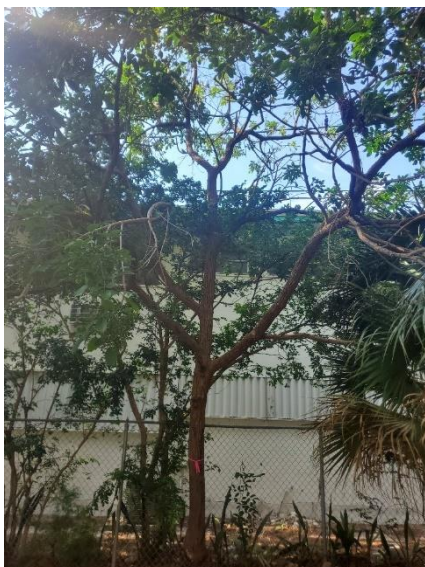
## Tree #6

Tree #6 is an individual single trunk Bischofia tree category I invasive exotic this tree is located middle of the property side of the property along landscape buffer area facing Ingraham Hwy and is currently proposed to remain on site. This tree is a Miami Dade county Prohibited species and an invasive exotic pest plant list category I as per FLEPPC and is highly encouraged to be removed in the future to prevent any spread throughout the property.

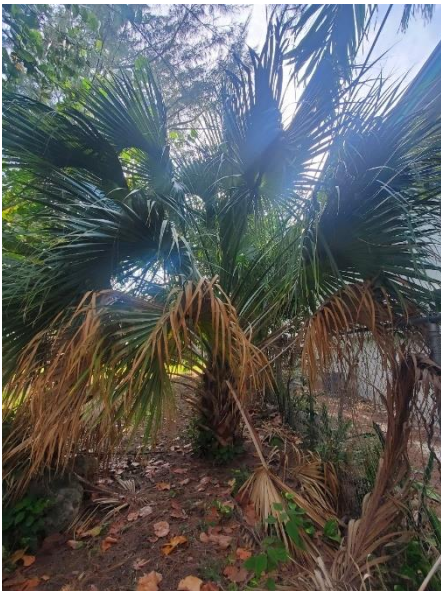
Tree #7 is a young size sable palm in a fair condition its upper canopy shows interveinal chlorosis and extreme burning on lower of fronds. This palm is a volunteer seedling probably from wildlife dispersal. This palm is currently proposed to be removed as part of the upcoming new construction activities.

Disposition – To be removed

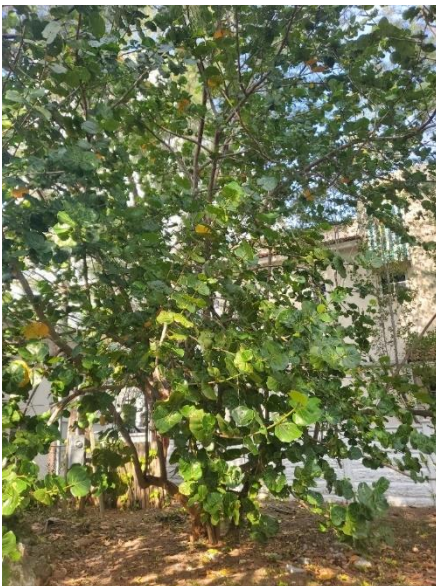
## Tree #8

Tree #8 is a young Seagrape tree located nort side of the property this tree probably was dispersed from wildlife seeds. Tree is in fair condition has severe codominant leaders and included bark and has been severely damaged and deformed during previous storm events and is growing more like a bush with several trunks. This tree is in conflict with proposed new construction and is currently proposed to be removed and mitigated on site.

Disposition - To be removed

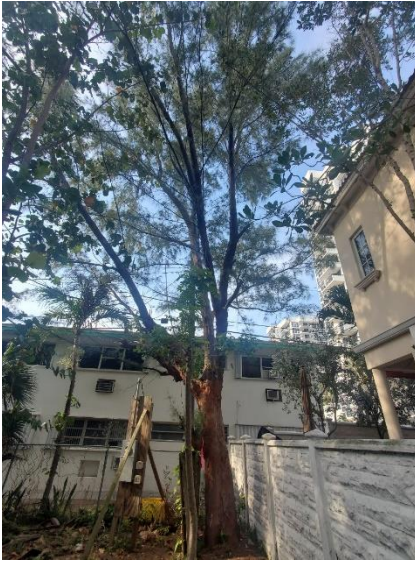
## Tree # 9

Tree #9 is a large Australian Pine as per attached picture. This tree is an invasive exotic tree species as per FLEPPC Category I list of species. Tree is located north east side of the property on site. This Australian pine is in poor condition with three main co-dominant leaders compromising tree stability and risk of failing. Damage to adjacent property is highly probable. This tree is in conflict as well with the proposed new development and is proposed to be removed with no mitigation required.

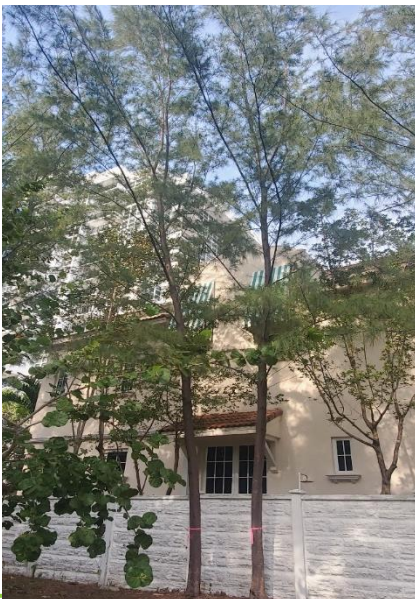
## Tree # 10 &amp; #11

Trees #10 & #11 are both Australian Pines invasive exotic tree species as per FLEPPC Category I list of species. Trees are located east side of the property on site. These Australian pines are seed dispersed by adjacent existing large Australian pine trees. Trees are in good condition with one single leader. Damage to adjacent property is highly probable. These trees are in conflict as well with the proposed new development and is proposed to be removed with no mitigation required.

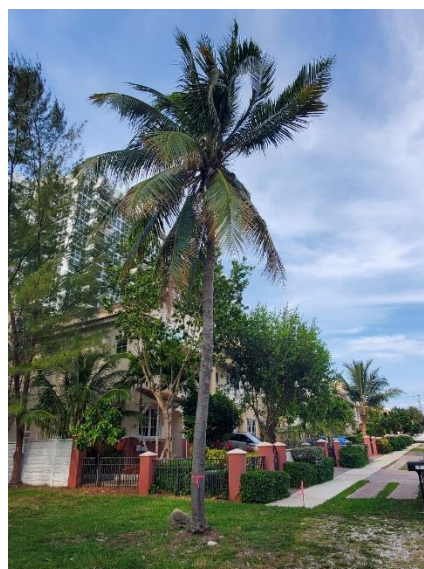
Tree # 13

Tree #13 is a Coconut palm. This palm is located SE side of the property and is in fair condition its upper canopy shows interveinal chlorosis and extreme burning on lower of fronds. The trunk shows clear signs of tapering reducing its girth on the top and slightly vent sideways due to severe nutritional deficiencies. This palm has been severely neglected over the years due to lack of care fertilization and watering. This palm is currently proposed to be removed as part of the upcoming new construction activities and will be mitigated on site.

Disposition – To be removed
