Arborist Report

Alliance Gateway Industrial, SW 27th Avenue
Pompano Beach

10/13/2022

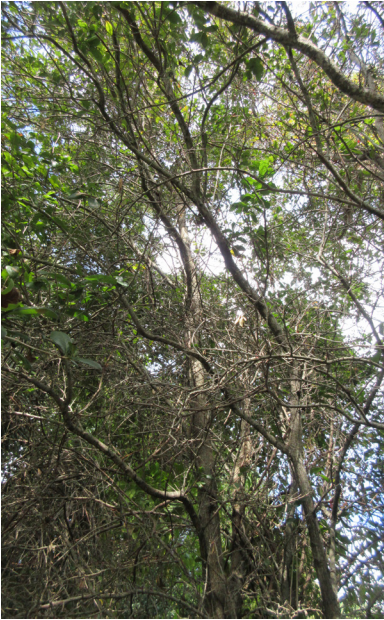
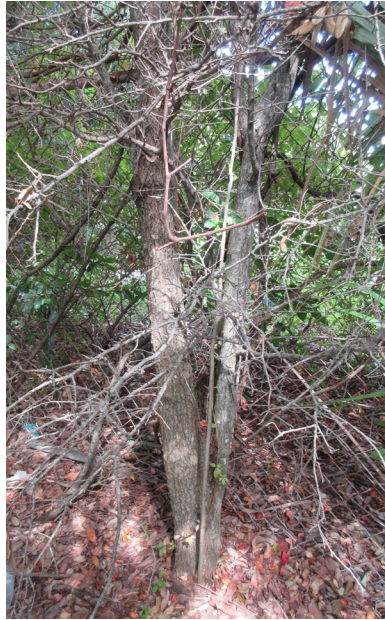
Condition -
FAIR

Tree #1 is a Live Oak located in the northwest corner of the property. It is in fair condition. The trunk divides into two with included bark. There is interior deadwood and galls are on the twigs. The canopy is thin and asymmetrical. The tree is competing with the nearby vegetation.

This tree has not been incorporated into the landscape plan and will therefore be removed.

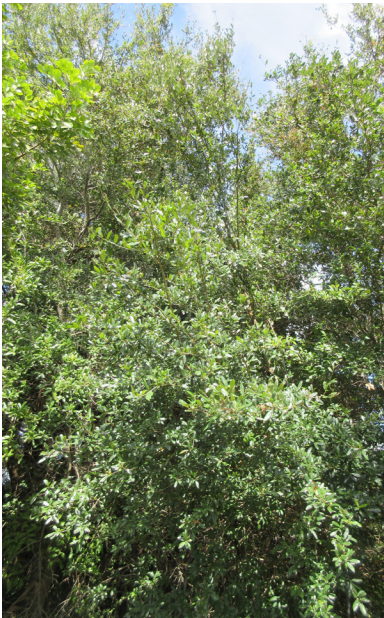
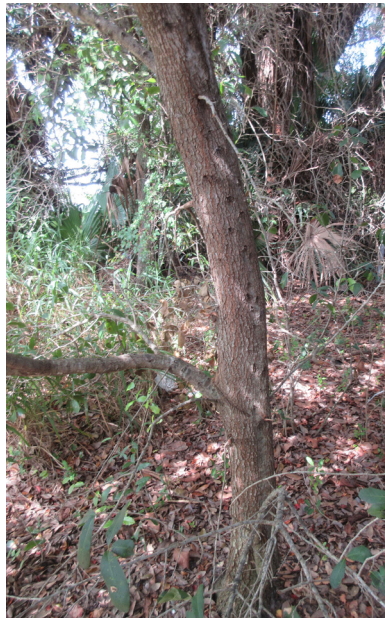
Condition -
GOOD

Tree #2 is a Live Oak located on the northwest corner of the property. It is in good condition. There is interior deadwood. The canopy is asymmetrical. The tree is competing with the nearby vegetation.

This tree has not been incorporated into the landscape plan and will therefore be removed.

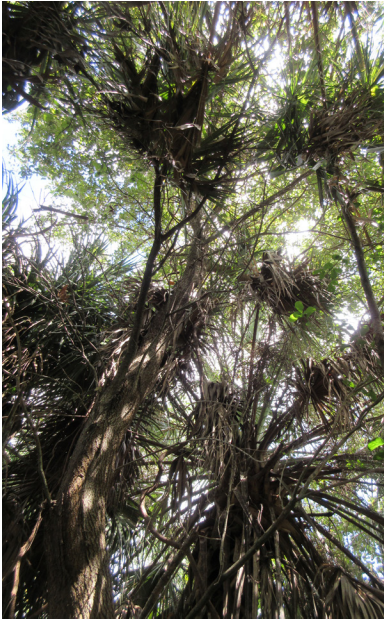
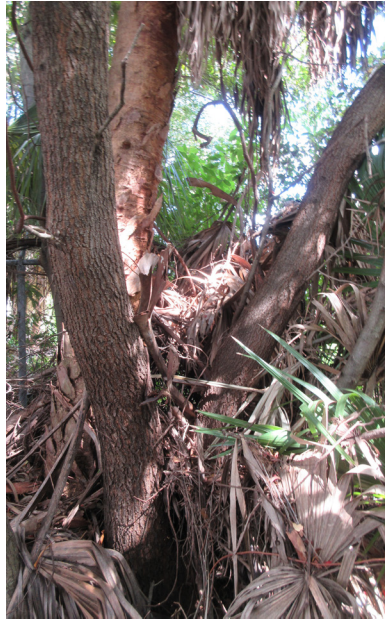
Condition -
FAIR

Tree #3 is a Live Oak located in the northwest corner of the property. It is in fair condition. The tree is double-trunked with included bark. There is interior deadwood. The tree is competing with the nearby vegetation.

This tree has not been incorporated into the landscape plan and will therefore be removed.

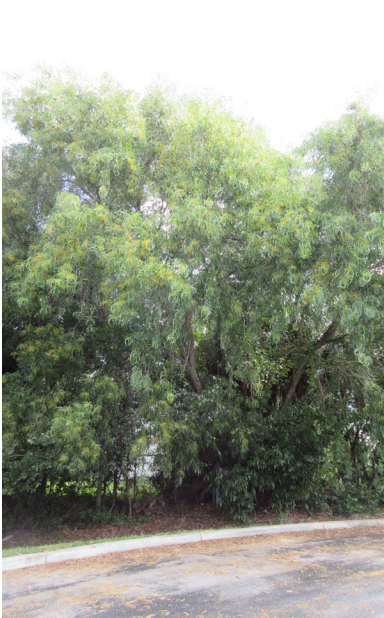
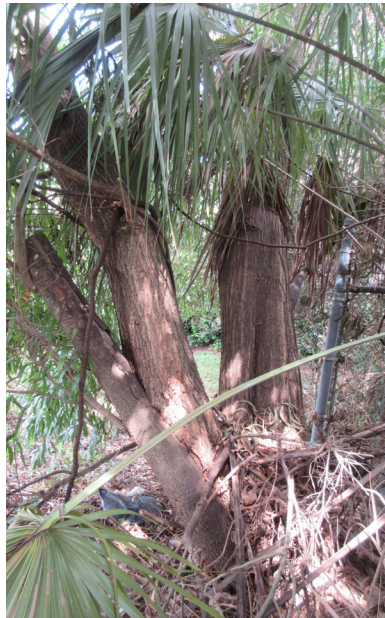
Condition -
FAIR

Tree #4 is an Earleaf Acacia located in the northwest corner of the property. It is double-trunked with a spreading canopy. There is a large branch stub present.

This species is highly invasive in South Florida and this tree will therefore need to be removed.

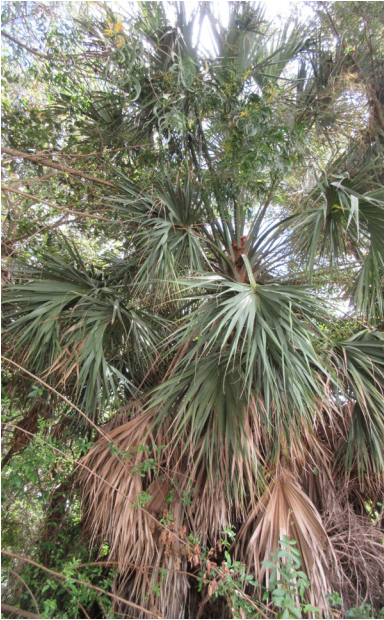
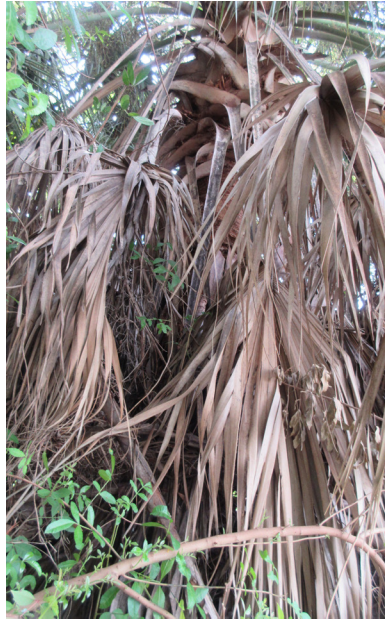
Condition -
GOOD

Tree #5 is a Sabal Palm located in the northwest corner of the property. It is in good condition. There are lower dead fronds. The tree is competing with the nearby vegetation.

This tree has not been incorporated into the landscape plan and will therefore be removed.

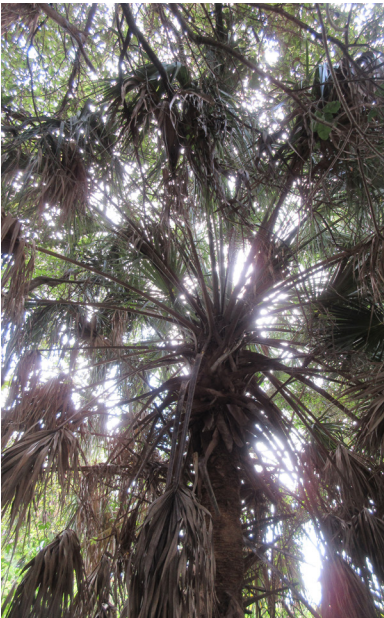
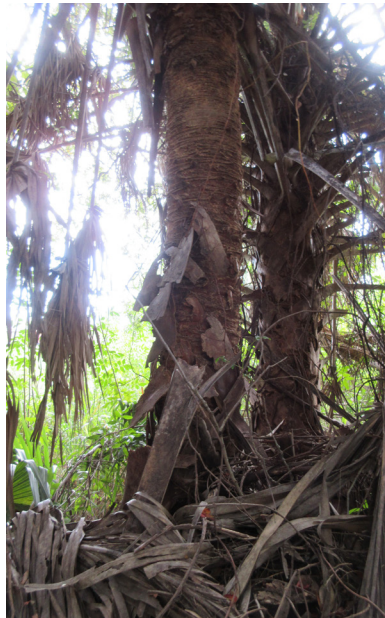
Condition -
FAIR

Tree #6 is a Sabal Palm located in the northwest corner of the property. It is in fair condition. The canopy is thin and there are lower dead fronds. The tree is competing with the nearby vegetation.

This tree has not been incorporated into the landscape plan and will therefore be removed.

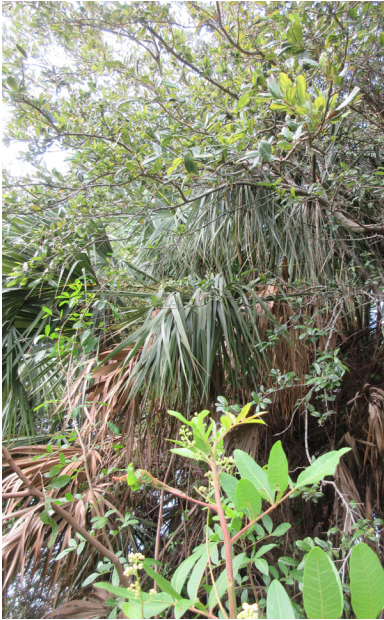
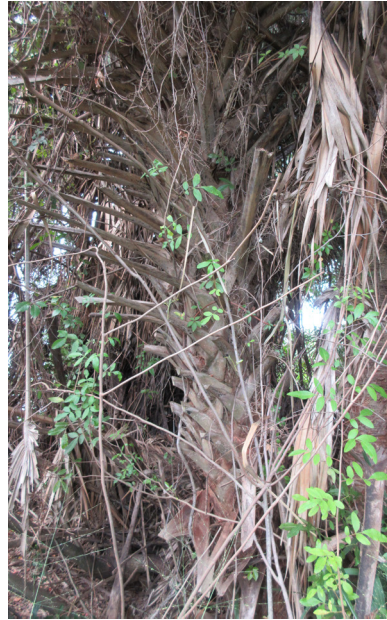
Condition -
FAIR

Tree #7 is a Sabal Palm located in the northwest corner of the property. It is in fair condition. The canopy is thin and there are lower dead fronds. The tree is competing with the nearby vegetation.

This tree has not been incorporated into the landscape plan and will therefore be removed.

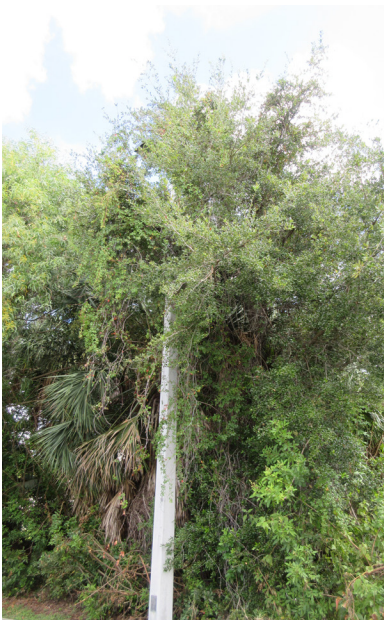
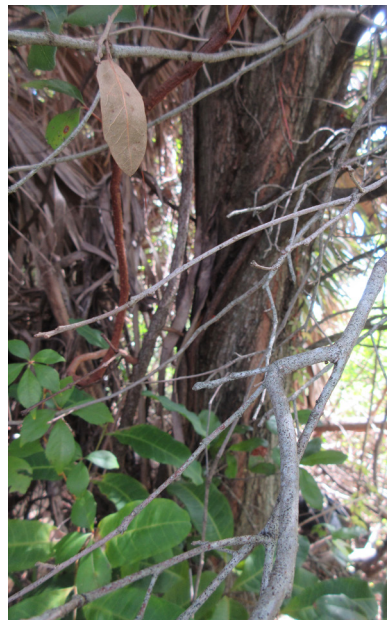
Condition -
GOOD

Tree #8 is a Live Oak located on the northwest corner of the property. It is in good condition. Vines are growing into the canopy and there is included bark between the limbs.

This tree has not been incorporated into the landscape plan and will therefore be removed.

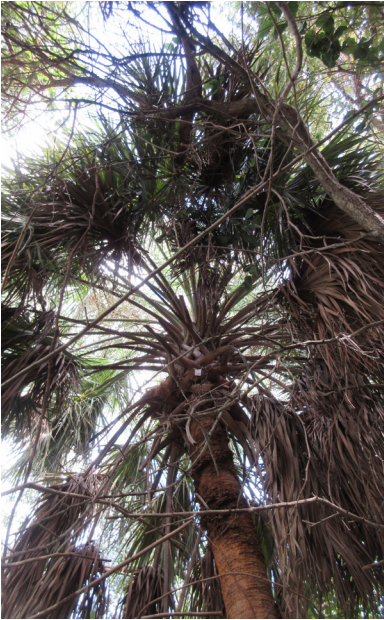
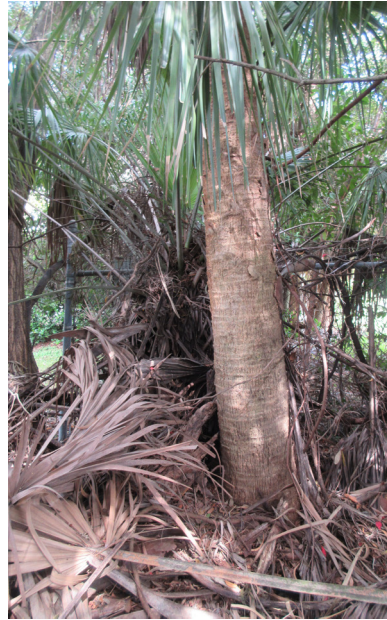
Condition -
FAIR

Tree #9 is a Sabal Palm located in the northwest corner of the property. It is in fair condition. The canopy is thin and there are lower dead fronds. The tree is competing with the nearby vegetation.

This tree has not been incorporated into the landscape plan and will therefore be removed.

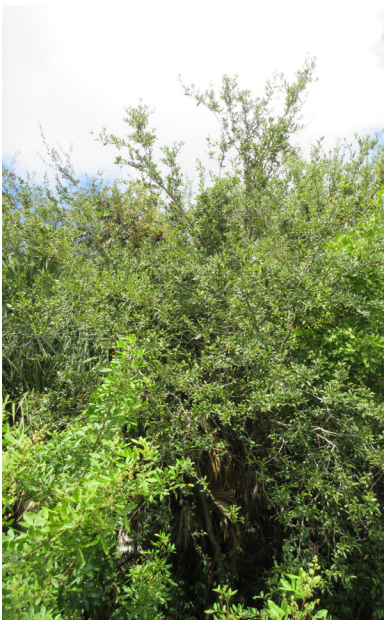
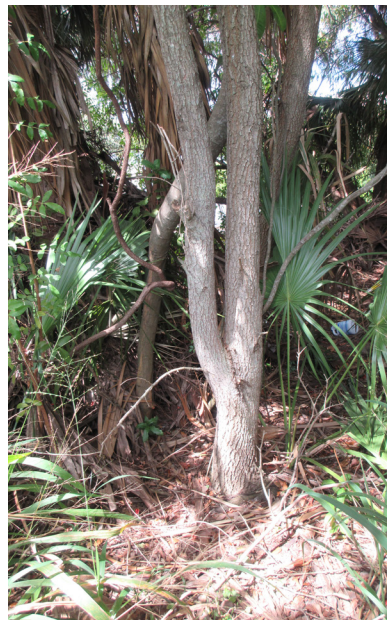
Condition -
FAIR

Tree #10 is a Live Oak located in the northwest corner of the property. It is in fair condition. The trunk divides into two with included bark. The canopy is asymmetrical and the tree is competing with the nearby vegetation.

This tree has not been incorporated into the landscape plan and will therefore be removed.

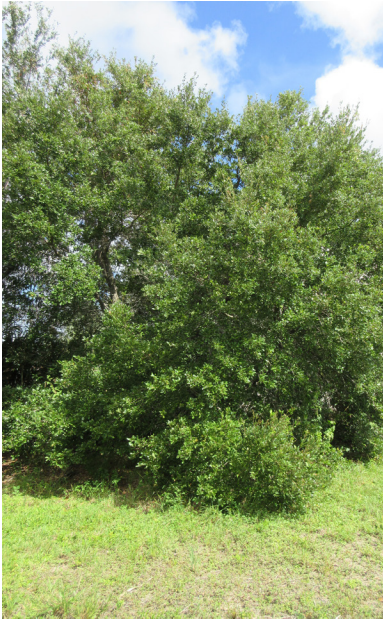
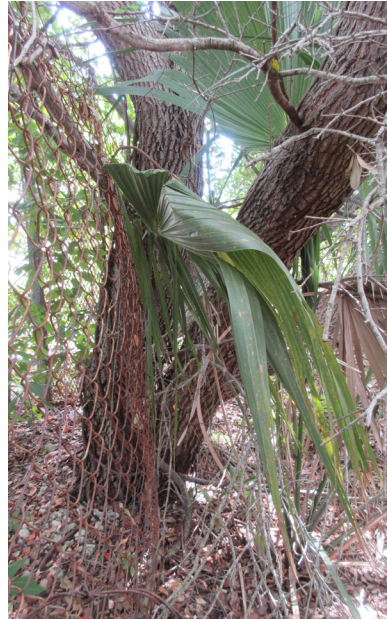
Condition -
GOOD

Tree #11 is a Live Oak located in the northwest corner of the property. The tree is in good condition. It is multi-trunked with included bark. There is chainlink fencing embedded in the trunk. The canopy is dense and spreading.

This tree has not been incorporated into the landscape plan and will therefore be removed.

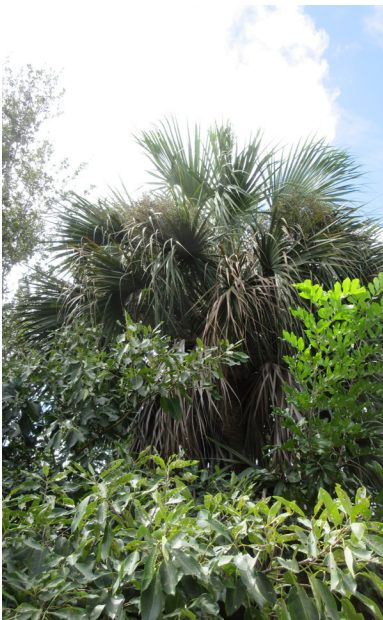
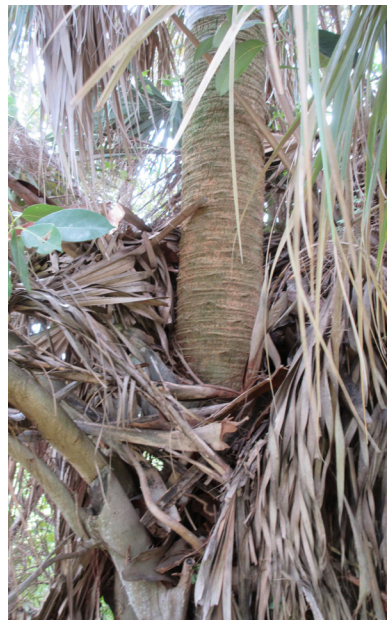
Condition -
FAIR

Tree #12 is a Sabal Palm located towards the northwest corner of the property. It is in fair condition. There are lower dead fronds. The tree is competing with the surrounding vegetation.

This tree has not been incorporated into the landscape plan and will therefore be removed.

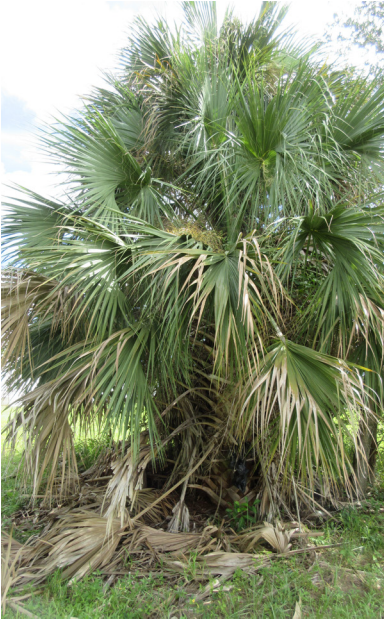
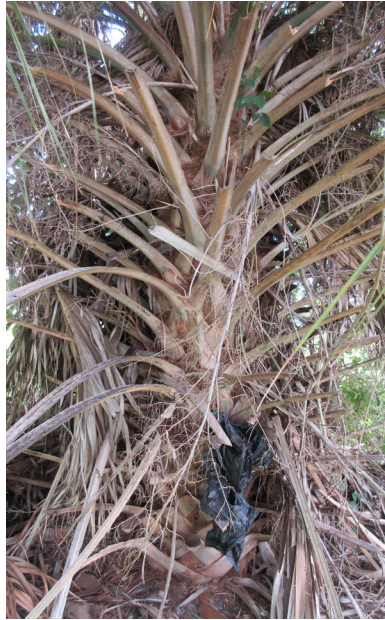
Condition -
GOOD

Tree #13 is a Sabal Palm located towards the northwest corner of the property. It is in good condition with a dense canopy. There are some lower dead fronds.

This tree has not been incorporated into the landscape plan and will therefore be removed.

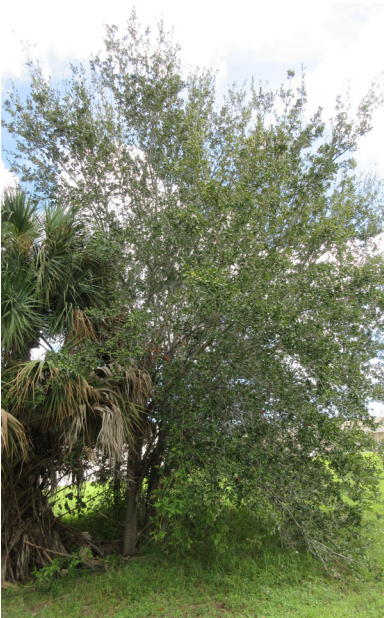
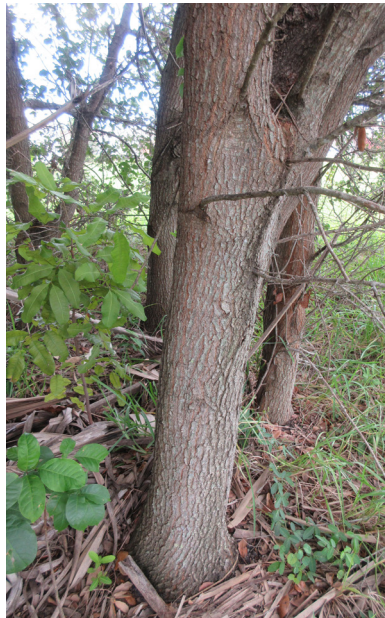
Condition -
FAIR

Tree #14 is a Live Oak located towards the northwest corner of the property. It is in fair condition. There is included bark between the limbs. The canopy is asymmetrical and the tree is competing with the nearby vegetation. There is interior deadwood. There are pest issues affecting the leaves.

This tree has not been incorporated into the landscape plan and will therefore be removed.

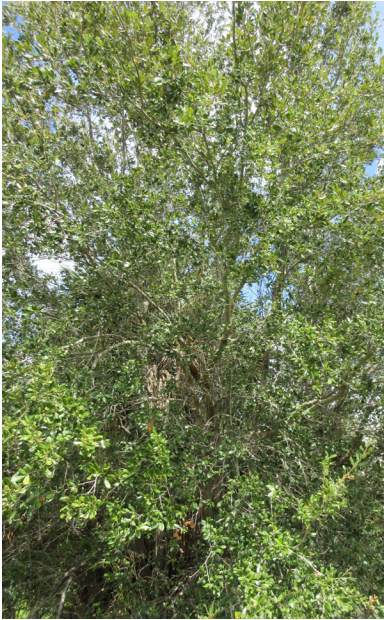
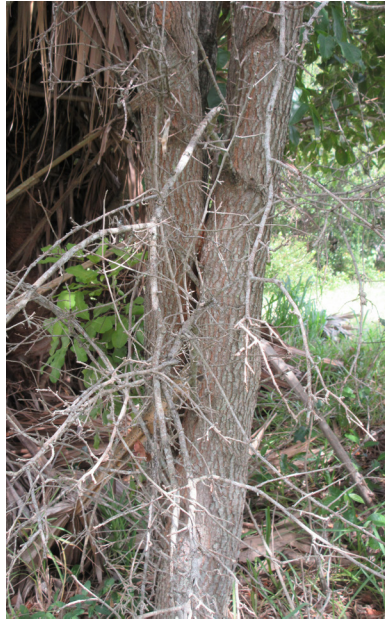
Condition -
FAIR

Tree #15 is a Live Oak located towards the northwest corner of the property. It is in fair condition. The tree is double trunked with crossing limbs. There is included bark between the limbs. The canopy is asymmetrical and the tree is competing with the nearby vegetation. There is interior deadwood. There are pest issues affecting the leaves.

This tree has not been incorporated into the landscape plan and will therefore be removed.

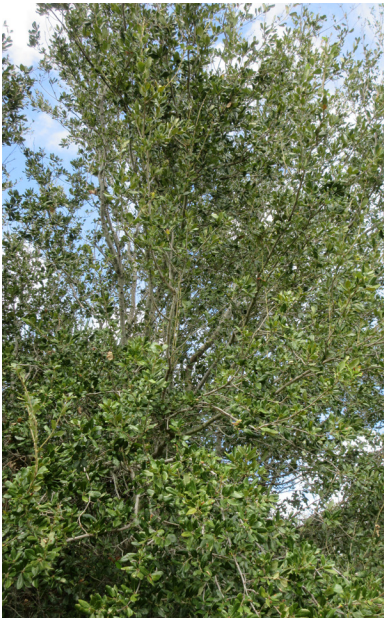
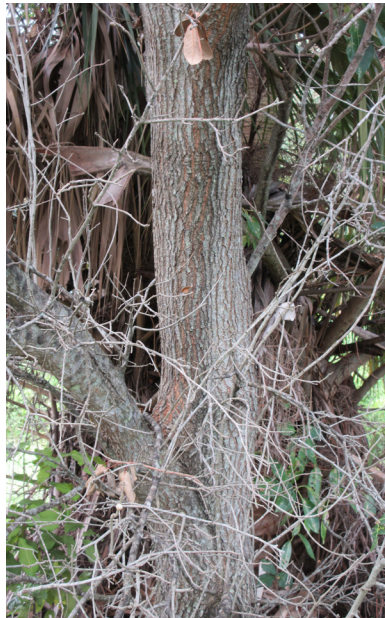
Condition -
FAIR

Tree #16 is a Live Oak located towards the northwest corner of the property. It is in fair condition. There is included bark between the limbs. The canopy is asymmetrical and the tree is competing with the nearby vegetation. There is interior deadwood. There are pest issues affecting the leaves.

This tree has not been incorporated into the landscape plan and will therefore be removed.

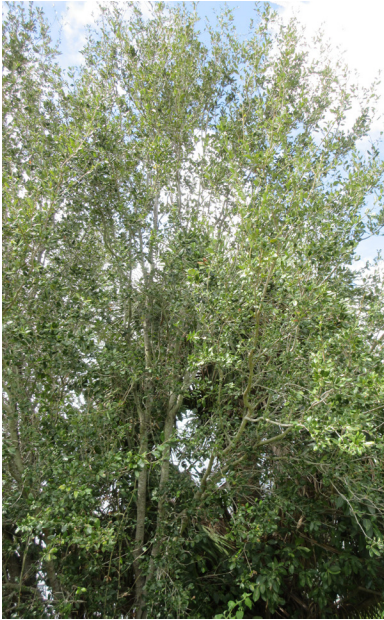
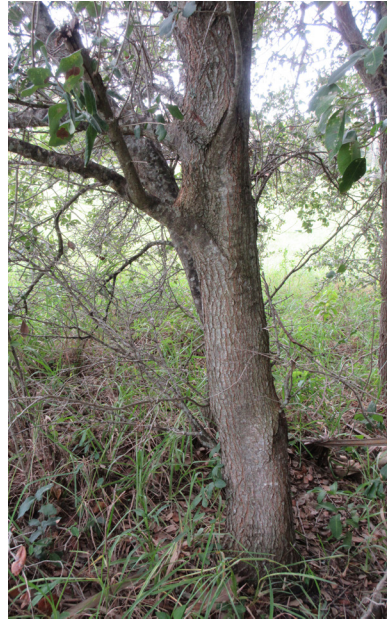
Condition -
FAIR

Tree #17 is a Live Oak located towards the northwest corner of the property. It is in fair condition. There is included bark between the limbs. The canopy is asymmetrical and the tree is competing with the nearby vegetation. There is interior deadwood. There are pest issues affecting the leaves.

This tree has not been incorporated into the landscape plan and will therefore be removed.

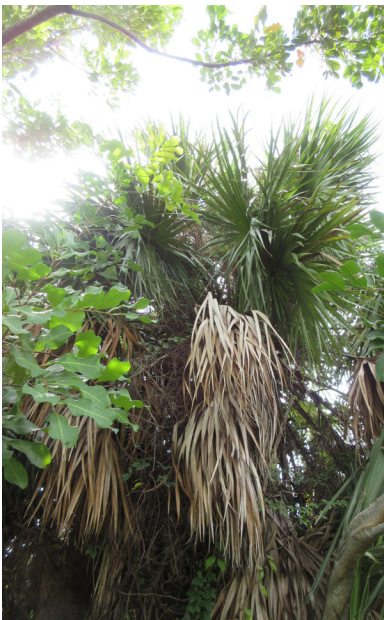
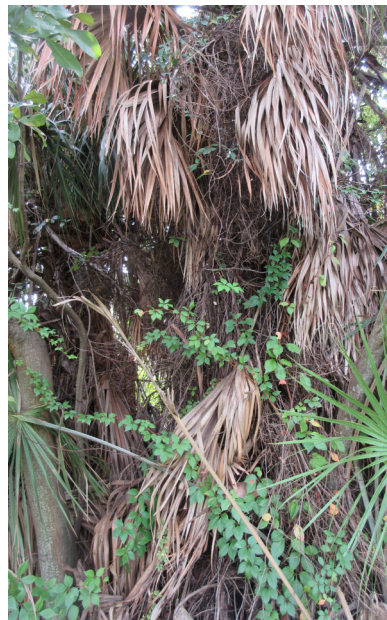
Condition -
FAIR

Tree #18 is a Sabal Palm located on the south side of the property. It is in fair condition. It has a thin canopy and many lower dead fronds. The tree is competing with the nearby vegetation.

This tree has not been incorporated into the landscape plan and will therefore be removed.

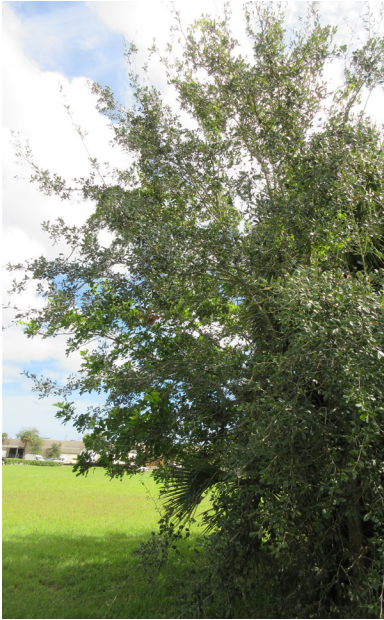
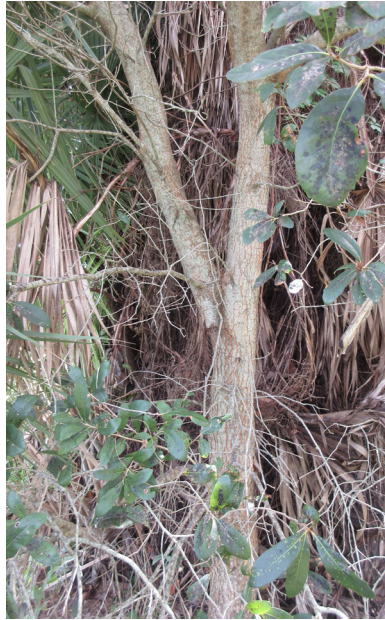
Condition -
FAIR

Tree #19 is a Live Oak located on the south side of the property. It is in fair condition. The trunk divides into two with included bark. The canopy is asymmetrical. The tree is competing with the nearby vegetation.

This tree has not been incorporated into the landscape plan and will therefore be removed.

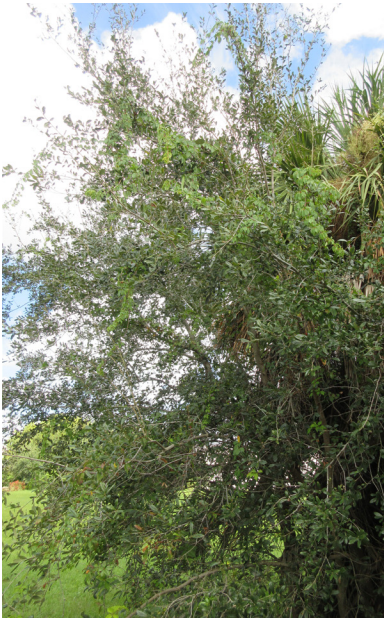
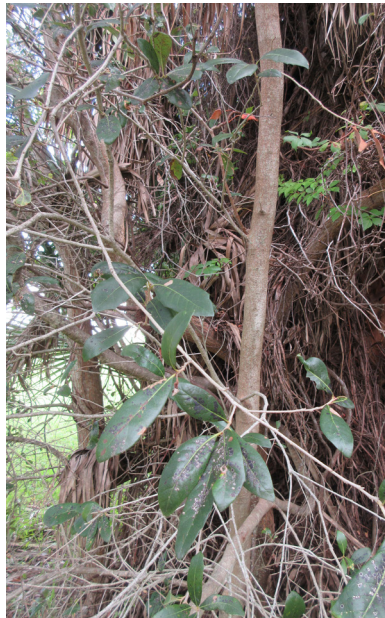
Condition -
FAIR

Tree #20 is a small Live Oak located on the south side of the property. It is in fair condition. The canopy is asymmetrical. The tree is competing with the nearby vegetation.

This tree has not been incorporated into the landscape plan and will therefore be removed.

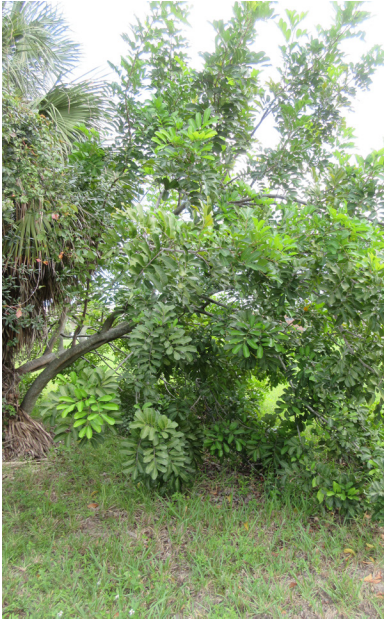
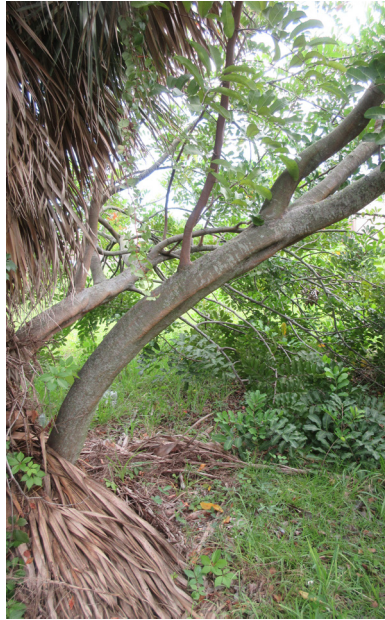
Condition -
FAIR

Tree #21 is a Carrotwood located on the south side of the property. The tree is in fair condition with poor form. The trunk is growing at a sharp angle.

This species is highly invasive in South Florida and this tree will therefore need to be removed.

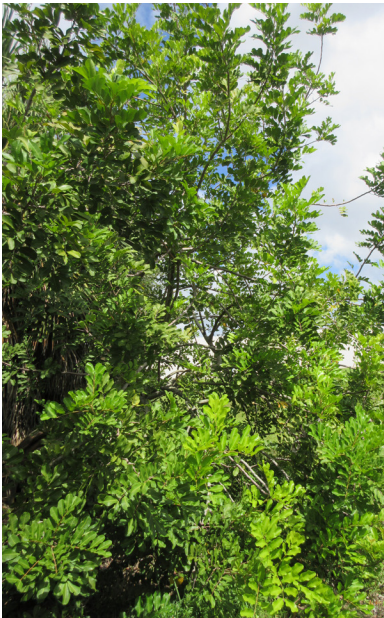
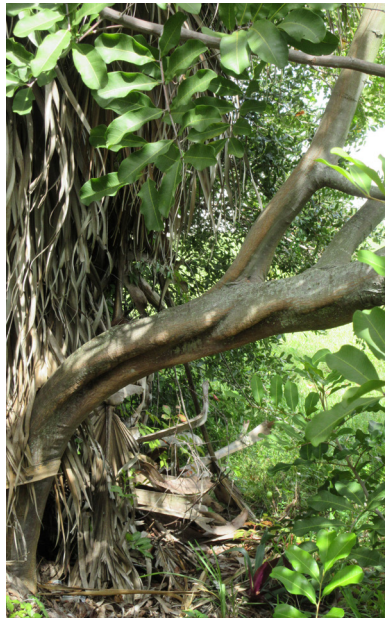
Condition -
FAIR

Tree #22 is a Carrotwood located on the south side of the property. The tree is in fair condition with poor form. The trunk is growing at a sharp angle.

This species is highly invasive in South Florida and this tree will therefore need to be removed.

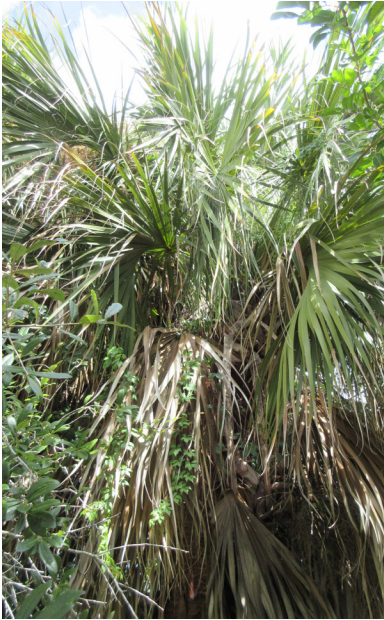
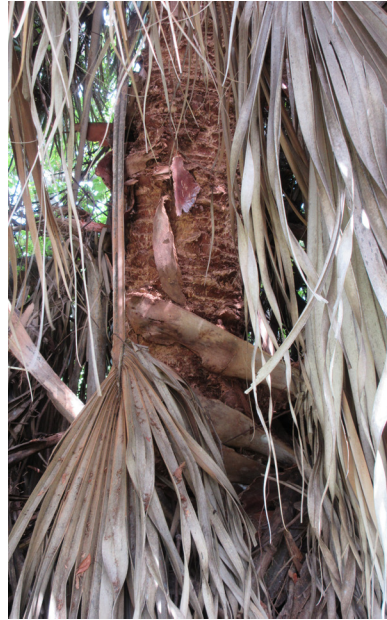
Condition -
FAIR

Tree #23 is a Sabal Palm located on the south side of the property. It is in fair condition with a small canopy and lower dead fronds. The tree is competing with the nearby vegetation.

This tree has not been incorporated into the landscape plan and will therefore be removed.

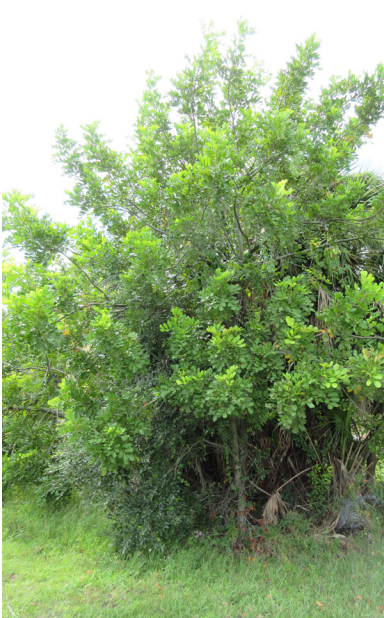
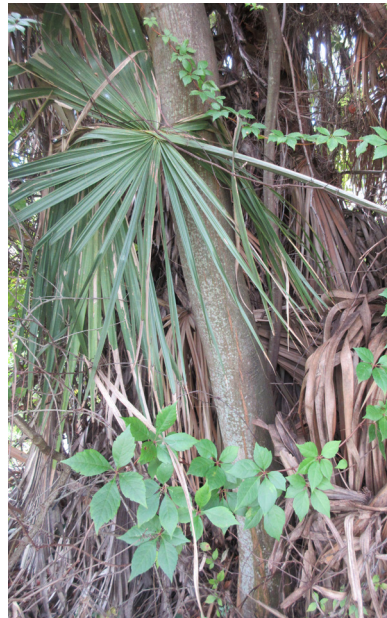
Condition -
GOOD

Tree #24 is a Carrotwood located on the south side of the property. It is in good condition and is growing vigorously. It has a nice form and dense canopy.

This species is highly invasive in South Florida and this tree will therefore need to be removed.

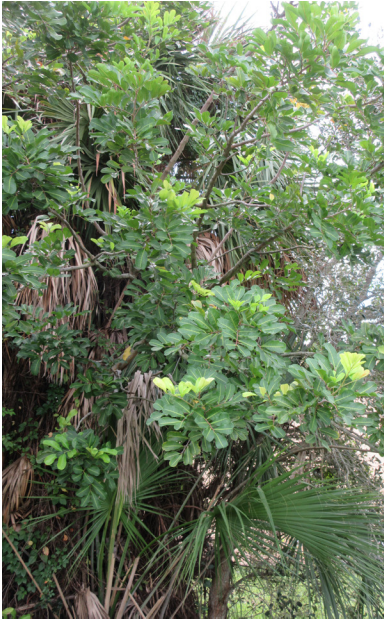
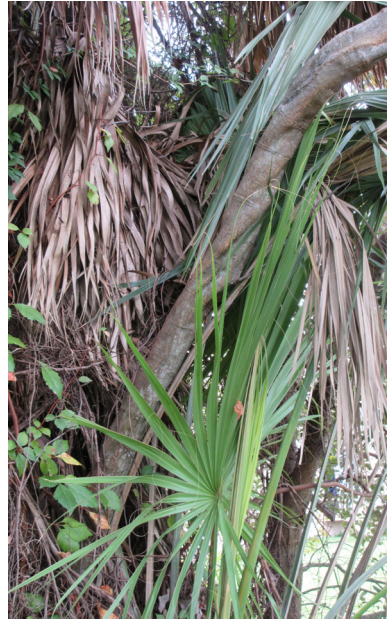
Condition -
FAIR

Tree #25 is a Carrotwood located on the south side of the property. It is in fair condition and is competing with the nearby vegetation.

This species is highly invasive in South Florida and this tree will therefore need to be removed.

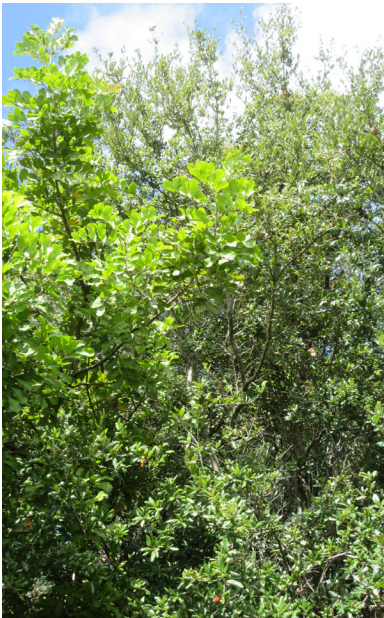
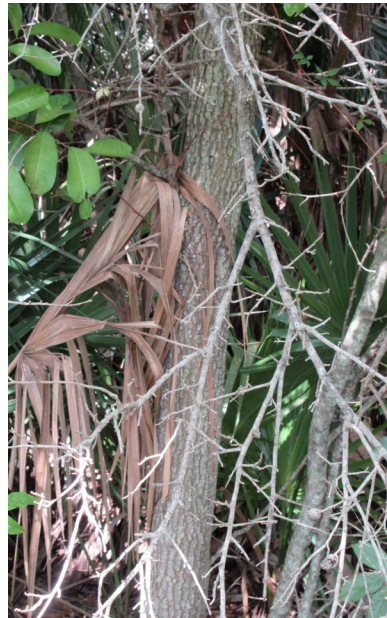
Condition -
GOOD

Tree #26 is a Live Oak located in the northwest corner of the property. It is in good condition. There is interior deadwood. The tree is competing with the nearby vegetation.

This tree has not been incorporated into the landscape plan and will therefore be removed.

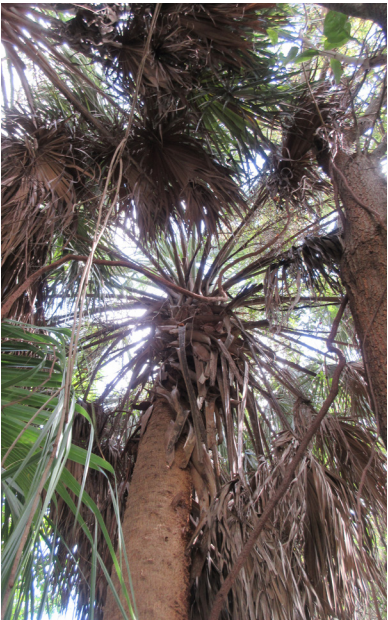
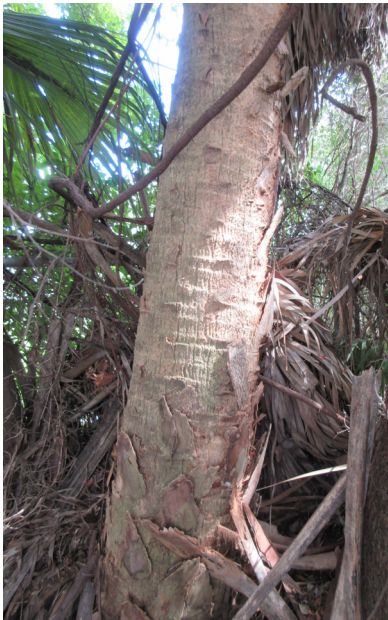
Condition -
POOR

Tree #27 is a Sabal Palm located in the northwest corner of the property. The tree is in poor condition. There are few live fronds and many dead fronds. The tree is competing with the nearby vegetation.

This tree has not been incorporated into the landscape plan and will therefore be removed.
