Rahim Vedaee  
ISA Certified Arborist #FL-9609A  
(954) 868-4753  
Rvedaee1@yahoo.com

An Arborist Report/Tree disposition was conducted for the above referenced property. During our inspection, four (4) specimen size trees were located on the property. Below is a detailed report of the one tree that are located on the property.

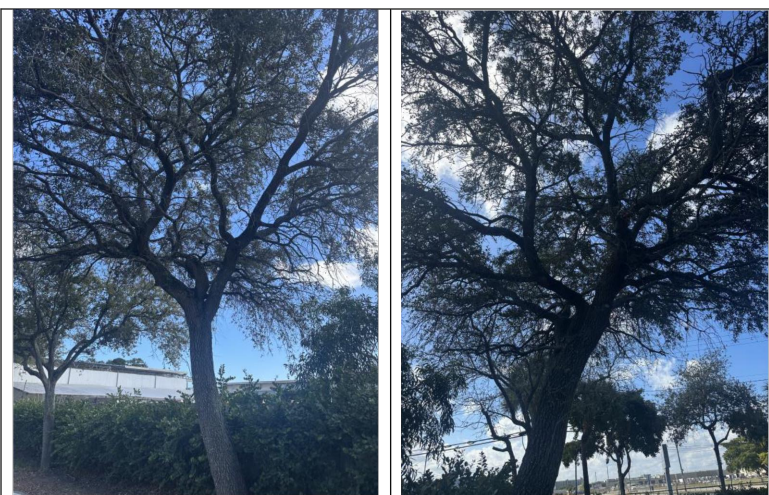
Please see photos below.  
Tree #3 Live Oak (*Quercus*

**Tree #3** Live Oak (*Quercus virginiana*) DBH 19", HT 30', SP 30', Cond 56% Appraisal \$3,531.84  
This tree is located on the South side of the property. This tree has several codominant stems. Many dead, broken and fused branches could be seen throughout the trees canopy. These branches will create weak attachments and susceptible to snapping or breaking off. Some of these leaders are growing with a twist some structural pruning is required. Structural pruning of the canopy will help with weight distribution and better canopy structure. Tree also is growing with a lean.

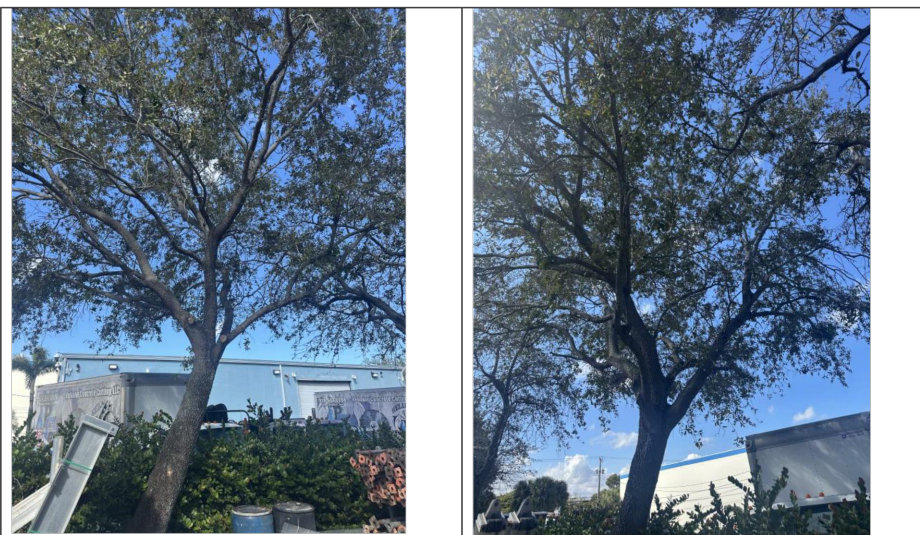
**Please see photos below.**  
Tree #22 Live Oak (*Quercus Virginiana*)

**Tree #22:** Live Oak (*Quercus virginiana*) DBH 18", HT 30', SP 31', Cond 62% Appraisal \$3,704.45  
This tree is located on the north side of the property. This tree is growing with a lean and has codominant stems. Some dead, broken and fused branches could be seen throughout the trees canopy. These branches will create weak attachments and susceptible to snapping or breaking off. Structural pruning of this canopy will help with weight distribution and better canopy structure. Materials are being stored around the base of the tree; removal of these materials is recommended to reduce impact to root zone.

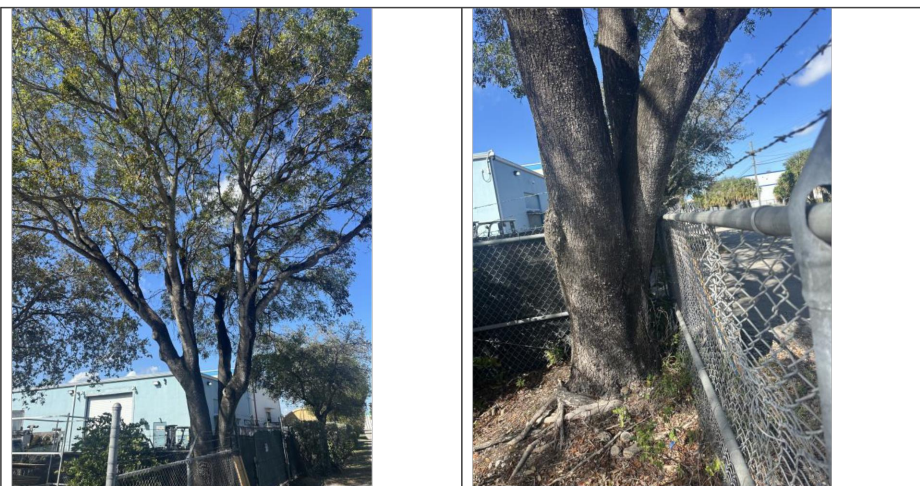
Please see photos below.  
Tree #26 Mahogany (*Swietenia mahagoni*)

**Tree #26** Mahogany (*Swietenia mahagoni*) DBH 29", HT 40', SP 34', Cond 50% Appraisal \$4,263  
This tree is located on the North east side of the property. This tree has codominant stems with include bark. Bark inclusions can result in cracked trunks and broken trees. One of the Stems is pushing against the fence. Girdling roots were also observed. Girdling roots are roots that wrap around a tree's trunk, restricting the flow of water and nutrients. The trees shows signs of stress with die back the tips and many dead, broken branches being visible throughout the trees canopy.

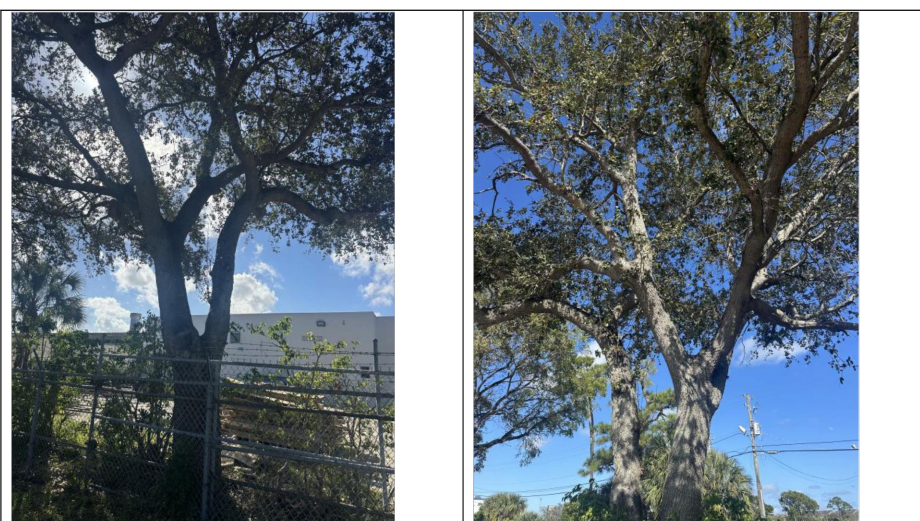
Tree #27 Live Oak (*Quercus Virginiana*)

**Tree #27** Live Oak (*Quercus virginiana*) DBH 26", HT 40', SP33', Cond 60% Appraisal \$5,178.26  
This tree is located on the east side of the property. Trees foot flare is pushing agents the fence causing the fence to bow out. Some dead, and decayed branches could be seen throughout the trees canopy. an old pruning wound could be seen on the east side of the trunk where the tree appears to have properly compartmentalized.
