## Rahim Vedaee

February 6, 2025  
2281 NW 16<sup>th</sup> Street  
Pompano Beach, FL

An Arborist Report/Tree disposition was conducted for the above referenced property. During our inspection, twenty-three (23) specimen size trees were located on the property. Below is a detailed report of the one tree that are located on the property.

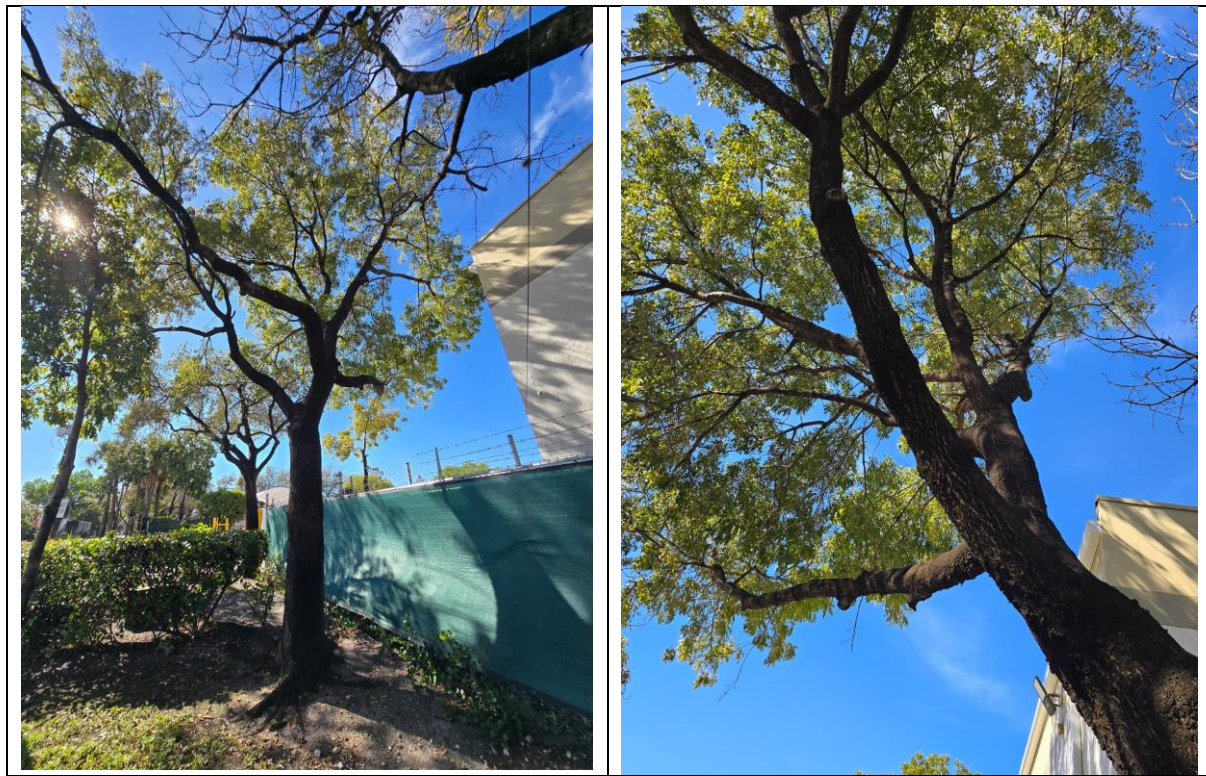
Tree **#58** Mahogany (*Swietenia mahagoni*)

**Tree #58** Mahogany (*Swietenia mahagoni*) DBH 24", HT 30', SP 30', Cond 49% Appraisal \$3,457.44

This tree is located on the east side of the property. This tree has a sparse and chlorotic canopy, with many dead and decayed limbs being visible. There are many other large maturing trees near by restricting the amount of sun light causing a reduction for the tree to photosynthesis properly.

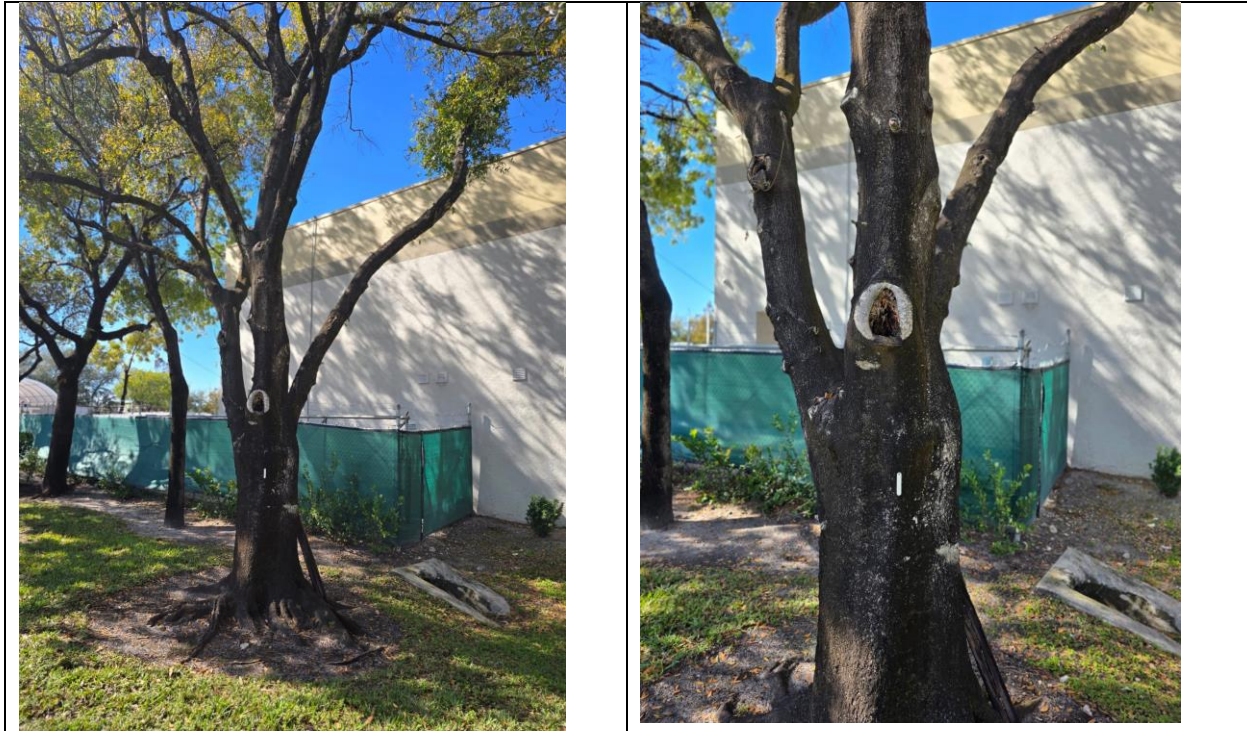
Tree #61 Laurel Oak (*Quercus laurifolia*)

**Tree #61** Laurel Oak (*Quercus laurifolia*) DBH 28", HT 50', SP 40', Cond 47% Appraisal \$2,961

This tree is located on the east side of the property. This tree has many codominant a large cavity on the trunk. The cavity measures 4 inches in width and 6 inches in length. Extent of the cavity is unknown. Many dead and decayed branches could be seen throughout the trees canopy.

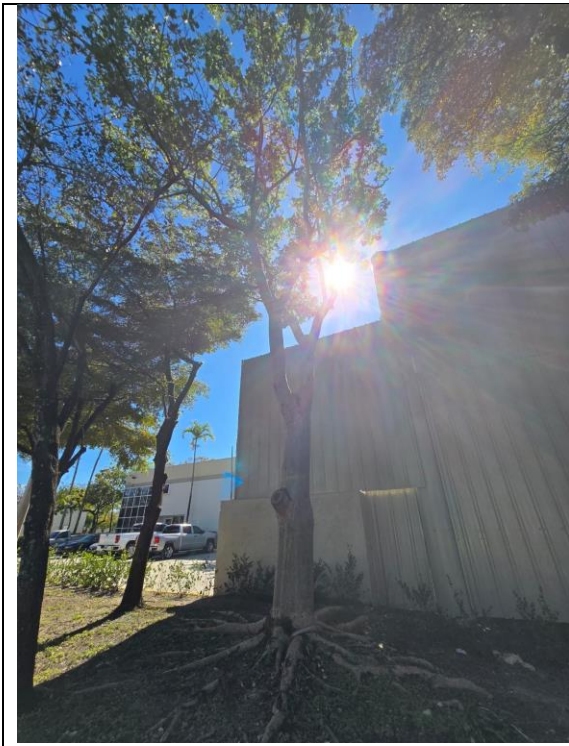
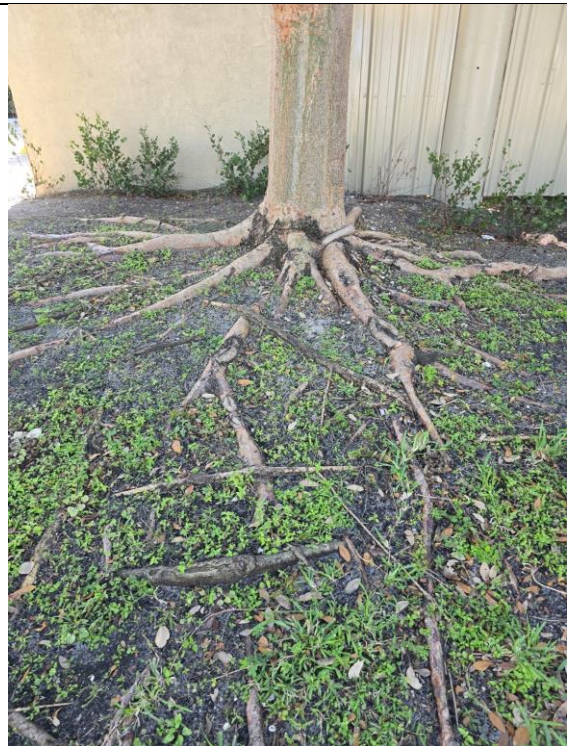
Tree #81 Gumbo Limbo (*Bursera simaruba*)

**Tree #81** Gumbo Limbo (*Bursera simaruba*) DBH 19", HT 50', SP 35', Cond 52% Appraisal \$2,883.72

This tree is located on the North east side of the property. This tree has codominant stems with majority of the canopy being concentrated at the top. this was most likely caused due to the close proximity of the building retracing the sun light exposure. Protruding roots could be seen throughout the area this could be from a number of factors such as erosion and lack of space. some dead, cross and fused branches.

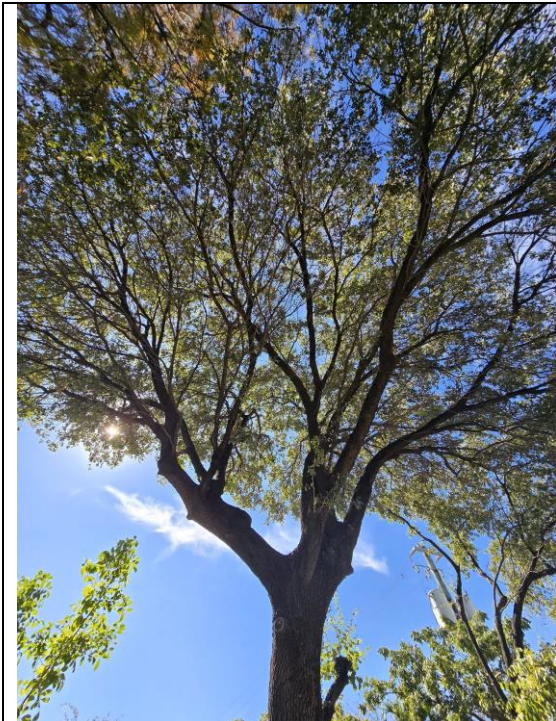
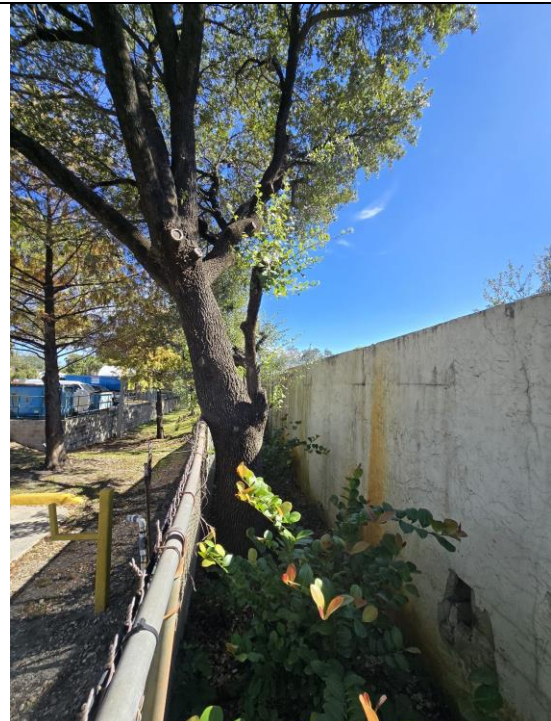
**Tree #97** Live Oak (*Quercus Virginiana*) DBH 24", HT 45', SP 35', Cond 54% Appraisal \$4,301.94

This tree is located on the neighboring property growing agents the divider fence. This tree is growing with a lean with the anchoring roots pushing agents the neighboring wall. Some dead, and decayed branches could be seen throughout the trees canopy.

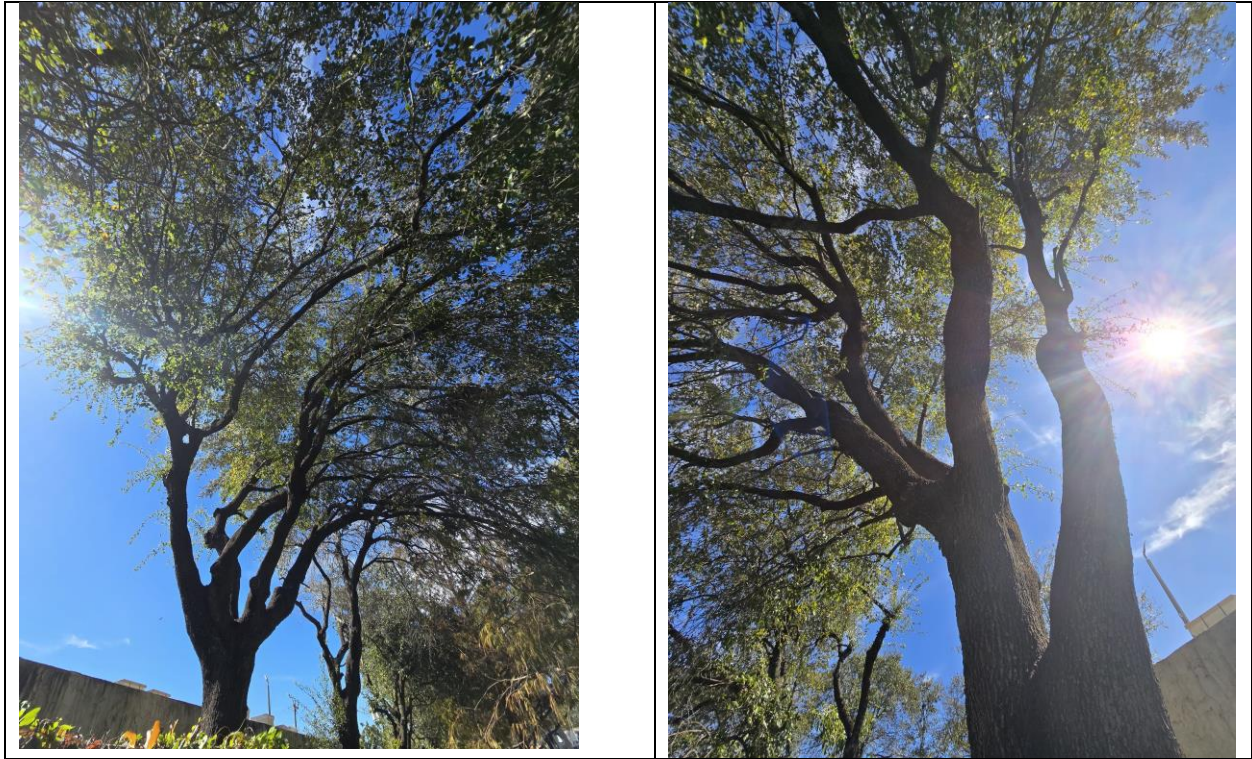
**Tree #104** Live Oak (*Quercus Virginiana*) DBH 24", HT 40', SP 45', Cond 55% Appraisal \$4,381.61  
This tree is located on the neighboring property growing between the divider fence and neighboring wall. This tree has a lopsided canopy with the all the canopy on the southside being removed. This tree has codominant stems with Some dead and decayed branches could be seen throughout this lopsided canopy.

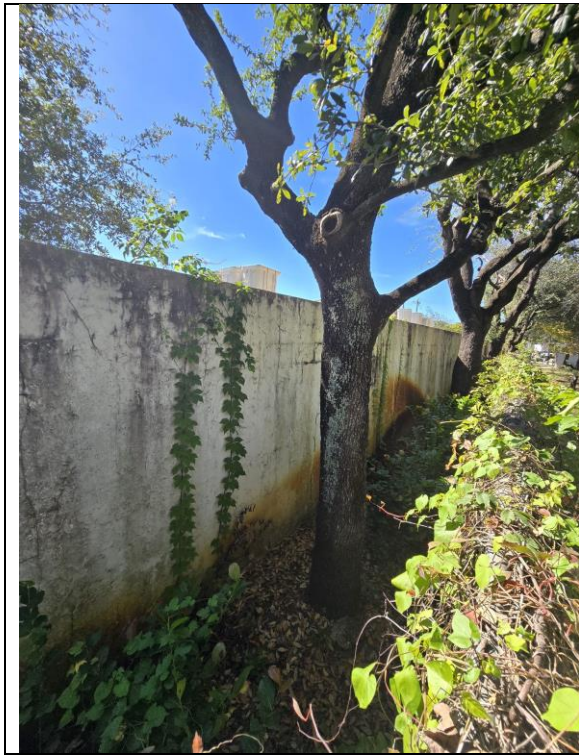
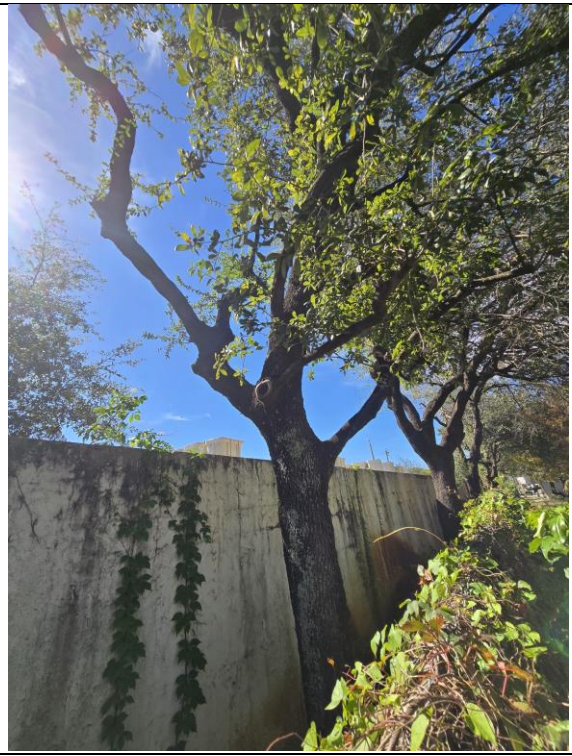
**Tree #105** Live Oak (*Quercus Virginiana*) DBH 18", HT 30', SP 30', Cond 45% Appraisal \$2,688.71  
This tree is located on the neighboring property growing between the divider fence and neighboring wall. This tree has a lopsided canopy with the all the canopy on the southside being removed. This tree entire tree is chlorotic with many dead, decayed and broken branches.

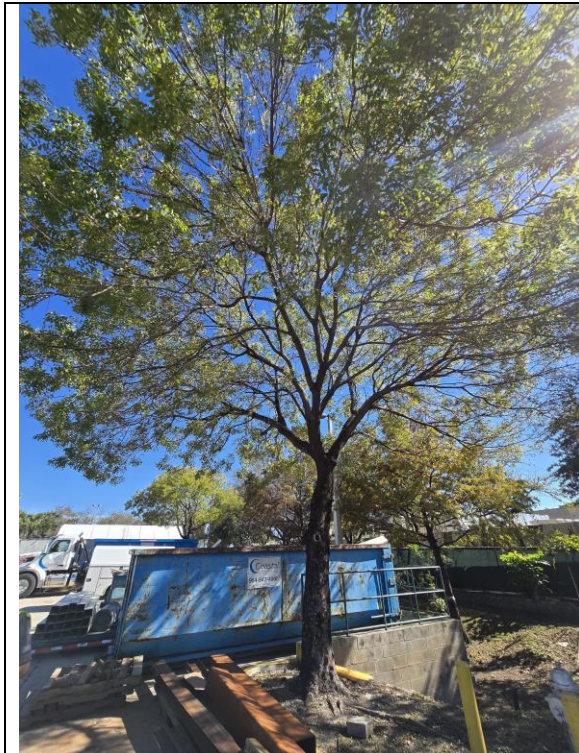
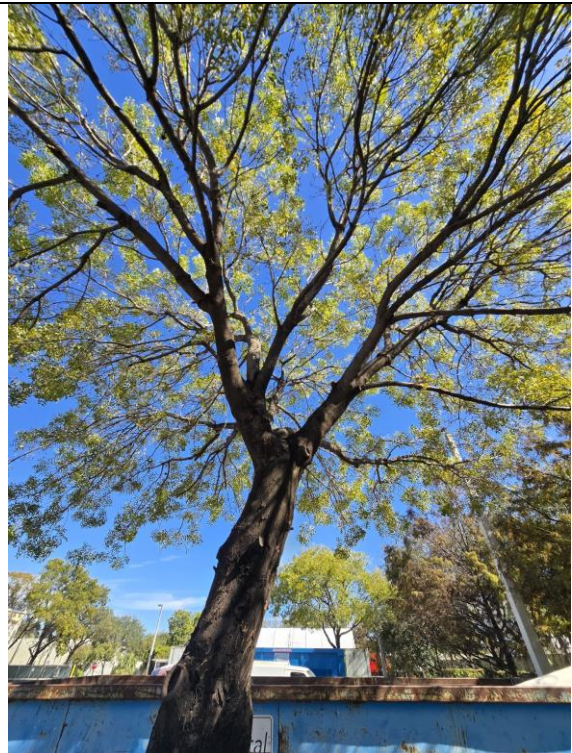
**Tree #112** Mahogany (*Swietenia mahagoni*) DBH 20'', HT 30', SP 40', Cond 60% Appraisal \$3,528  
 This tree is located in a parking island. This tree has codominant stems with some dead, cross, broken and fused branches being visible in the trees canopy. this tree is suffering from a nutritional deficiency with the entire canopy being chlorotic.

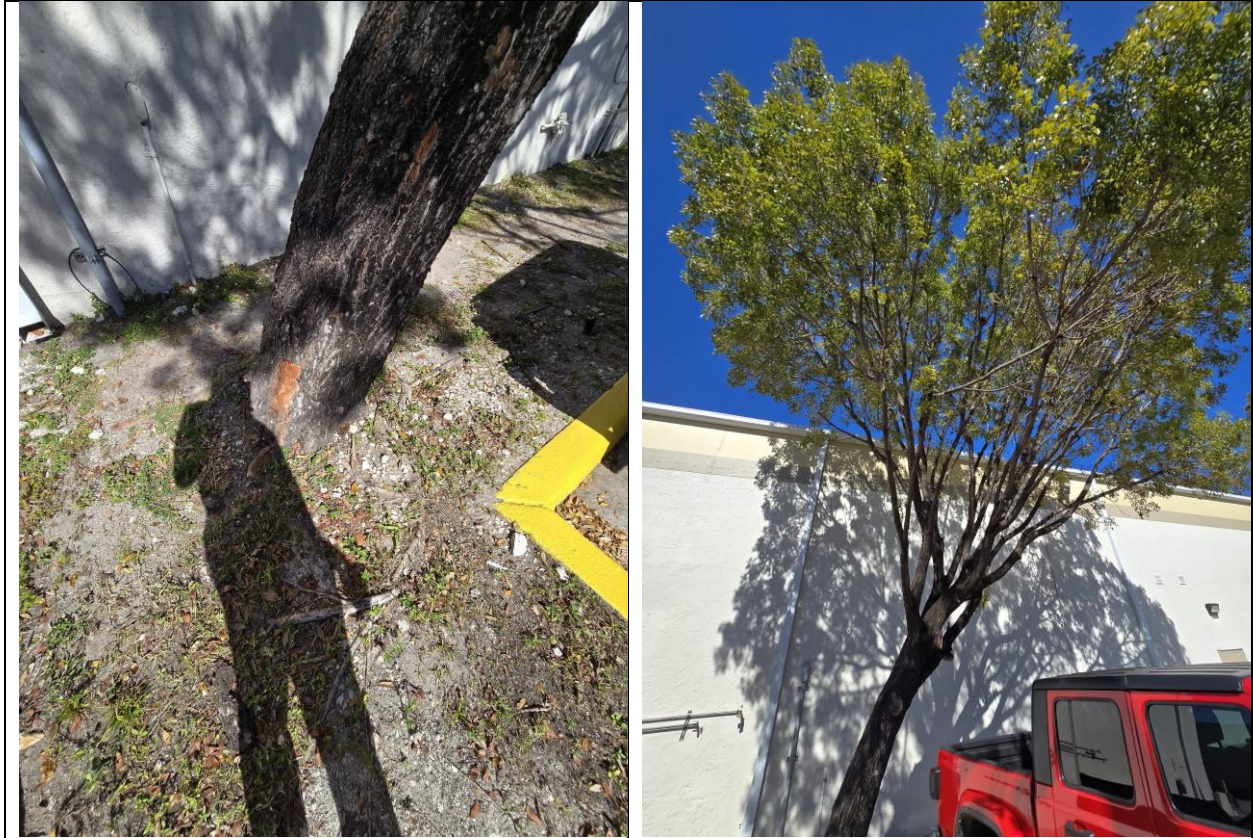
Tree #113 Mahogany (*Swietenia mahagoni*)

**Tree #113** Mahogany (*Swietenia mahagoni*) DBH 18", HT 30', SP 40', Cond 55% Appraisal \$2,910.6

This tree is located in front of building 2200. This tree has several codominant stems with majority of the canopy being concentrated at the top. The tree is growing with a severe lean due to its close proximity to the building. Nutritional deficiency was visible throughout the canopy with the entire canopy being chlorotic.

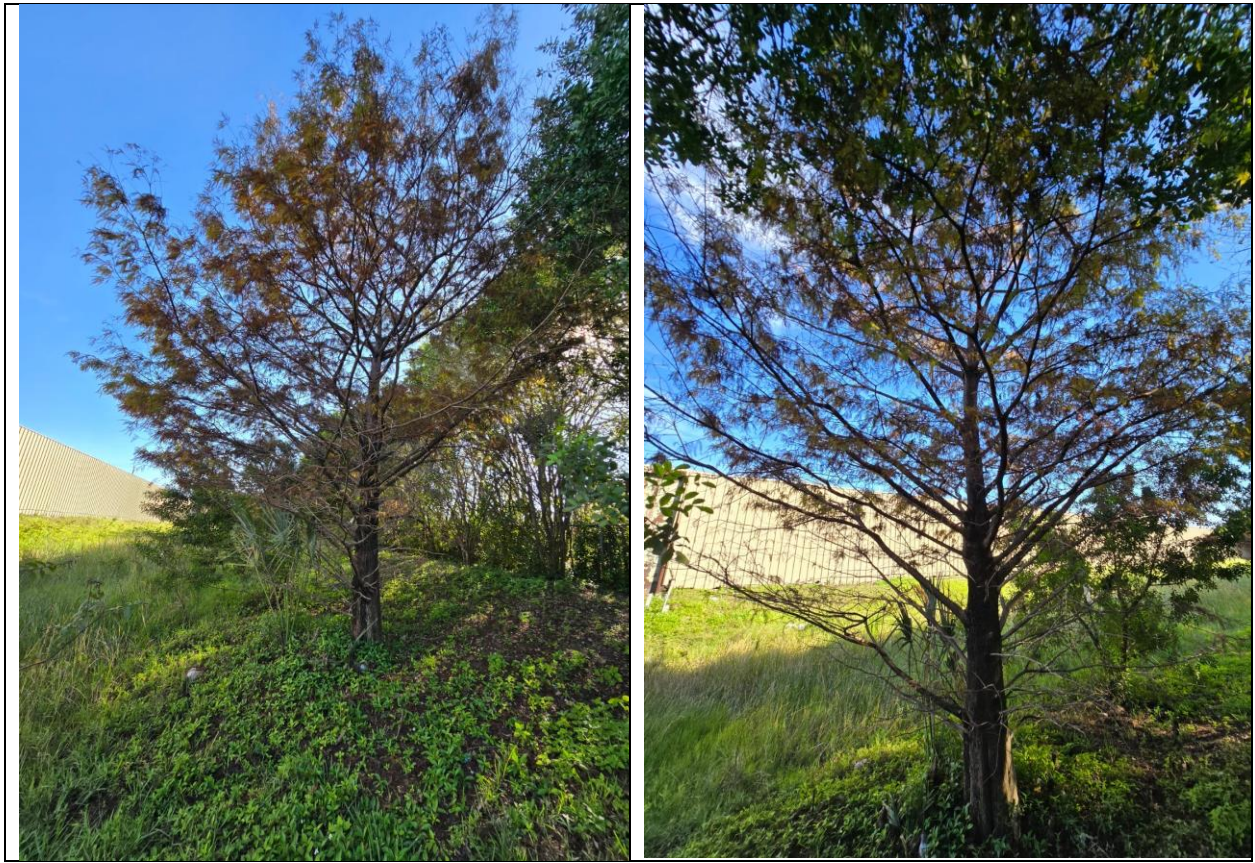
Tree #182 Bald Cypress (*Taxodium distichum*)

**Tree #182** Bald Cypress (*Taxodium distichum*) DBH 18", HT 25', SP 25', Cond 65% Appraisal \$2,193.75

This tree is located on the west side of the property inside a retention area. Some dead and broken branches could be seen throughout the trees canopy. Overall this tree is healthy with no signs of insects and diseases.

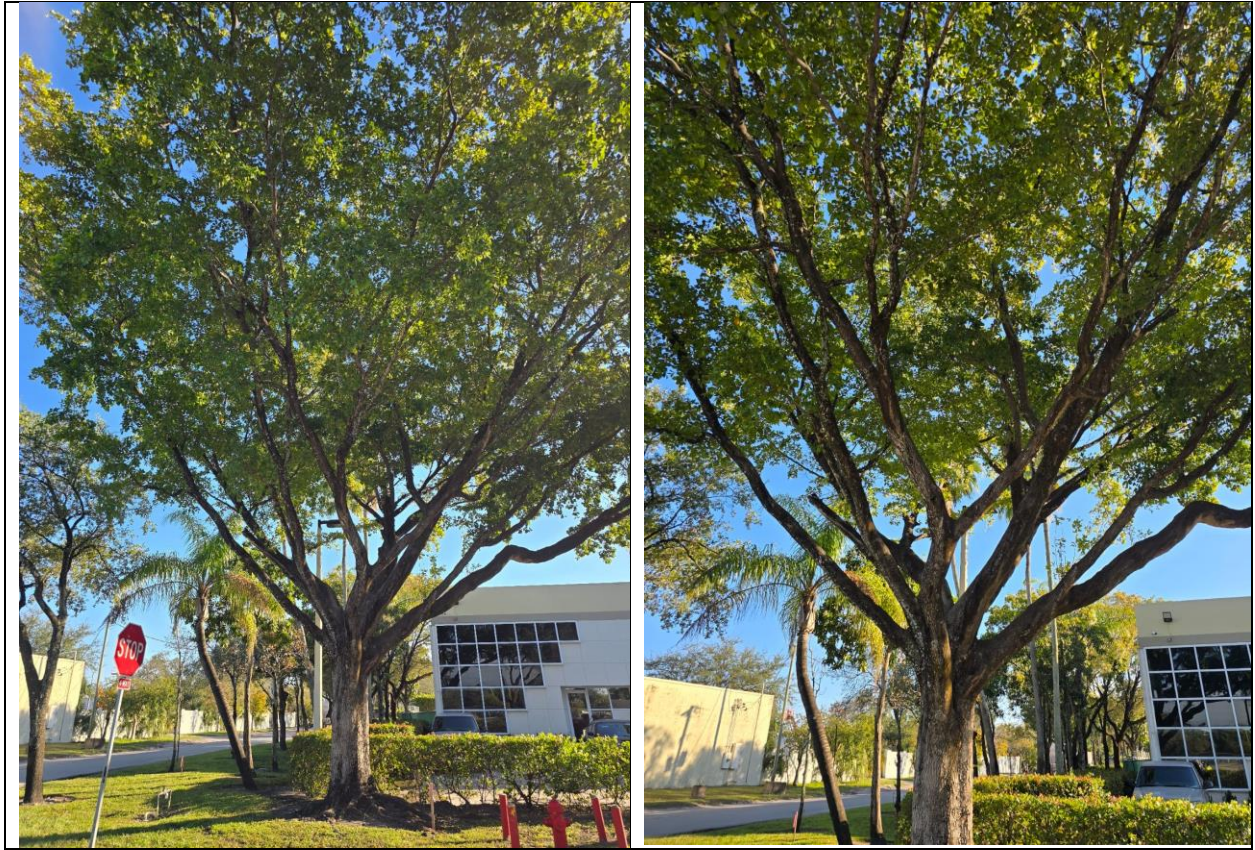
Tree **#215** Black Olive (*Bucida buchera*)

**Tree #215** Black Olive (*Bucida buchera*) DBH 28", HT 45', SP 40', Cond 70% Appraisal \$5,710.66  
This tree is located on the north east corner of the property. This tree has several codominant stems with a large canopy. This tree has not been maintained in a while with many dead, broken and crossed branches being visible throughout. Some of these large stems are beginning to fuse with each other, removal of some of these close leaders will remove possible bark inclusion in the future. Overall, this tree is healthy with no signs of insects or diseases.
