BRANCH OUT CONSULTING

RE: ISA Certified Arborist Report
1600 S Federal Highway
Pompano Beach, FL 33062

This document is an evaluation of the location, size, and condition of all trees onsite and within the right-of-way at 1600 S Federal Highway on January 13, 2025. All observations are visual from the ground. Tree locations were mapped as an overlay on existing survey. Existing property survey was cropped to depict tree locations and is not to scale. Palms are single trunk unless otherwise noted. This report is not a risk assessment. This report may be utilized for permitting purposes. Tree dispositions determined by others.

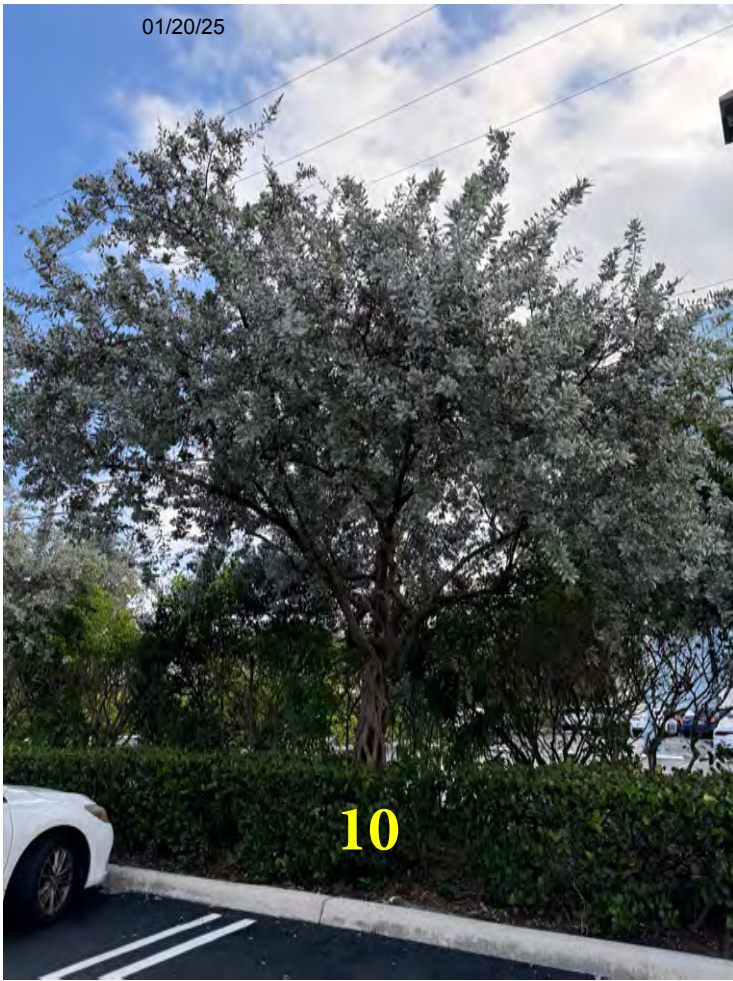
10	False Tamarind	<i>Lysiloma latisiliquum</i>	20	55%	14	20		314	Poor structure. Multiple codominant trunks in lower half with included bark. Limited root zone in all directions. Roots lifting pavement and curb. Poor vigor. Dieback of limbs 1-3" in diameter throughout interior.
11	Silver Buttonwood	<i>Conocarpus erectus</i>	10	80%	16	14		154	Limited root zone. Over-extended branches.
12	Silver Buttonwood	<i>Conocarpus erectus</i>	10	60%	18	14		154	Poor structure. Multiple codominant trunks in lower half. Sparse foliage within crown. Overextended branches.
13	Montgomery Palm	<i>Veitchia montgomeryana</i>		80%	10	5	7	20
