PZ24-12000008  
01/15/2025

## Arborist Report

3225 NE 5th St,  
Pompano Beach, FL  
33062

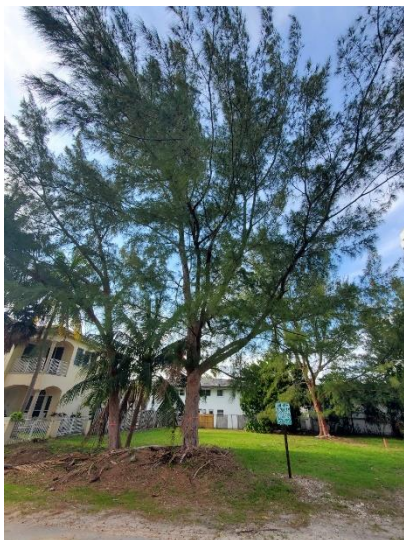
Tree # 1  
PZ24-12000008  
Common Name  
01/15/2025

Tree #1 is an Australian Pine an invasive exotic tree species as per FLEPPC Category I list of species. Tree is located south side of the property on site. This Australian pine is in poor condition with many co-dominant leaders compromising tree stability and risk of failing. This tree is in conflict as well with the proposed new development and is proposed to be removed with no mitigation required.

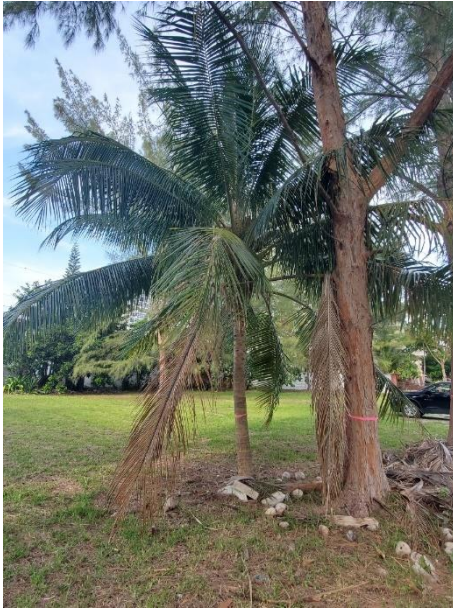
## Tree # 3

Condition – fair

Tree #3 is a Coconut palm. This palm is in fair condition its upper canopy shows interveinal chlorosis and extreme burning on lower of fronds. The trunk shows clear signs of tapering reducing its girth on the top and slightly vent sideways due to severe nutritional deficiencies. This palm has been severely neglected over the years due to lack of care fertilization and watering. This palm is currently proposed to be removed as part of the upcoming new construction activities and will be mitigated on site.

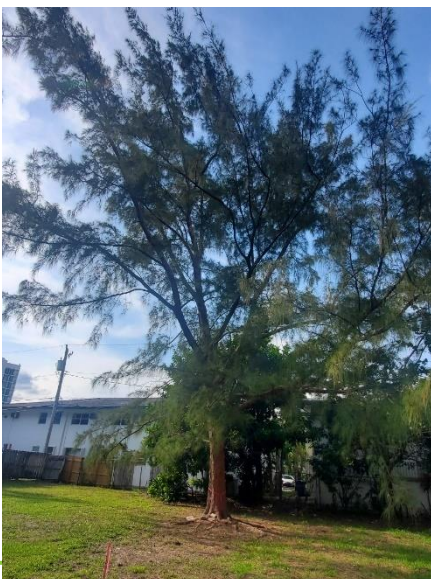
## Tree # 4

Condition – Poor

Tree #4 is an Australian Pine is an invasive exotic tree species as per FLEPPC Category I list of species. Tree is located in the middle of the lot north side of the property on site. This Australian pine is in poor condition with three main co-dominant leaders compromising tree stability and risk of failing. This tree is in conflict as well with the proposed new development and is proposed to be removed with no mitigation required.

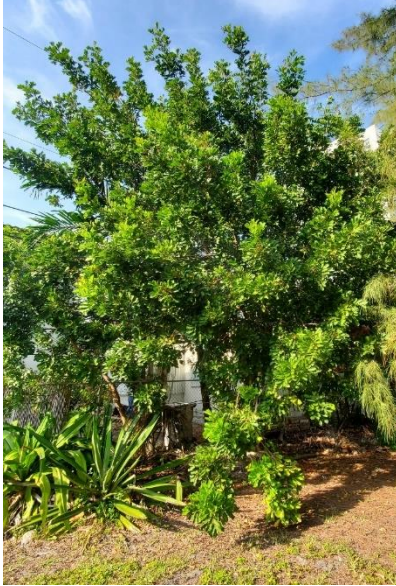
Tree #5 is a Carrotwood tree a very highly invasive exotic tree category 1 as per FLEPPC latest list. This tree is located N side of the property. This tree is probably a seedling of other invasive exotics found in this property or adjacent neighbors. Therefore, immediate removal is recommended and current disposition as per site development is to be removed with no mitigation required.

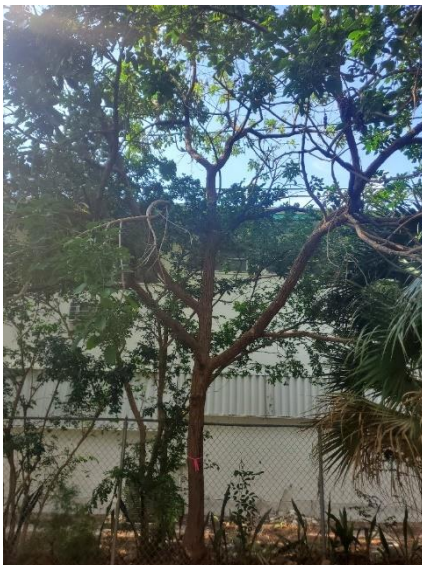
Tree #6 is an individual single trunk Bischofia tree category I invasive exotic this tree is located middle of the property side of the property along landscape buffer area facing Ingraham Hwy and is currently proposed to remain on site. This tree is a Miami Dade county Prohibited species and an invasive exotic pest plant list category I as per FLEPPC and is highly encouraged to be removed in the future to prevent any spread throughout the property.

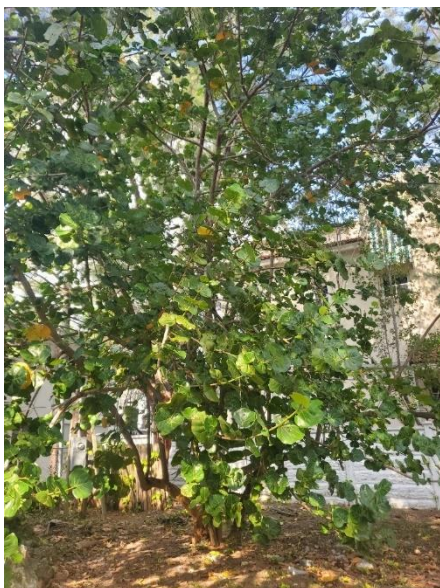
#### Tree #8

Condition – Fair

Tree #8 is a young Seagrape tree located north side of the property this tree probably was dispersed from wildlife seeds. Tree is in fair condition has severe codominant leaders and included bark and has been severely damaged and deformed during previous storm events and is growing more like a bush with several trunks. This tree is in conflict with proposed new construction and is currently proposed to be removed and mitigated on site.

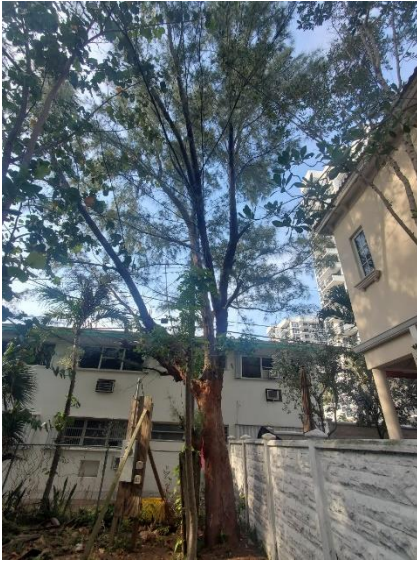
## Tree # 9

Tree #9 is a large Australian Pine as per attached picture. This tree is an invasive exotic tree species as per FLEPPC Category I list of species. Tree is located north east side of the property on site. This Australian pine is in poor condition with three main co-dominant leaders compromising tree stability and risk of failing. Damage to adjacent property is highly probable. This tree is in conflict as well with the proposed new development and is proposed to be removed with no mitigation required.

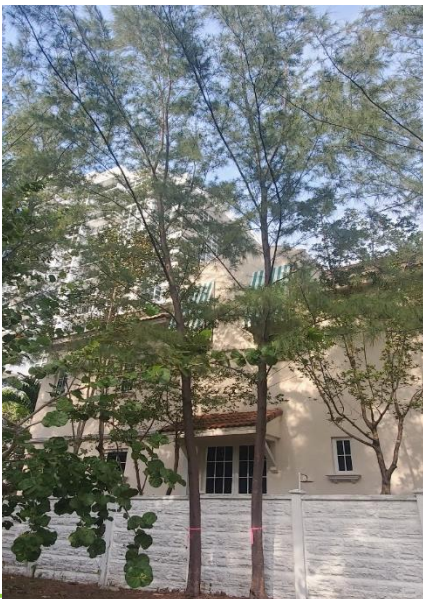
## Tree # 10 &amp; #11

Trees #10 & #11 are both Australian Pines invasive exotic tree species as per FLEPPC Category I list of species. Trees are located east side of the property on site. These Australian pines are seed dispersed by adjacent existing large Australian pine trees. Trees are in good condition with one single leader. Damage to adjacent property is highly probable. These trees are in conflict as well with the proposed new development and is proposed to be removed with no mitigation required.

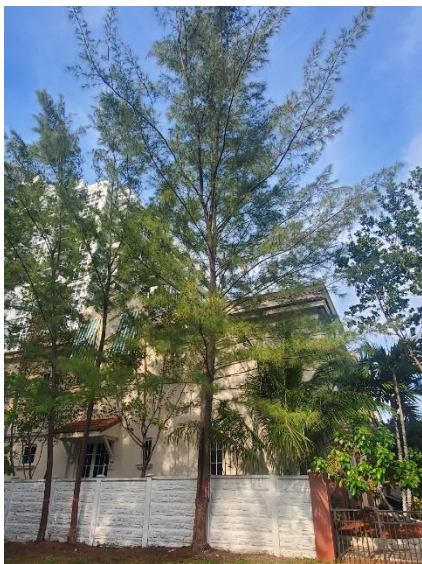
Tree #12 is an Australian Pine an invasive exotic tree species as per FLEPPC Category I list of species. Tree is located south side of the property on site. This Australian pine is in good condition with one main leader. Damage to adjacent property is highly probable. This tree is in conflict as well with the proposed new development and is proposed to be removed with no mitigation required.

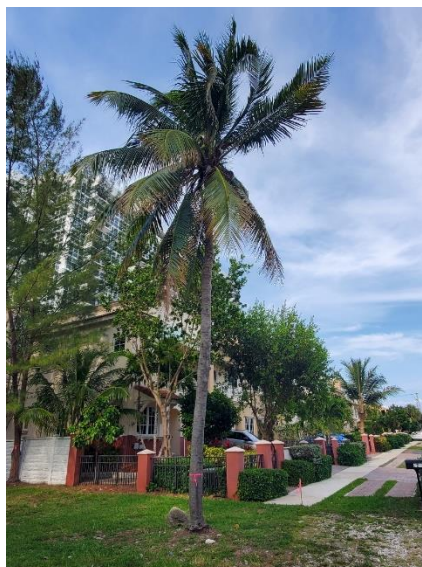
**Tree # 13****Common Name**

Tree #13 is a Coconut palm. This palm is located SE side of the property and is in fair condition its upper canopy shows interveinal chlorosis and extreme burning on lower of fronds. The trunk shows clear signs of tapering reducing its girth on the top and slightly vent sideways due to severe nutritional deficiencies. This palm has been severely neglected over the years due to lack of care fertilization and watering. This palm is currently proposed to be removed as part of the upcoming new construction activities and will be mitigated on site.
