Tree evaluation Prepared by Santos Gonzalez ISA Certified Arborist FL-9537A

Tree Evaluation for: All Landscape Data Inc.

9-Aug-25 Address: 1441 SW 29 Ave Pompano Beach, FL 33069/2900 Gateway Dr. Pompano Beach, FL 33069

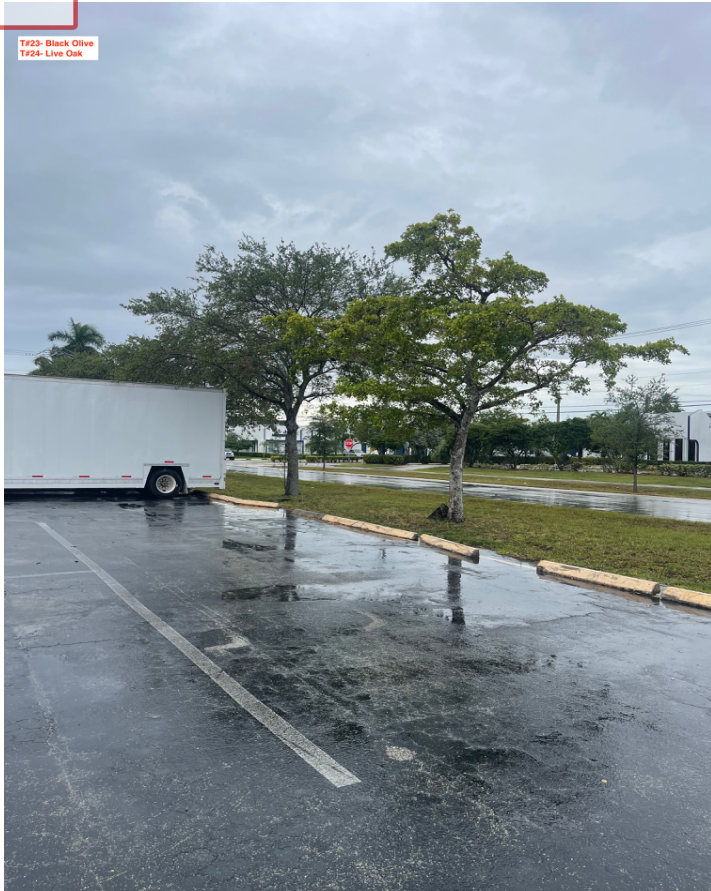
T#23- Black Olive  
T#24- Live Oak

| 23 | Bucida busera | Black Olive | 8" | 24' | 26' | 6' | 4' | | 70% | Fair- confined root space; codominant branches; deadwood 1-2"; recommend structural pruning. | |
| 24 | Quercus virginiana | Live Oak | 14" | 26' | 32' | 8' | 6' | | 70% | Fair- codominant branches; bark inclusions; recommend crown reduction. | |

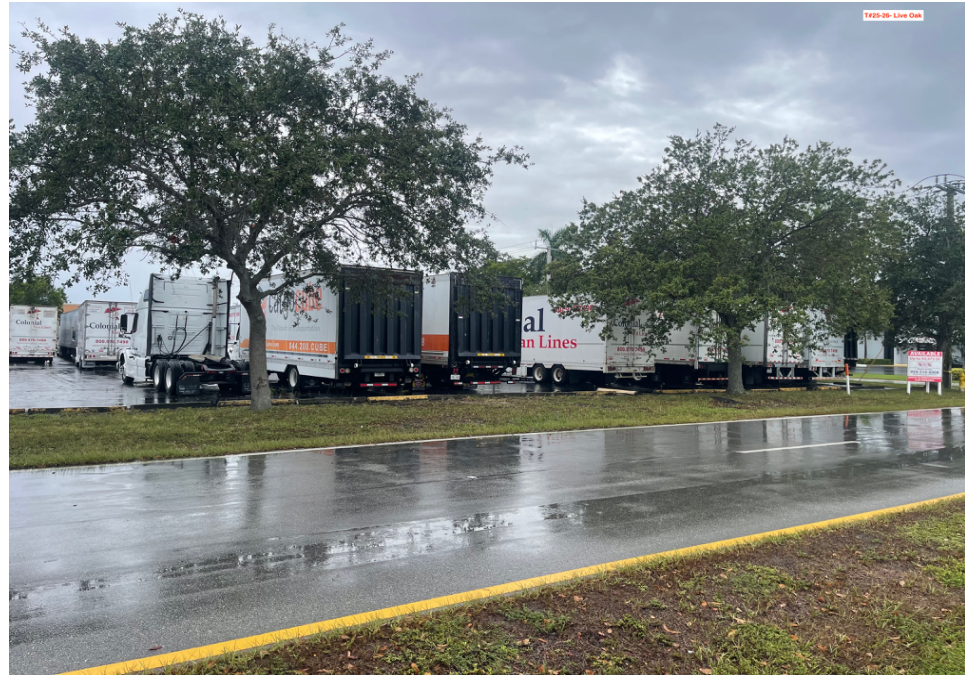
T#25-26- Live Oak

| 25 | Quercus virginiana | Live Oak | 14" | 36' | 29' | 8' | 6' | | 70% | Fair- codominant brachnes with inclusions; poor aspect ratio branches; recommend a crown reduction | |
| 26 | Quercus virginiana | Live Oak | 16" | 39' | 29' | 10' | 6' | | 70% | Fair- codominant brachnes with inclusions; poor aspect ratio branches; recommend a crown reduction | |

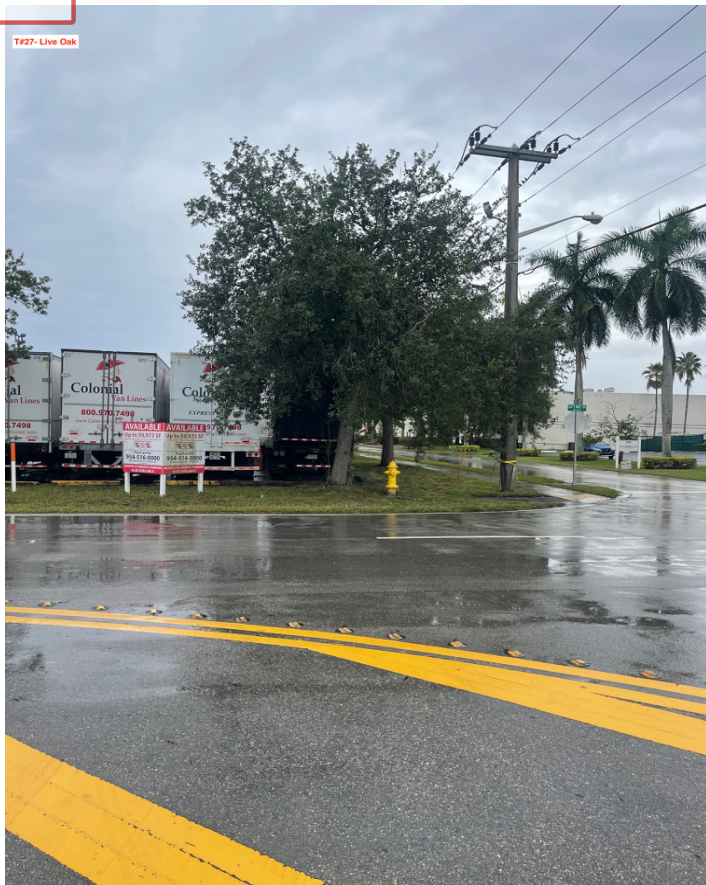
T127- Live Oak

| 27 | Quercus virginiana | Live Oak | 16" | 39' | 29' | 10' | 6' | | 70% | Fair- codominant brachnes with inclusions; poor aspect ratio branches; recommend a crown reduction | |

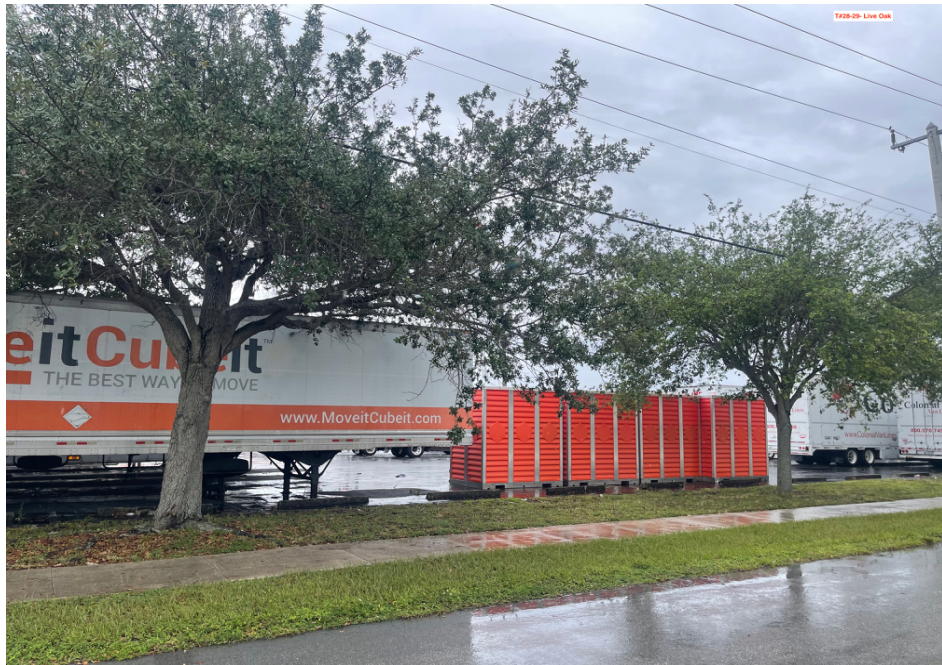
T128-20- Live Oak

| 28 | Quercus virginiana | Live Oak | 19" | 34' | 26' | 10' | 6' | | 70% | Fair- codominant<br>bracnhes with<br>inclusions; poor<br>aspect ratio branches;<br>recommend a crown<br>reduction | \$3,716.00 |
