[jgomez@logicaservices.com](mailto:jgomez@logicaservices.com)**Re: Arboricultural Consulting Services for 324 Northwest 6<sup>th</sup> Street, Pompano Beach, Florida**

I visited the above-mentioned property on Tuesday, May 16<sup>th</sup>, to evaluate +/- 24 trees, take photographs (Specimen sized trees only), calculate Rule 14-10 appraisal values, perform relocation evaluations, and note any defects.

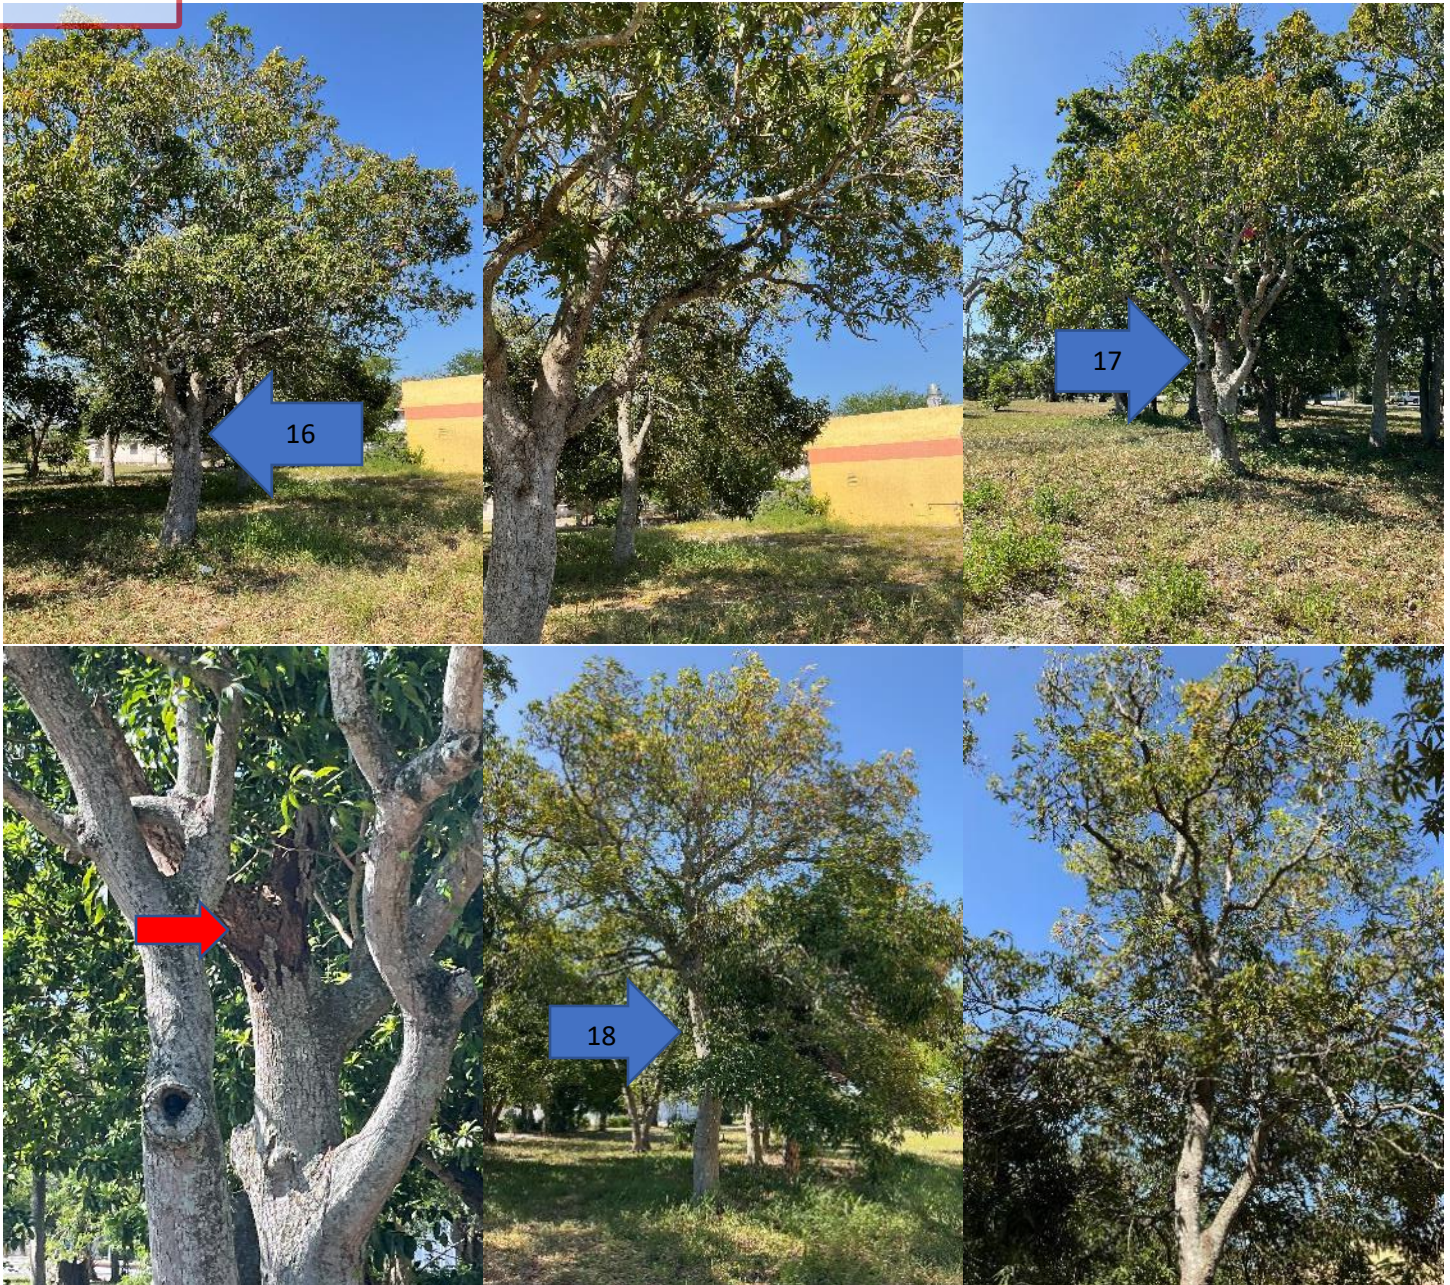
## Trees 16, 17, &amp; 18

Mango Trees (*Mangifera indica*), facing south and west. Note poor structure, deadwood, and canopy dieback for Tree #16, poor structure, deadwood, canopy dieback, visual evidence of decay (red arrow), and canopy crowding for Tree #17, and poor structure, canopy dieback, chlorotic foliage, and deadwood for Tree #18.

10	Green Buttonwood	<i>Conocarpus erectus</i>	14	7	4		Fair	57%	\$ 306.38	Y	Trunk wound
11	Montgomery Palm	<i>Veitchia arecina</i>	17	6	6	12	Fair	52%	\$ 302.12	N	Nutrient deficiencies
12	Silver Buttonwood	<i>Conocarpus erectus var. sericeus</i>	18	12	8		Fair	48%	\$ 1,116.00	N	Poor structure, visual evidence of decay, unbalanced crown
13	Montgomery Palm	<i>Veitchia arecina</i>	26	7	8	19	Fair	54%	\$ 489.51	N	Nutrient deficiencies
14	Montgomery Palm	<i>Veitchia arecina</i>	16	6	6	14	Fair	54%	\$ 306.18	N	Nutrient deficiencies
14a	Silver Buttonwood	<i>Conocarpus erectus var. sericeus</i>	14	12	5		Fair	54%	\$ 486.00	N	Poor structure, heading cut
14b	Montgomery Palm	<i>Veitchia arecina</i>	17	6	7	13	Fair	52%	\$ 305.76	N	Nutrient deficiencies
15	Sabal Palm	<i>Sabal palmetto</i>	24	8	15	20	Good	70%	\$ 192.50	Y	
16	Mango	<i>Mangifera indica</i>	32	24	21		Fair	54%	\$ 2,677.46	N	Poor structure, deadwood, canopy dieback

17	Mango	<i>Mangifera indica</i>	26	18	27		Poor	40%	\$ 2,473.30	N	Poor structure, deadwood, canopy dieback, visual evidence of decay, canopy crowding
18	Mango	<i>Mangifera indica</i>	35	25	18		Fair	53%	\$ 2,225.97	N	Poor structure, canopy dieback, chlorotic foliage, deadwood
19	Mango	<i>Mangifera indica</i>	28	15	14		Fair	52%	\$ 1,728.98	N	Poor structure, deadwood, canopy crowding
20	Sapodilla	<i>Manilkara zapota</i>	39	27	23		Fair	55%	\$ 2,770.63	N	Visual evidence of decay, storm damage, large trunk wound, deadwood
21	Sabal Palm	<i>Sabal palmetto</i>	14	8	8	5	Good	70%	\$ 192.50	Y	Immature palm
22	Mango	<i>Mangifera indica</i>	33	24	23		Fair	53%	\$ 2,844.29	N	Poor structure, canopy dieback, storm damage, canopy crowding
23	Mango	<i>Mangifera indica</i>	31	26	18		Fair	50%	\$ 2,099.97	N	Poor structure, large diameter deadwood, canopy dieback
24	Mango	<i>Mangifera indica</i>	15	12	8		Poor	30%	\$ 559.99	N	Poor structure, storm damage, visual evidence of decay, canopy crowding

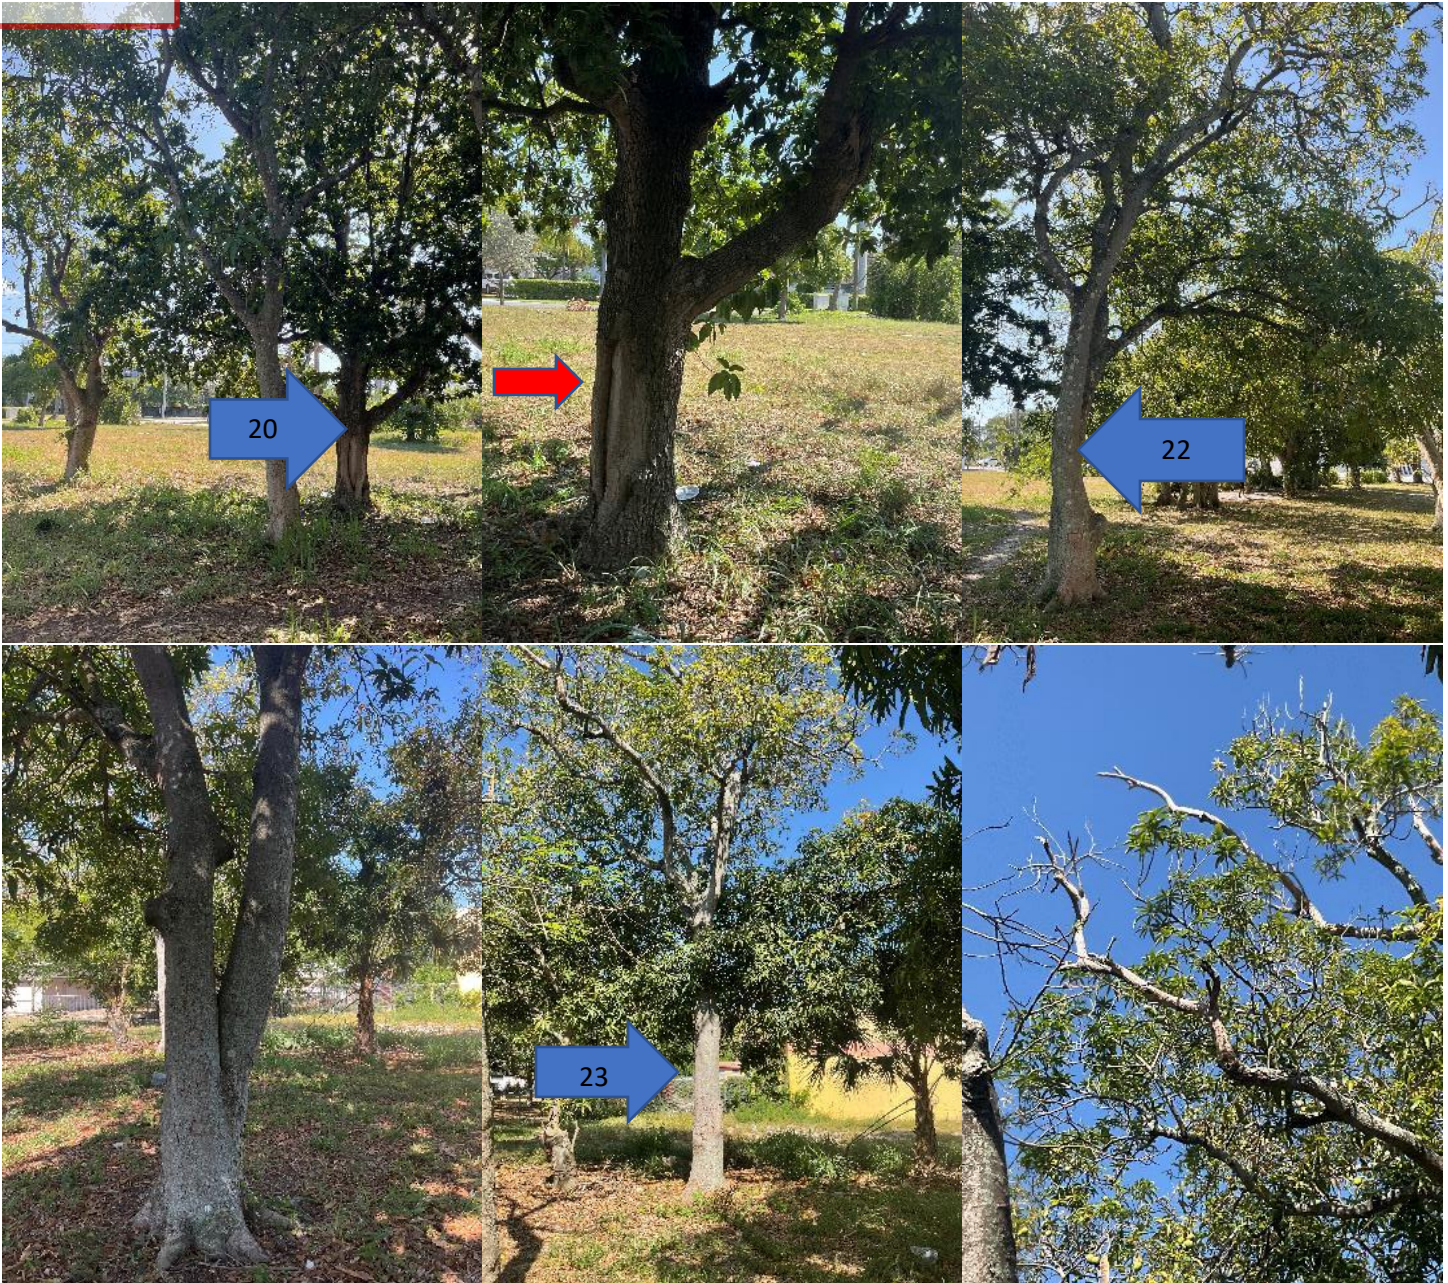
## Trees 20, 22, &amp; 23

Sapodilla (*Manilkara zapota*) Tree #20, and Mango Trees (*Mangifera indica*) Tree #'s 22 & 23 facing east, south, and west. Note visual evidence of decay, storm damage, large trunk wound (red arrow), and deadwood for Tree #20, poor structure, canopy dieback, storm damage, and canopy crowding for Tree #22, and poor structure, large diameter deadwood, and canopy dieback for Tree #23.
