ARBORIST REPORT

200 N. Federal Hwy.
Pompano Beach, Fl 33062

Assignment/Overview

Treage LLC was contacted by George Akirtava of Elit Group to do a Certified Arborist Report/Tree Assessment at 200 N. Federal Hwy. in Pompano Beach, FL.

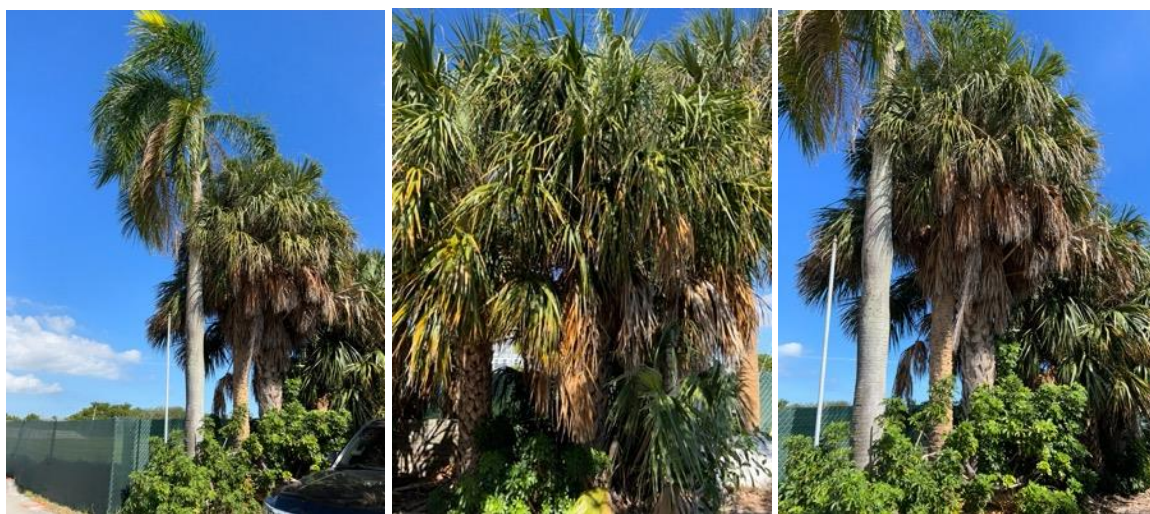
Tree #1 – *Roystonea regia*, Royal Palm – this tree is located in the northwest corner of the property adjacent to the parking lot and next to the ROW. It is crowded with minor chlorosis and a slightly undersized canopy. Overall, it is in fair condition and is proposed for removal.

Tree #2 – *Sabal palmetto*, Sabal Palm – this tree is located directly east of Tree #1. It is very crowded with a pronounced curve in the upper trunk due to the crowded conditions. It is in fair condition and is proposed for removal.

Tree #3 – *Sabal palmetto*, Sabal Palm – this tree is located directly east of Tree #2 on the northeast side of the property. It is very crowded and has live fronds only on one side of the trunk due to severe crowding. It is in poor condition and is proposed for removal.

Tree #4 – *Sabal palmetto*, Sabal Palm – this tree is located directly east of Tree #3. It is very crowded and overgrown but otherwise is in fair condition. This tree is proposed for removal.

Tree #5 – *Sabal palmetto*, Sabal Palm – this tree is located directly east of Tree #4. It is very crowded and overgrown but otherwise is in fair condition. It is proposed for removal.

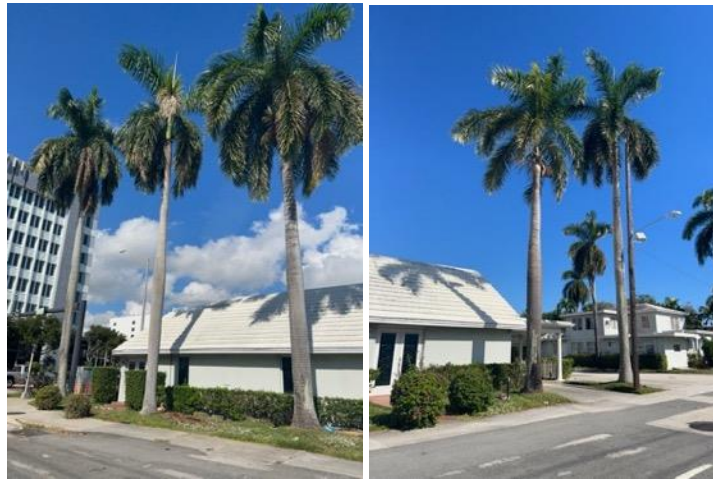
Tree #15 – *Roystonea regia*, Royal Palm – this tree is located on the south side of the property east of the covered walkway to the covered porch area. It shows signs of very minor nutrient deficiency, but otherwise is in good condition with no significant defects. It is proposed for removal.

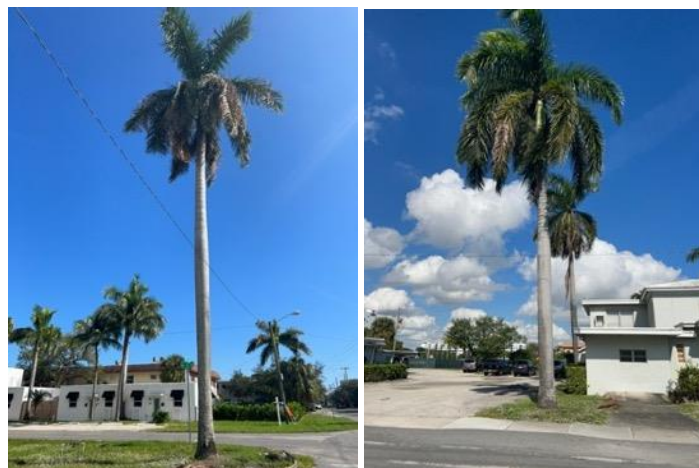
Tree #17 – *Roystonea regia*, Royal Palm – this tree is located on the south side of the property just east of the entrance to the asphalt parking lot. It is in good condition with no significant defects. It is proposed for removal.

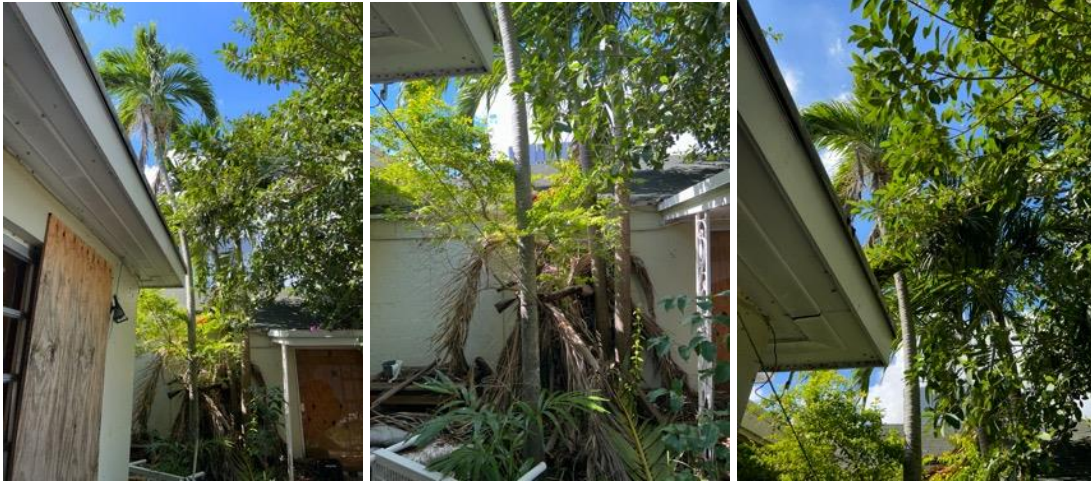
Tree #18 – *Adonidia merrillii*, Christmas Palm – this refers to a cluster of 3 palms located inside of a courtyard area on the east side of the existing back building. They are slightly crowded, but otherwise in fair to good condition. They are proposed for removal.

NOTE: Tree #18 appears to be the same as Tree #11 on the survey; therefore, it has been assigned to this tree which was not included on the survey.

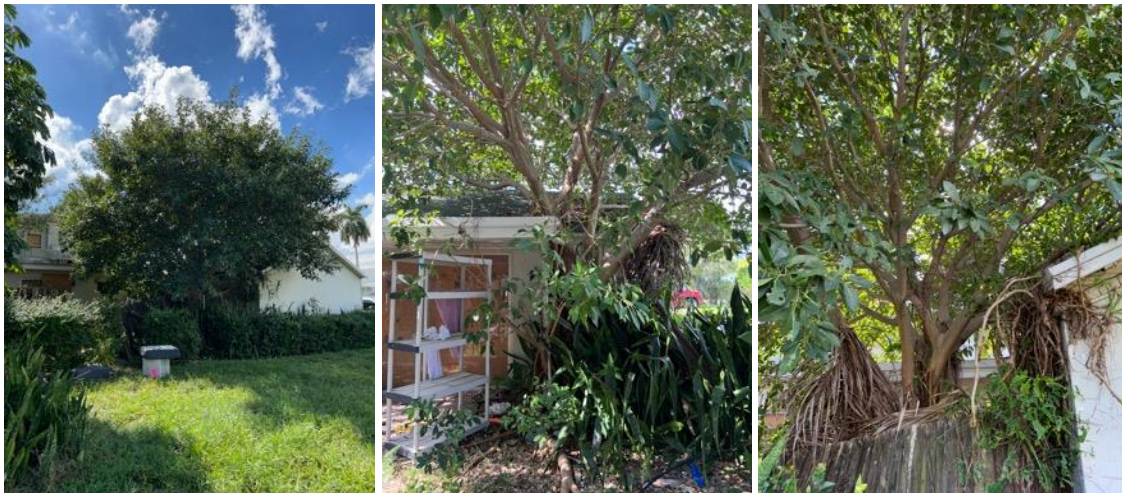
Tree #19 – *Ficus aurea*, Strangler Fig – this tree is located on the northeast side of the existing building on the east side of the property. It is crowded, overgrown, and unmaintained with minor deadwood present, but overall it is in fair condition. This tree is proposed for removal.

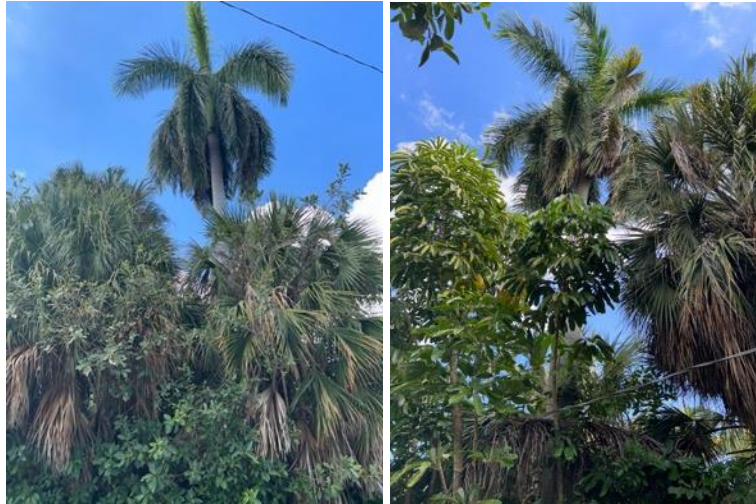
Tree #20 – *Roystonea regia*, Royal Palm – this tree is located in an overgrown cluster of vegetation on the east side of the property. It is very crowded and overgrown and could not be accessed due to its location within a fenced area. It shows signs of very minor nutrient deficiency. Overall it is in fair condition and is proposed for removal.

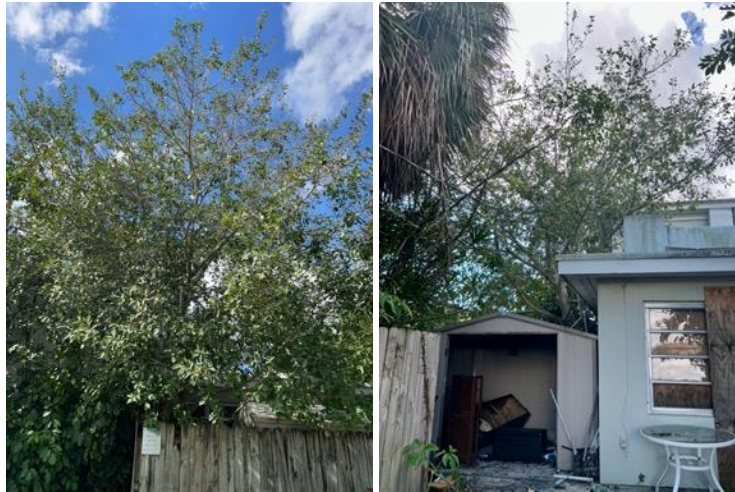
Tree #22 – *Ficus aurea*, Strangler Fig – this tree is located on the east side of the building on the east side of the property. It is inaccessible due to its location inside a fenced area. It appears to be crowded, overgrown and unmaintained with areas of slightly sparse foliage. Overall, it is in fair condition and will be removed.

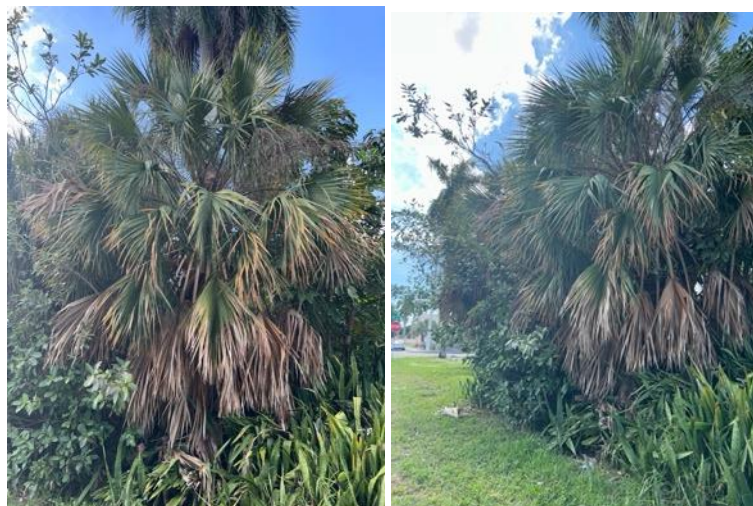
Tree #23 – *Sabal palmetto*, Sabal Palm – this tree is located on the north side of the overgrown cluster of vegetation on the east side of the property. It is very crowded, and overgrown. Overall it is in fair condition and is proposed for removal.

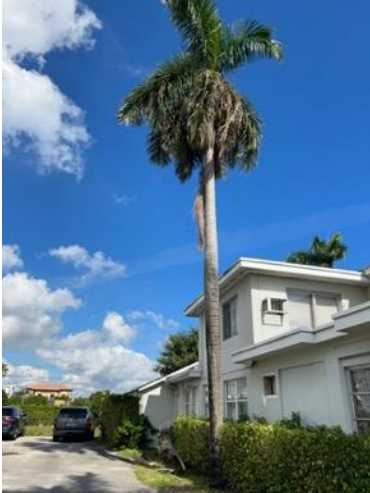
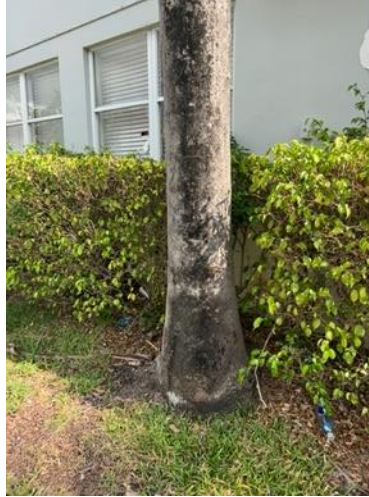
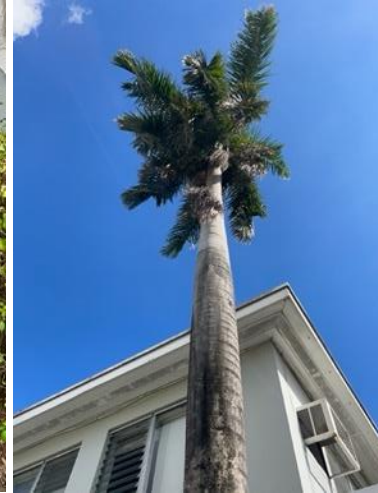
Tree #24 – *Roystonea regia*, Royal Palm – this tree is located on the west side of the back building that is on the east side of the property. It is growing within 5.5' of the existing building. It shows very minor signs of nutrient deficiency and is in overall good condition.

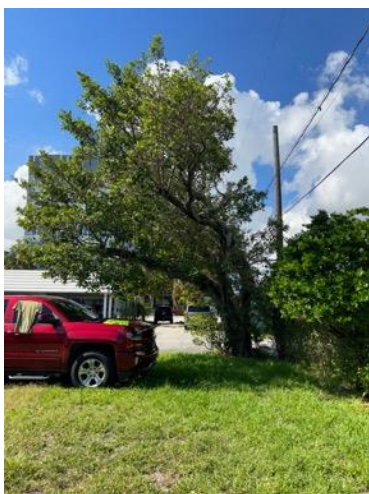
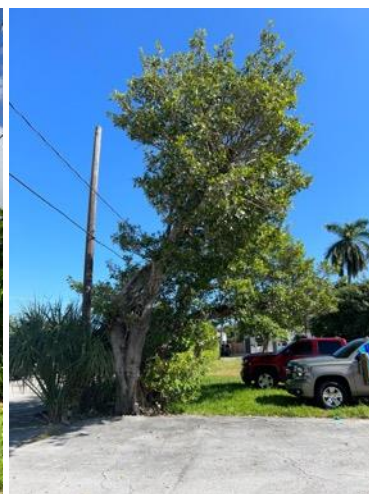
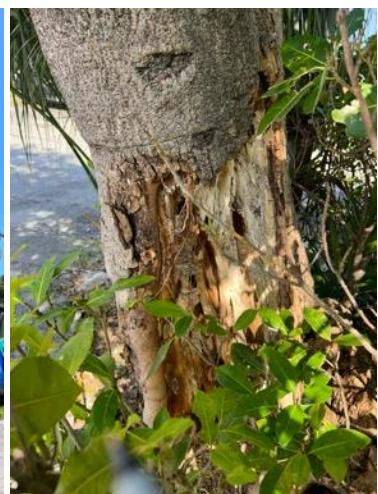
Tree #25 – *Ficus aurea*, Strangler Fig – this tree is located on the north side of the main parking lot near the entrance to the small parking lot (Lot 17, Block 5). It has extensive internal decay at the base of the trunk and in all remaining scaffold limbs. There is decayed wood, apparent termite damage, and fruiting fungal bodies present. Based on a Level 2 inspection and using the ISA Risk Rating matrix, this tree constitutes a high risk and there are no mitigation options that can reduce its risk to moderate or less; therefore, it is recommended for consideration for removal without a permit or mitigation per FS 163.045.

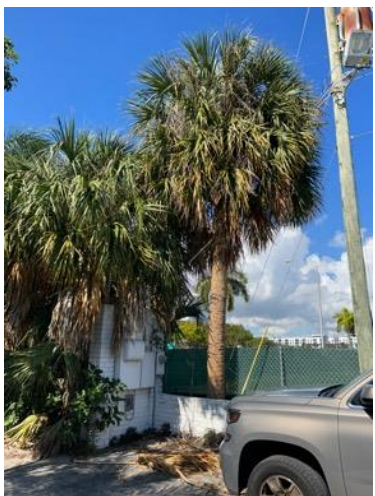
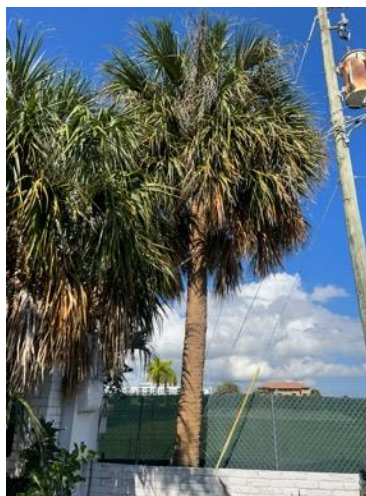
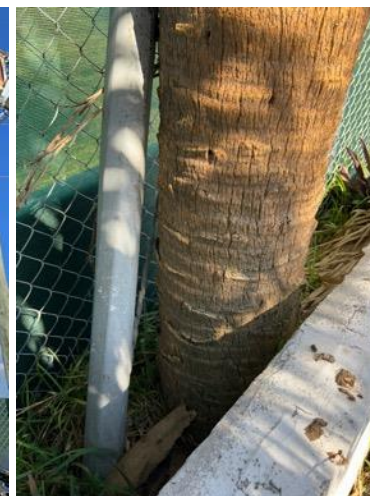
Tree #26 – *Sabal palmetto*, Sabal Palm – this tree is located just east of Trees #1-5 on the northeast side of the property/parking lot. It is somewhat crowded but otherwise is in good condition. It is proposed for removal.

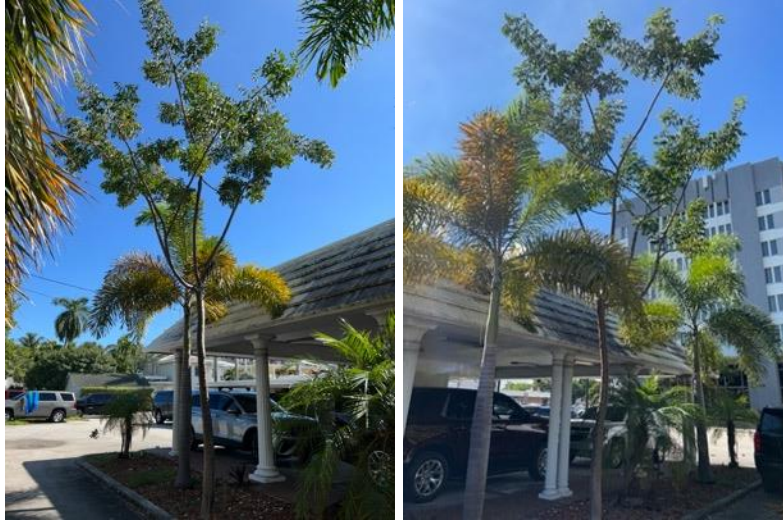
Tree #27 – *Bursera simarouba*, Gumbo Limbo – this tree is located east of Tree #6 in the planting island on the north side of the covered valet drop off area. It is a relatively young tree in fair condition with a slightly weak growth habit but no other significant defects. It is proposed for removal.

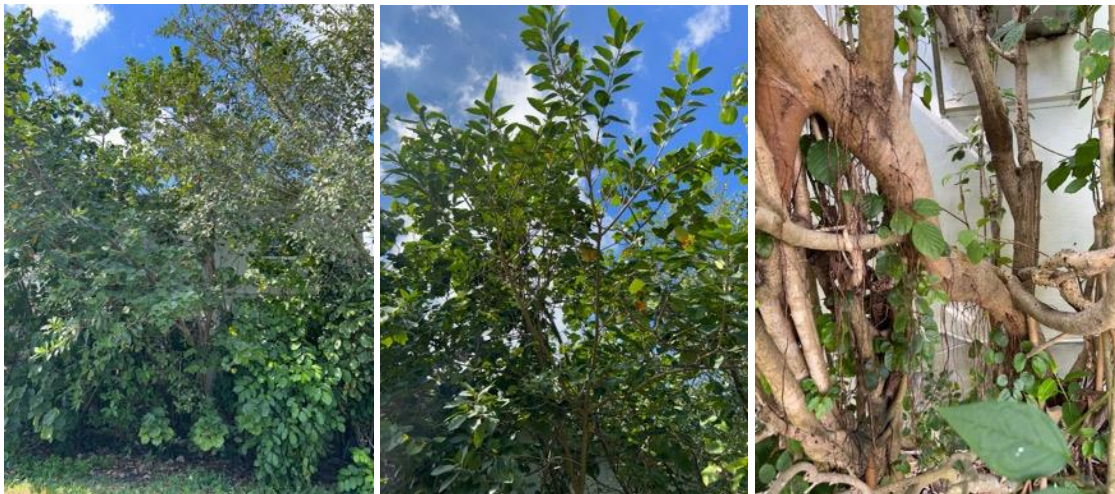
Tree #28 – *Ficus aurea*, Strangler Fig – this is a small volunteer that is growing in an overgrown cluster of Sea Hibiscus on the east side of the existing back building. It is crowded and leaning and has a weak growth habit/structure as a result. It is in poor condition and will be removed.

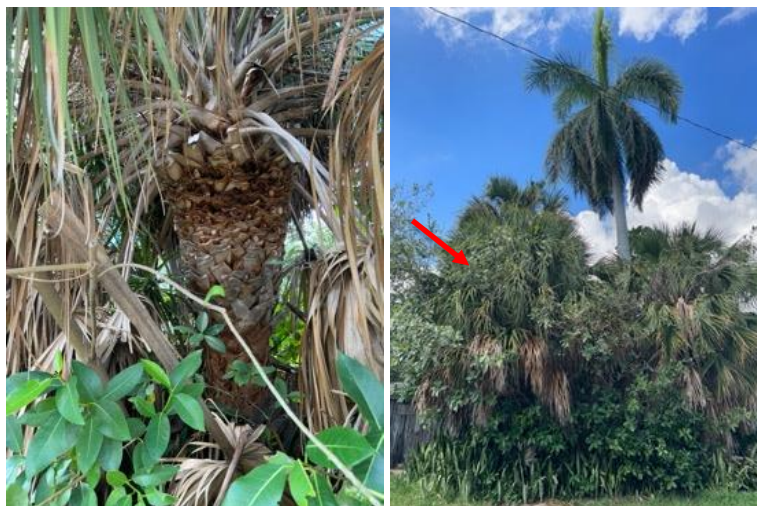
Tree #30 – *Sabal palmetto*, Sabal Palm – this tree is located directly in front of Tree #21 on the east side of the property. It is very crowded, overgrown with vines, and unmaintained. Overall, it is in fair condition and is proposed for removal.

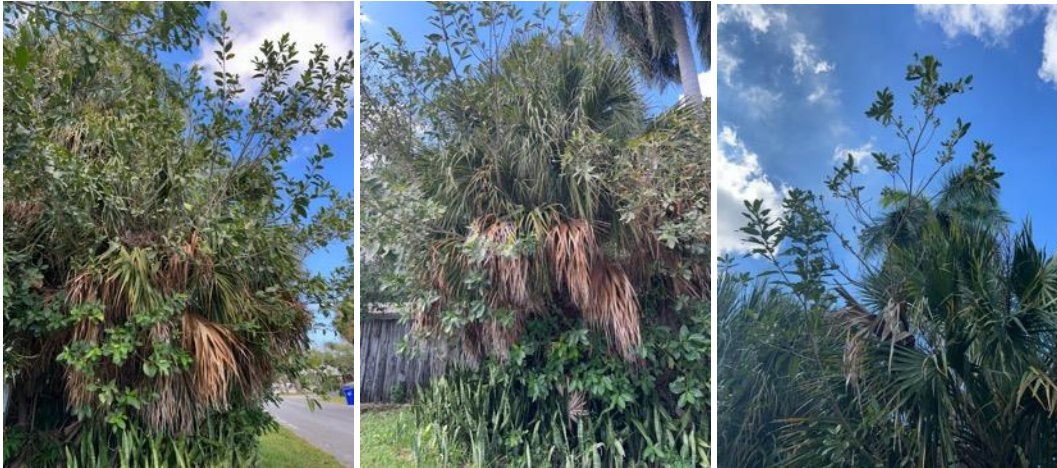
Tree #31 – *Ficus aurea*, Strangler Fig – there is at least one Strangler Fig growing in the middle of the overgrown cluster of vegetation containing Trees #20-21. It is very crowded, overgrown, inaccessible and difficult to see, but at least 3 individual trunks, each 2-3" DBH, were observed with minimal amounts of foliage visible as well. For the sake of this assessment, it is assumed that this is one tree. It is in poor condition and will be removed.

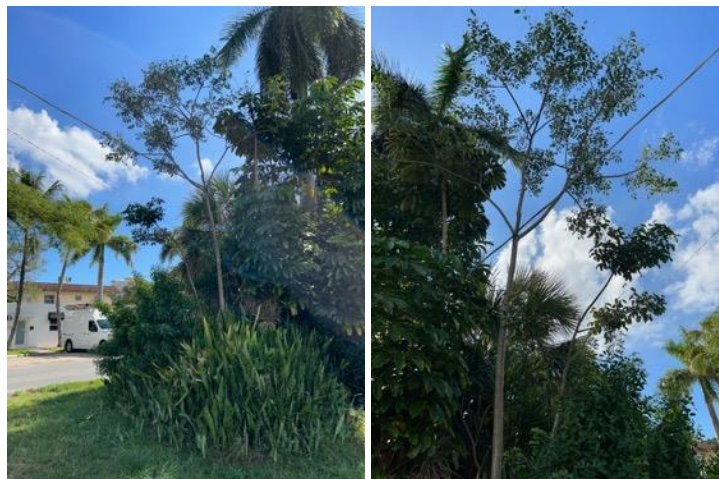
Tree #32 – *Bursera simarouba*, Gumbo Limbo – this tree is located on the north side of the cluster of overgrown vegetation on the east side of the property (north of Trees #20 and 23). It is crowded and overgrown with a slightly weak structure, and it is growing among utility wires. Overall, it is in fair condition and is proposed for removal.

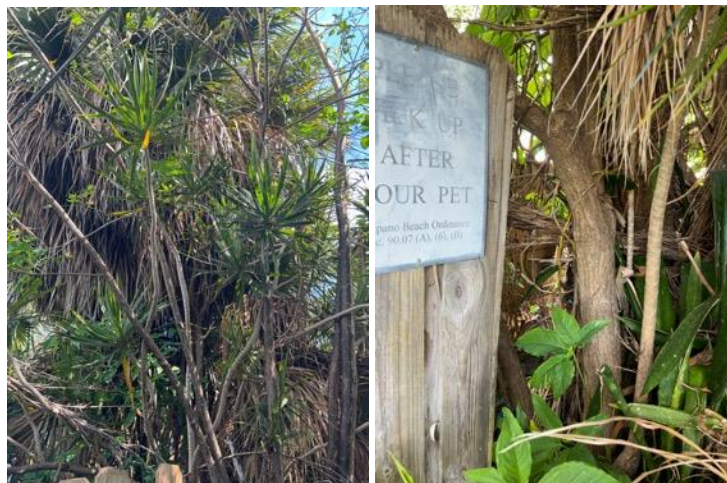
***Dracaena reflexa*, Dracaena** – there is a small cluster of Dracaena located on the southwest side of the cluster of vegetation on the east side of the property (adjacent to Tree #21). It is crowded and overgrown. It is more of an overgrown shrub than a tree, so it is recommended for removal without a permit or mitigation, to be confirmed by the City.

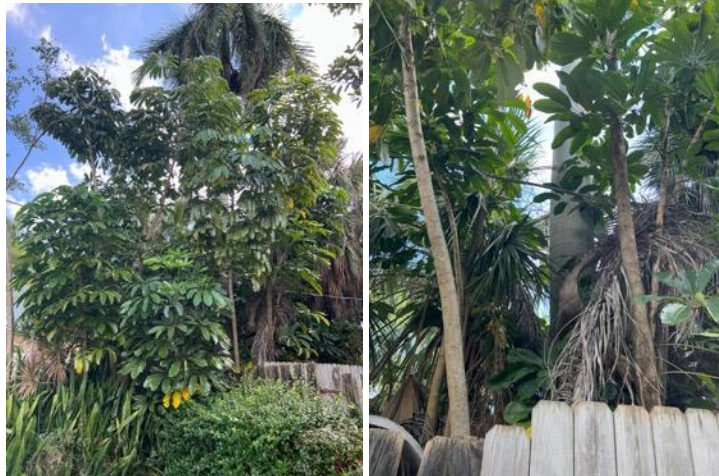
***Schefflera actinophylla*, Umbrella tree** – there are 2 clusters of Umbrella tree located on the northwest side of the overgrown cluster of vegetation on the east side of the property (adjacent to Tree #20). This is considered a nuisance species that should not require a permit or mitigation for removal, to be confirmed by the City.
