PZ24-12000021

Arboriculture Tree Report

Lots 930,931,932 & 933, Collier City

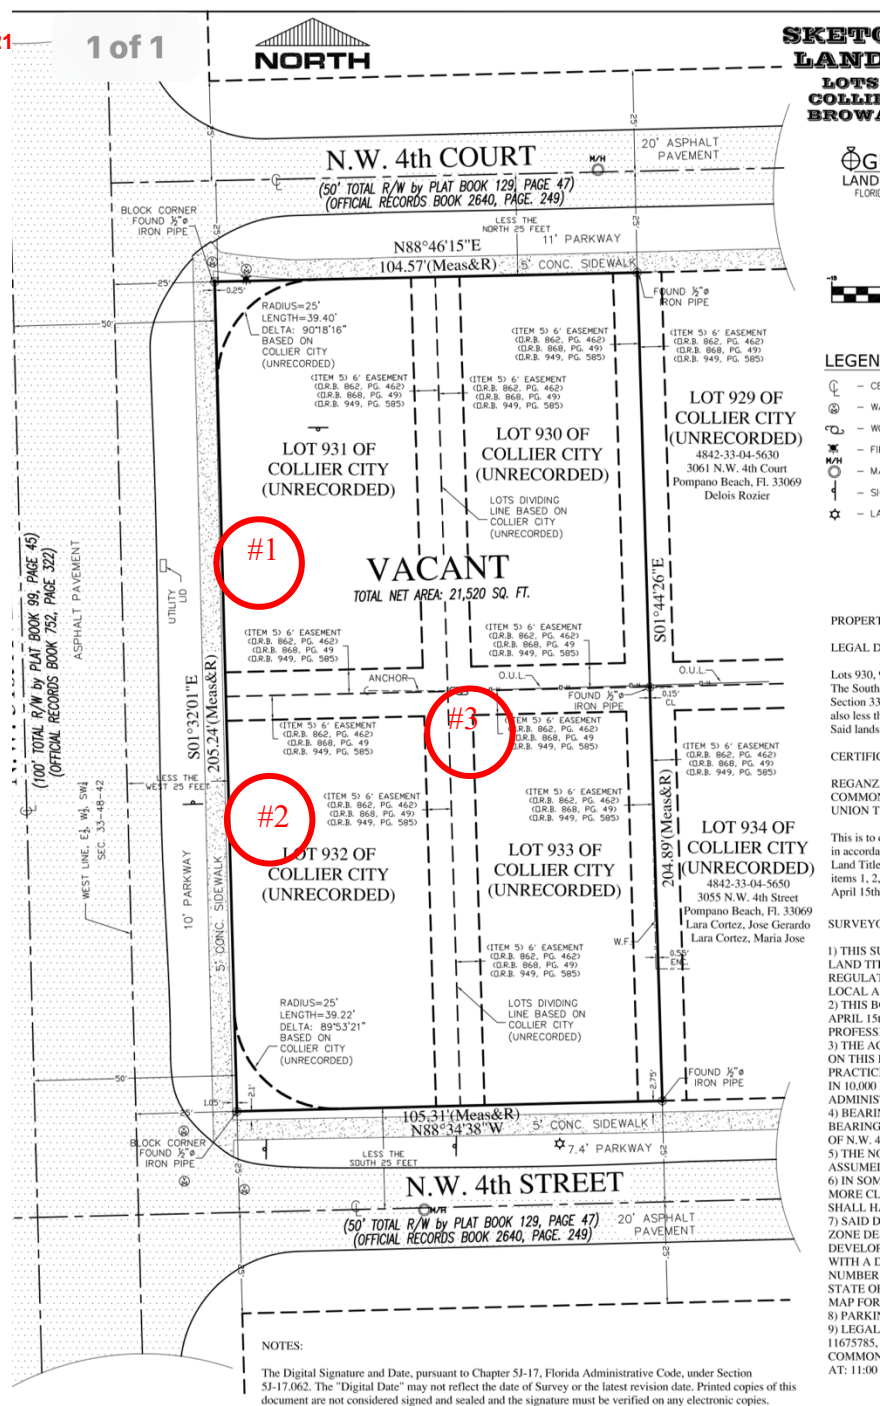
Tree ID#	Common name	Botanical name	DBH (Inch)	CRZ (FT)	TPZ (FT)	Height CT (FT)	Height OA (FT)	Condition	Canopy Spread (FT)	Notes
1	Sabal palm	<i>Sabal palmetto</i>	14"	4'	4'	22'	27'	70%	12'	
2	Sabal palm	<i>Sabal palmetto</i>	14"	4'	4'	22'	27'	70%	12'	
3	Sabal palm	<i>Sabal palmetto</i>	12"	4'	4'	3'	8'	70%	12'	Too small. Three trunks
