# ARBORIST REPORT

200 N. Federal Hwy.  
Pompano Beach, Fl 33062

Treage LLC was contacted by George Akirtava of Elit Group to do a Certified Arborist Report/Tree Assessment at 200 N. Federal Hwy. in Pompano Beach, FL.

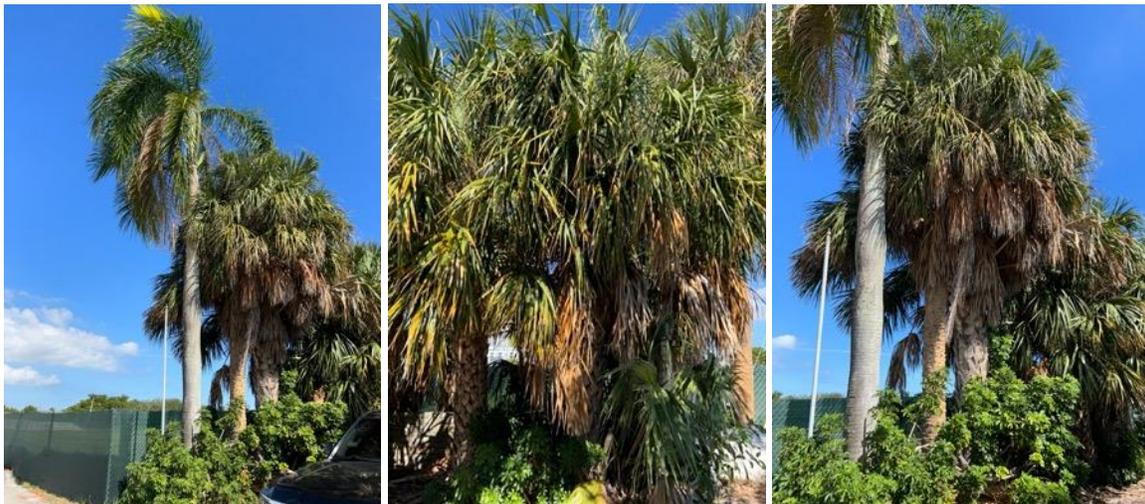
**Tree #1 – *Roystonea regia*, Royal Palm** – this tree is located in the northwest corner of the property adjacent to the parking lot and next to the ROW. It is crowded with minor chlorosis and a slightly undersized canopy. Overall, it is in fair condition and is proposed for removal.

**Tree #2 – *Sabal palmetto*, Sabal Palm** – this tree is located directly east of Tree #1. It is very crowded with a pronounced curve in the upper trunk due to the crowded conditions. It is in fair condition and is proposed for removal.

**Tree #3 – *Sabal palmetto*, Sabal Palm** – this tree is located directly east of Tree #2 on the northeast side of the property. It is very crowded and has live fronds only on one side of the trunk due to severe crowding. It is in poor condition and is proposed for removal.

**Tree #4 – *Sabal palmetto*, Sabal Palm** – this tree is located directly east of Tree #3. It is very crowded and overgrown but otherwise is in fair condition. This tree is proposed for removal.

**Tree #5 – *Sabal palmetto*, Sabal Palm** – this tree is located directly east of Tree #4. It is very crowded and overgrown but otherwise is in fair condition. It is proposed for removal.

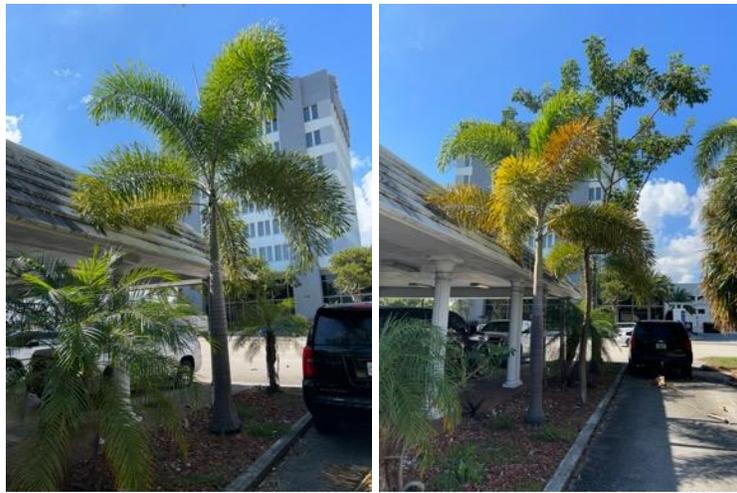
**Tree #6 – *Wodyetia bifurcata*, Foxtail Palm** – this tree is located in a small planting island on the north side of a covered valet area. It has minor chlorosis and is slightly crowded but otherwise is in fair condition with no significant defects. It is proposed for removal.

**Tree #7 – *Wodyetia bifurcata*, Foxtail Palm** – this tree is located near the east end of the planting island. It has moderate to severe chlorosis and is in overall moderate condition. This palm is proposed for removal.

**Trees #8-10 – *Phoenix roebellini*, Pygmy Date Palm** – this refers to 3 Pygmy Date palms located in the planting island with Trees #6-7. They are all under regulation size, so they should not require a permit or mitigation for their removal.

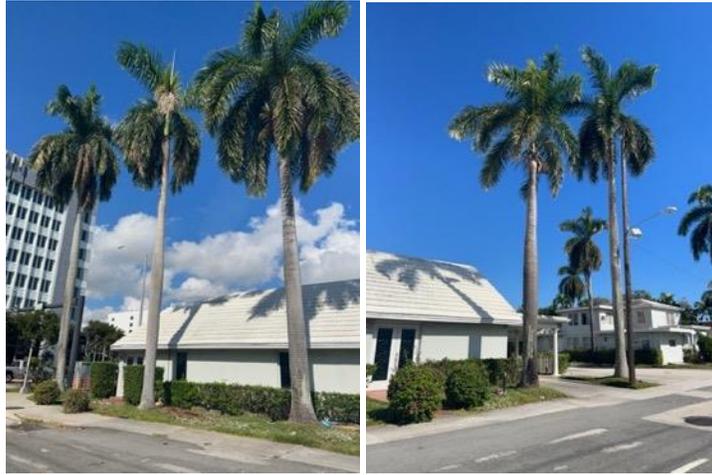
**Tree #11 – *Roystonea regia*, Royal Palm** – this tree is located next to the ROW in the southwest corner of the property. It is in good condition with no significant defects. It is proposed for removal.

**Tree #12 – *Roystonea regia*, Royal Palm** – this tree is located near the ROW on the southwest side of the property slightly east of Tree #11. It has a slightly undersized canopy, possibly due to minor nutrient deficiency, but otherwise is in good condition with no significant defects. It is proposed for removal.

**Tree #13 – *Roystonea regia*, Royal Palm** – this tree is located on the south side of the property east of Tree #12. It is in good condition with no significant defects. It is proposed for removal.

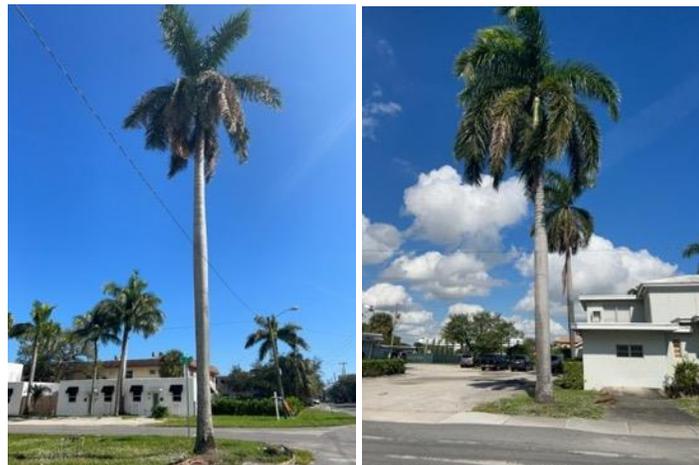
**Tree #14 – *Roystonea regia*, Royal Palm** – this tree is located on the south side of the property east of Trees #11-13 and just west of the concrete walkway to the covered porch area. It shows signs of minor chlorosis/nutrient deficiency, but otherwise is in good condition with no significant defects. It is proposed for removal.

**Tree #15 – *Roystonea regia*, Royal Palm** – this tree is located on the south side of the property east of the covered walkway to the covered porch area. It shows signs of very minor nutrient deficiency, but otherwise is in good condition with no significant defects. It is proposed for removal.

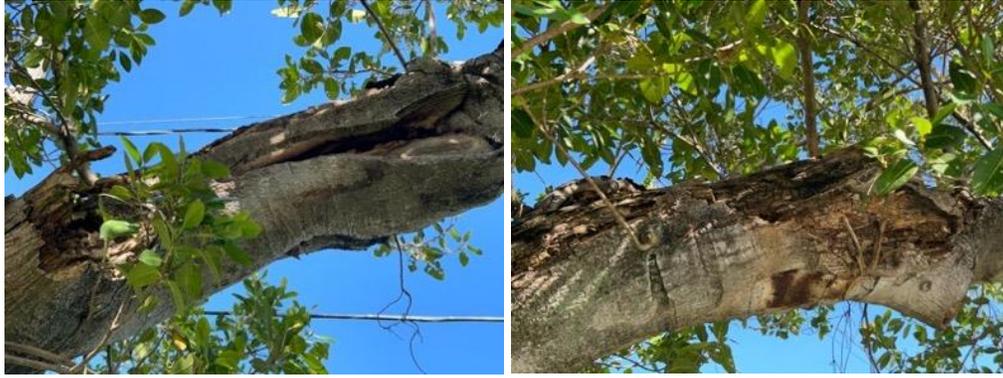
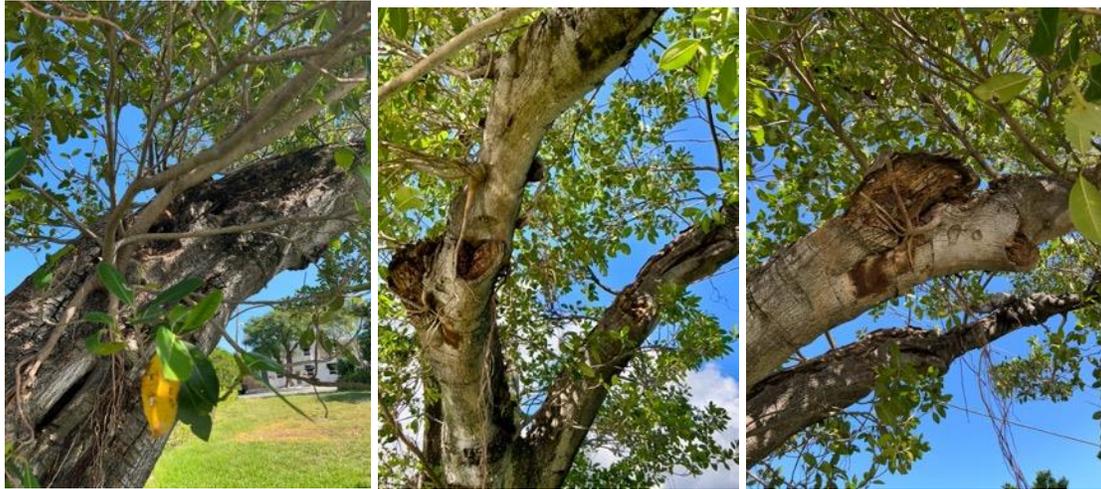
**Tree #25 – *Ficus aurea*, Strangler Fig** – this tree is located on the north side of the main parking lot near the entrance to the small parking lot (Lot 17, Block 5). It has extensive internal decay at the base of the trunk and in all remaining scaffold limbs. There is decayed wood, apparent termite damage, and fruiting fungal bodies present. Based on a Level 2 inspection and using the ISA Risk Rating matrix, this tree constitutes a high risk and there are no mitigation options that can reduce its risk to moderate or less; therefore, it is recommended for consideration for removal without a permit or mitigation per FS 163.045.

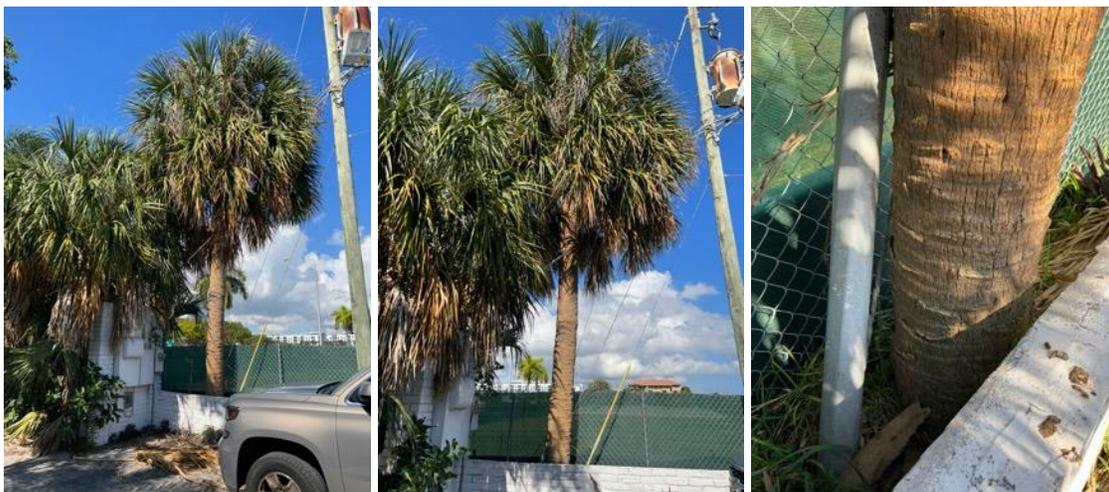
**Tree #26 – *Sabal palmetto*, Sabal Palm** – this tree is located just east of Trees #1-5 on the northeast side of the property/parking lot. It is somewhat crowded but otherwise is in good condition. It is proposed for removal.

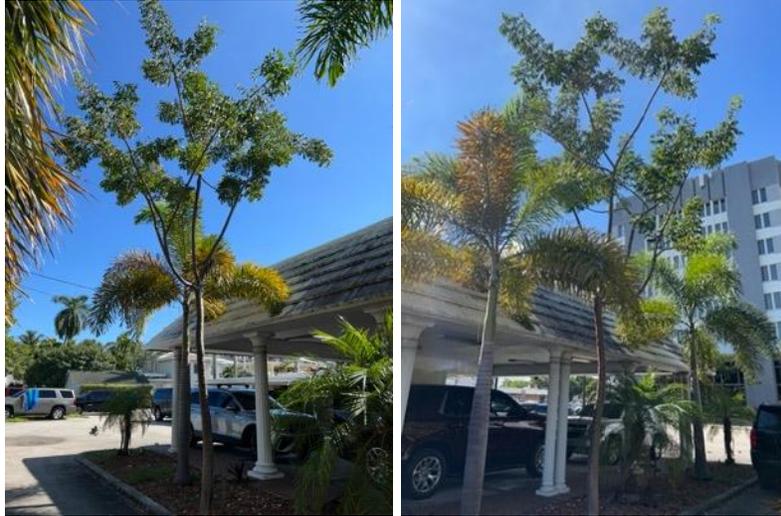
**Tree #27 – *Bursera simarouba*, Gumbo Limbo** – this tree is located east of Tree #6 in the planting island on the north side of the covered valet drop off area. It is a relatively young tree in fair condition with a slightly weak growth habit but no other significant defects. It is proposed for removal.

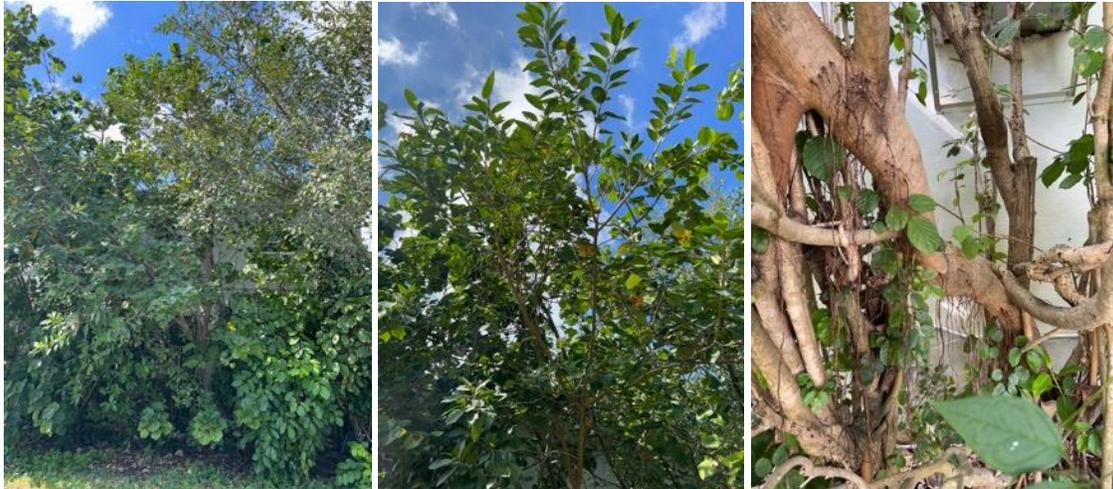
**Tree #28 – *Ficus aurea*, Strangler Fig** – this is a small volunteer that is growing in an overgrown cluster of Sea Hibiscus on the east side of the existing back building. It is crowded and leaning and has a weak growth habit/structure as a result. It is in poor condition and will be removed.

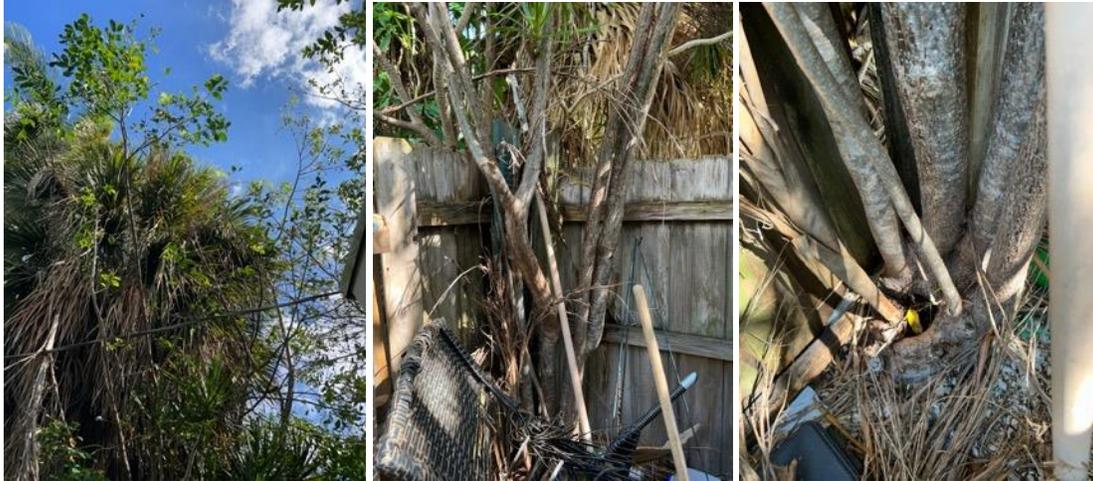
**Tree #29 – *Bursera simarouba*, Gumbo Limbo** – this tree is growing on the southwest corner of the cluster of overgrown vegetation on the east side of the existing back building; it is likely a volunteer. It is growing against a wooden fence and appears to have been trimmed multiple times near ground level so that it consists of multiple sprouts. There is a decay cavity near the base of the trunk. The canopy is small and sparse. Overall, this tree is in poor condition. It is proposed for removal.

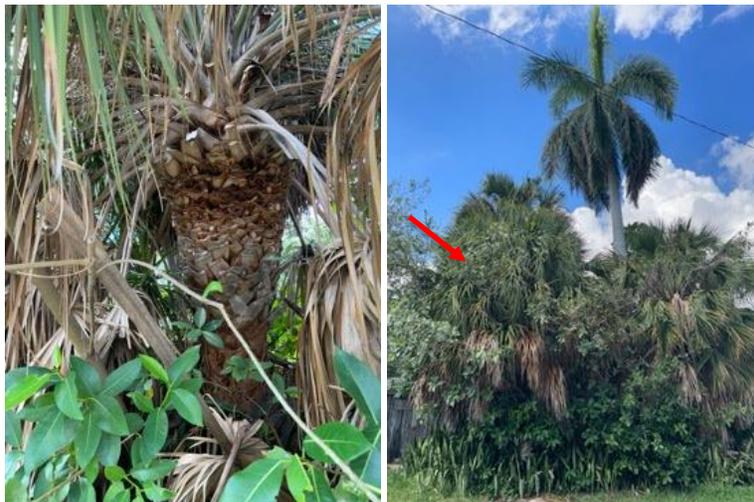
**Tree #30 – *Sabal palmetto*, Sabal Palm** – this tree is located directly in front of Tree #21 on the east side of the property. It is very crowded, overgrown with vines, and unmaintained. Overall, it is in fair condition and is proposed for removal.

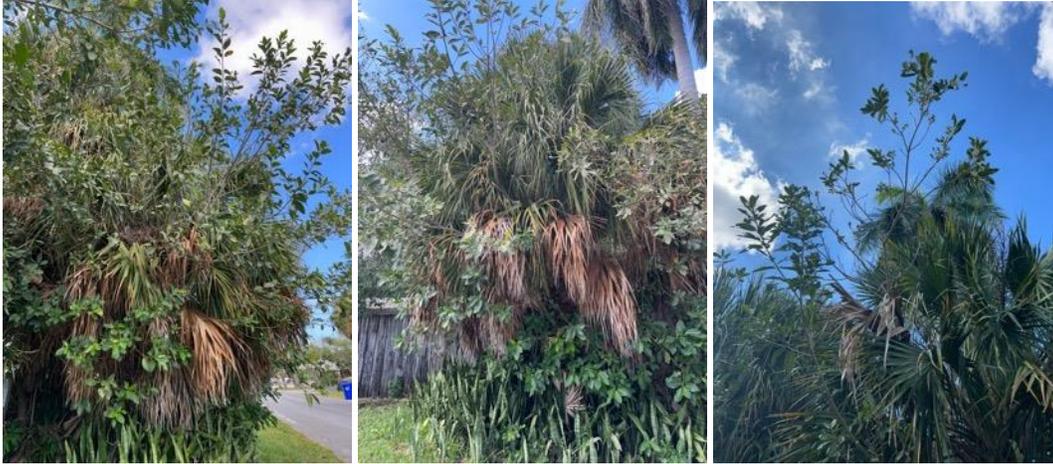
**Tree #31 – *Ficus aurea*, Strangler Fig** – there is at least one Strangler Fig growing in the middle of the overgrown cluster of vegetation containing Trees #20-21. It is very crowded, overgrown, inaccessible and difficult to see, but at least 3 individual trunks, each 2-3” DBH, were observed with minimal amounts of foliage visible as well. For the sake of this assessment, it is assumed that this is one tree. It is in poor condition and will be removed.

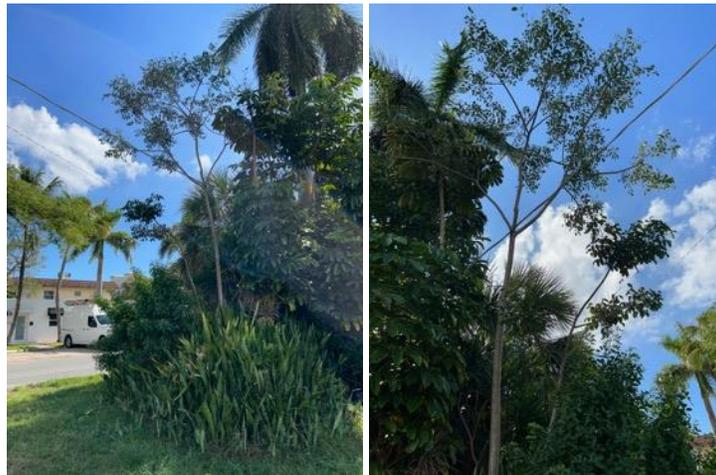
**Tree #32 – *Bursera simarouba*, Gumbo Limbo** – this tree is located on the north side of the cluster of overgrown vegetation on the east side of the property (north of Trees #20 and 23). It is crowded and overgrown with a slightly weak structure, and it is growing among utility wires. Overall, it is in fair condition and is proposed for removal.

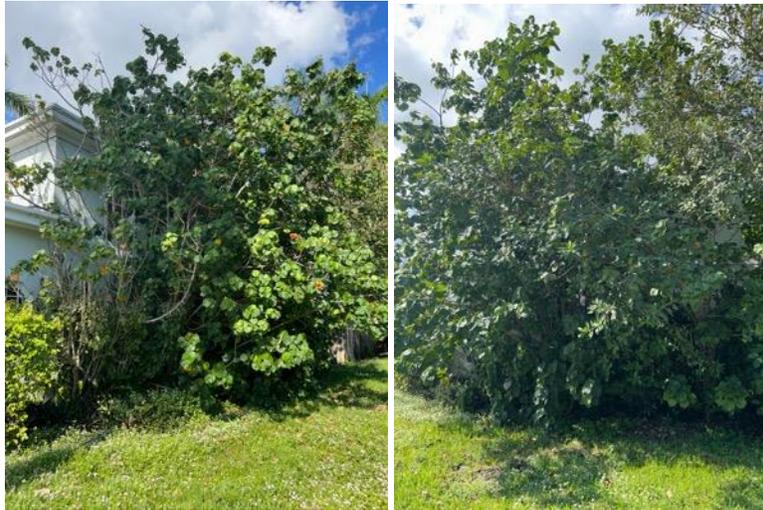
***Hibiscus tiliaceus*, Sea Hibiscus** – this refers to a large overgrown cluster of Sea Hibiscus located on the east side of the property against the southeast side of the back building. There appear to be 2 distinct individual clusters present. They are crowded, overgrown and unmaintained, and in overall moderate condition. This is more of an overgrown shrub than a tree, so it is recommended for removal without mitigation to be confirmed by the City.

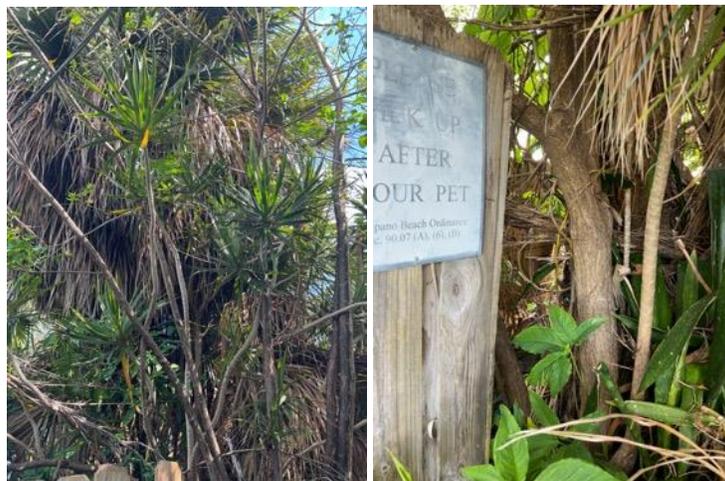
***Dracaena reflexa*, Dracaena** – there is a small cluster of Dracaena located on the southwest side of the cluster of vegetation on the east side of the property (adjacent to Tree #21). It is crowded and overgrown. It is more of an overgrown shrub than a tree, so it is recommended for removal without a permit or mitigation, to be confirmed by the City.

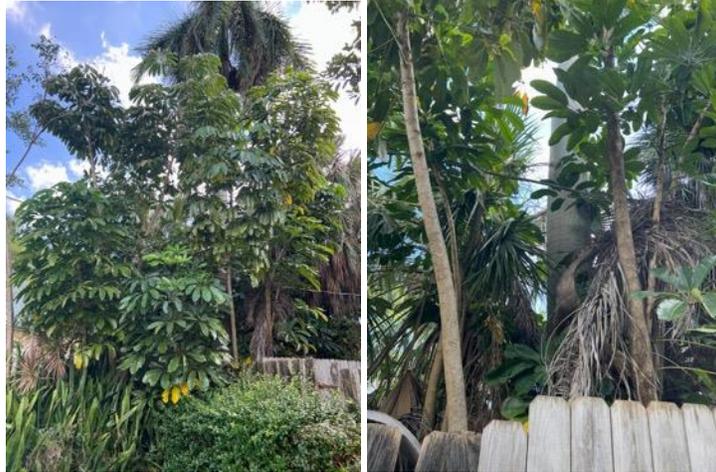
***Schefflera actinophylla*, Umbrella tree** – there are 2 clusters of Umbrella tree located on the northwest side of the overgrown cluster of vegetation on the east side of the property (adjacent to Tree #20). This is considered a nuisance species that should not require a permit or mitigation for removal, to be confirmed by the City.
