Enclosed please find the updated Certified Arborist Report/Tree Assessment for the property located at 200 N. Federal Hwy. in Pompano Beach, FL conducted on November 16, 2022.

ARBORIST REPORT

200 N. Federal Hwy.
Pompano Beach, Fl 33062

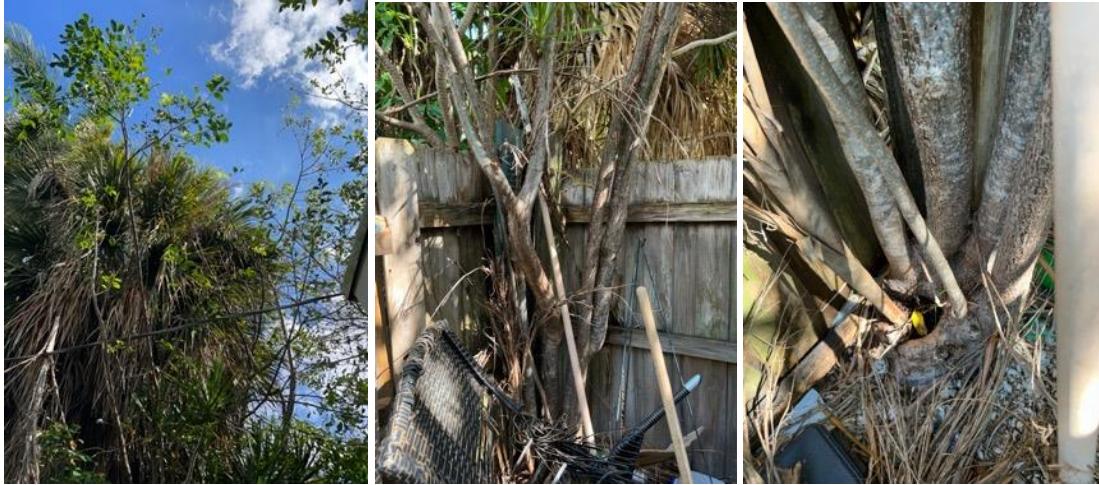
Tree #29 – *Bursera simarouba*, Gumbo Limbo – this tree is growing on the southwest corner of the cluster of overgrown vegetation on the east side of the existing back building; it is likely a volunteer. It is growing against a wooden fence and appears to have been trimmed multiple times near ground level so that it consists of multiple sprouts. There is a decay cavity near the base of the trunk. The canopy is small and sparse. Overall, this tree is in poor condition. It is proposed for removal.

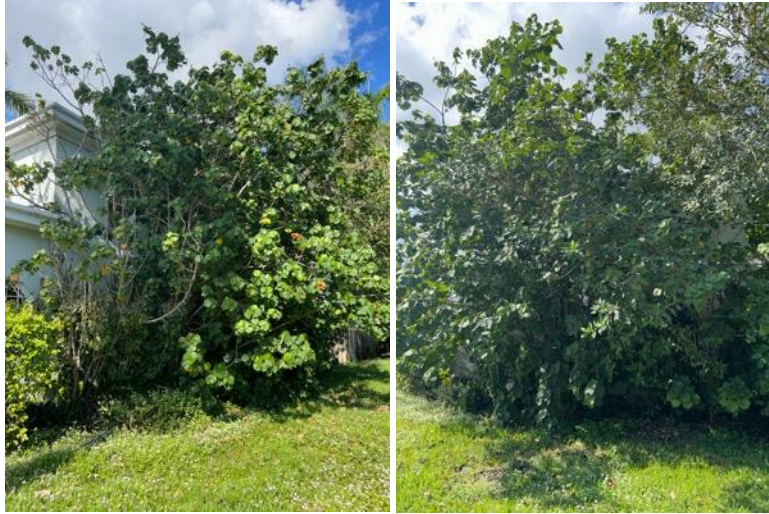
***Hibiscus tiliaceus*, Sea Hibiscus** – this refers to a large overgrown cluster of Sea Hibiscus located on the east side of the property against the southeast side of the back building. There appear to be 2 distinct individual clusters present. They are crowded, overgrown and unmaintained, and in overall moderate condition. This is more of an overgrown shrub than a tree, so it is recommended for removal without mitigation to be confirmed by the City.

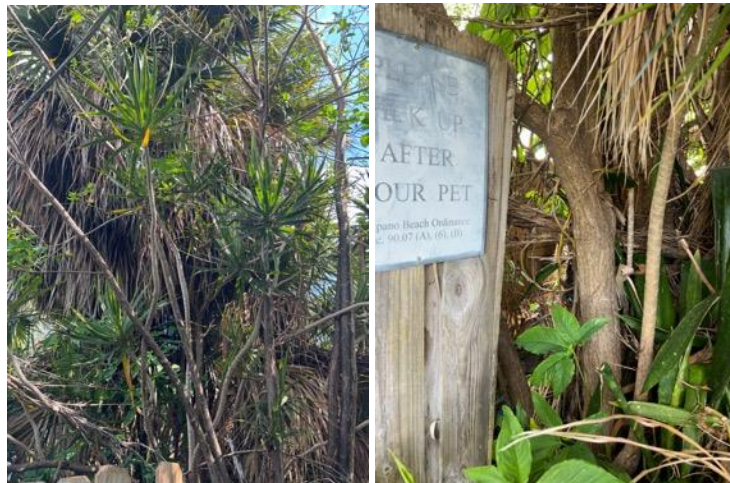
***Dracaena reflexa*, Dracaena** – there is a small cluster of Dracaena located on the southwest side of the cluster of vegetation on the east side of the property (adjacent to Tree #21). It is crowded and overgrown. It is more of an overgrown shrub than a tree, so it is recommended for removal without a permit or mitigation, to be confirmed by the City.
