Tree Resource Evaluation for 524 N. Riverside Drive, Pompano Beach

December 18, 2019

Summary

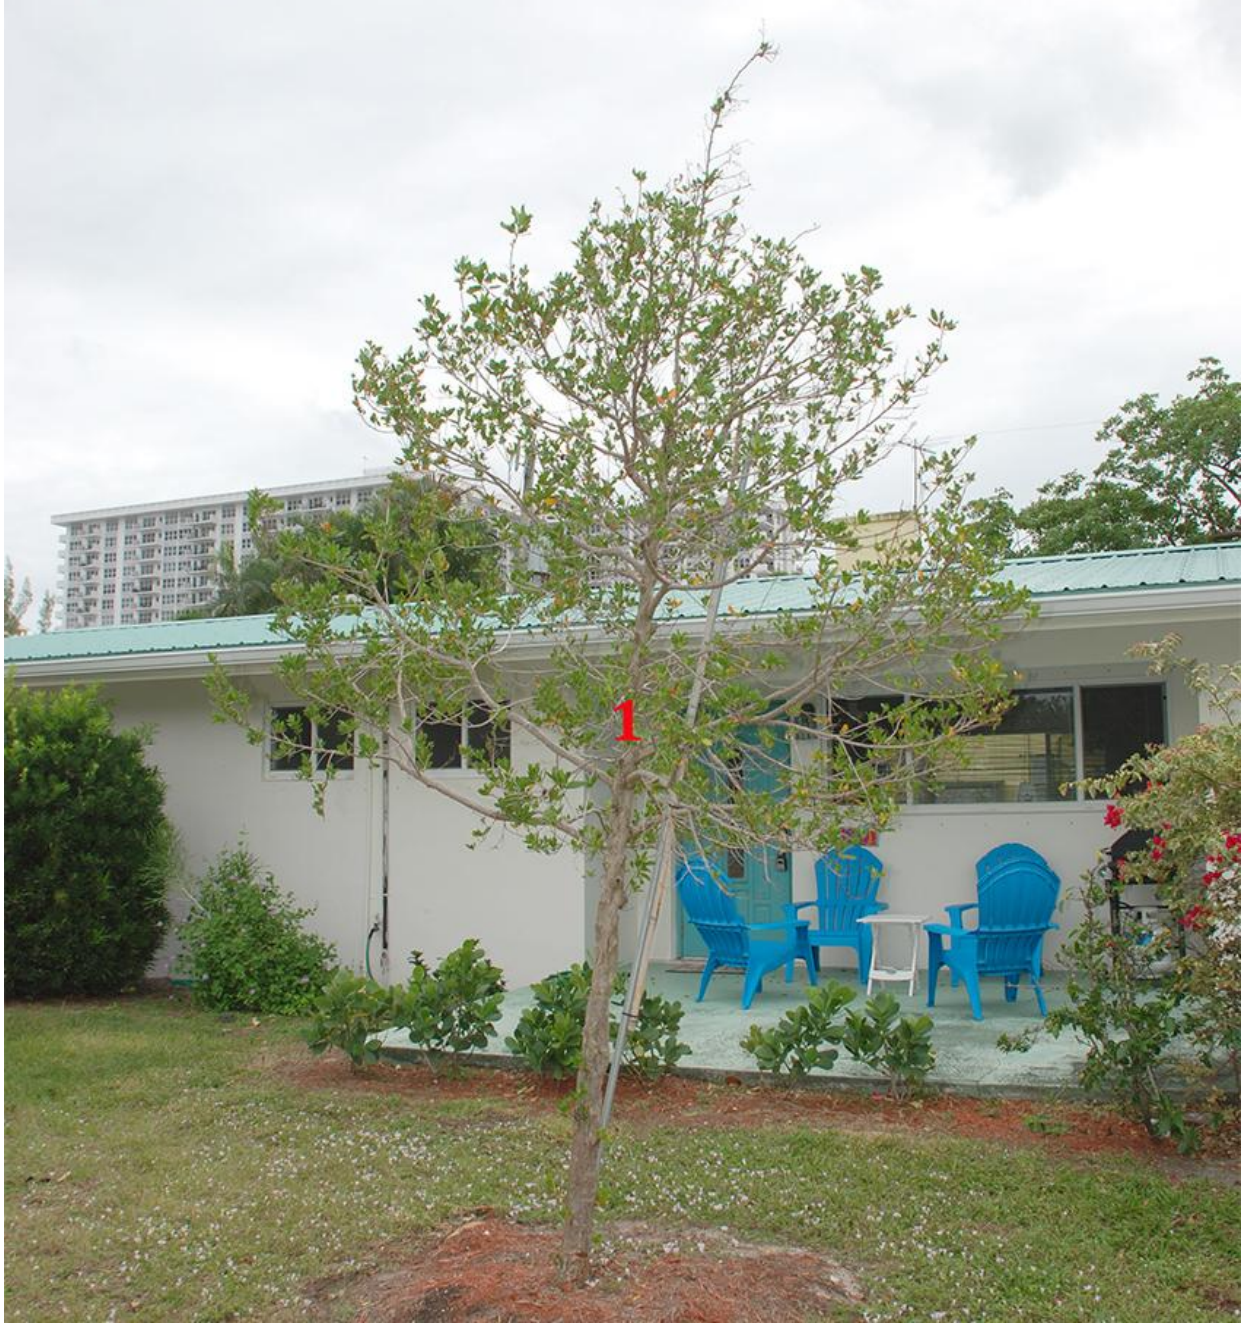
Photo 1 above is tree 1 viewed from the north. This tree appears to have been recently planted.

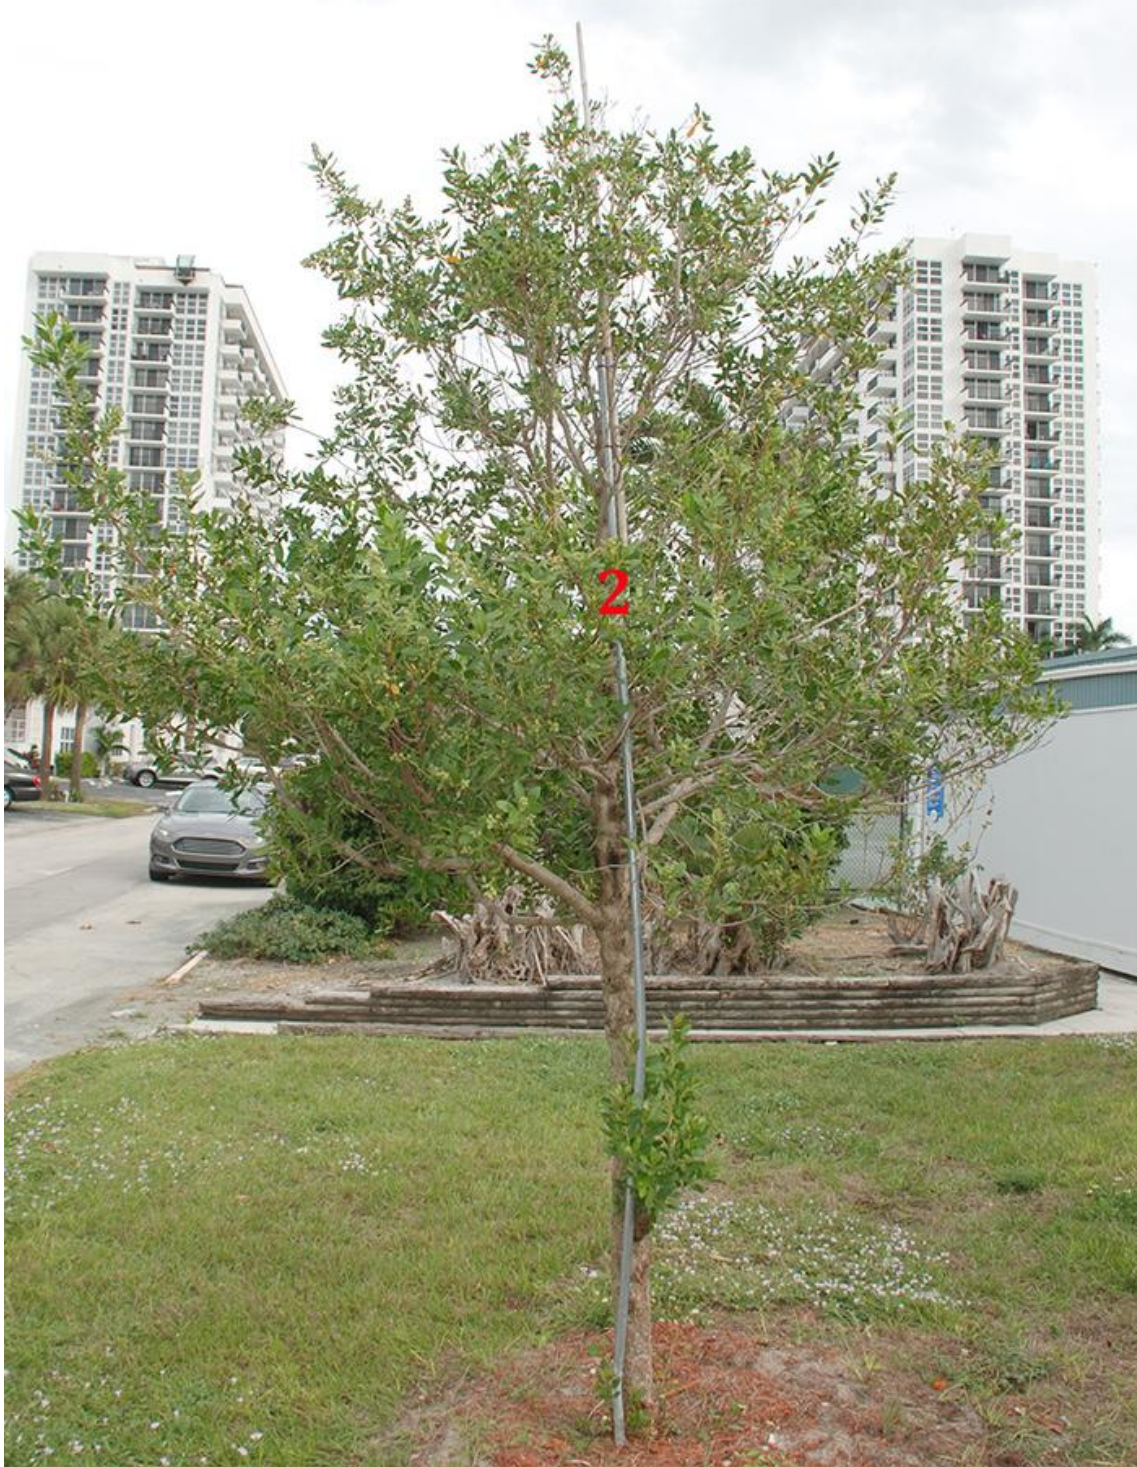
Photo 2 above is tree 2 viewed from the west. This tree appears to have been recently planted.

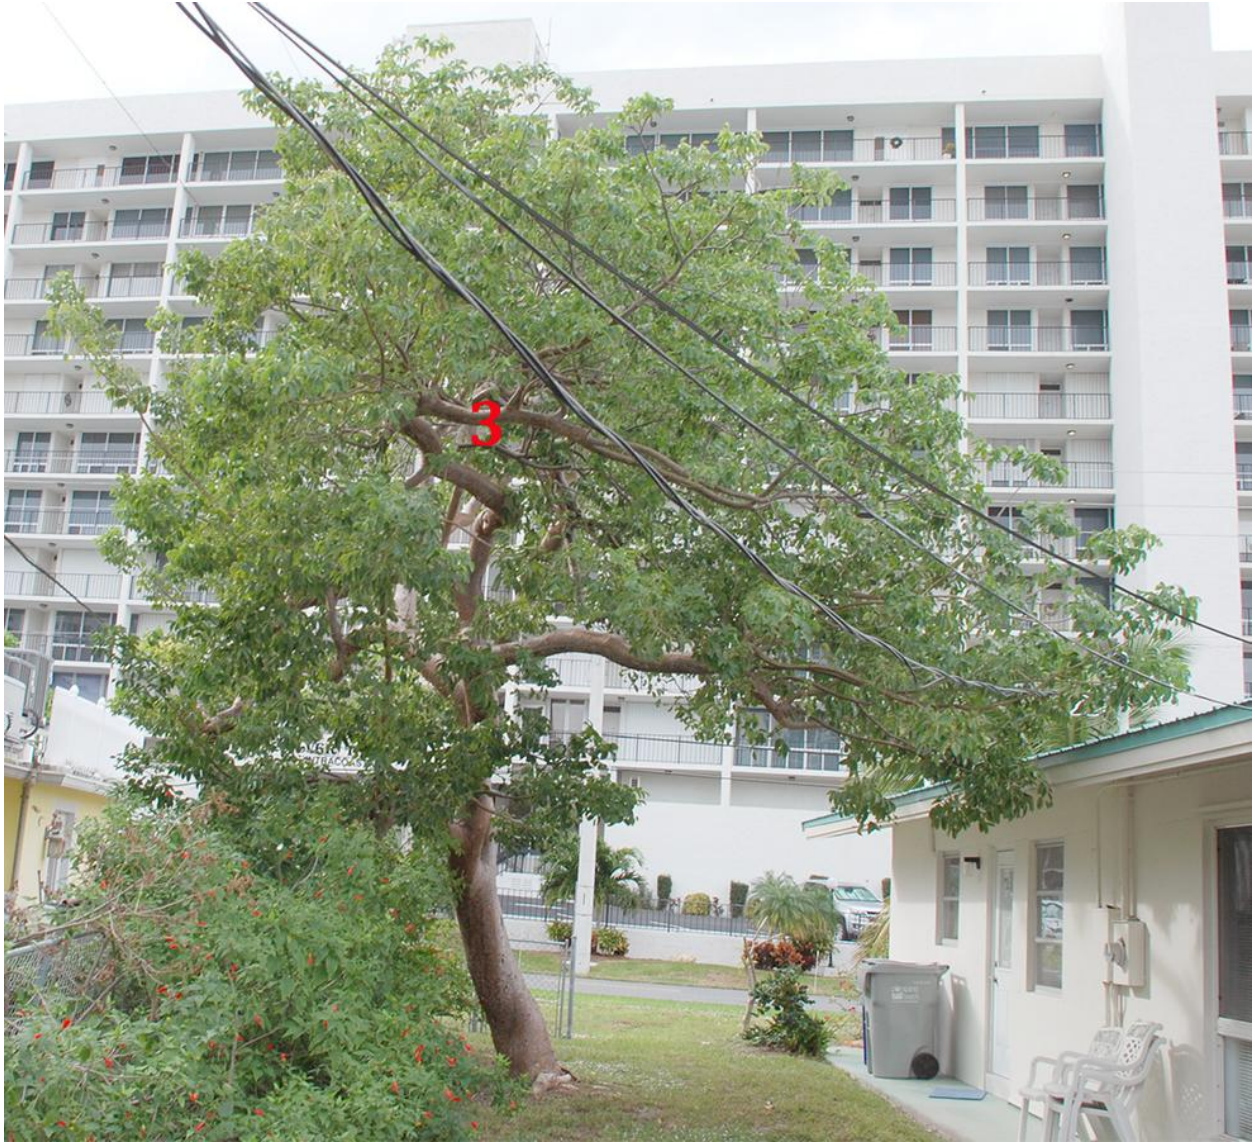
Photo 3 above is tree 3 viewed from the east. Note the powerlines in the canopy.

Any trees to remain onsite or in the right-of-way should have their canopies cleared of dead wood and hazardous branches by an ISA Certified Arborist. Any work near power lines must be done by an arborist qualified to work near energized power lines.

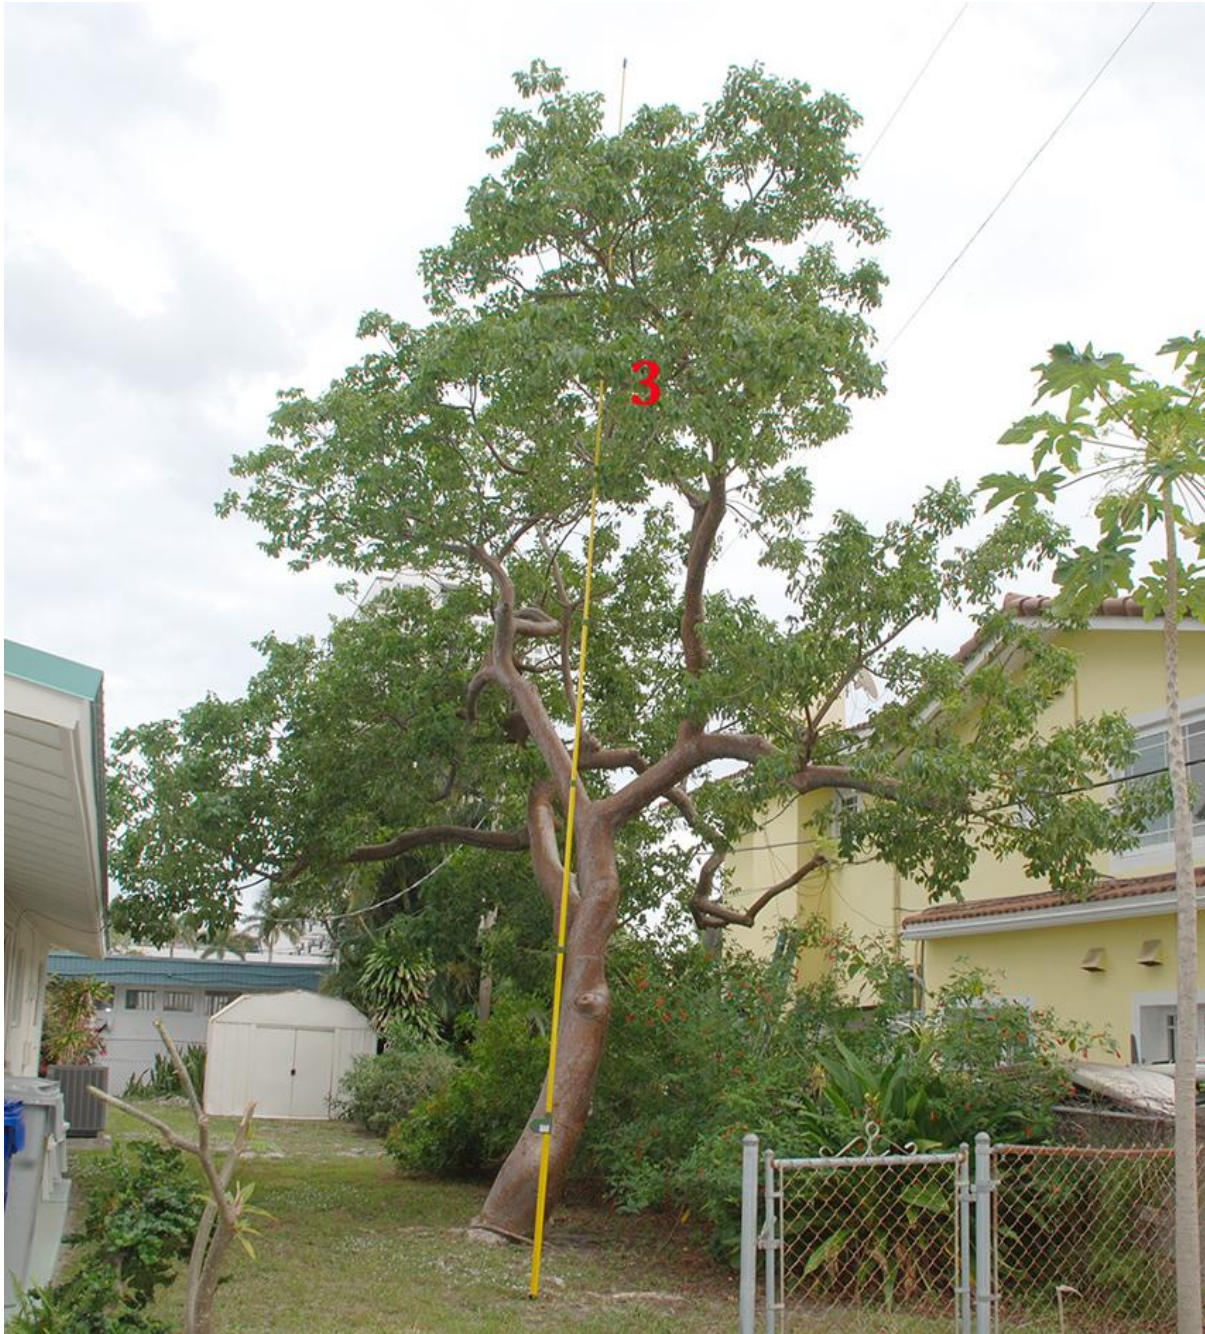
Photo 4 above is tree 3 viewed from the west. Note the powerlines in the canopy.

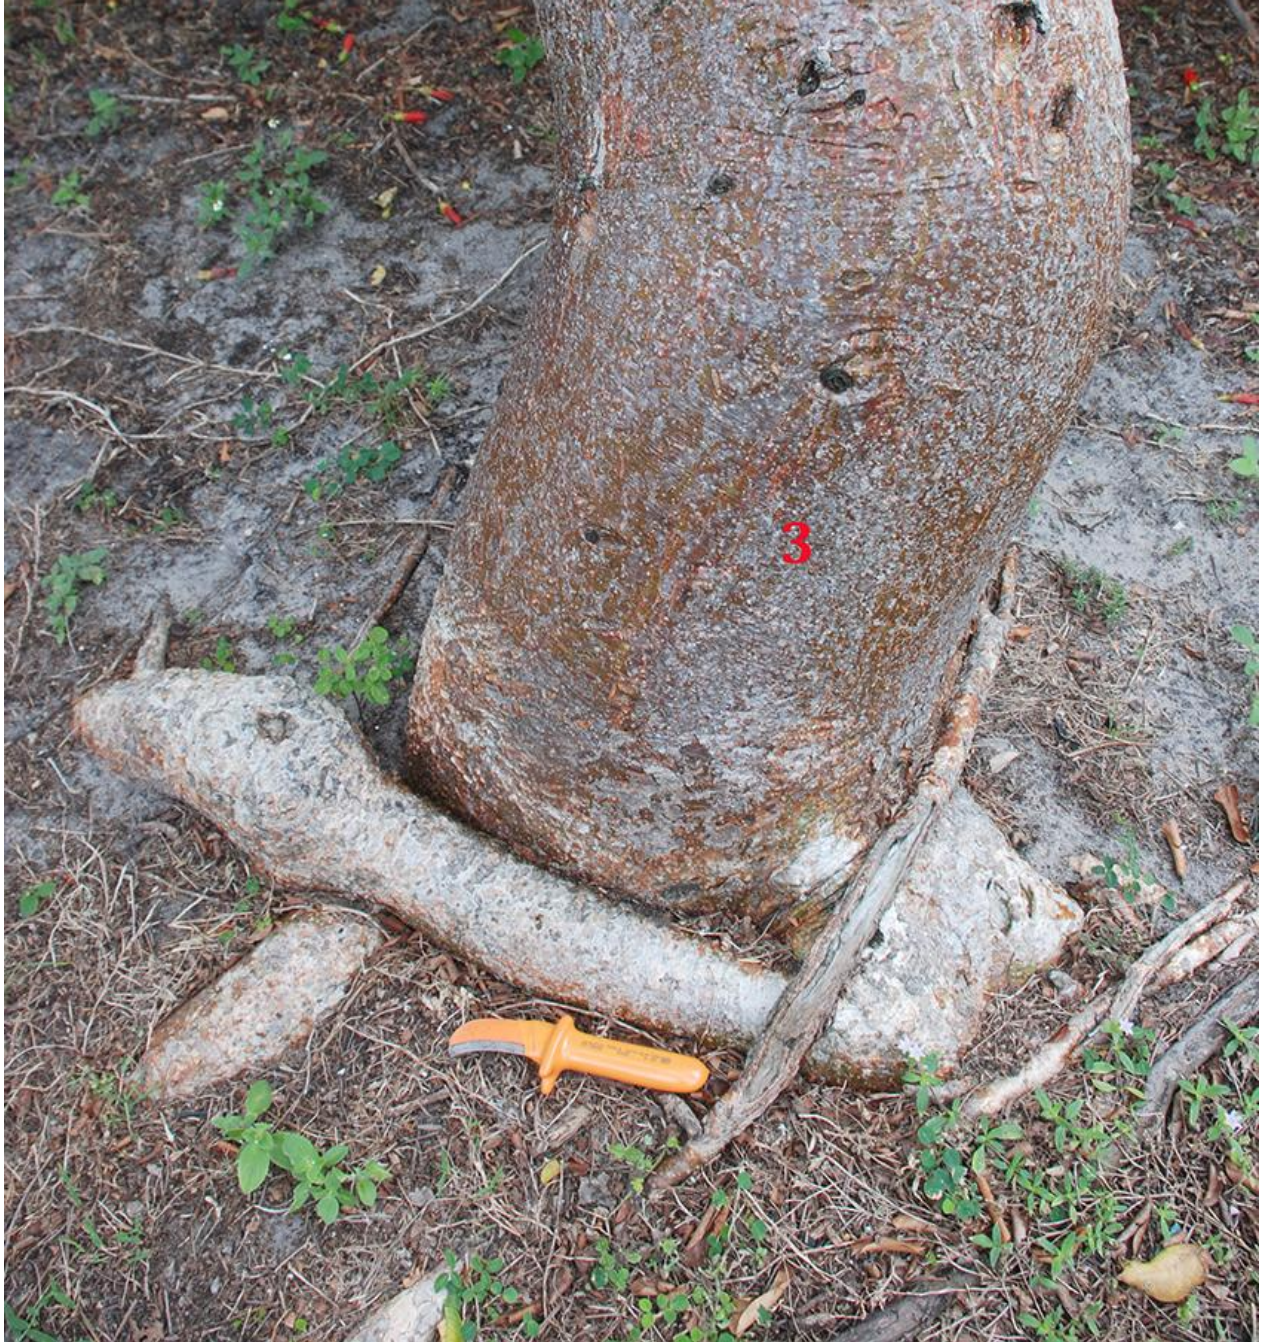
Photo 5 above is the north side of the trunk and root collar of tree 3 showing girdling roots. The orange knife is 7 inches in length.

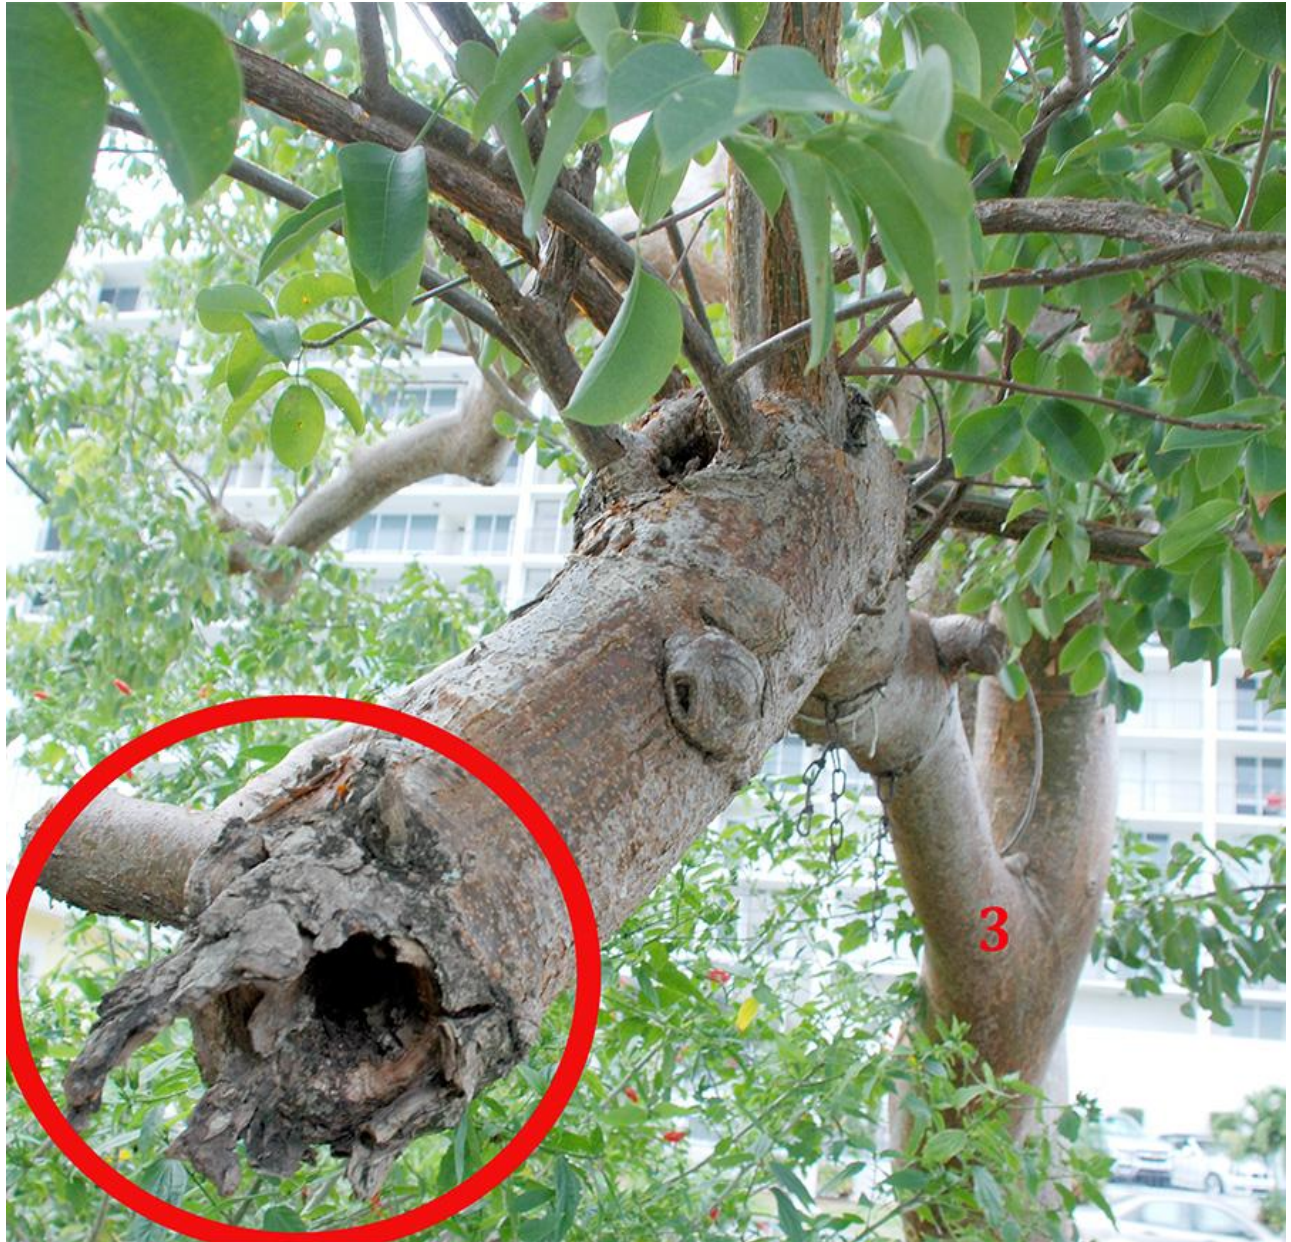
Photo 6 above is the lowest scaffold branch on the east side of tree 3 showing significant signs of decay in the circled area.

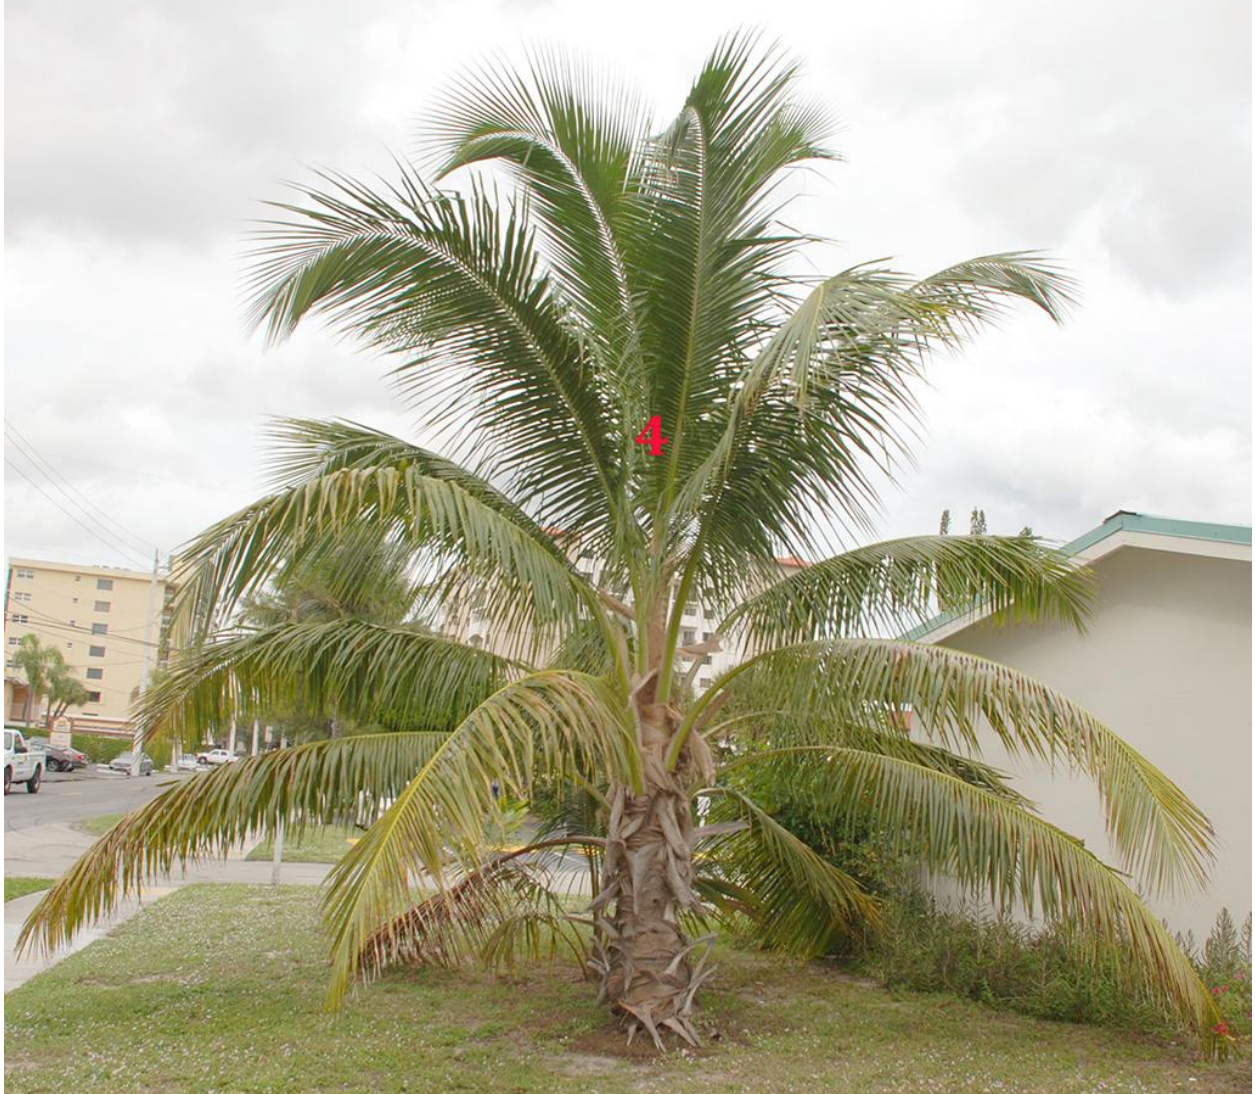
Photo 7 above is palm 4 viewed from the south.

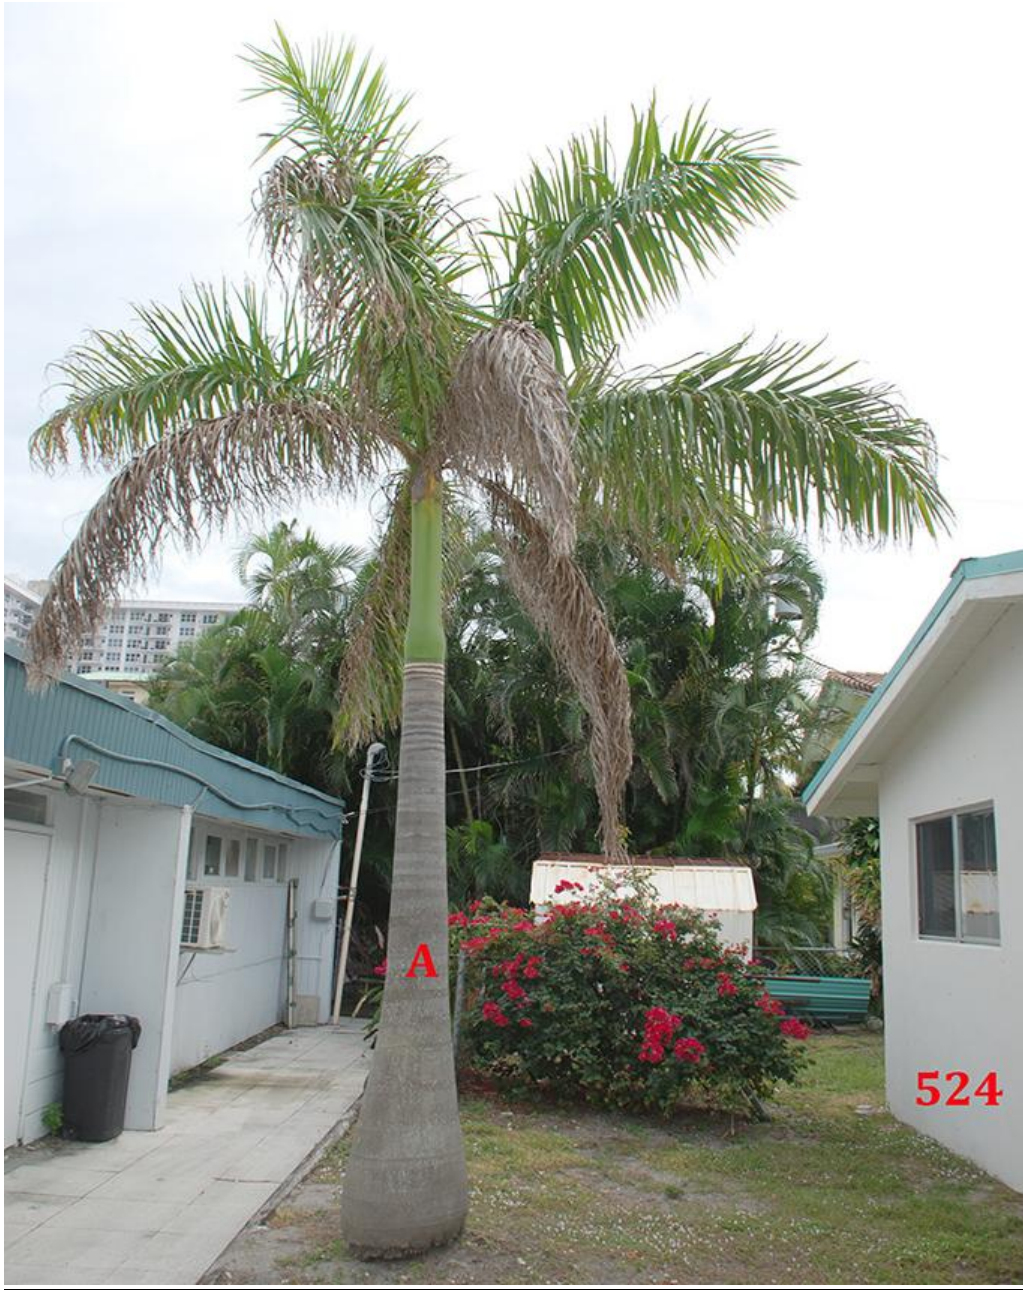
Photo 8 above is palm A which may be entirely on the adjacent property to the east.
