July 18, 2018

RE: Oldcastle Coastal Facility – 1200 NW 18th St., Pompano Beach, CPTED/Security Public Safety Plan

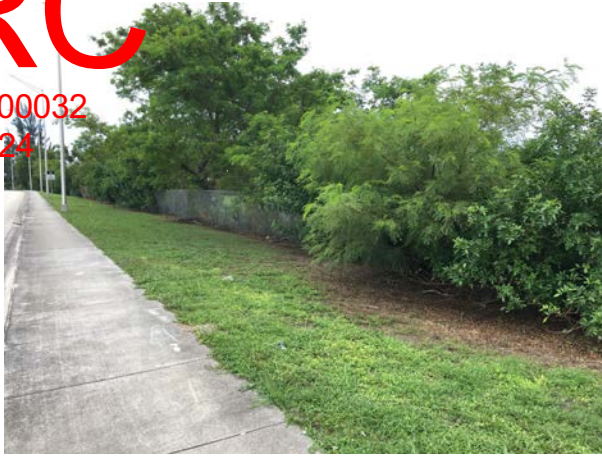
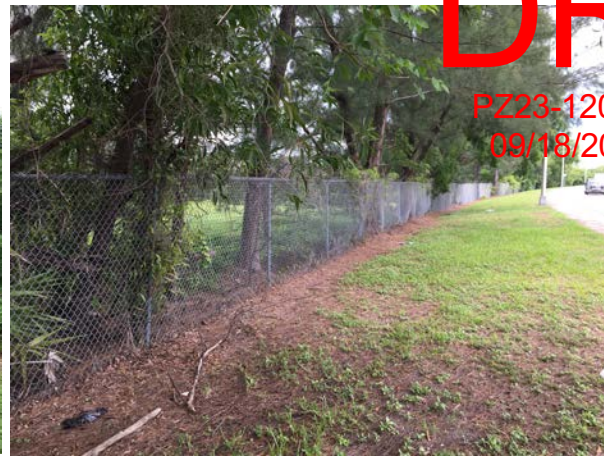
The west boundary on Andrews Avenue is chain link fencing and overgrown shrubs and non-native Australian Pine.

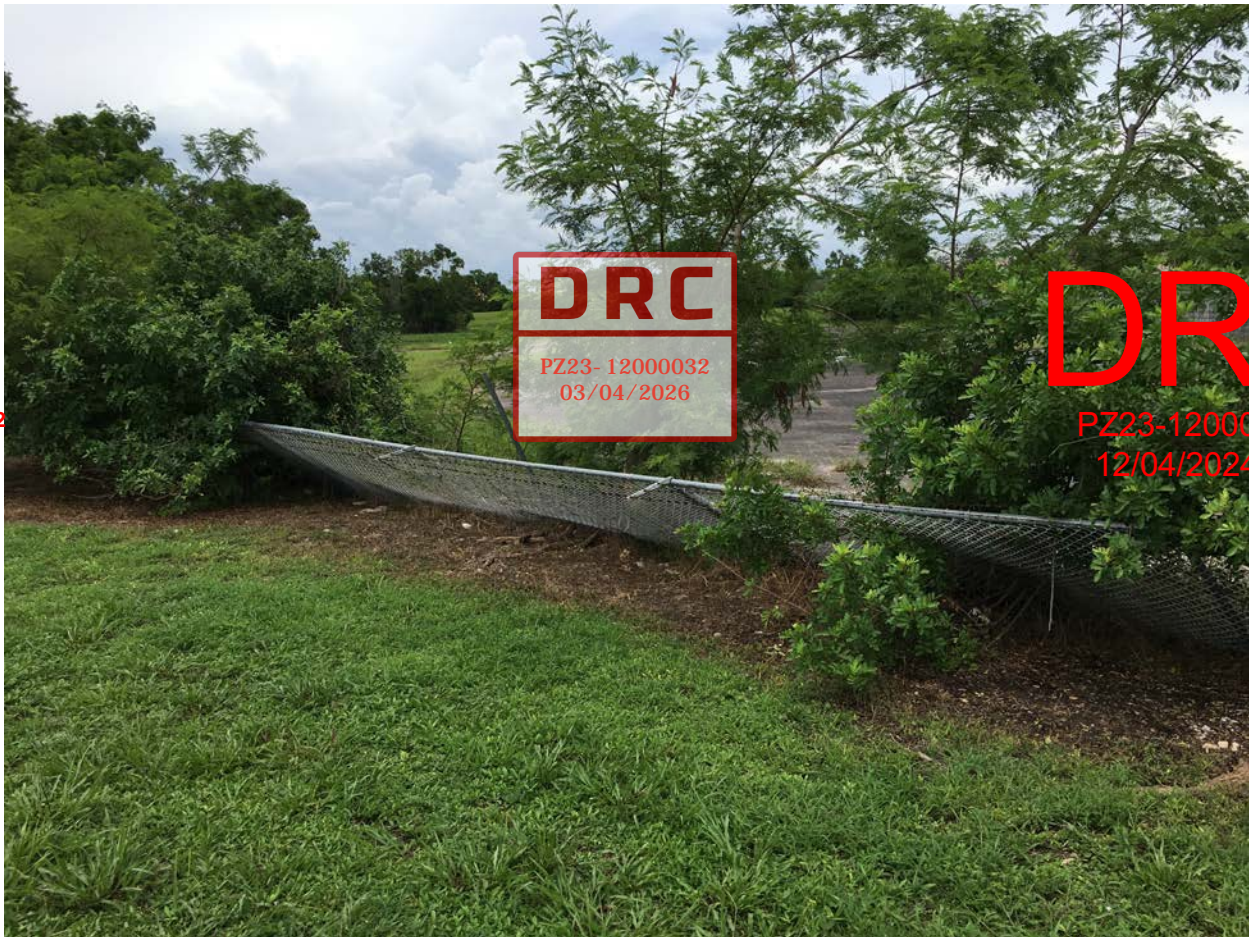
The West Boundary has sections of the chain link fence that are damaged and lying down.

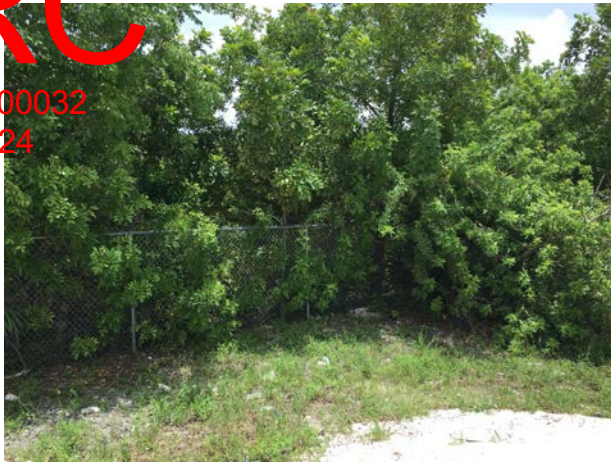
The East boundary is six-foot chain link with overgrown shrub.

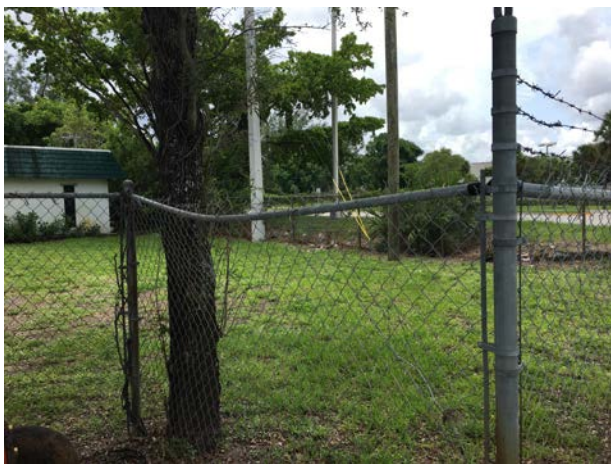
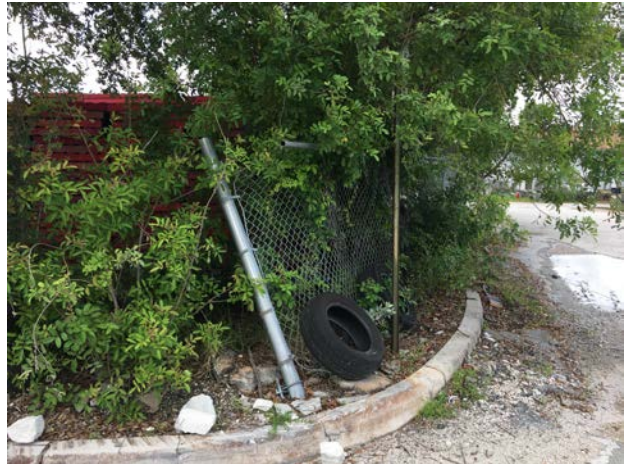
The north boundary fencing is heavily damaged.

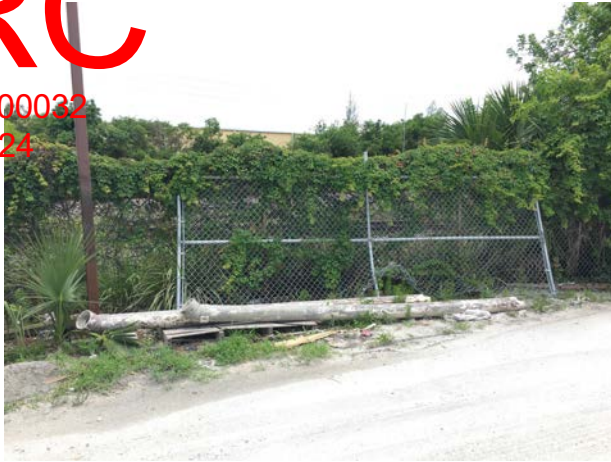
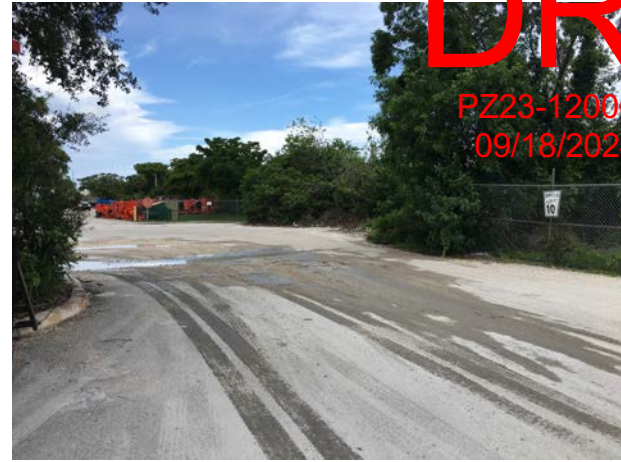
The northeast gate has been knocked off the tracks and lays against the east perimeter fence. The open access allows trucks with aggregate product to enter in the site, but also has no barriers to keep trespassers out.

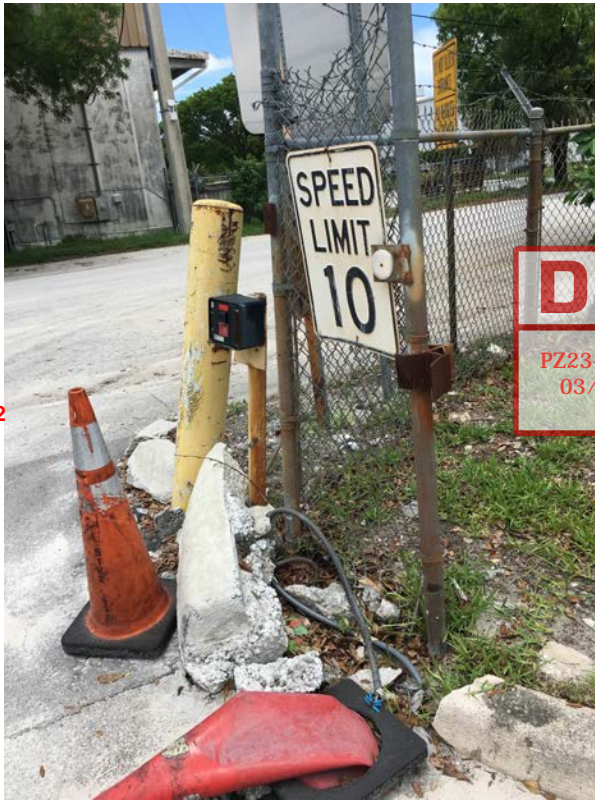
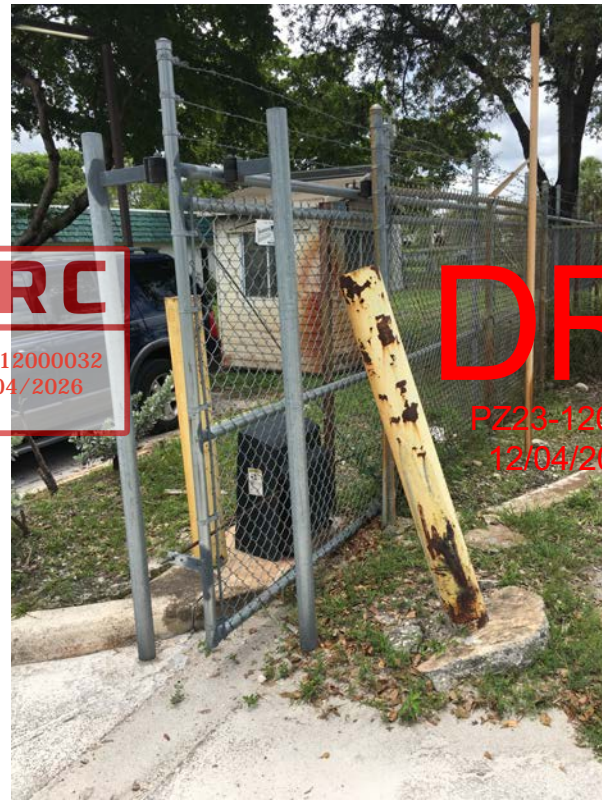
The Northwest gate is the primary entrance for administration, employee vehicles. The gate is non-functional and is in disrepair.

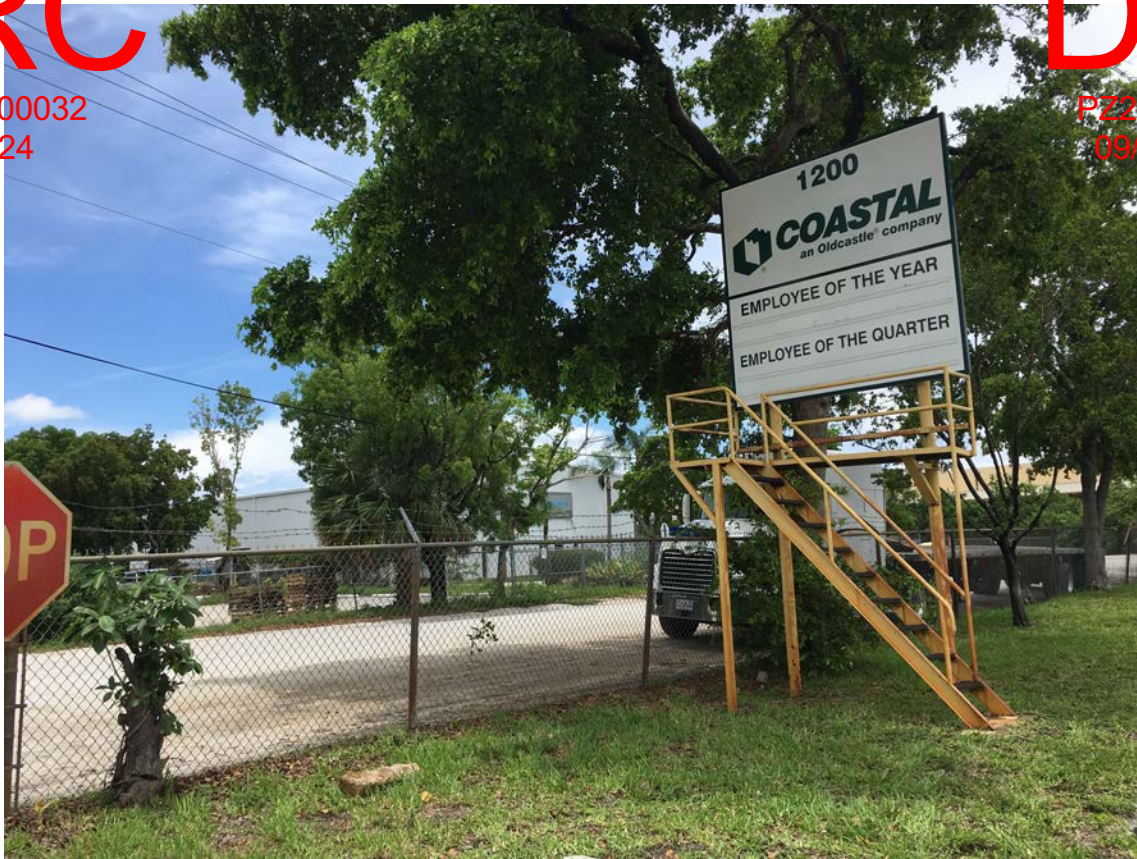
The north boundary on NW 18th Street has the marquee sign for the plant. It is difficult to see from the main road, Andrews Avenue.

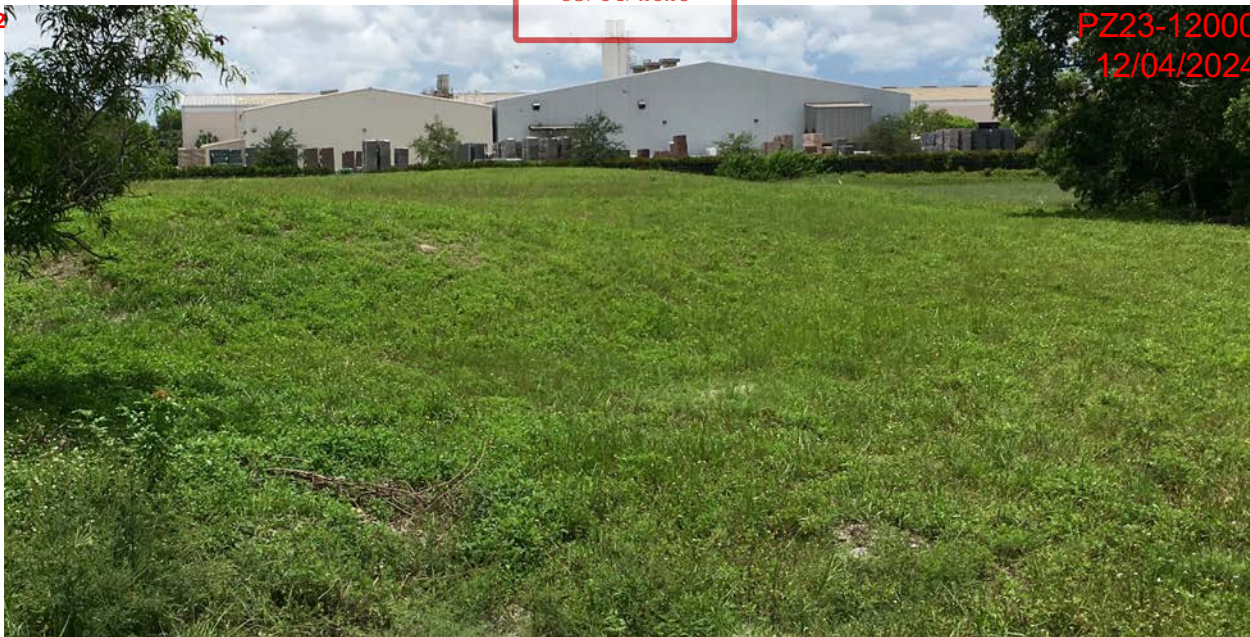
The South boundary is open real estate between the Bonsal Plant and the Oldcastle Distribution Center.

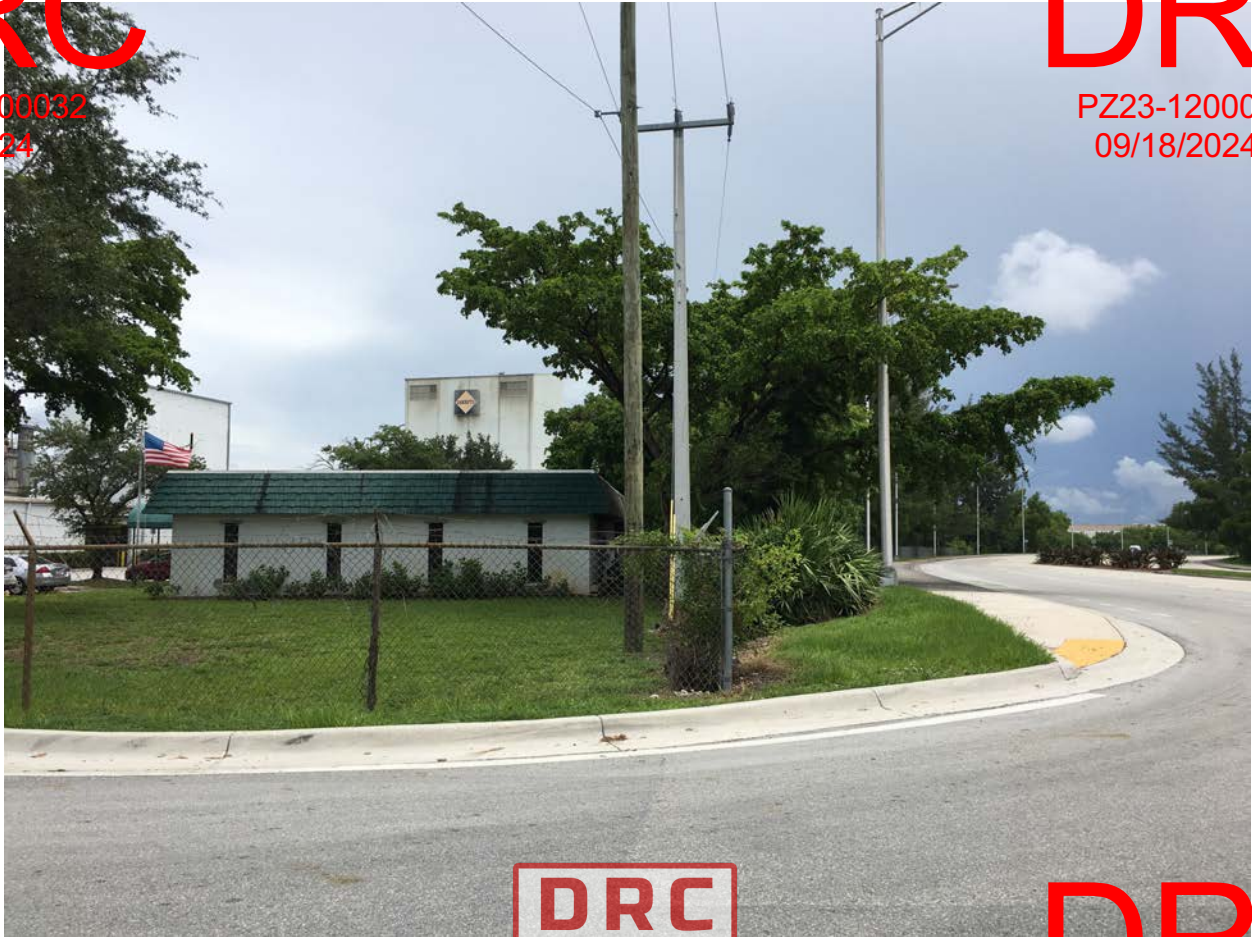
There are no controls for vehicles once trucks turn on 18^h Street. There are no barriers controlling access to the parking lot and the north side.

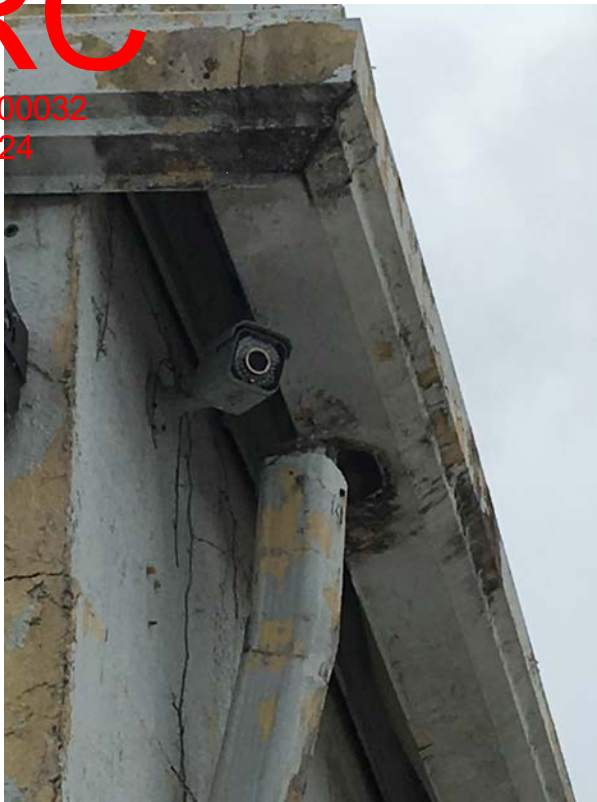
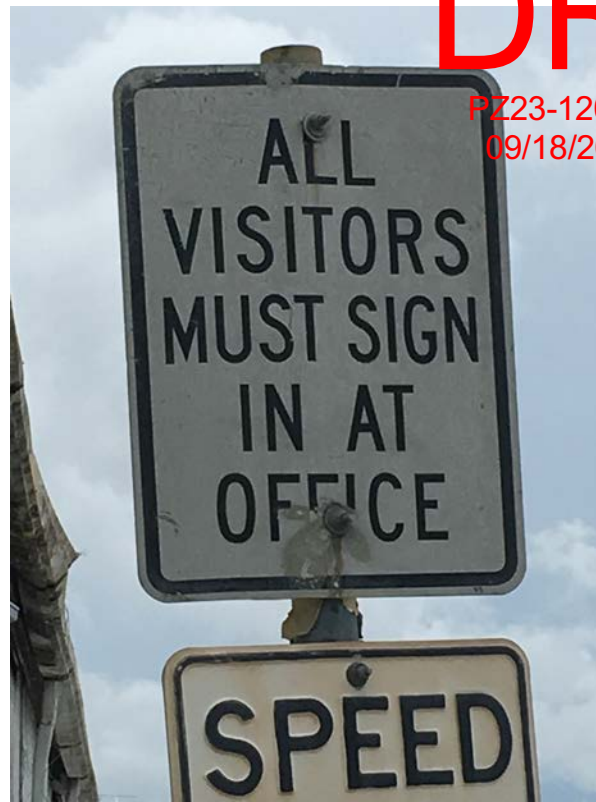
Natural surveillance of the north parking lot and northwest vehicle entrance is achievable from the windows of the administrative offices if staff is present. There is no mechanical surveillance being used on the property, on the site or inside the plant or administrative spaces. While remnants of an old CCTV system were there, it is not functional. Access to the site are not controlled by gates because of the high volume of truck traffic daily, so to prevent theft, vandalism, pilferage, or illegal dumping, vehicles and persons entering the site should be under mechanical surveillance.

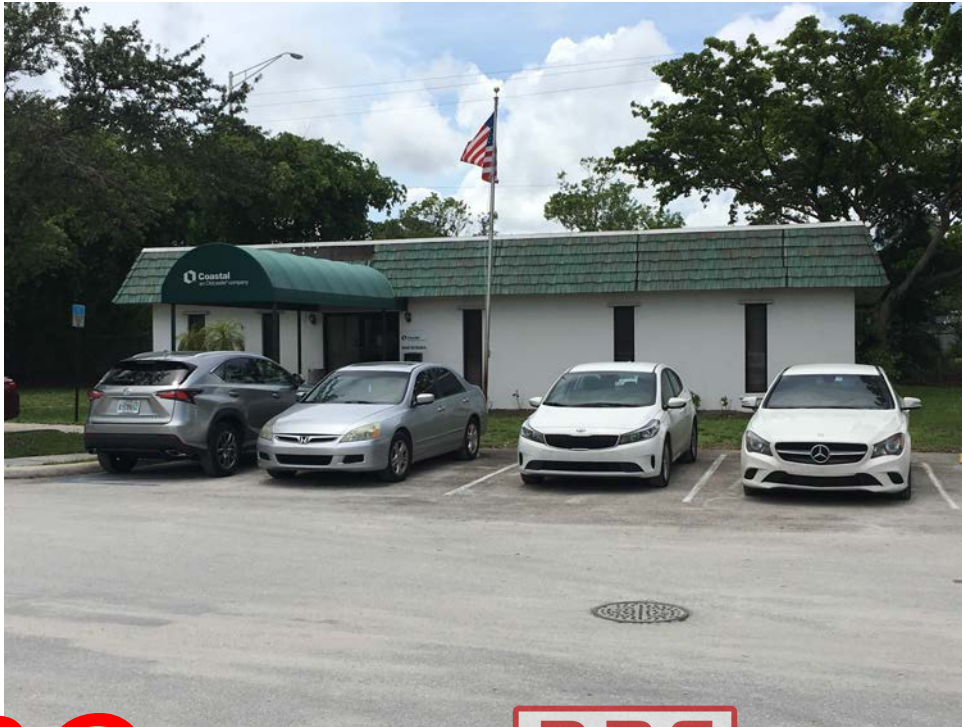
The business office entrance faces east and the north side of the site.

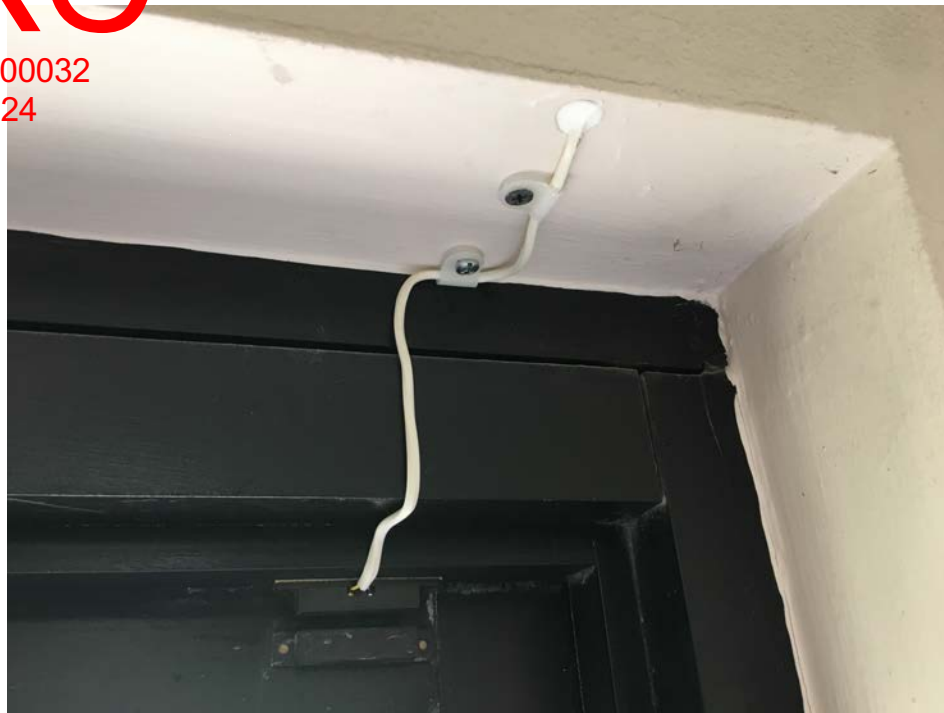
The office has a make shift security system that is monitored but needs to be updated. There is no exterior light along the east side of the business office.

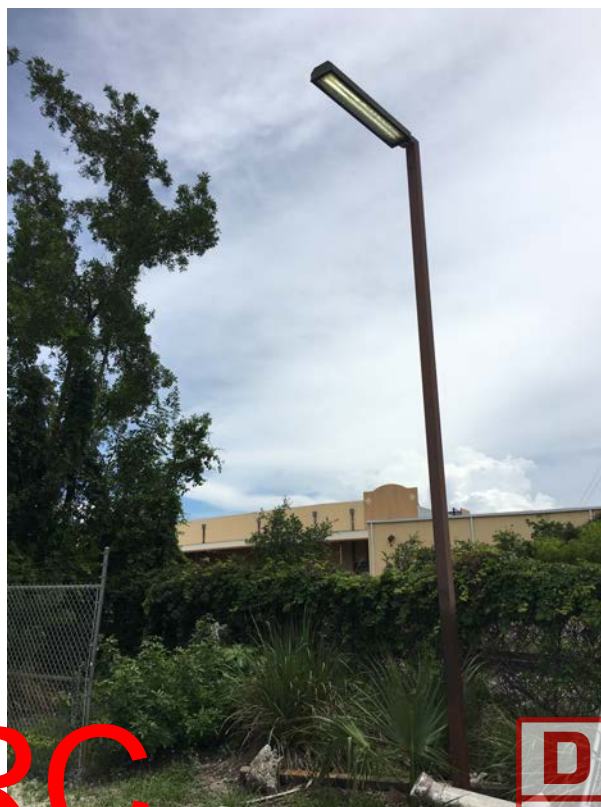
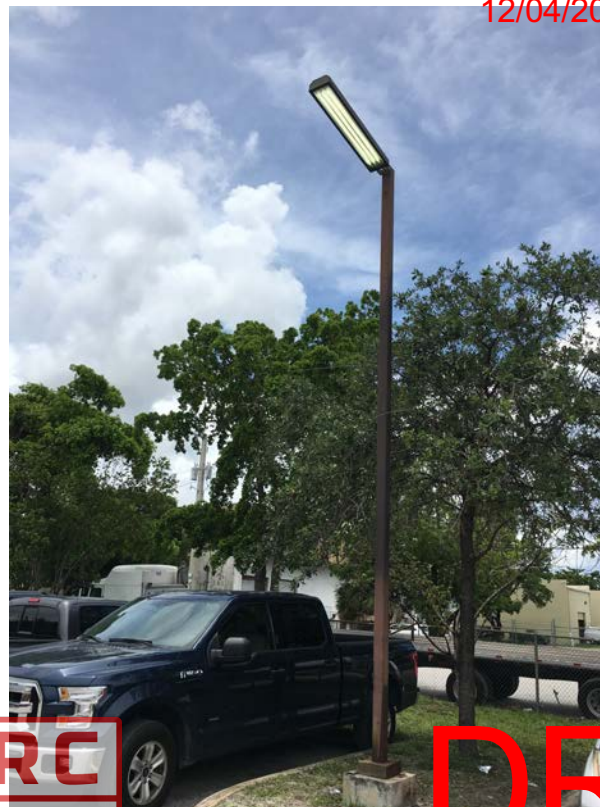
The pole lighting actually uses florescent tubes, and was turned on during daylight hours.

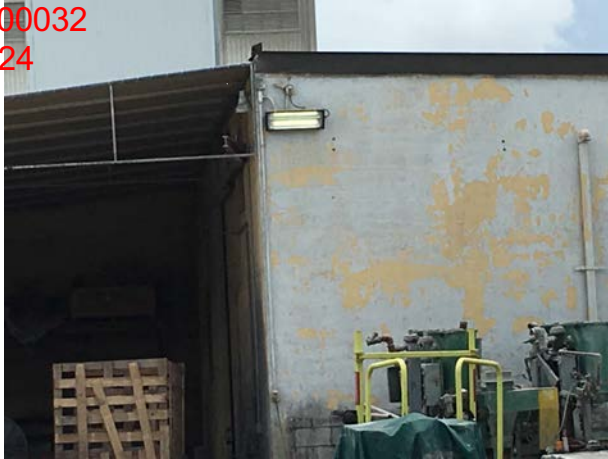
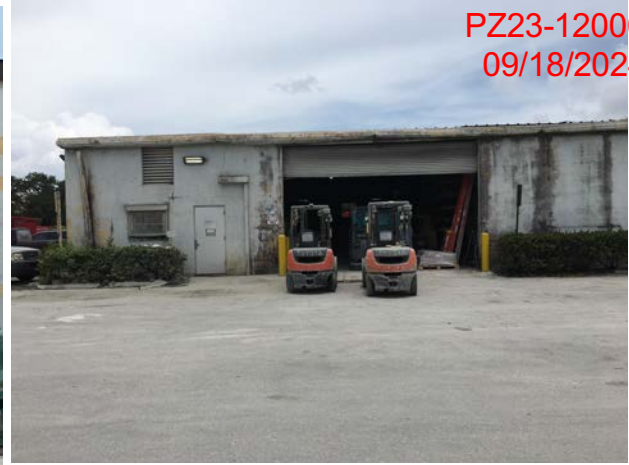
The exterior building lighting is florescent tubes, which are inadequate to properly light the grounds.

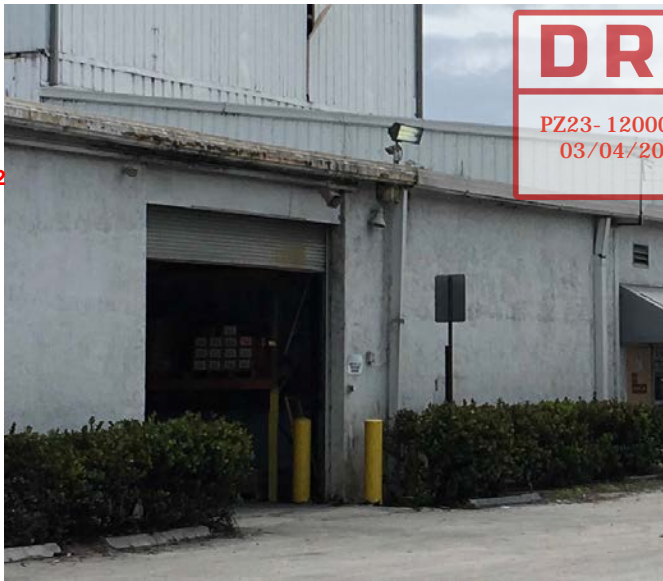
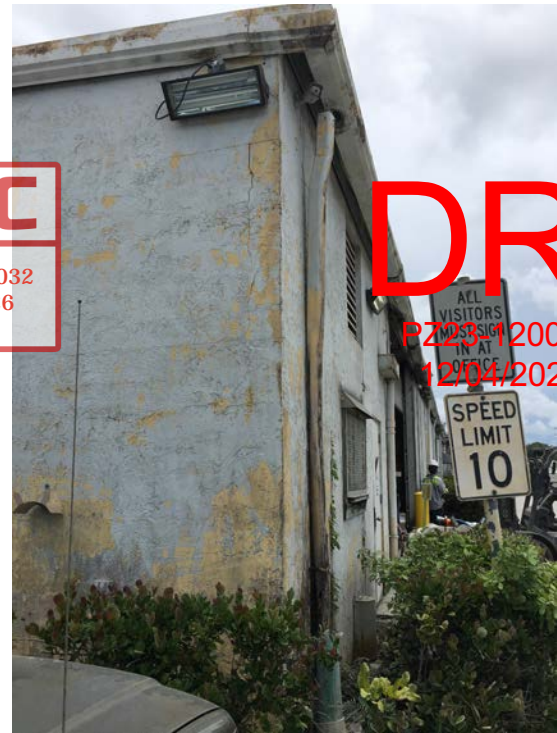
The exterior lighting using florescent tubes as the light source was inefficient and not effective to evenly light the site and building exterior.

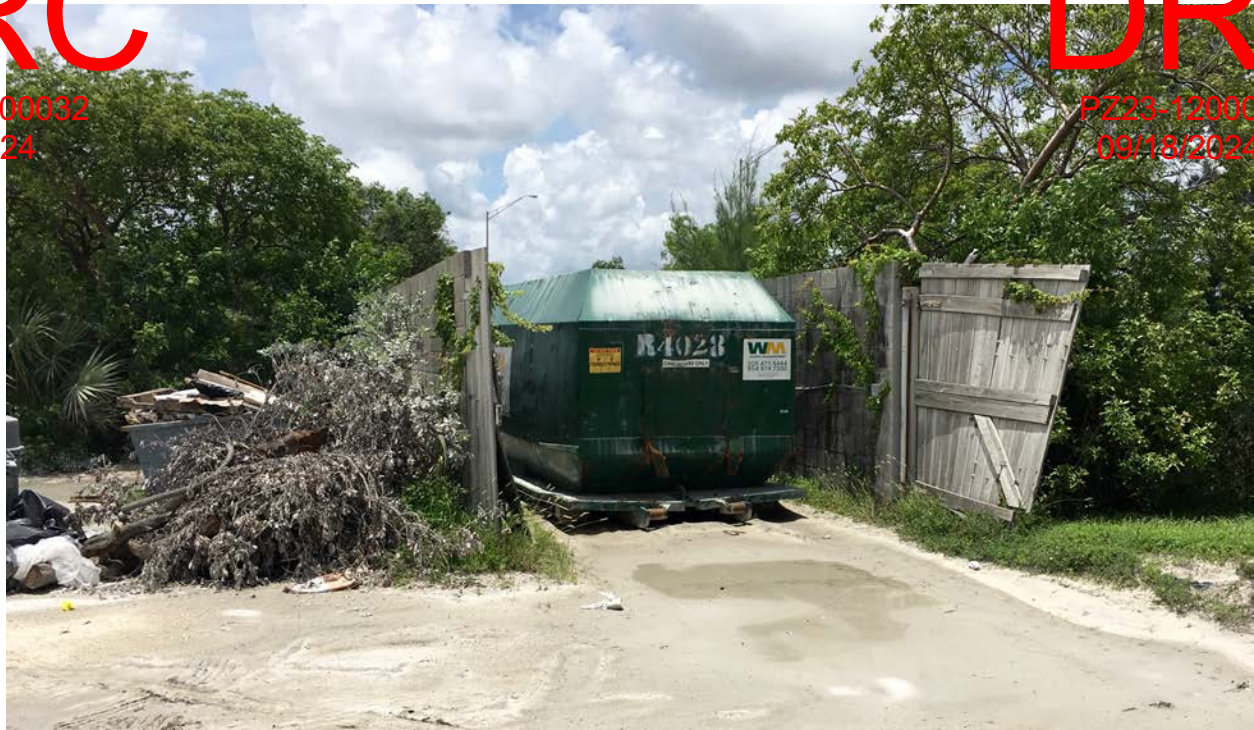
The exterior dumpster area is located in the south part of the yard area across from the Plant. The screening needs to be in working order, and lockable, and the area cleaned up. The dumpster is not set down on a concrete pad. There is no drainage capacity. The wooden gates and shielding are damaged and does not close properly. There is no locking capability to prevent outsiders from outside persons dumping trash.

The new proposed dumpster area should be on a concrete pad that can withstand picking up and dropping down by a garbage truck. There should be bollards/bumpers to prevent the truck from hitting the dumpster enclosure. The dumpster should be shielded on three sides with a screening that complies with zoning regulations. Swing gates that are locked should be used to protect the dumpster from illegal or unwanted dumpster diving or dumping. The front screening should be raised so that a person in the dumpster area can be observed from the outside. The gates should be lockable so they can be secured when not being used. If there is any trespassing in the exterior site areas, the person will stand out and be observed and challenged.

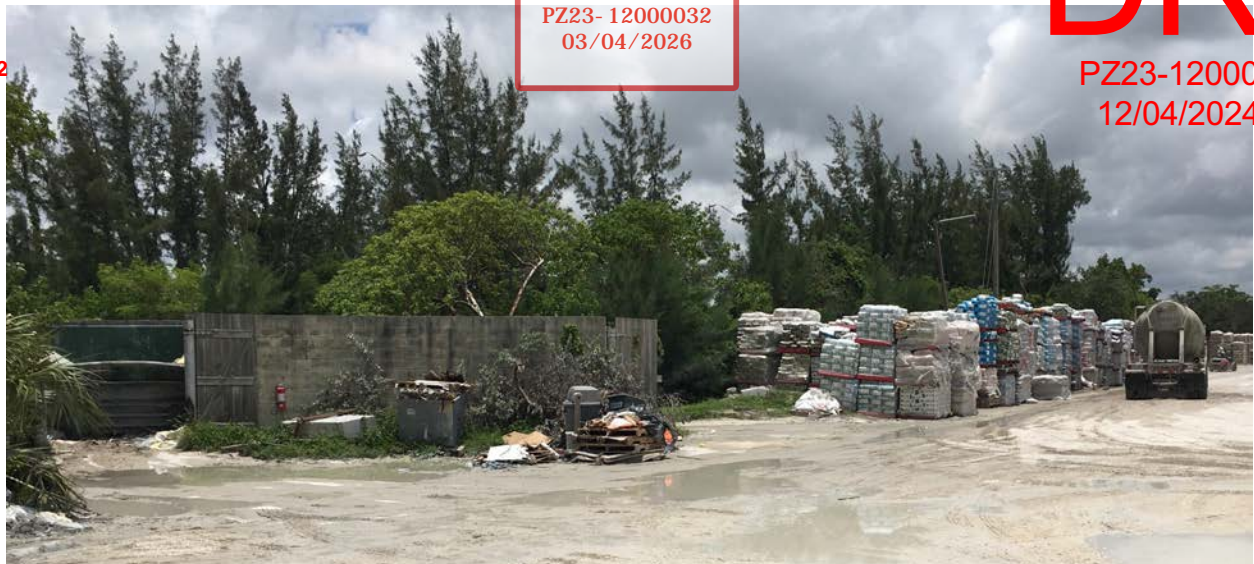
There appears to be some dumping just adjacent to the dumpster. In the new site plan the dumpster will be designed to have compliant surrounding shielding and be secured.

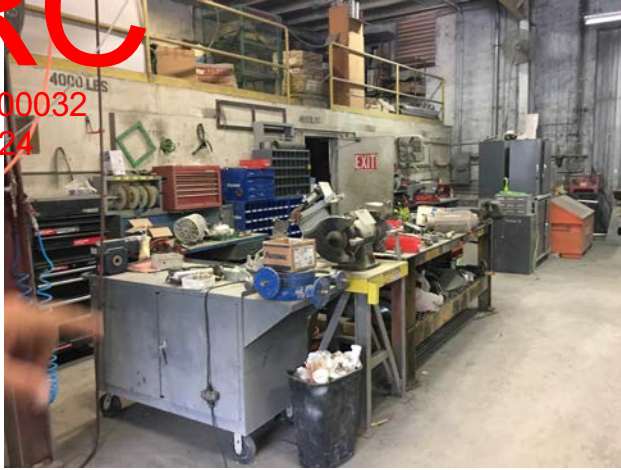
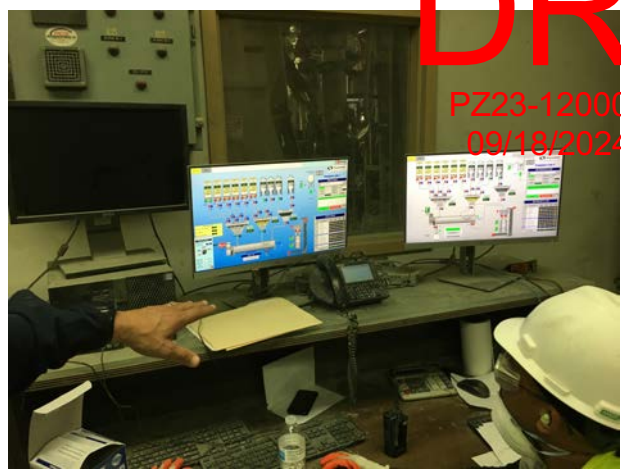
Tools and equipment is an attractive asset that need to be protected.

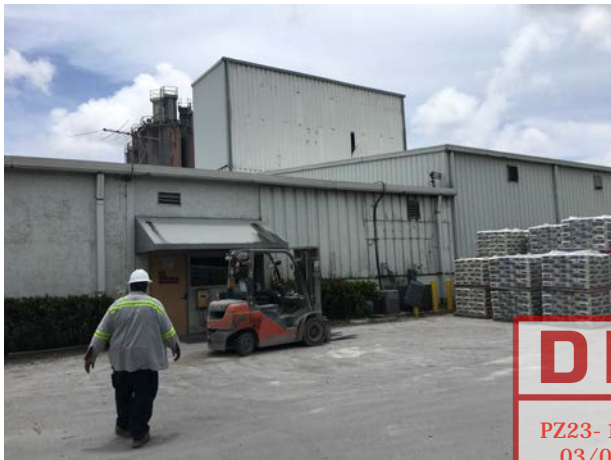
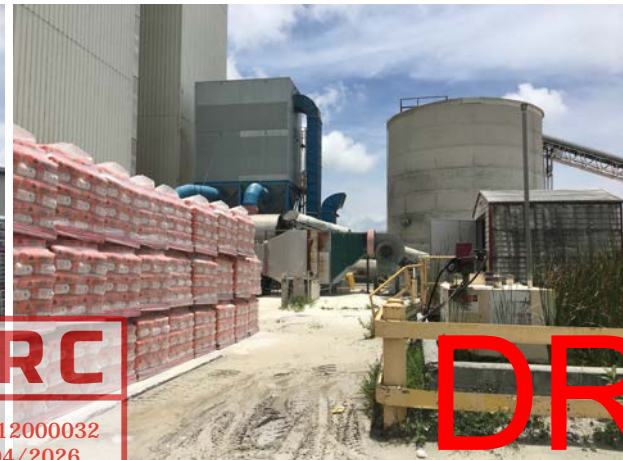
Forklifts and product stacked are assets that need to be protected.

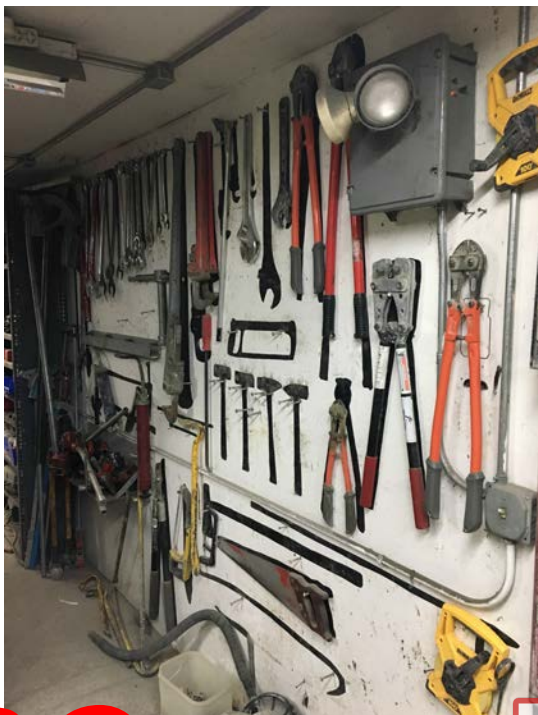
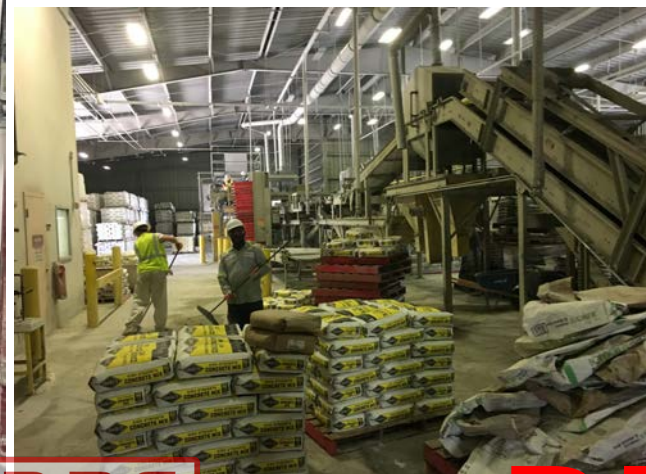
Tools and machinery must be protected from loss, theft, pilferage, or vandalism.
