February 9, 2025
1220 SW 12th Ave
Pompano Beach, FL

An Arborist Report/Tree disposition was conducted for the above referenced property. During our inspection, four (4) specimen size trees were located on the property. Below is a detailed report of the one tree that are located on the property.

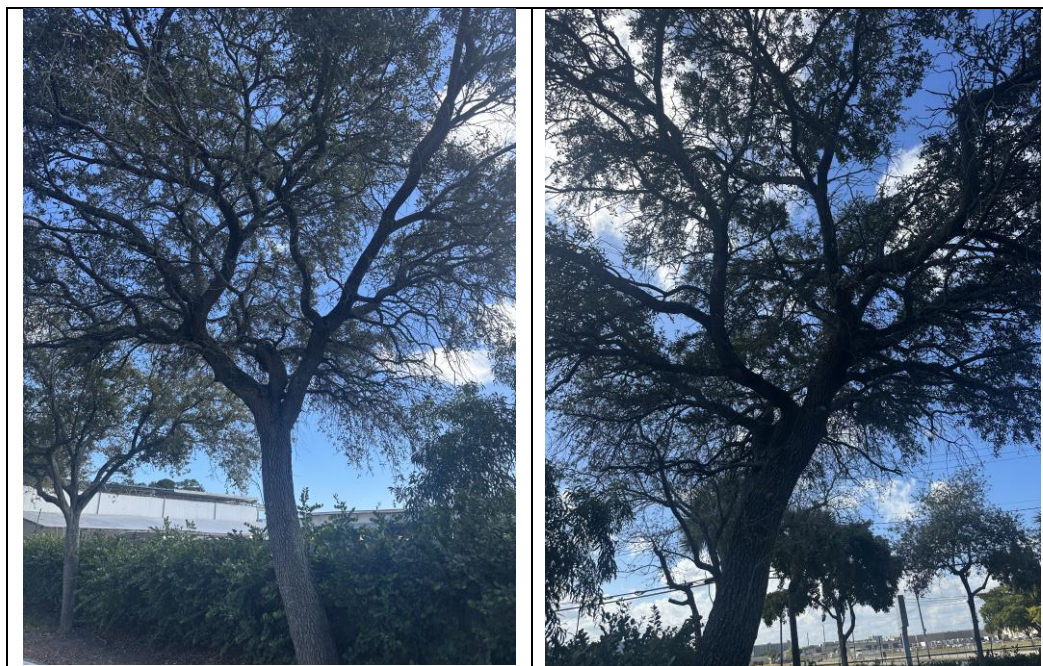
Tree #3 Live Oak (*Quercus Virginiana*) DBH 19", HT 30', SP 30', Cond 56% Appraisal \$3,531.84

This tree is located on the South side of the property. This tree has several codominant stems. Many dead, broken and fused branches could be seen throughout the trees canopy. These branches will create weak attachments and susceptible to snapping or breaking off. Some of these leaders are growing with a twist some structural pruning is required. Structural pruning of the canopy will help with weight distribution and better canopy structure. Tree also is growing with a lean.

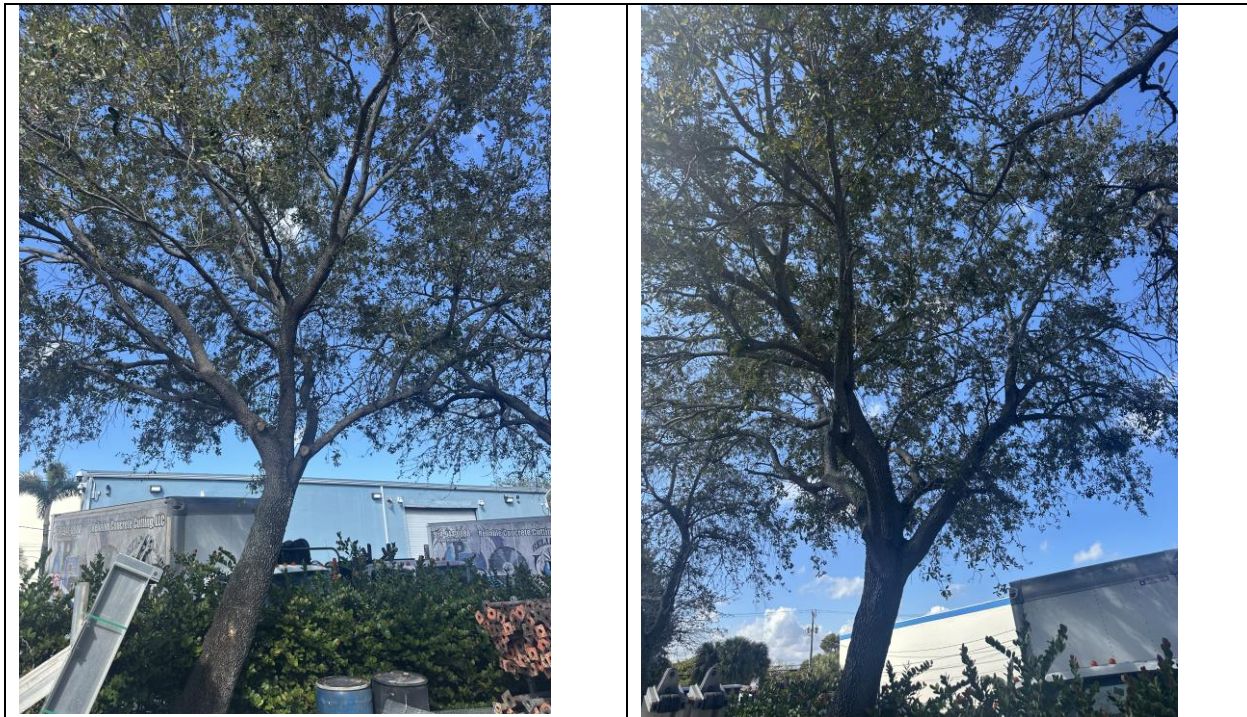
Tree #22 Live Oak (*Quercus Virginiana*) DBH 18", HT 30', SP 31', Cond 62% Appraisal \$3,704.45

This tree is located on the north side of the property. This tree is growing with a lean and has codominant stems. Some dead, broken and fused branches could be seen throughout the trees canopy. These branches will create weak attachments and susceptible to snapping or breaking off. Structural pruning of this canopy will help with weight distribution and better canopy structure. Materials are being stored around the base of the tree; removal of these materials is recommended to reduce impact to root zone.

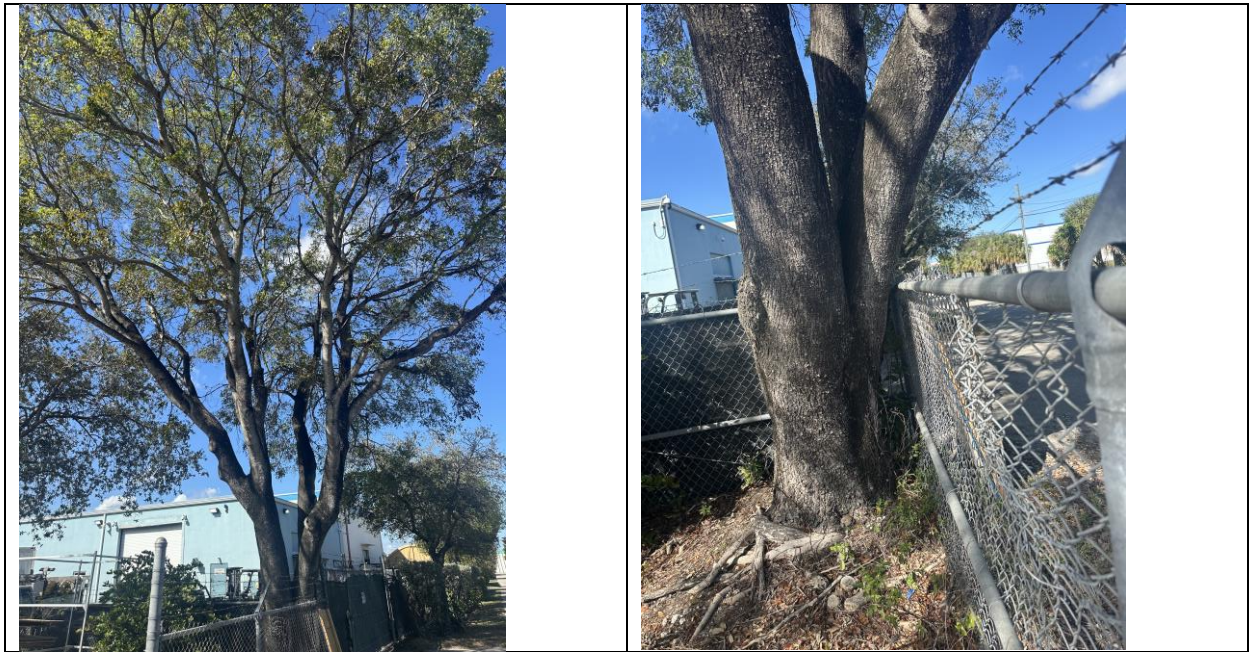
Tree #26 Mahogany (*Swietenia mahagoni*) DBH 29", HT 40', SP 34', Cond 50% Appraisal \$4,263

This tree is located on the North east side of the property. This tree has codominant stems with included bark. Bark inclusions can result in cracked trunks and broken trees. One of the Stems is pushing agents the fence. Girdling roots were also observed, Girdling roots are roots that wrap around a tree's trunk, restricting the flow of water and nutrients. The trees shows signs of stress with die back the tips and many dead, broken branches being visible throughout the trees canopy.

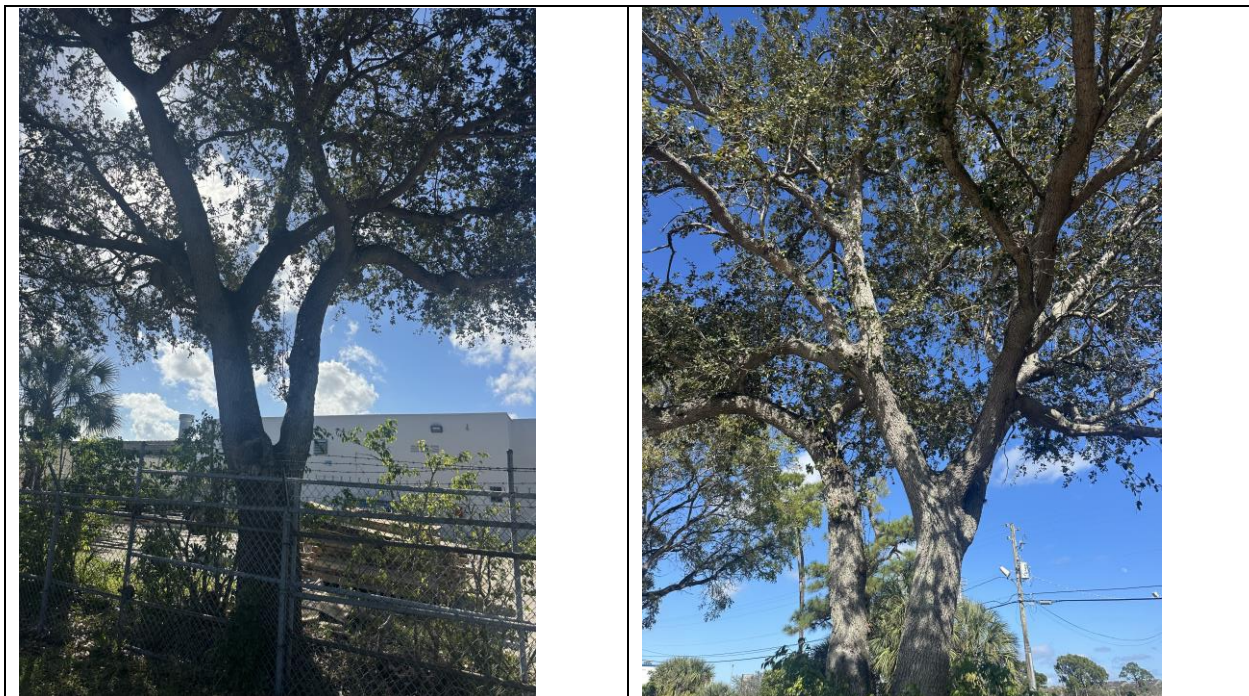
Tree #27 Live Oak (*Quercus Virginiana*) DBH 26", HT 40', SP33', Cond 60% Appraisal \$5,178.26
 This tree is located on the east side of the property. Trees foot flare is pushing agents the fence causing the fence to bow out. Some dead, and decayed branches could be seen throughout the trees canopy. an old pruning wound could be seen on the east side of the trunk where the tree appears to have properly compartmentalized.
