Enclosed please find the updated Certified Arborist Report/Tree Assessment for the property located at 200 N. Federal Hwy. in Pompano Beach, FL conducted on November 16, 2022.

ARBORIST REPORT 200 N. Federal Hwy. Pompano Beach, Fl 33062

Assignment/Overview

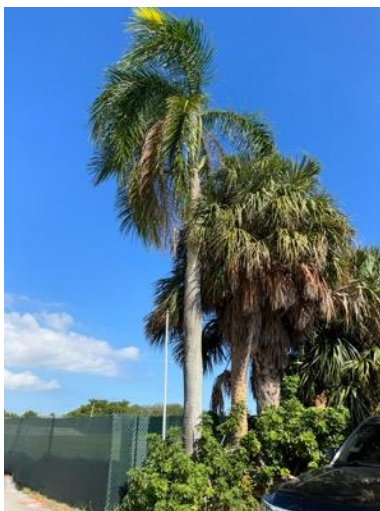
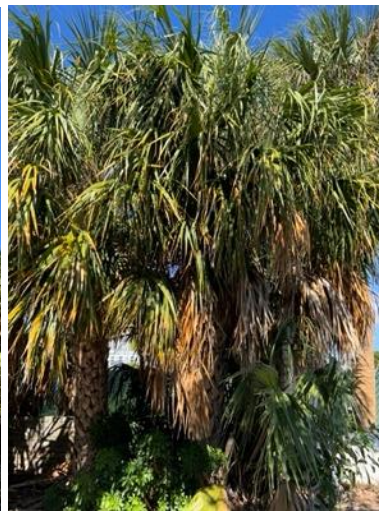
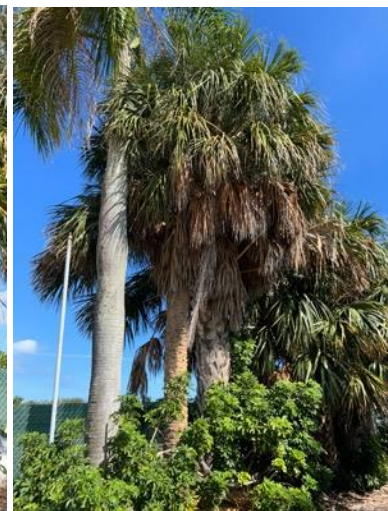
Tree #1 – *Roystonea regia*, Royal Palm – this tree is located in the northwest corner of the property adjacent to the parking lot and next to the ROW. It is crowded with minor chlorosis and a slightly undersized canopy. Overall, it is in fair condition and is proposed for removal.

Tree #2 – *Sabal palmetto*, Sabal Palm – this tree is located directly east of Tree #1. It is very crowded with a pronounced curve in the upper trunk due to the crowded conditions. It is in fair condition and is proposed for removal.

Tree #3 – *Sabal palmetto*, Sabal Palm – this tree is located directly east of Tree #2 on the northeast side of the property. It is very crowded and has live fronds only on one side of the trunk due to severe crowding. It is in poor condition and is proposed for removal.

Tree #4 – *Sabal palmetto*, Sabal Palm – this tree is located directly east of Tree #3. It is very crowded and overgrown but otherwise is in fair condition. This tree is proposed for removal.

Tree #5 – *Sabal palmetto*, Sabal Palm – this tree is located directly east of Tree #4. It is very crowded and overgrown but otherwise is in fair condition. It is proposed for removal.

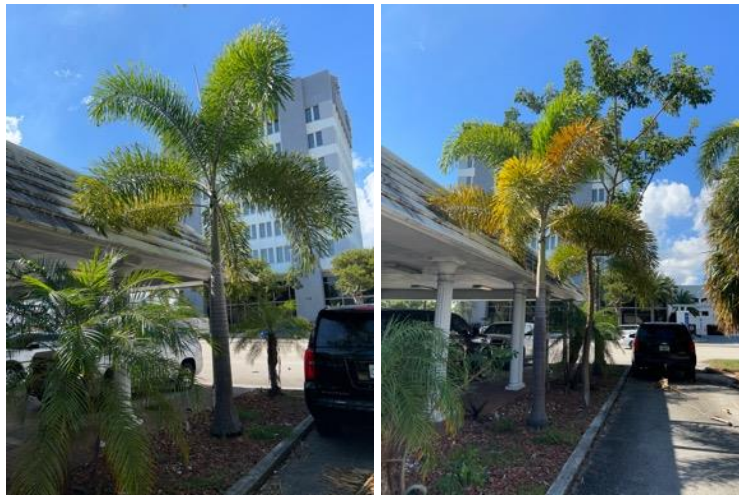
Tree #6 – *Wodyetia bifurcata*, Foxtail Palm – this tree is located in a small planting island on the north side of a covered valet area. It has minor chlorosis and is slightly crowded but otherwise is in fair condition with no significant defects. It is proposed for removal.

Tree #7 – *Wodyetia bifurcata*, Foxtail Palm – this tree is located near the east end of the planting island. It has moderate to severe chlorosis and is in overall moderate condition. This palm is proposed for removal.

Trees #8-10 – *Phoenix roebellini*, Pygmy Date Palm – this refers to 3 Pygmy Date palms located in the planting island with Trees #6-7. They are all under regulation size, so they should not require a permit or mitigation for their removal.

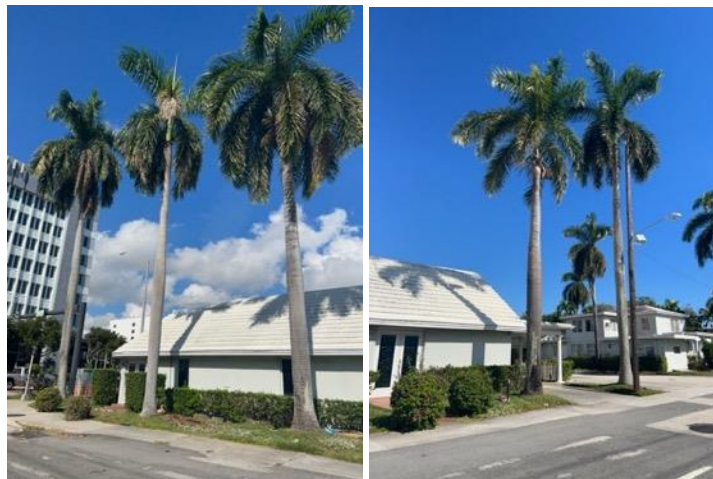
Tree #14 – *Roystonea regia*, Royal Palm – this tree is located on the south side of the property east of Trees #11-13 and just west of the concrete walkway to the covered porch area. It shows signs of minor chlorosis/nutrient deficiency, but otherwise is in good condition with no significant defects. It is proposed for removal.

Tree #15 – *Roystonea regia*, Royal Palm – this tree is located on the south side of the property east of the covered walkway to the covered porch area. It shows signs of very minor nutrient deficiency, but otherwise is in good condition with no significant defects. It is proposed for removal.

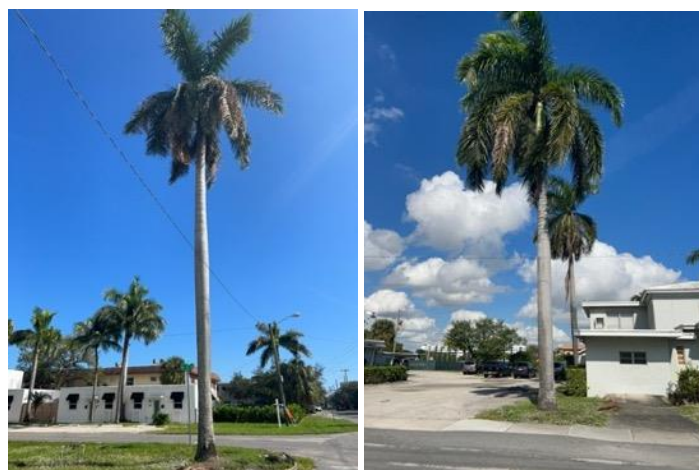
Tree #16 – *Roystonea regia*, Royal Palm – this tree is located near the southeast corner of the property. It shows very minor signs of nutrient deficiency but otherwise is in good condition. It is proposed for removal.

Tree #17 – *Roystonea regia*, Royal Palm – this tree is located on the south side of the property just east of the entrance to the asphalt parking lot. It is in good condition with no significant defects. It is proposed for removal.

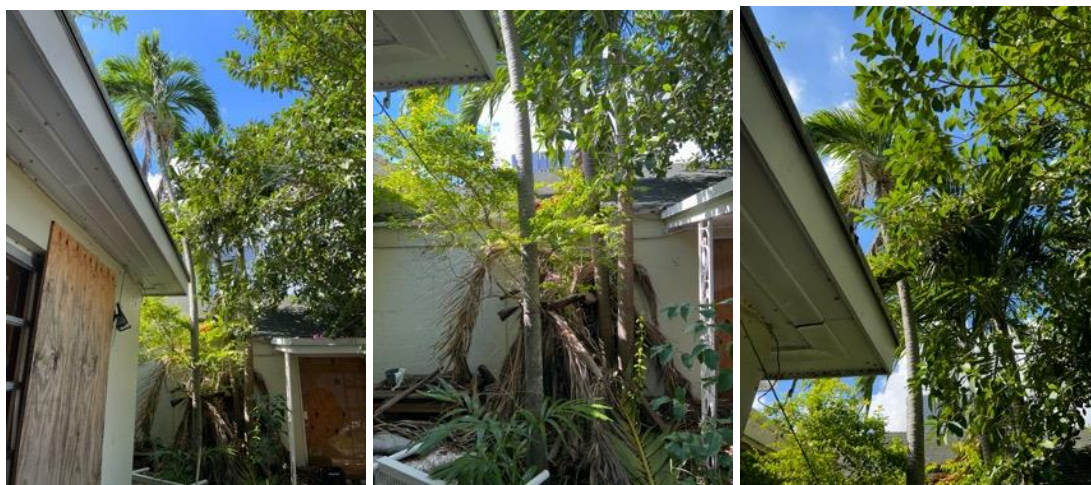
Tree #18 – *Adonidia merrillii*, Christmas Palm – this refers to a cluster of 3 palms located inside of a courtyard area on the east side of the existing back building. They are slightly crowded, but otherwise in fair to good condition. They are proposed for removal.

NOTE: Tree #18 appears to be the same as Tree #11 on the survey; therefore, it has been assigned to this tree which was not included on the survey.

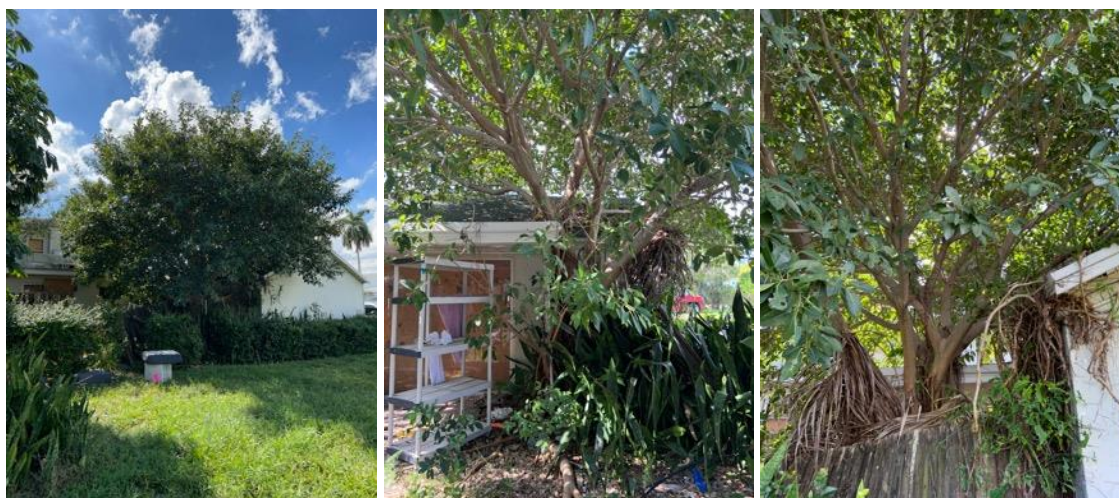
Tree #19 – *Ficus aurea*, Strangler Fig – this tree is located on the northeast side of the existing building on the east side of the property. It is crowded, overgrown, and unmaintained with minor deadwood present, but overall it is in fair condition. This tree is proposed for removal.

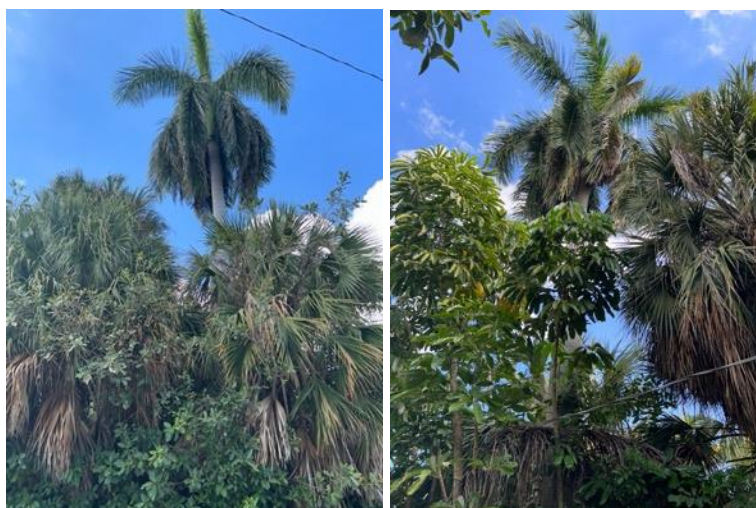
Tree #20 – *Roystonea regia*, Royal Palm – this tree is located in an overgrown cluster of vegetation on the east side of the property. It is very crowded and overgrown and could not be accessed due to its location within a fenced area. It shows signs of very minor nutrient deficiency. Overall it is in fair condition and is proposed for removal.

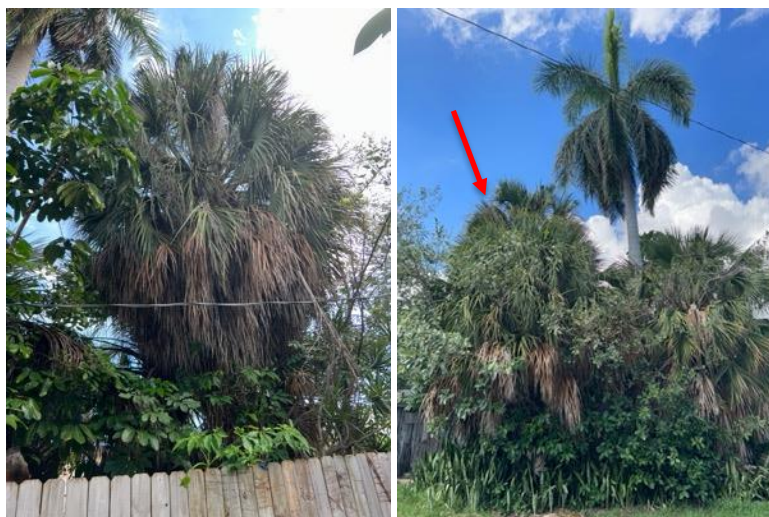
Tree #21 – *Sabal palmetto*, Sabal Palm – this tree is located on the south side of the overgrown cluster of vegetation on the east side of the property. It is very crowded and overgrown, and was inaccessible, but otherwise it is in good condition. It is proposed for removal.

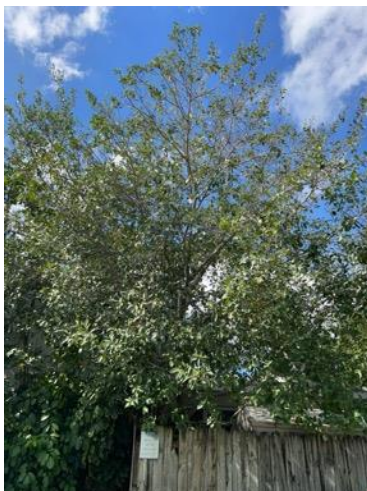
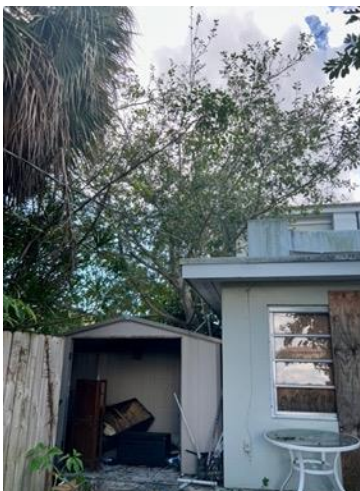
Tree #22 – *Ficus aurea*, Strangler Fig – this tree is located on the east side of the building on the east side of the property. It is inaccessible due to its location inside a fenced area. It appears to be crowded, overgrown and unmaintained with areas of slightly sparse foliage. Overall, it is in fair condition and will be removed.

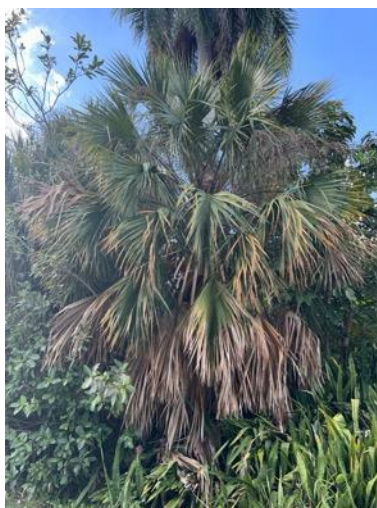
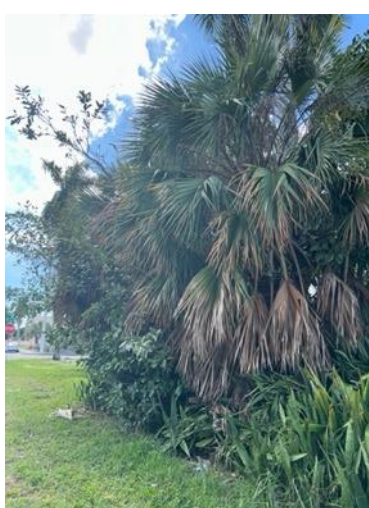
Tree #23 – *Sabal palmetto*, Sabal Palm – this tree is located on the north side of the overgrown cluster of vegetation on the east side of the property. It is very crowded, and overgrown. Overall it is in fair condition and is proposed for removal.

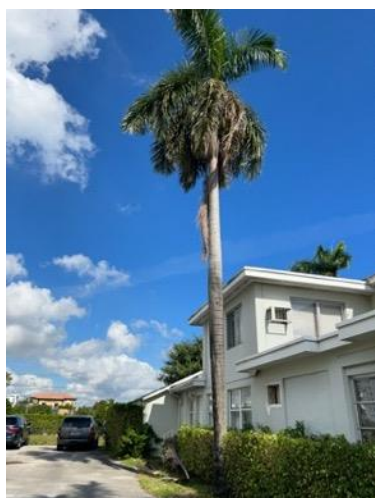
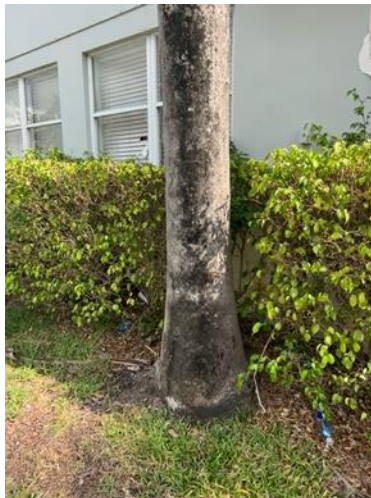
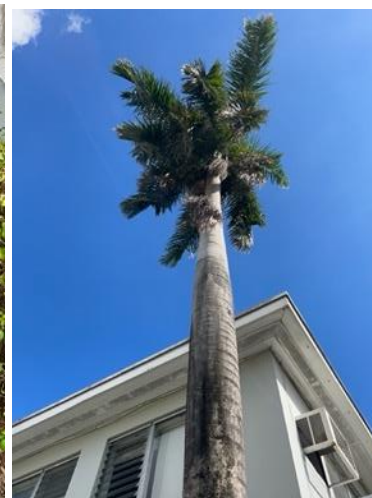
Tree #24 – *Roystonea regia*, Royal Palm – this tree is located on the west side of the back building that is on the east side of the property. It is growing within 5.5' of the existing building. It shows very minor signs of nutrient deficiency and is in overall good condition.

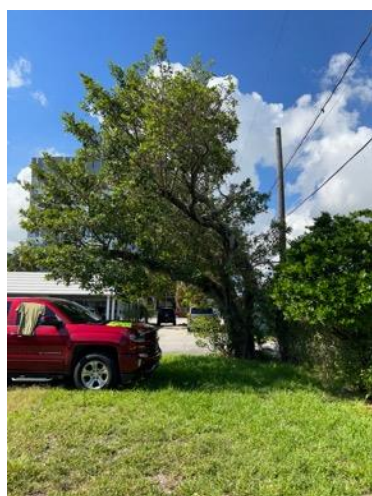
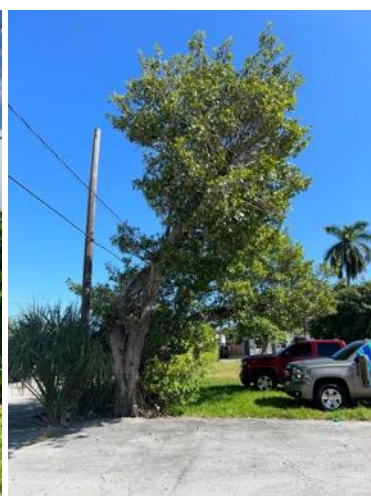
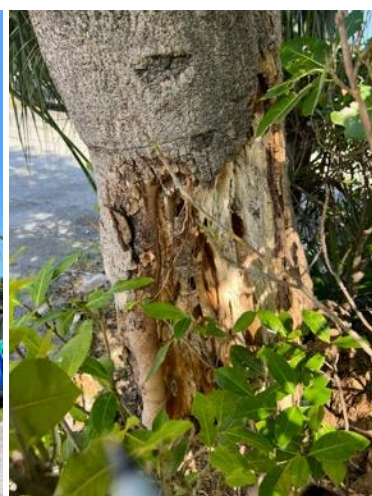
Tree #25 – *Ficus aurea*, Strangler Fig – this tree is located on the north side of the main parking lot near the entrance to the small parking lot (Lot 17, Block 5). It has extensive internal decay at the base of the trunk and in all remaining scaffold limbs. There is decayed wood, apparent termite damage, and fruiting fungal bodies present. Based on a Level 2 inspection and using the ISA Risk Rating matrix, this tree constitutes a high risk and there are no mitigation options that can reduce its risk to moderate or less; therefore, it is recommended for consideration for removal without a permit or mitigation per FS 163.045.

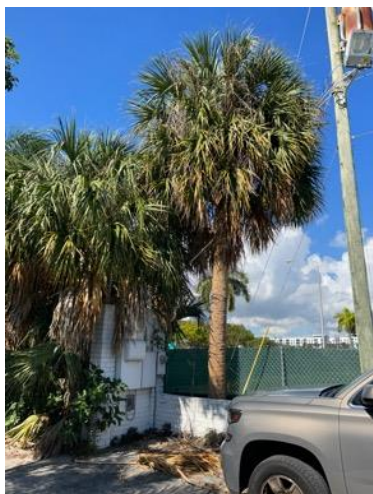
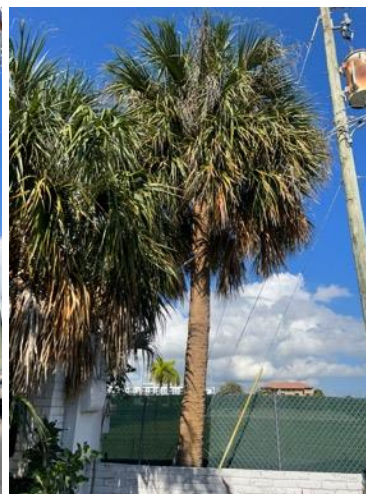
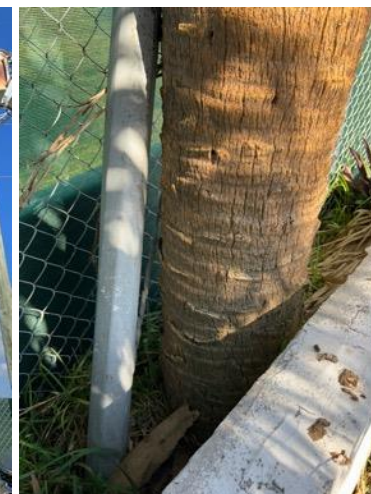
Tree #26 – *Sabal palmetto*, Sabal Palm – this tree is located just east of Trees #1-5 on the northeast side of the property/parking lot. It is somewhat crowded but otherwise is in good condition. It is proposed for removal.

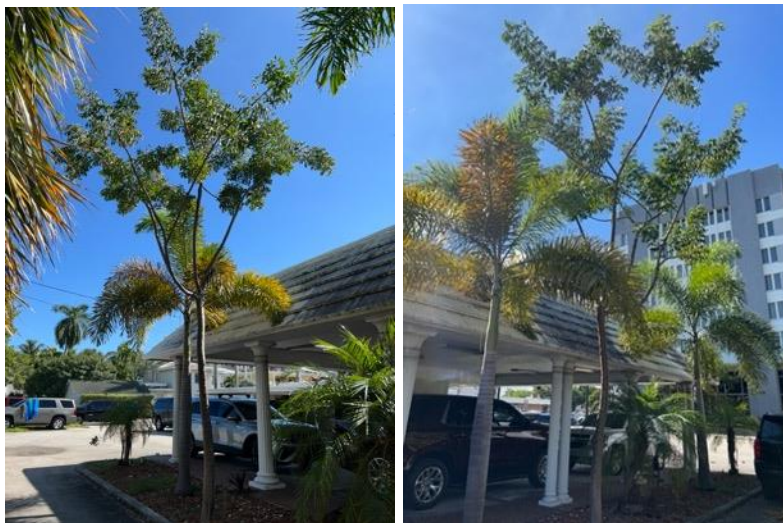
Tree #27 – *Bursera simarouba*, Gumbo Limbo – this tree is located east of Tree #6 in the planting island on the north side of the covered valet drop off area. It is a relatively young tree in fair condition with a slightly weak growth habit but no other significant defects. It is proposed for removal.

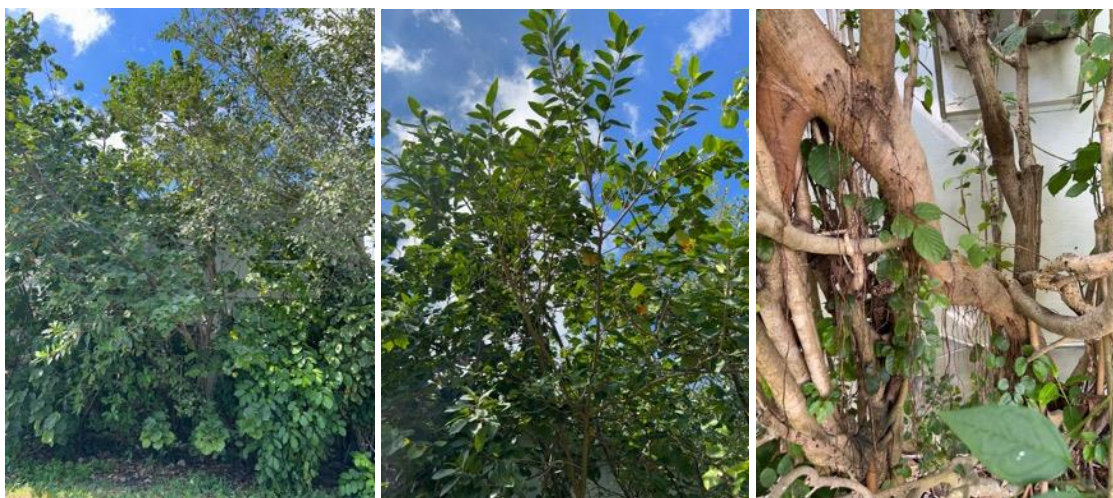
Tree #28 – *Ficus aurea*, Strangler Fig – this is a small volunteer that is growing in an overgrown cluster of Sea Hibiscus on the east side of the existing back building. It is crowded and leaning and has a weak growth habit/structure as a result. It is in poor condition and will be removed.

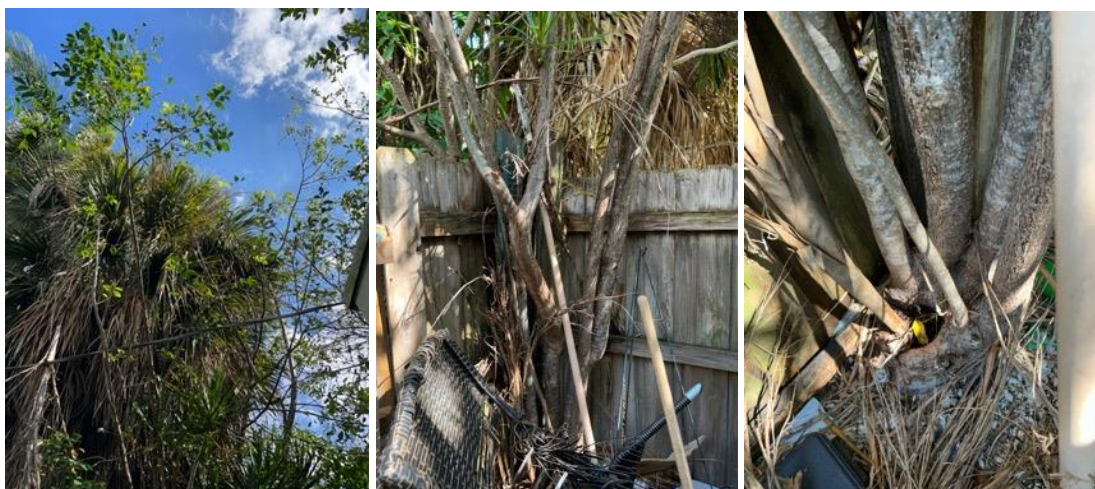
Tree #29 – *Bursera simarouba*, Gumbo Limbo – this tree is growing on the southwest corner of the cluster of overgrown vegetation on the east side of the existing back building; it is likely a volunteer. It is growing against a wooden fence and appears to have been trimmed multiple times near ground level so that it consists of multiple sprouts. There is a decay cavity near the base of the trunk. The canopy is small and sparse. Overall, this tree is in poor condition. It is proposed for removal.

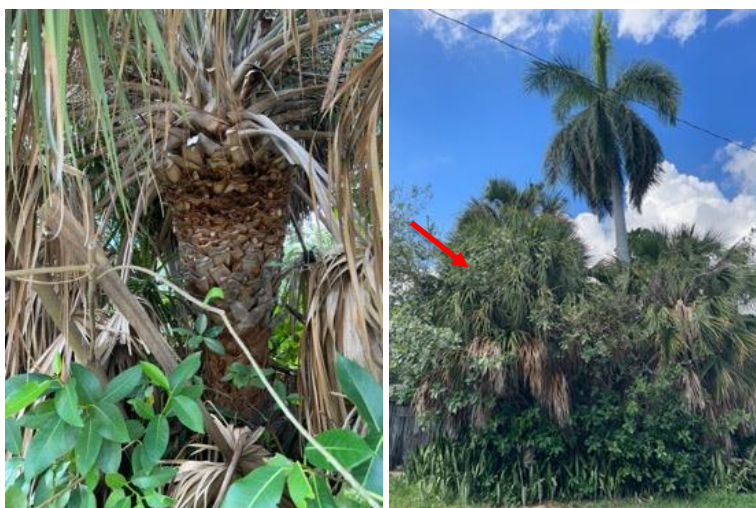
Tree #30 – *Sabal palmetto*, Sabal Palm – this tree is located directly in front of Tree #21 on the east side of the property. It is very crowded, overgrown with vines, and unmaintained. Overall, it is in fair condition and is proposed for removal.

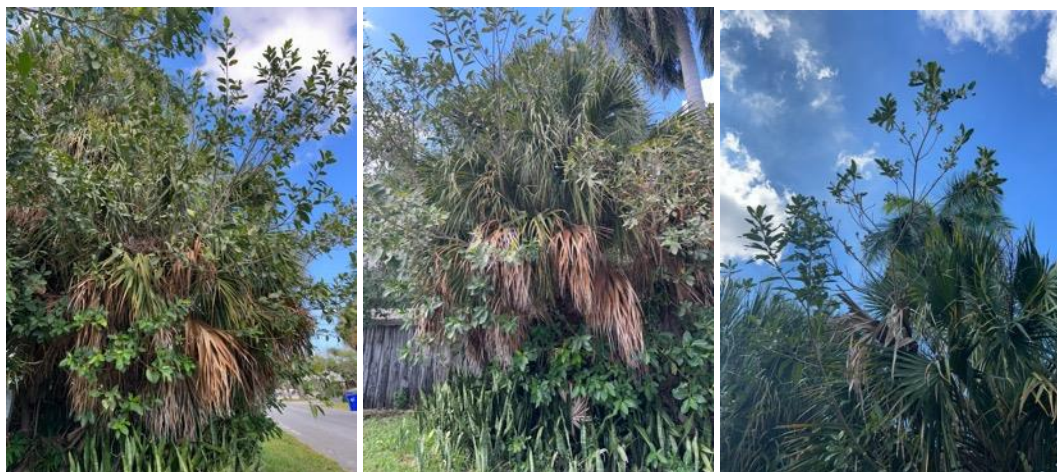
Tree #31 – *Ficus aurea*, Strangler Fig – there is at least one Strangler Fig growing in the middle of the overgrown cluster of vegetation containing Trees #20-21. It is very crowded, overgrown, inaccessible and difficult to see, but at least 3 individual trunks, each 2-3" DBH, were observed with minimal amounts of foliage visible as well. For the sake of this assessment, it is assumed that this is one tree. It is in poor condition and will be removed.

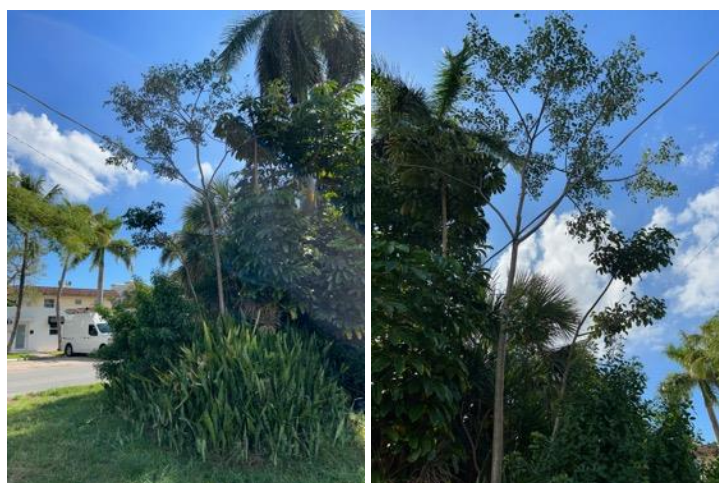
Tree #32 – *Bursera simarouba*, Gumbo Limbo – this tree is located on the north side of the cluster of overgrown vegetation on the east side of the property (north of Trees #20 and 23). It is crowded and overgrown with a slightly weak structure, and it is growing among utility wires. Overall, it is in fair condition and is proposed for removal.

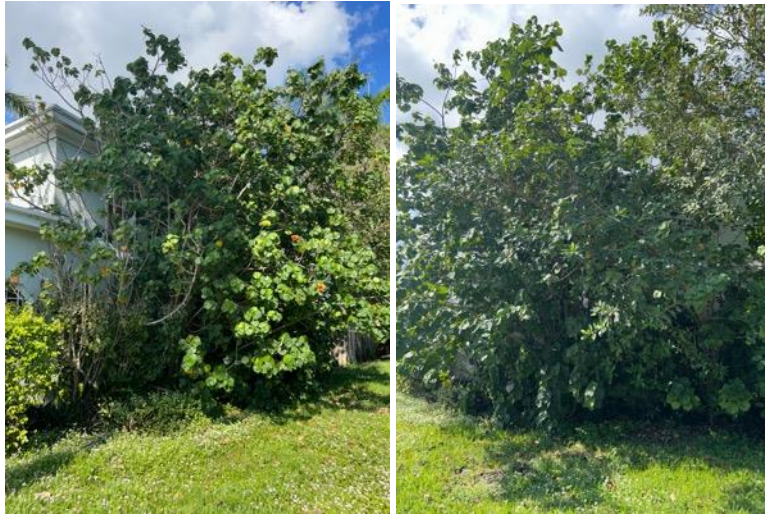
***Hibiscus tiliaceus*, Sea Hibiscus** – this refers to a large overgrown cluster of Sea Hibiscus located on the east side of the property against the southeast side of the back building. There appear to be 2 distinct individual clusters present. They are crowded, overgrown and unmaintained, and in overall moderate condition. This is more of an overgrown shrub than a tree, so it is recommended for removal without mitigation to be confirmed by the City.

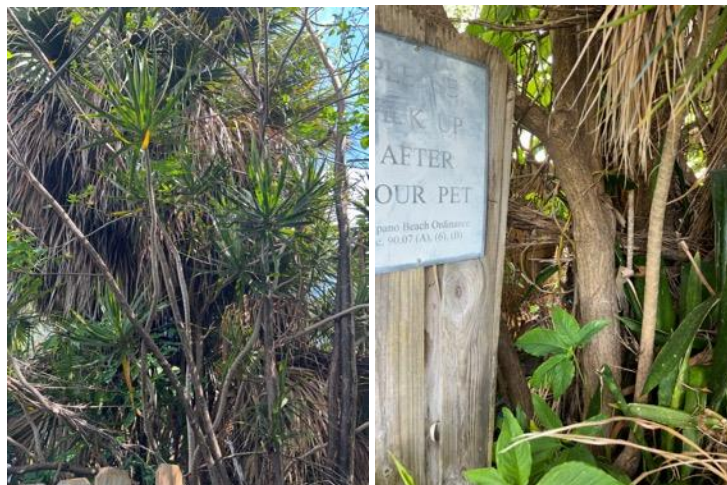
***Dracaena reflexa*, Dracaena** – there is a small cluster of Dracaena located on the southwest side of the cluster of vegetation on the east side of the property (adjacent to Tree #21). It is crowded and overgrown. It is more of an overgrown shrub than a tree, so it is recommended for removal without a permit or mitigation, to be confirmed by the City.

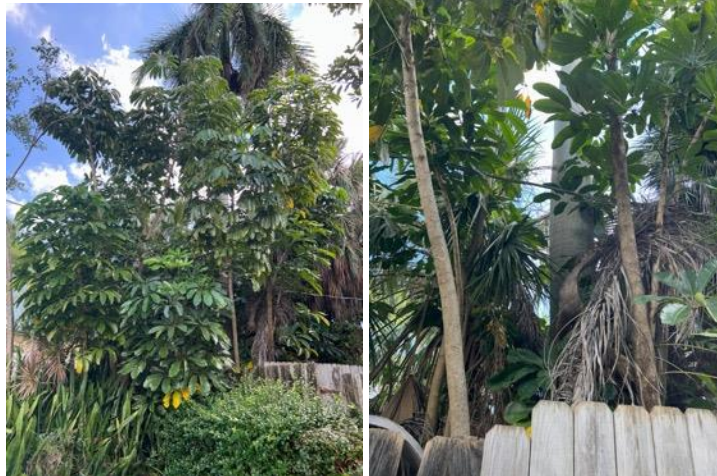
***Schefflera actinophylla*, Umbrella tree** – there are 2 clusters of Umbrella tree located on the northwest side of the overgrown cluster of vegetation on the east side of the property (adjacent to Tree #20). This is considered a nuisance species that should not require a permit or mitigation for removal, to be confirmed by the City.
