Enclosed please find the updated Certified Arborist Report/Tree Assessment for the property located at 200 N. Federal Hwy. in Pompano Beach, FL conducted on November 16, 2022.

ARBORIST REPORT

200 N. Federal Hwy.
Pompano Beach, Fl 33062

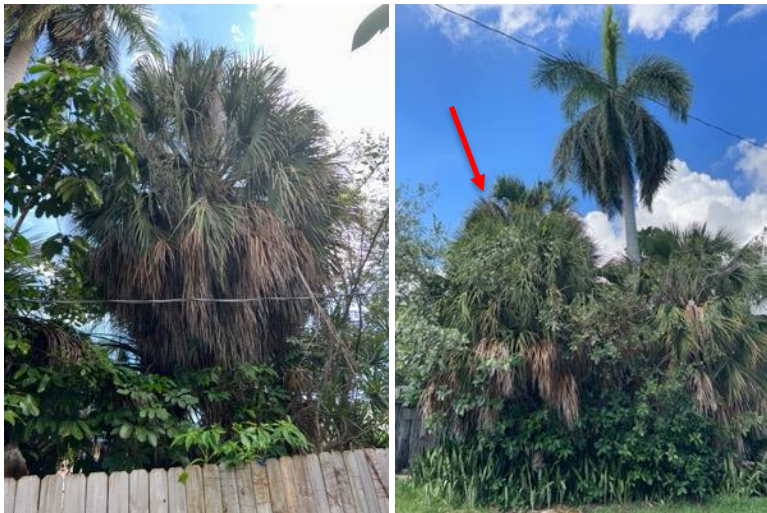
Tree #21 – *Sabal palmetto*, Sabal Palm – this tree is located on the south side of the overgrown cluster of vegetation on the east side of the property. It is very crowded and overgrown, and was inaccessible, but otherwise it is in good condition. It is proposed for removal.

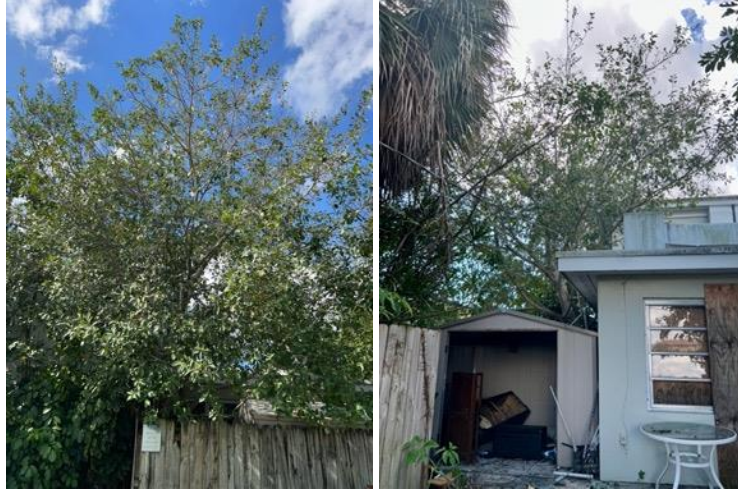
Tree #22 – *Ficus aurea*, Strangler Fig – this tree is located on the east side of the building on the east side of the property. It is inaccessible due to its location inside a fenced area. It appears to be crowded, overgrown and unmaintained with areas of slightly sparse foliage. Overall, it is in fair condition and will be removed.

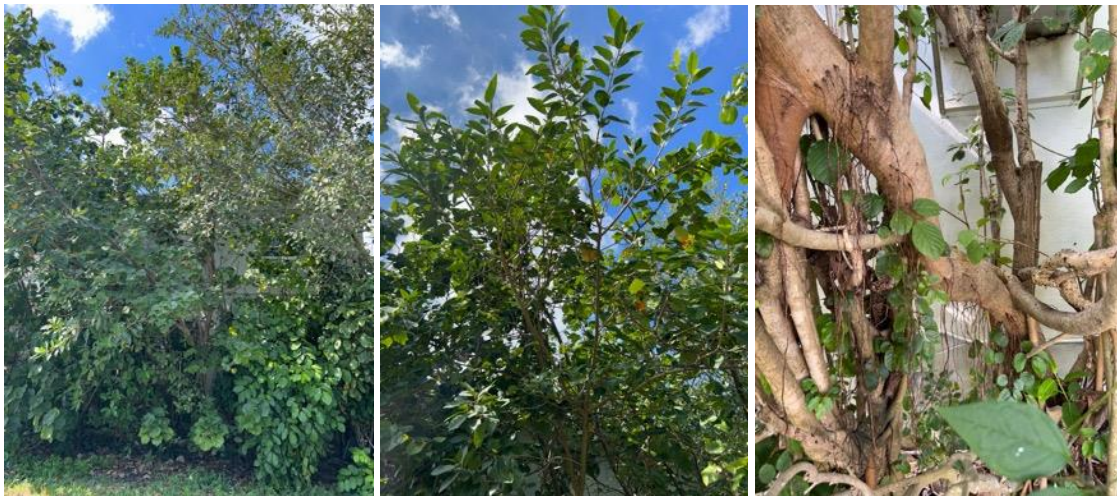
Tree #28 – *Ficus aurea*, Strangler Fig – this is a small volunteer that is growing in an overgrown cluster of Sea Hibiscus on the east side of the existing back building. It is crowded and leaning and has a weak growth habit/structure as a result. It is in poor condition and will be removed.

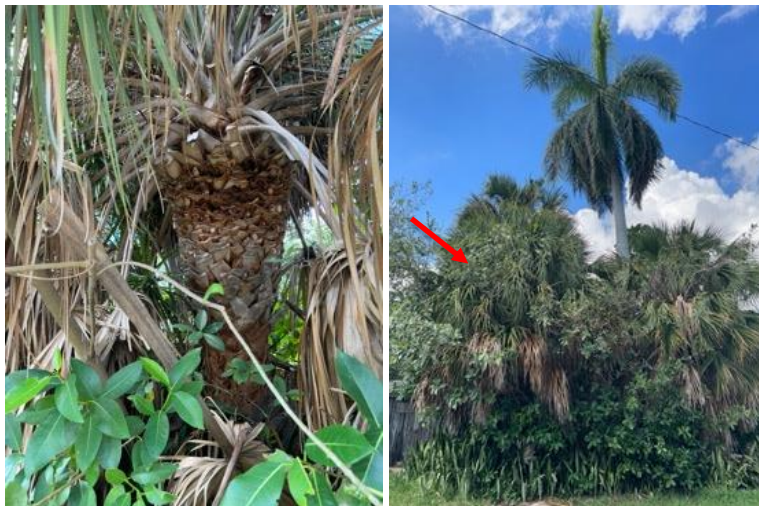
Tree #30 – *Sabal palmetto*, Sabal Palm – this tree is located directly in front of Tree #21 on the east side of the property. It is very crowded, overgrown with vines, and unmaintained. Overall, it is in fair condition and is proposed for removal.
