ARBORIST REPORT

872 McNab Rd.
Pompano Beach, FL 33030

Treage LLC was contacted by Andres Montero of AMLA Studio in July 2023 to conduct a Certified Arborist Report at 872 McNab Rd., Pompano Beach, FL.

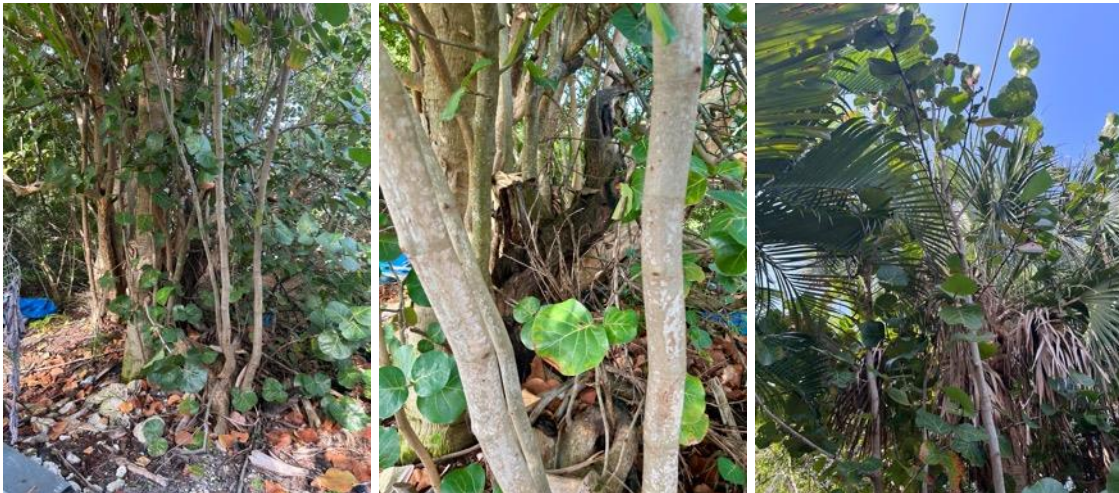
Tree #4 – *Coccoloba uvifera*, Seagrape – this tree is growing directly west of Tree #3. It has a large dead/decayed trunk that terminates at approximately 5' height and only small upright sprouts remaining. This tree is very crowded and overgrown and it has a poor branching structure. Overall, it is in moderate to poor condition.

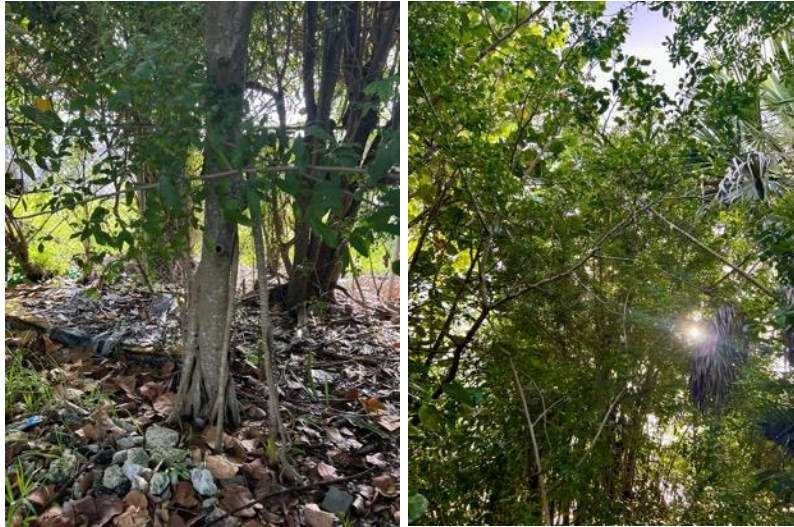
Tree #11 – *Ficus benjamina*, Weeping Fig – this tree is located slightly west of Tree #10. It is very crowded and overgrown and leaning somewhat as a result. Overall, it is in moderate condition. It will require a permit if it is removed, or protection during construction per measures below if it remains.

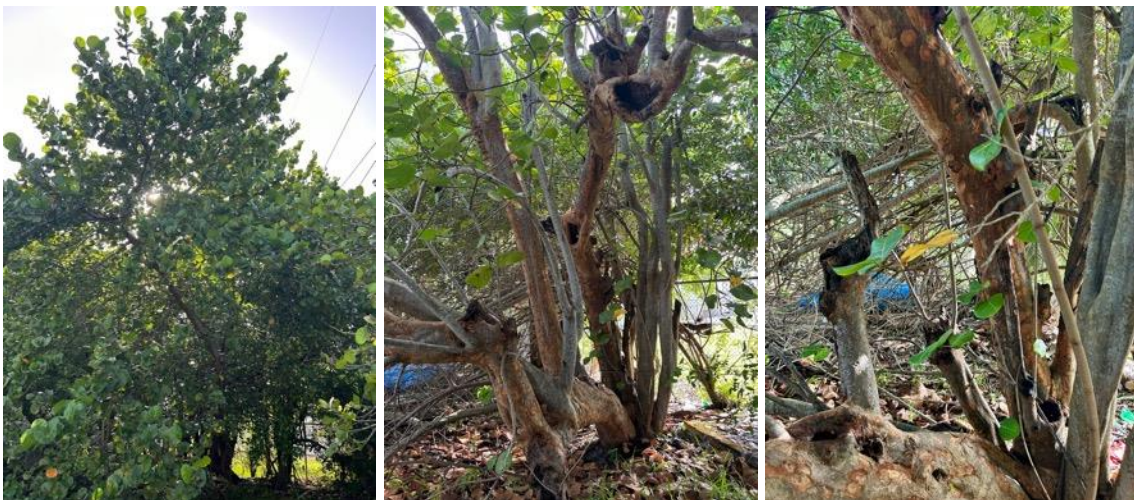
Tree #12 – *Coccoloba uvifera*, Seagrape – this large tree is growing slightly northwest of Tree #10 near the southeast corner of the property. It consists of multiple trunks, the majority of which have poor cuts and tears with deadwood and decay present. Overall, this tree is in borderline fair condition. It is recommended for canopy cleaning/maintenance pruning and further evaluation to determine its disposition.

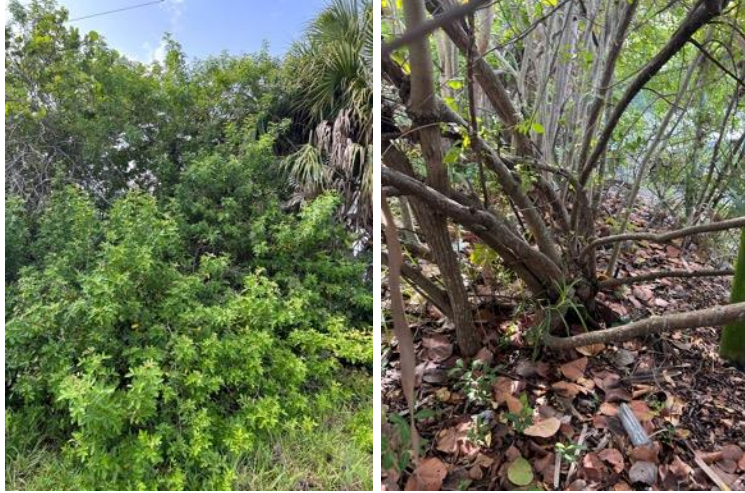
Tree #18 – *Schinus terebinthifolia*, Brazilian Pepper – this tree is growing just west of Tree #17. It is overgrown, unmaintained, and is a Nuisance Species that must be removed with a no-fee permit.

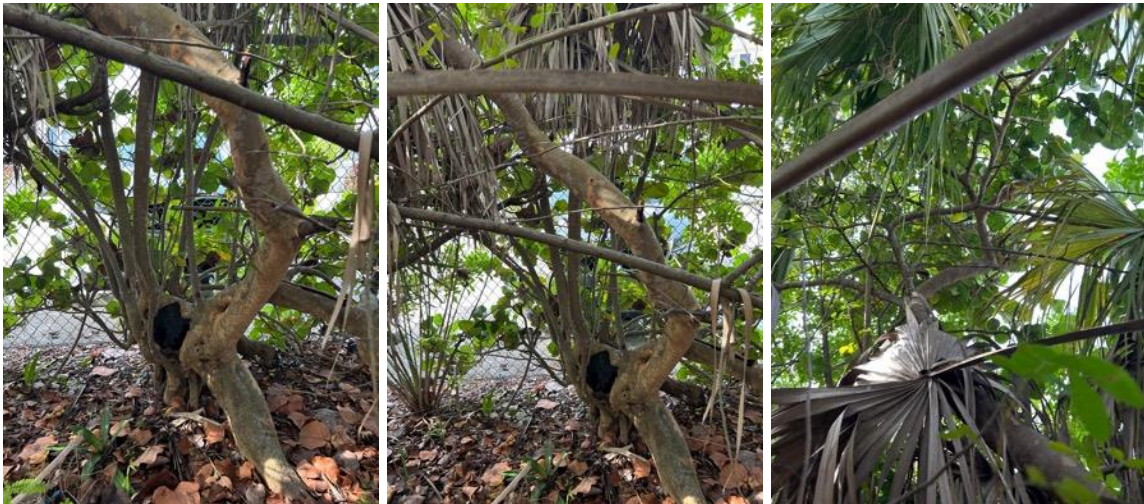
Tree #19 – *Coccoloba uvifera*, Seagrape – this tree is growing against the fence just west of Tree #18. There is one limb that bends and extends backward over the neighboring property and otherwise there are only small sprouts originating above a decay cavity at the base of the trunk. Overall, this tree is in poor condition. It is most likely a good candidate for removal due to its condition.

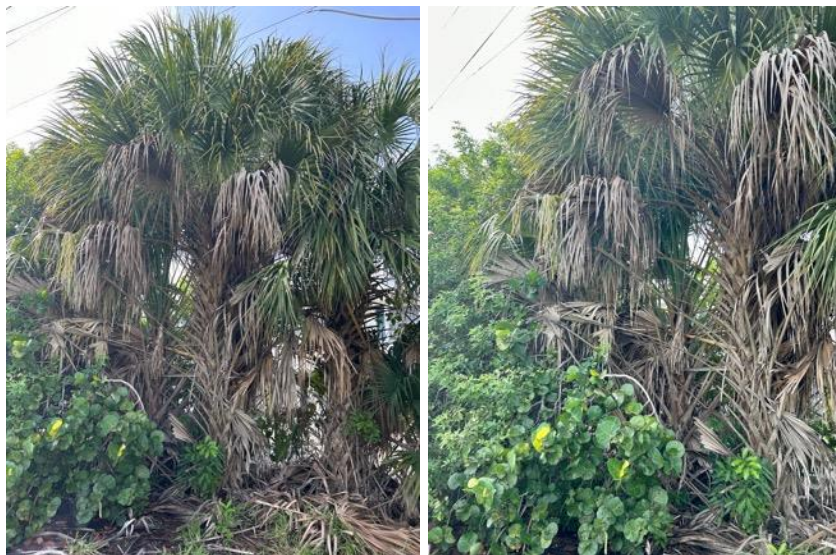
Tree #21 – *Sabal palmetto*, Sabal Palm – this tree is growing in the middle of a cluster of Sabals along the fence line with Trees #19-20. Its trunk is barely visible due to extreme crowding. It does have its boots still present. This tree could remain with protection during construction, but it is growing in close proximity to utility lines. As an alternative, it may be a decent candidate for relocation onsite per specifications below. Otherwise, it will require a permit and mitigation if it is removed.

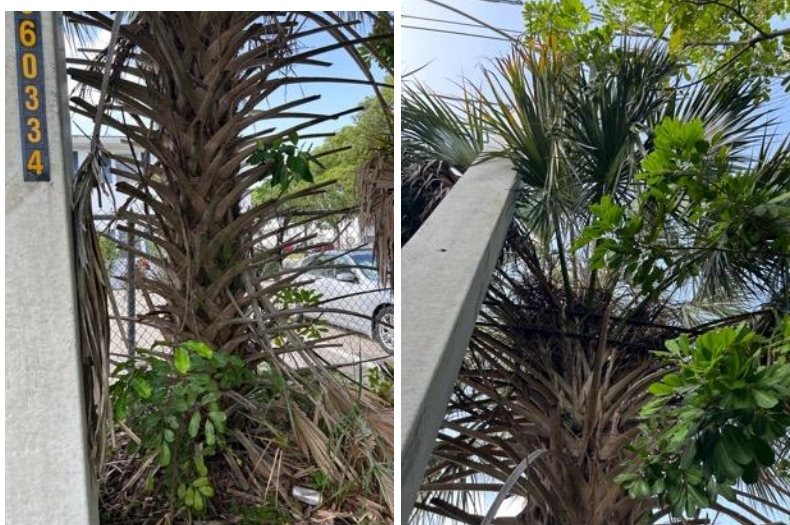
Tree #23 – *Sabal palmetto*, Sabal Palm – this tree is growing just west of Tree #22 and a utility pole near the south fence line. It is very crowded but otherwise in fair condition. It is growing among the adjacent utility lines. It still has its boots present. This tree could remain with protection during construction, but it is growing in very close proximity to a utility pole/utility lines. As an alternative, it may be a decent candidate for relocation onsite per specifications below. Otherwise, it will require a permit and mitigation if it is removed.

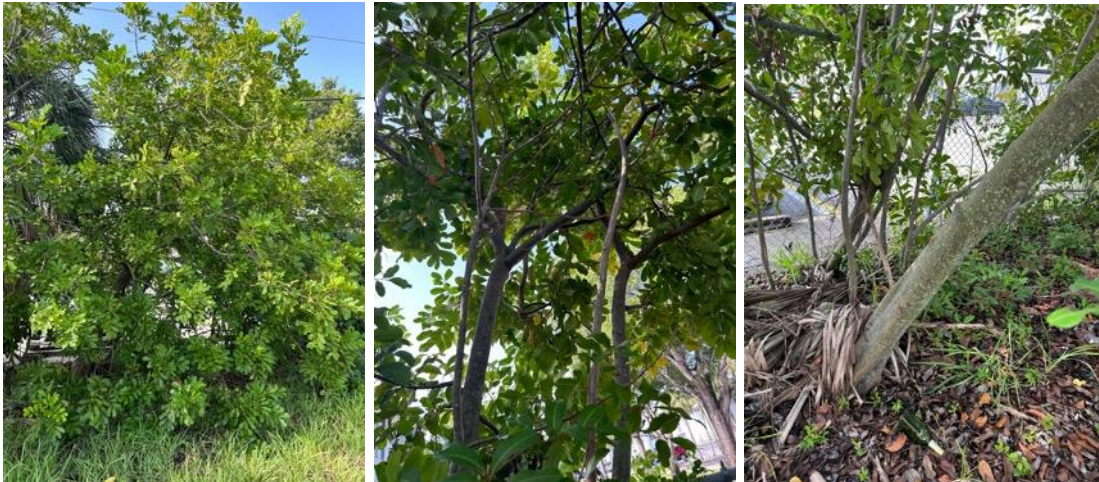
Tree #29 - *Cupaniopsis anacardioides*, Carrotwood – this tree is growing just west of Tree #28 near the property line. It is crowded and leaning in poor condition. This is a Nuisance Species that requires removal with a no-fee permit.

Tree #30 - *Cupaniopsis anacardioides*, Carrotwood – this tree is growing just behind Tree #29 near the property line. It is crowded and in poor condition with small tears present. This is a Nuisance Species that requires removal with a no-fee permit.
