ATLAS SAFETY & SECURITY DESIGN, INC.

RE: Oldcastle Coastal Facility – 1200 NW 18th St., Pompano Beach, CPTED/Security Public Safety Plan

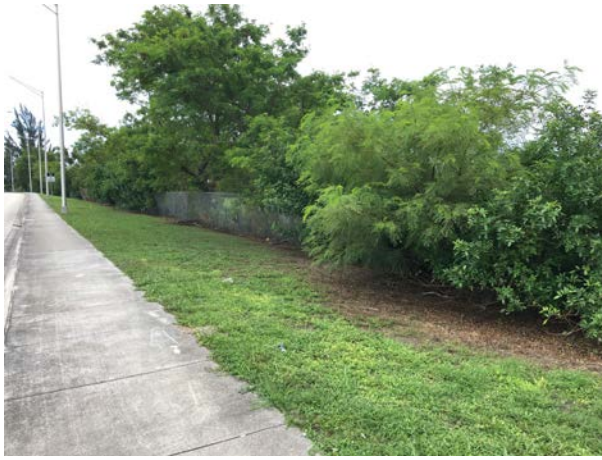
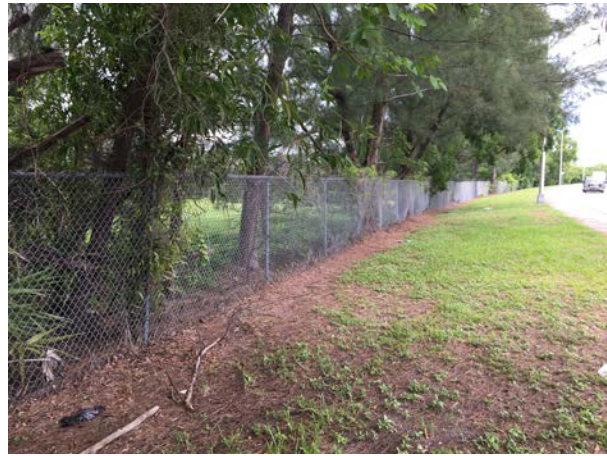
The west boundary on Andrews Avenue is chain link fencing and overgrown shrubs and non-native Australian Pine.

The west border definition will be improved with an attractive picket metal code compliant fencing with plantings, and a vehicle gate. It is recommended that as the site is improved to accommodate a sidewalk connection, and new monumental sign, and additional stripping at the entrance of onto Andrews Avenue will be added to direct the heavy trucks and rigs.

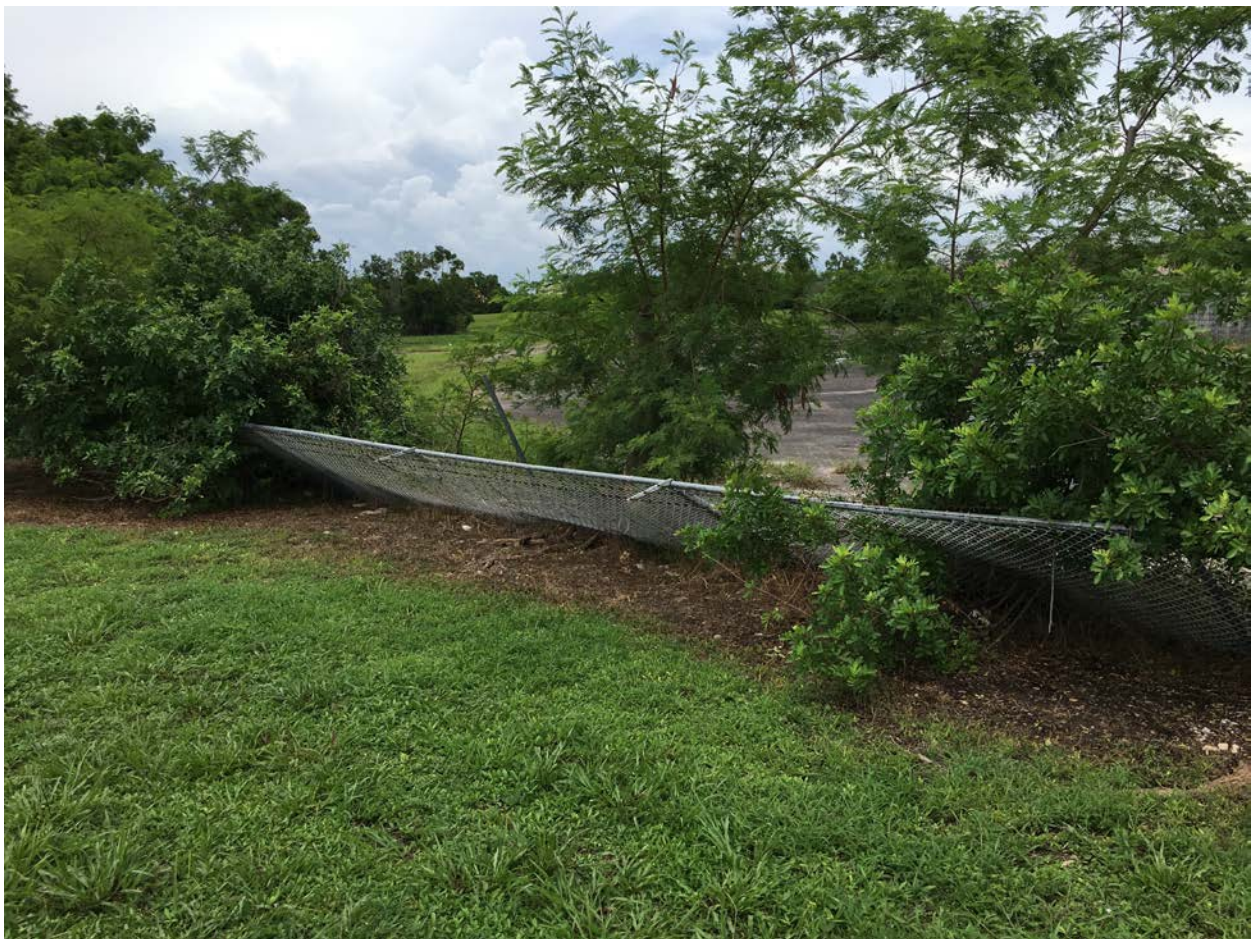
The West Boundary has sections of the chain link fence that are damaged and lying down.

Territorial Reinforcement /Boundary definition – Fencing and Plantings – The existing six-foot high chain link fencing requires extensive repair and maintenance on the north, south and east sides. Plantings should be maintained to be no higher than the fence line on the boundaries. Tree canopies should be maintained clear under 8 feet, with a tree trunk six inches in diameter or greater. If new saplings are planted, do not mutilate them to comply with the canopy requirement until they are mature trees with a six inch diameter trunk or greater, and if the tree canopies are blocking the field of vision.

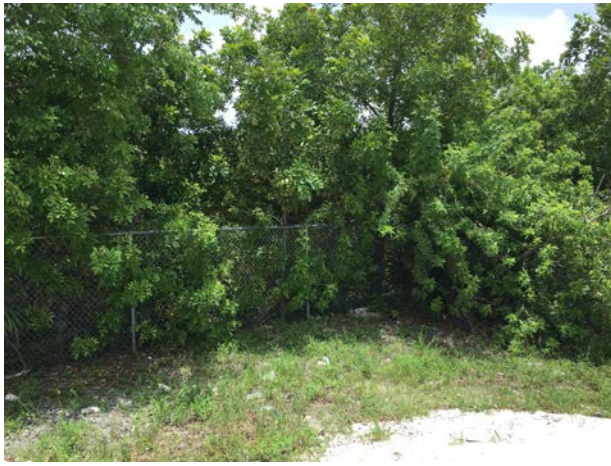
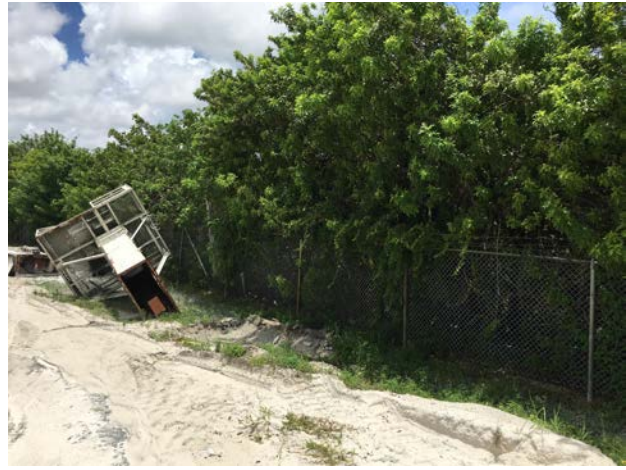
The East boundary is six-foot chain link with overgrown shrub.

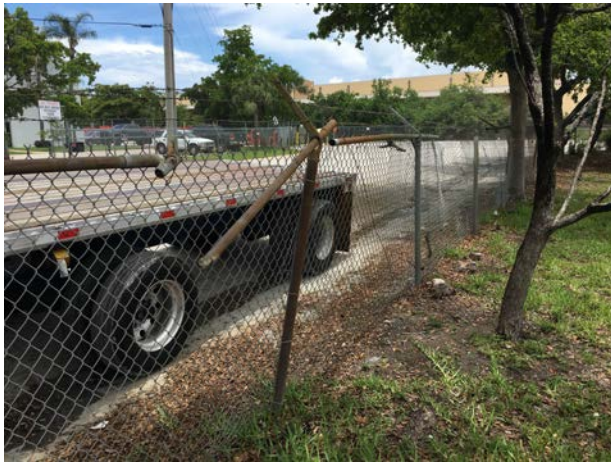
The North boundary is presently the primary access and egress points to the plant on NW 18th Street. There are two gates openings. Both gates are left open and have been damaged and non-operational. The barbed wire on the top of the chain link fencing has been damaged and not consistent.

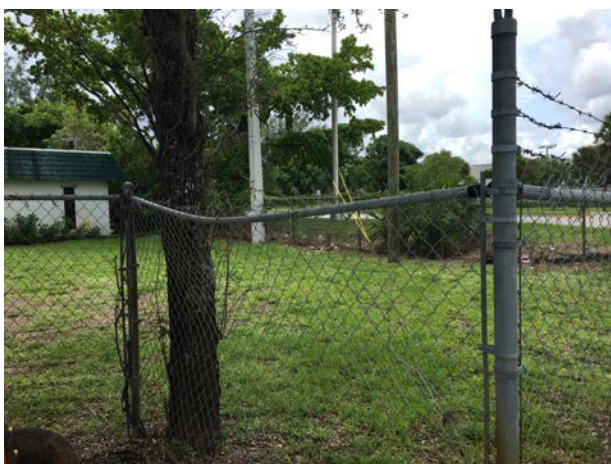
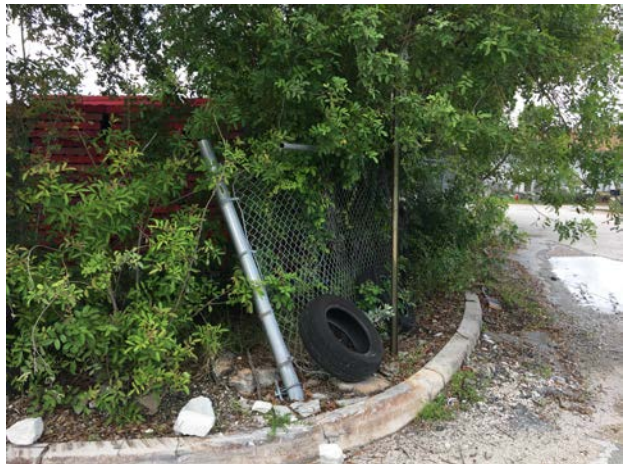
The north boundary fencing is heavily damaged.

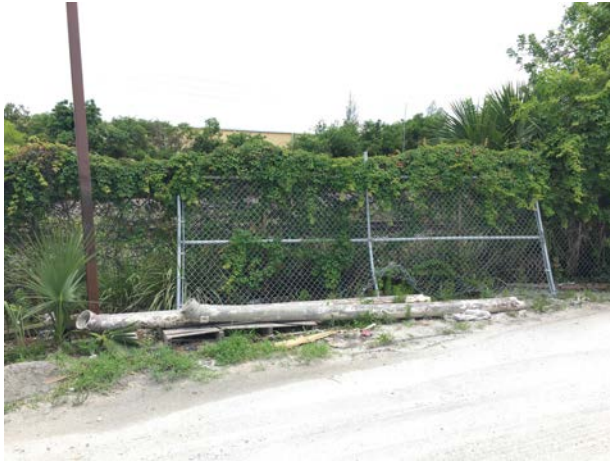
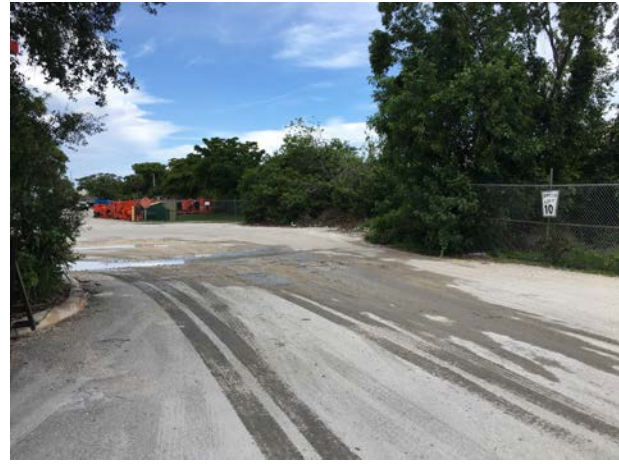
The northeast gate has been knocked off the tracks and lays against the east perimeter fence. The open access allows trucks with aggregate product to enter in the site, but also has no barriers to keep trespassers out.

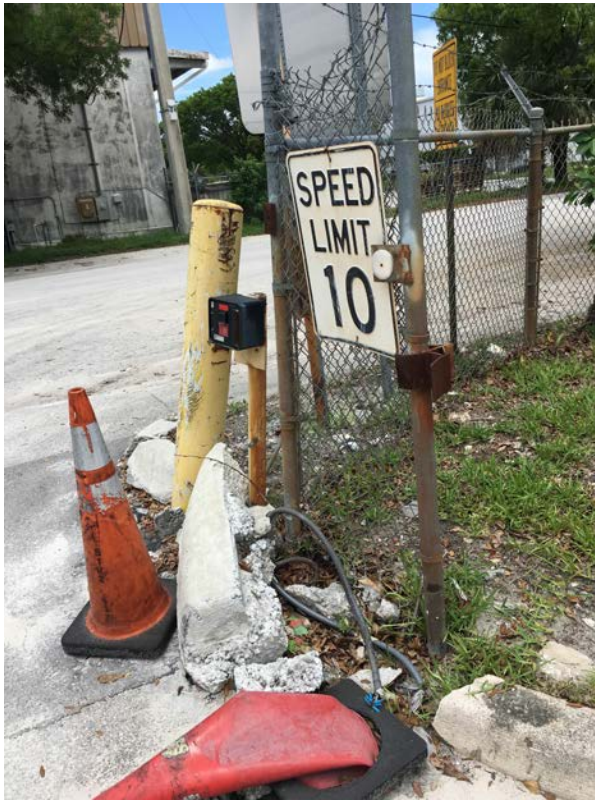
The Northwest gate is the primary entrance for administration, employee vehicles. The gate is non-functional and is in disrepair.

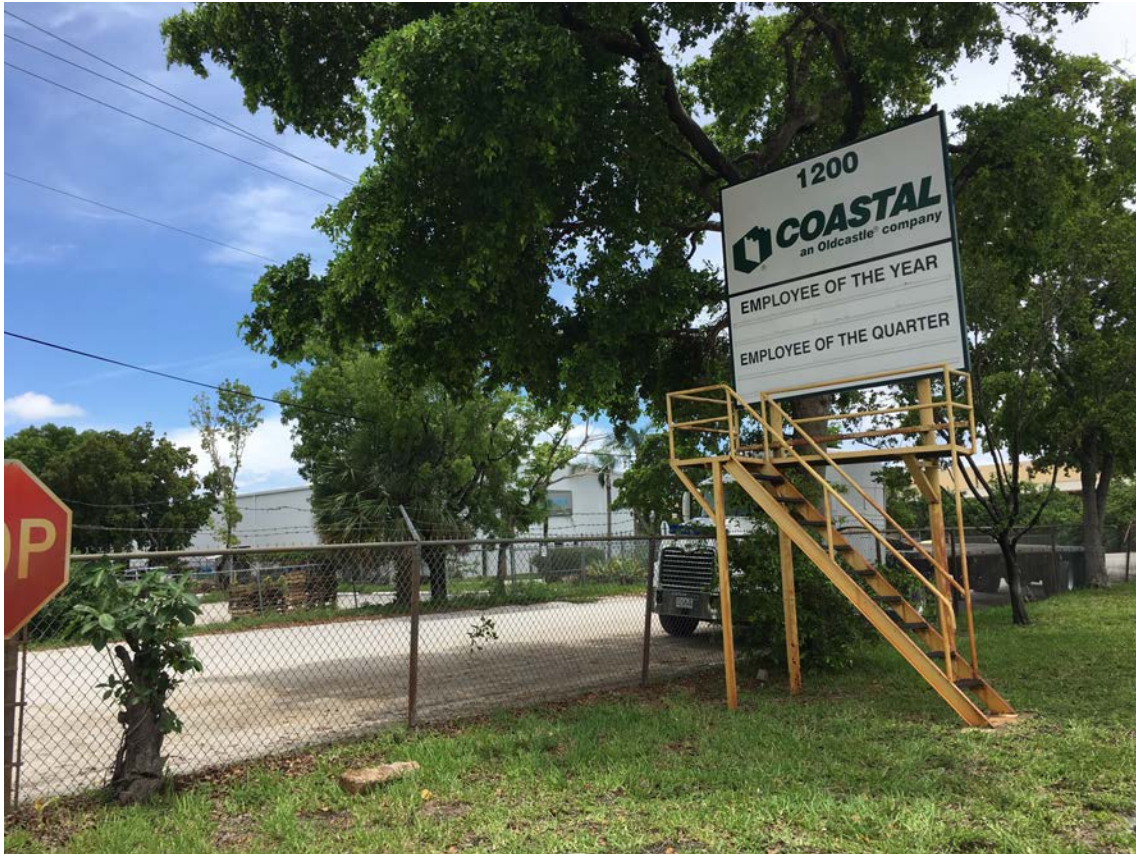
The north boundary on NW 18th Street has the marquee sign for the plant. It is difficult to see from the main road, Andrews Avenue.

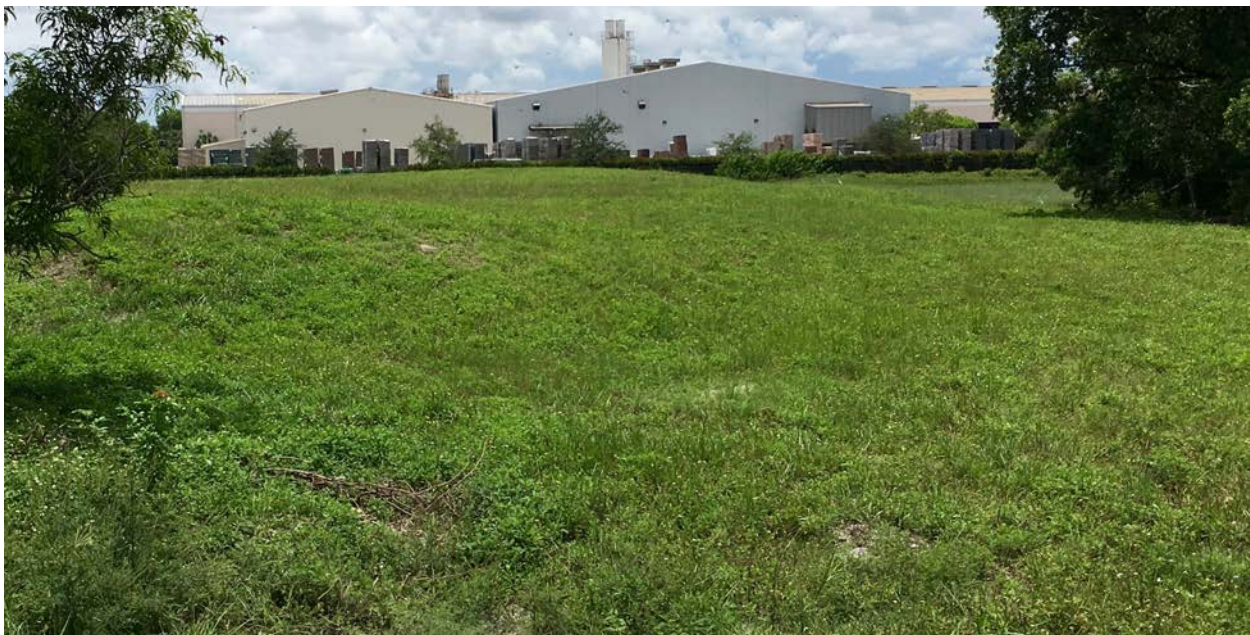
The South boundary is open real estate between the Bonsal Plant and the Oldcastle Distribution Center.

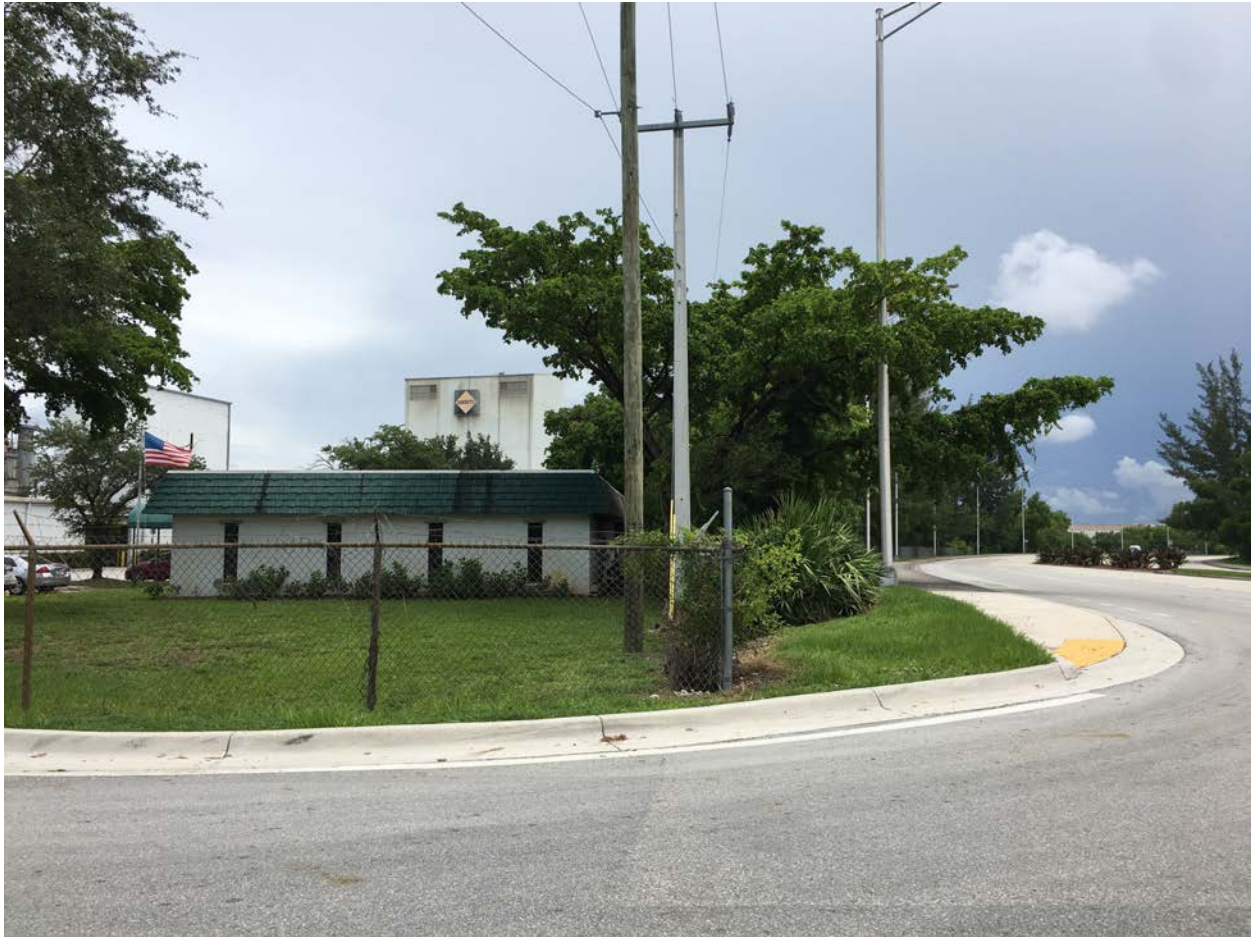
There are no controls for vehicles once trucks turn on 18^h Street. There are no barriers controlling access to the parking lot and site on the north side.

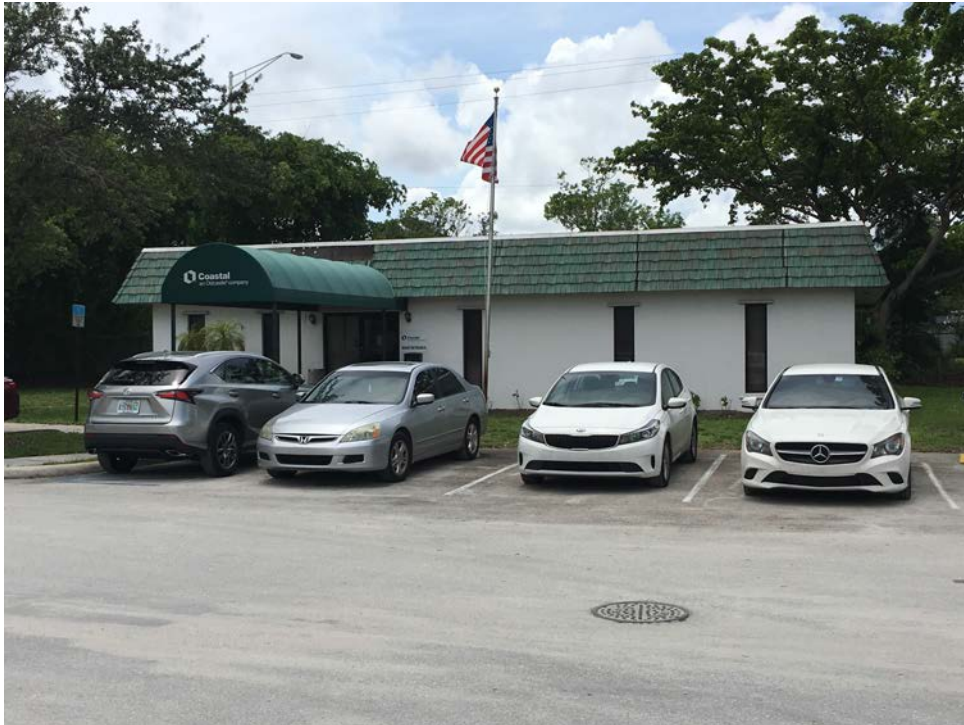
The business office entrance faces east and the north side of the site.

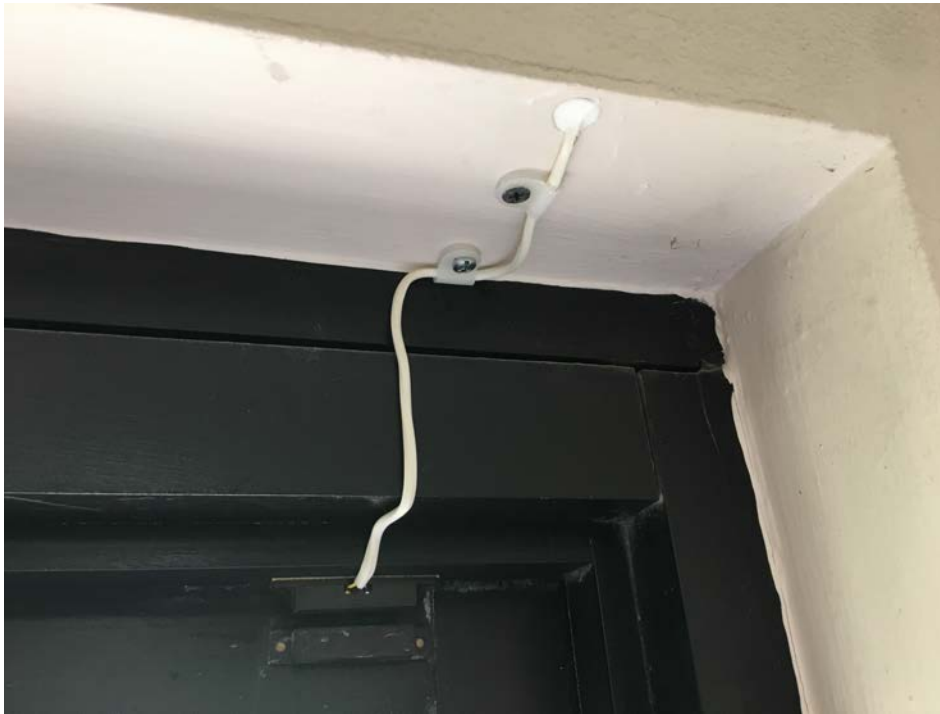
The office has a make shift security system that is monitored but needs to be updated. There is no exterior light along the east side of the business office.

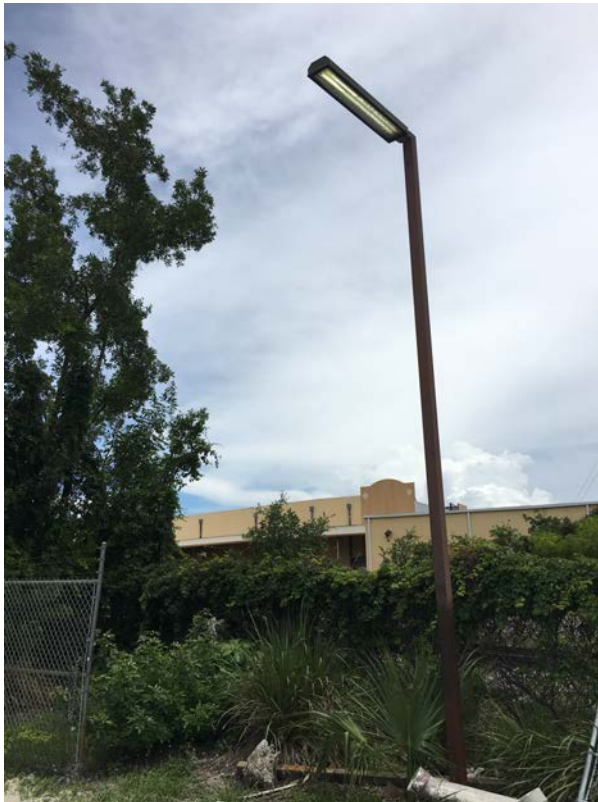
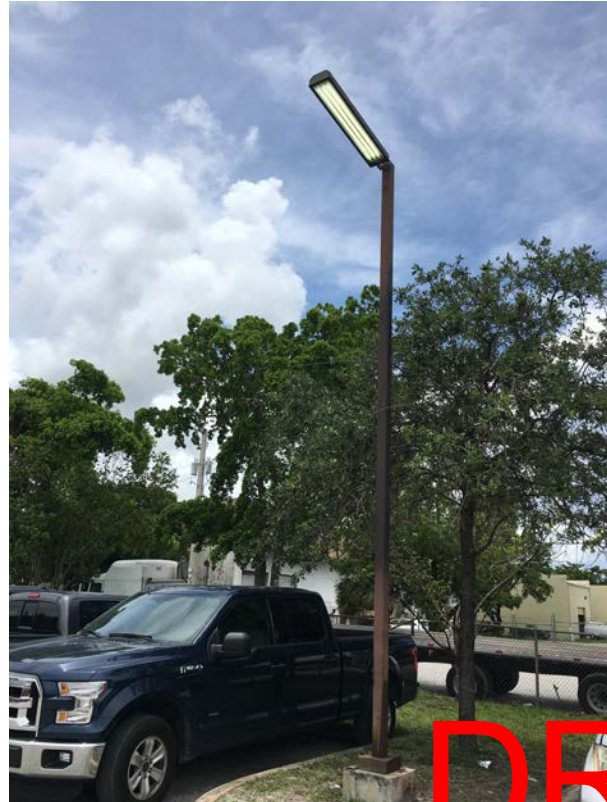
The pole lighting actually uses florescent tubes, and was turned on during daylight hours.

Perimeter Lighting – The proposed photometric lighting plan will provide adequate lighting for the site and parking areas, without the effects of light trespass or light pollution. On the west and south vehicle entrances light levels are a minimum of 1 footcandle (FC) or greater. The storage yard generally has at least ½ footcandle minimum average coverage. The plant and office buildings will have exterior lighting that illuminate the building exterior in the hours of darkness. It will be important to view any illegitimate activity on the site and around the buildings. Therefore, lighting should be uniform and consistent on the stock and pallet areas with enough lighting to be able to observe movement by any potential trespassers. The exterior showroom areas should have a minimum of ½ FC of lighting to facilitate pedestrian movement and support video surveillance. The plant's renovated lighting is adequate on the east, west and north sides. However, where the silo's are located on the south side, additional luminaires will be added, as there are vehicles parked, stock pallets, and heavy machinery that should be observable.

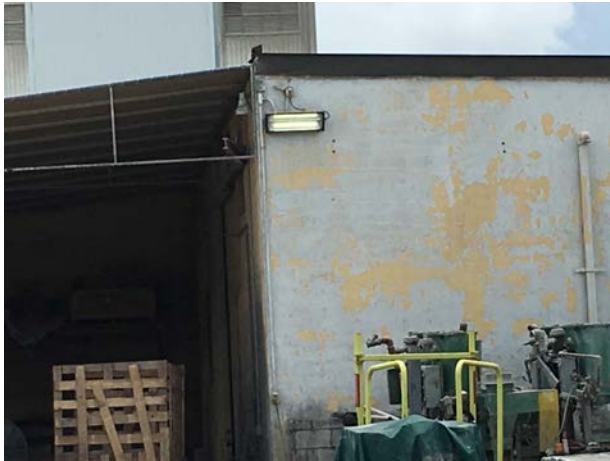
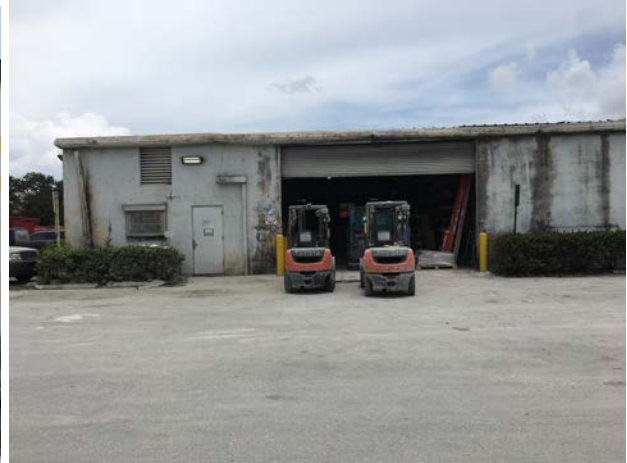
The exterior building lighting is florescent tubes, which are inadequate to properly light the grounds.

Building exterior lighting – The newly renovated and retrofitted lighting plan is providing adequate illuminate to the exterior of the buildings, the stock areas, the exterior yard area, and vehicular entrances for good visibility and accountability. Additional lighting is needed on all sides of the plant, and the three vehicle entrances to complete the lighting goals.

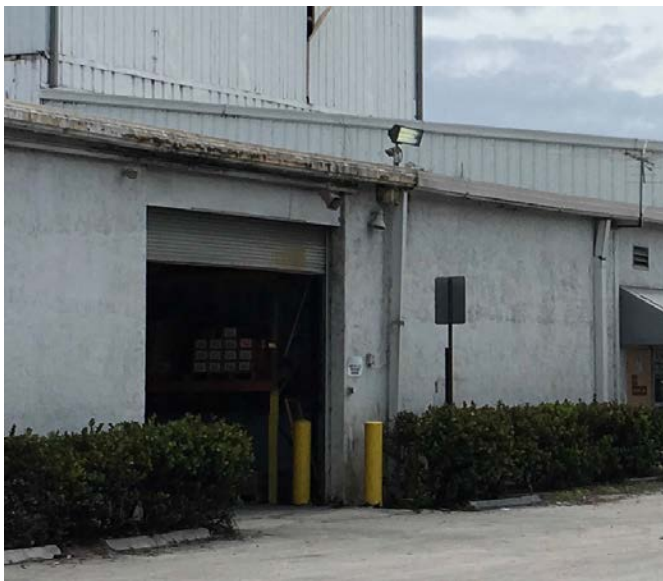
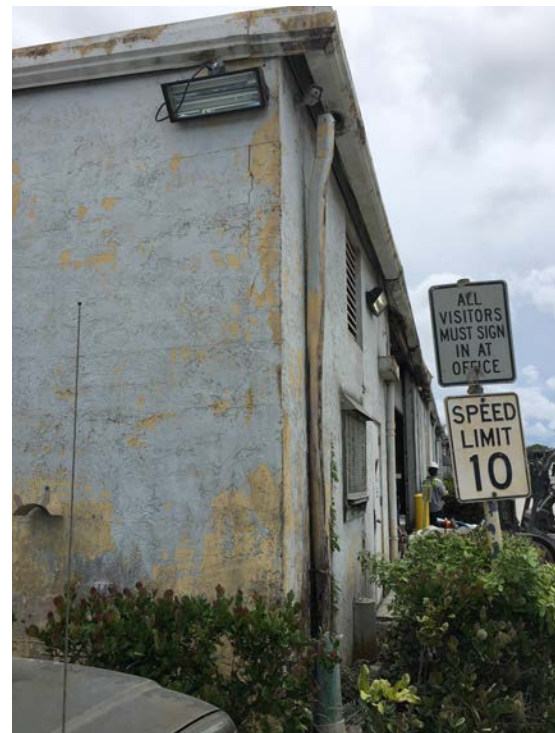
The exterior lighting using florescent tubes as the light source was inefficient and not effective to evenly light the site and building exterior.

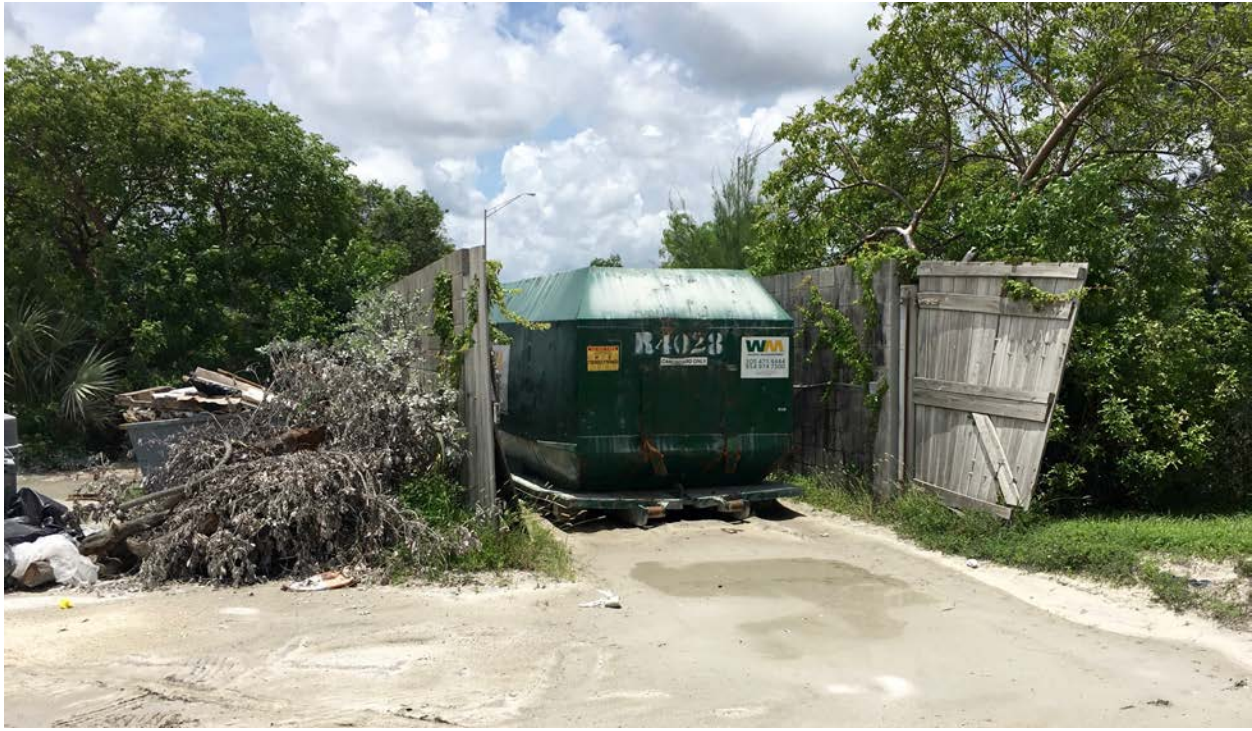
The exterior dumpster area is located in the south part of the yard area across from the Plant. The screening needs to be in working order, and lockable, and the area cleaned up. The dumpster is not set down on a concrete pad. There is no drainage capacity. The wooden gates and shielding are damaged and does not close properly. There is no locking capability to prevent outsiders from outside persons dumping trash.

The new proposed dumpster area should be on a concrete pad that can withstand picking up and dropping down by a garbage truck. There should be bollards/bumpers to prevent the truck from hitting the dumpster enclosure. The dumpster should be shielded on three sides with a screening that complies with zoning regulations. Swing gates that are locked should be used to protect the dumpster from illegal or unwanted dumpster diving or dumping. The front screening should be raised so that a person in the dumpster area can be observed from the outside. The gates should be lockable so they can be secured when not being used. If there is any trespassing in the exterior site areas, the person will stand out and be observed and challenged.

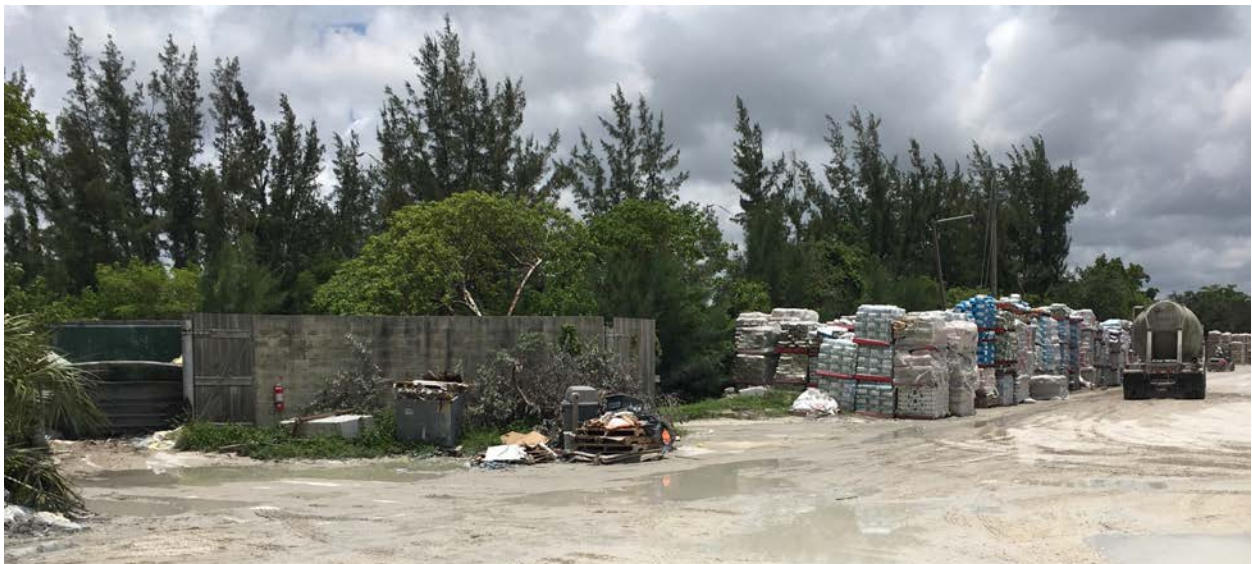
There appears to be some dumping just adjacent to the dumpster. In the new site plan the dumpster will be designed to have compliant surrounding shielding and be secured.

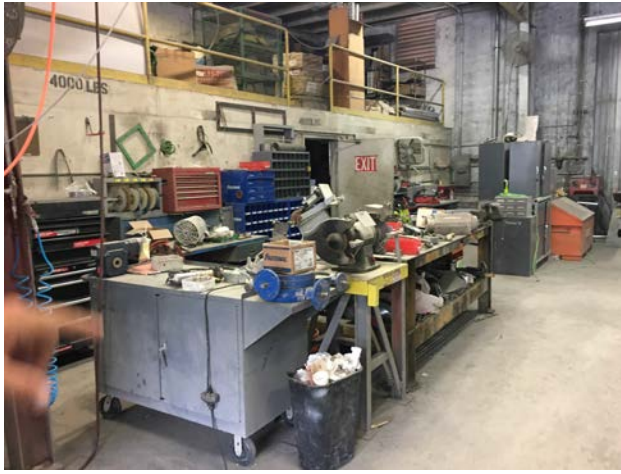
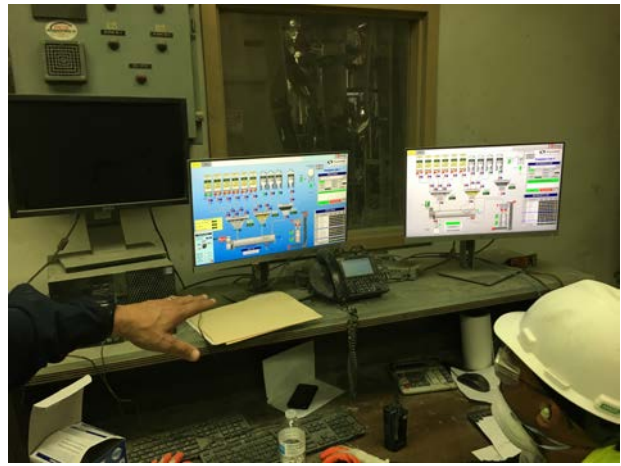
Tools and equipment is an attractive asset that need to be protected.

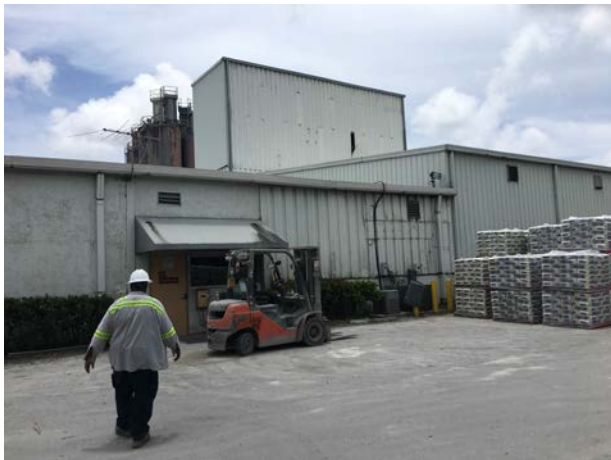
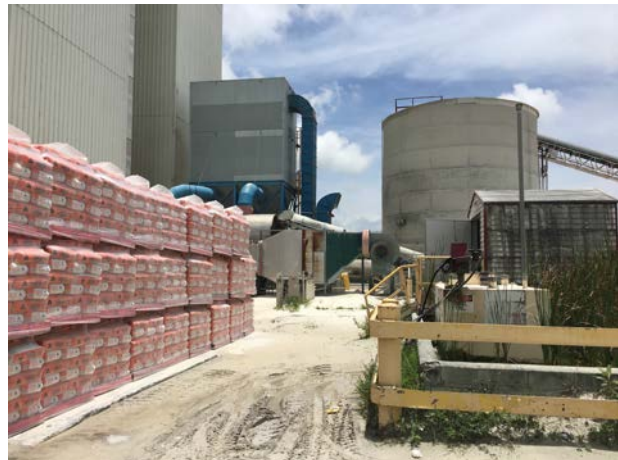
Forklifts and product stacked are assets that need to be protected.

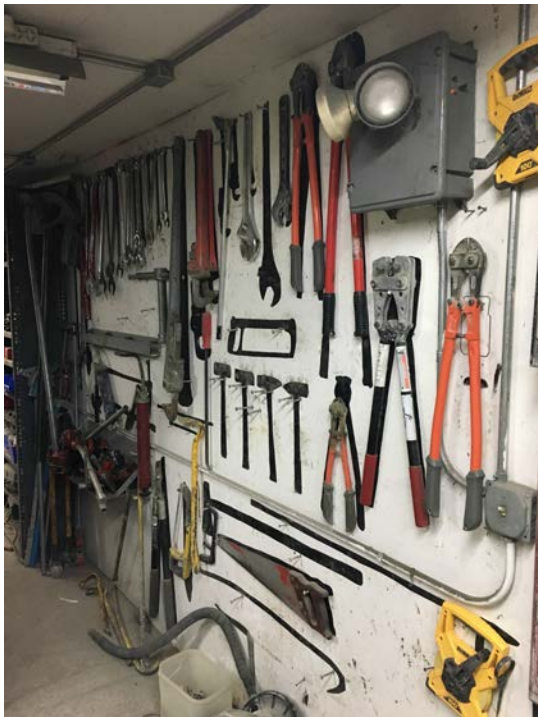
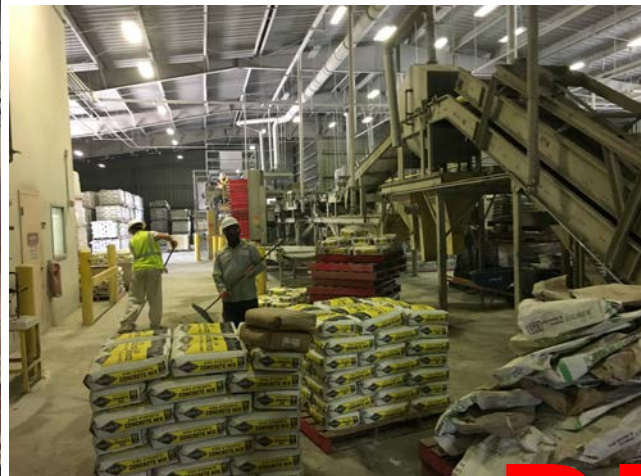
Tools and machinery must be protected from loss, theft, pilferage, or vandalism.
