jgomez@logicaservices.com**Re: Arboricultural Consulting Services for 324 Northwest 6th Street, Pompano Beach, Florida**

I visited the above-mentioned property on Tuesday, May 16th, to evaluate +/- 24 trees, take photographs (Specimen sized trees only), calculate Rule 14-10 appraisal values, perform relocation evaluations, and note any defects.

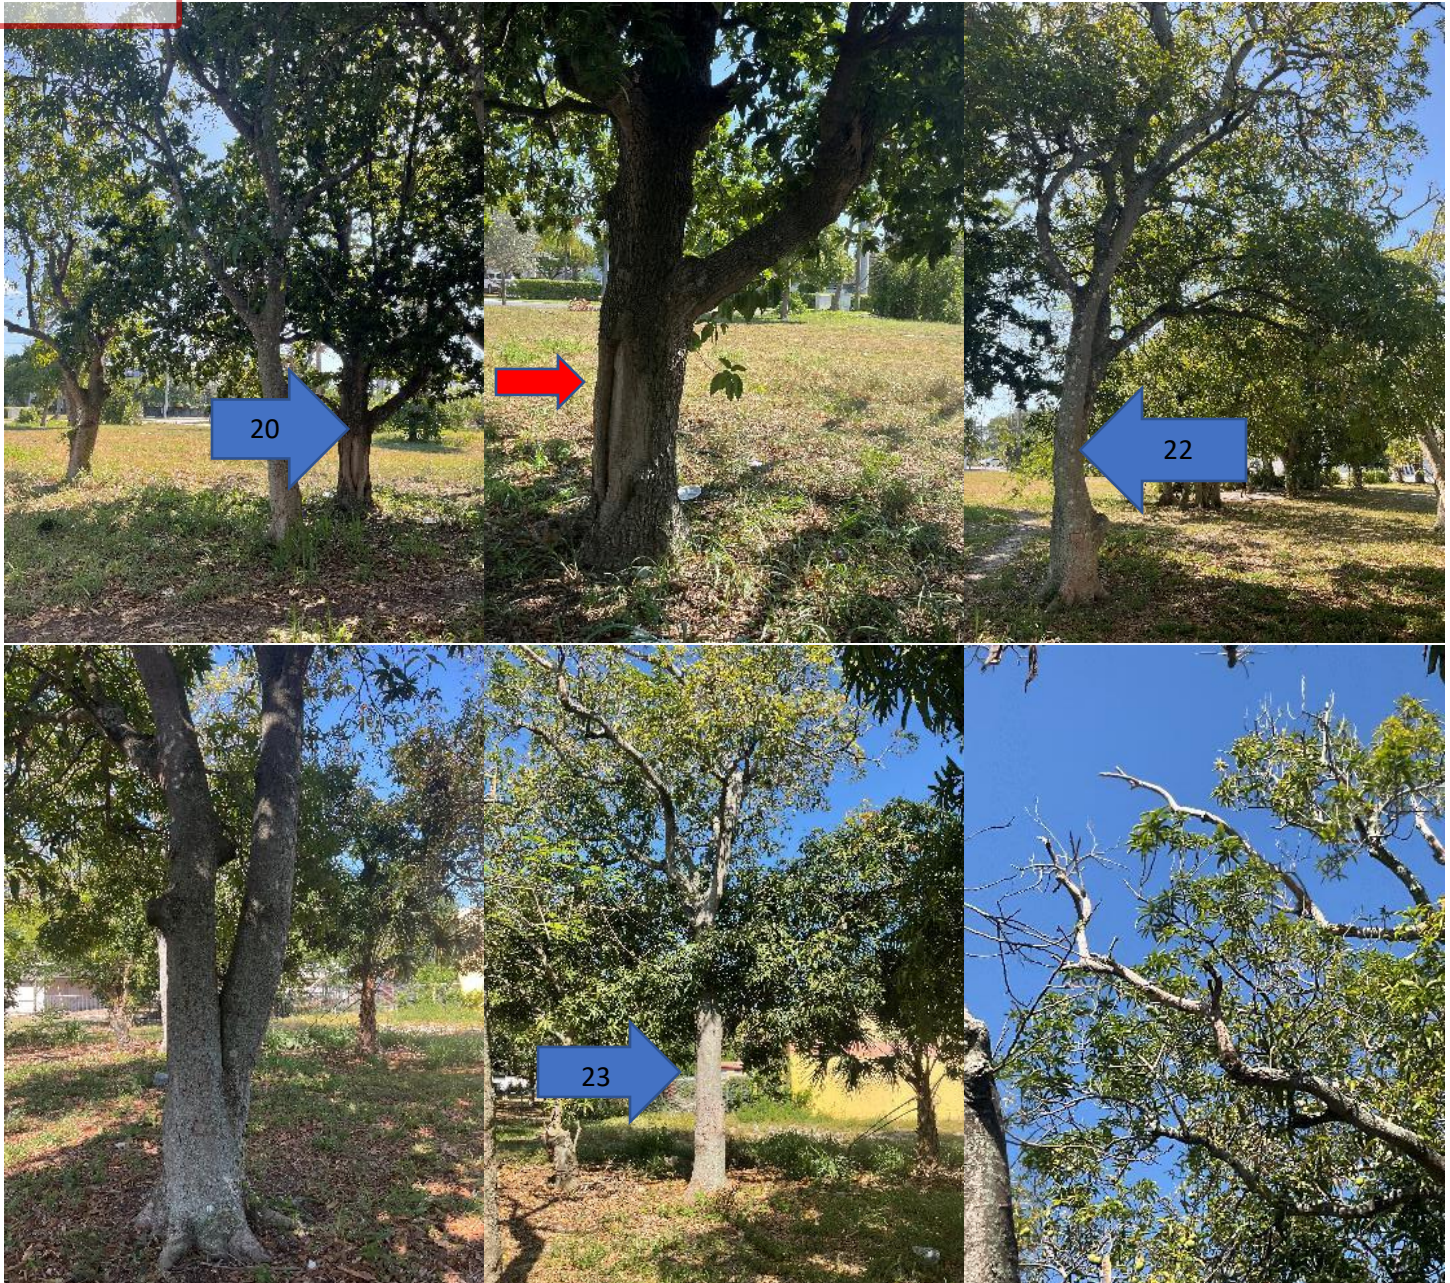
Trees 20, 22, & 23

Sapodilla (*Manilkara zapota*) Tree #20, and Mango Trees (*Mangifera indica*) Tree #'s 22 & 23 facing east, south, and west. Note visual evidence of decay, storm damage, large trunk wound (red arrow), and deadwood for Tree #20, poor structure, canopy dieback, storm damage, and canopy crowding for Tree #22, and poor structure, large diameter deadwood, and canopy dieback for Tree #23.

| PZ22-12000032 | 5.16.23 | 324 NW 6th St. Pompano Beach, FL | | | | | | | | | |
|---|---|---|---|---|---|---|---|---|---|---|---|
| 20 | Sapodilla | <i>Manilkara zapota</i> | 39 | 27 | 23 | | Fair | 55% | \$ 2,770.63 | N | Visual evidence of decay, storm damage, large trunk wound, deadwood |
| 22 | Mango | <i>Mangifera indica</i> | 33 | 24 | 23 | | Fair | 53% | \$ 2,844.29 | N | Poor structure, canopy dieback, storm damage, canopy crowding |
| 23 | Mango | <i>Mangifera indica</i> | 31 | 26 | 18 | | Fair | 50% | \$ 2,099.97 | N | Poor structure, large diameter deadwood, canopy dieback |
