Enclosed please find the updated Certified Arborist Report/Tree Assessment for the property located at 200 N. Federal Hwy. in Pompano Beach, FL conducted on November 16, 2022.

# ARBORIST REPORT

200 N. Federal Hwy.  
Pompano Beach, Fl 33062

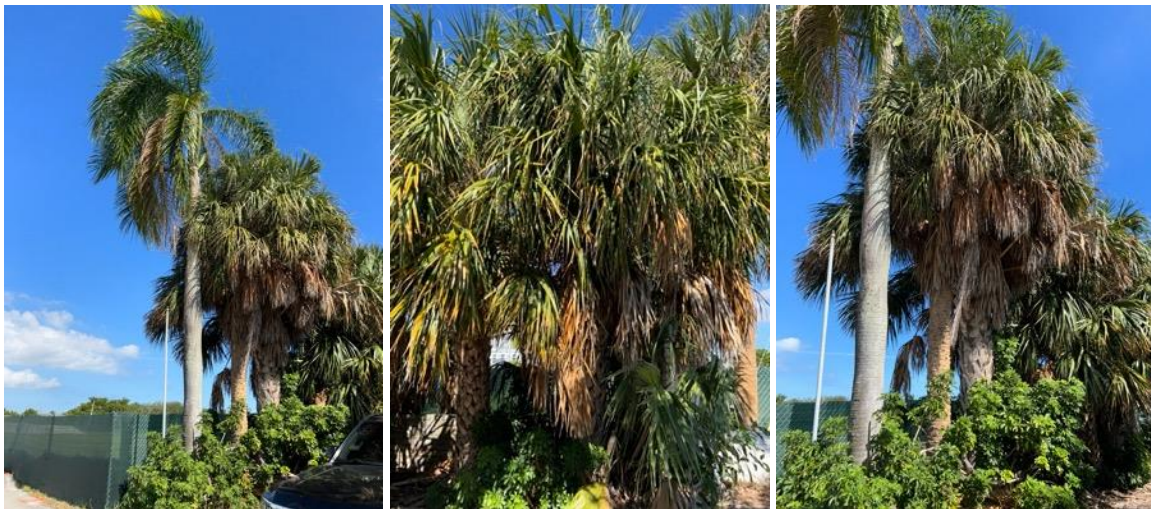
**Tree #1 – *Roystonea regia*, Royal Palm** – this tree is located in the northwest corner of the property adjacent to the parking lot and next to the ROW. It is crowded with minor chlorosis and a slightly undersized canopy. Overall, it is in fair condition and is proposed for removal.

**Tree #2 – *Sabal palmetto*, Sabal Palm** – this tree is located directly east of Tree #1. It is very crowded with a pronounced curve in the upper trunk due to the crowded conditions. It is in fair condition and is proposed for removal.

**Tree #3 – *Sabal palmetto*, Sabal Palm** – this tree is located directly east of Tree #2 on the northeast side of the property. It is very crowded and has live fronds only on one side of the trunk due to severe crowding. It is in poor condition and is proposed for removal.

**Tree #4 – *Sabal palmetto*, Sabal Palm** – this tree is located directly east of Tree #3. It is very crowded and overgrown but otherwise is in fair condition. This tree is proposed for removal.

**Tree #5 – *Sabal palmetto*, Sabal Palm** – this tree is located directly east of Tree #4. It is very crowded and overgrown but otherwise is in fair condition. It is proposed for removal.

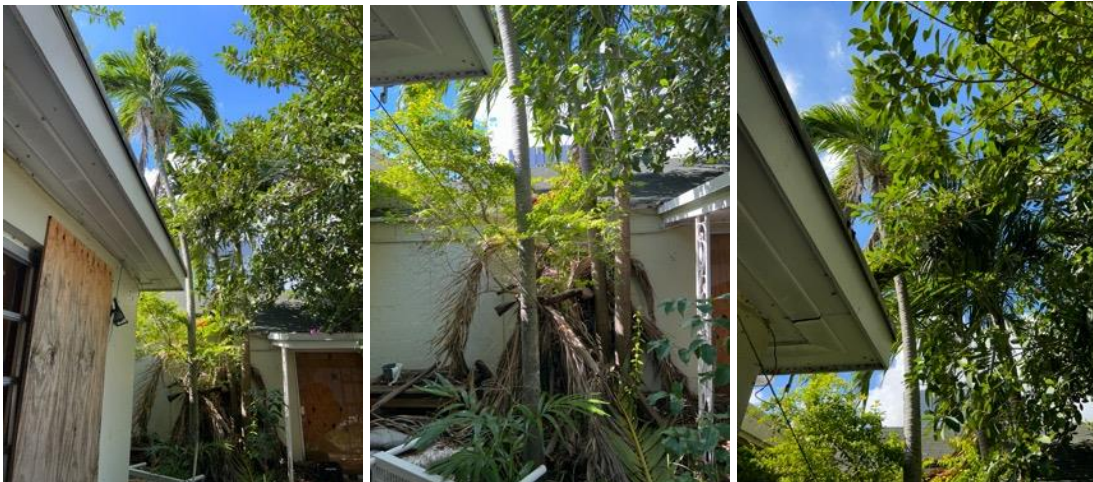
**Tree #16 – *Roystonea regia*, Royal Palm** – this tree is located near the southeast corner of the property. It shows very minor signs of nutrient deficiency but otherwise is in good condition. It is proposed for removal.

**Tree #17 – *Roystonea regia*, Royal Palm** – this tree is located on the south side of the property just east of the entrance to the asphalt parking lot. It is in good condition with no significant defects. It is proposed for removal.
