Arborist Report

3225 NE 5th St,
Pompano Beach, FL
33062

PZ24-12000008

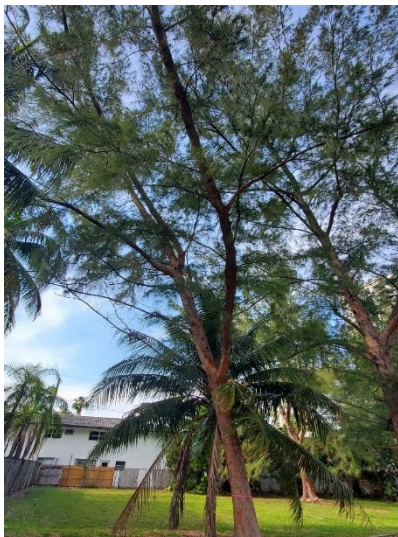
Tree # 2**Common Name**

Scientific Name*Casuarina equisetifolia***DBH (in) – 16 "****Height (ft) – 35'****Canopy Spread (ft) 30'****Condition – Poor****Native? - No****Disposition – To be removed****Invasive Exotic- YES**

Tree #2 is an Australian Pine is an invasive exotic tree species as per FLEPPC Category I list of species. Tree is located south side of the property on site. This Australian pine is in poor condition with two main co-dominant leaders compromising tree stability and risk of failing. This tree is in conflict as well with the proposed new development and is proposed to be removed with no mitigation required.

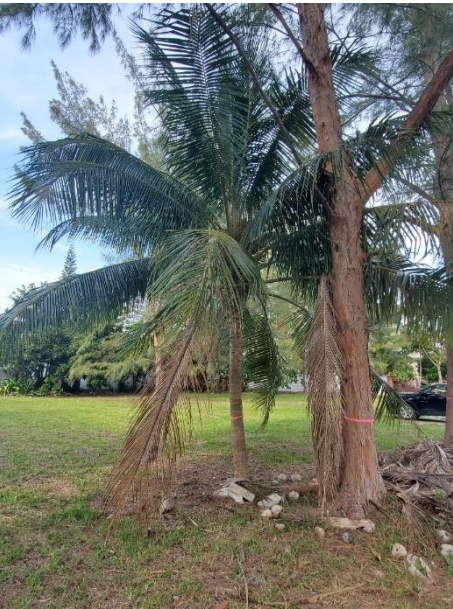
Tree # 3

Common Name	DBH (in) – 8 ”	Condition – fair	Native? - No
Coconut Palm	Height (ft) – 16’	Disposition – To be removed	
Scientific Name	Canopy Spread (ft) 15’		
<u>Cocos nucifera</u>

Tree #3 is a Coconut palm. This palm is in fair condition its upper canopy shows interveinal chlorosis and extreme burning on lower of fronds. The trunk shows clear signs of tapering reducing its girth on the top and slightly vent sideways due to severe nutritional deficiencies. This palm has been severely neglected over the years due to lack of care fertilization and watering. This palm is currently proposed to be removed as part of the upcoming new construction activities and will be mitigated on site.

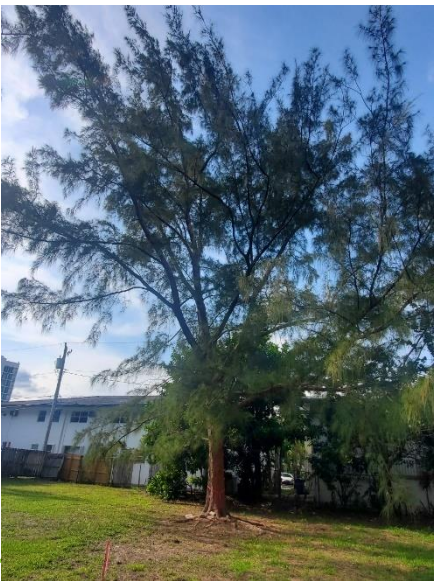
Tree # 4

Common Name	DBH (in) – 23 ”	Condition – Poor	Native? - No
Australian Pine	Height (ft) – 50’	Disposition – To be removed	
Scientific Name	Canopy Spread (ft) 40’	Invasive Exotic- YES	
<u>Casuarina equisetifolia</u>

Tree #4 is an Australian Pine is an invasive exotic tree species as per FLEPPC Category I list of species. Tree is located in the middle of the lot north side of the property on site. This Australian pine is in poor condition with three main co-dominant leaders compromising tree stability and risk of failing. This tree is in conflict as well with the proposed new development and is proposed to be removed with no mitigation required.

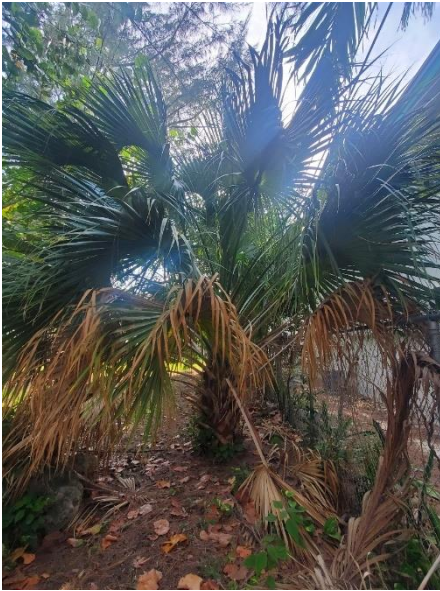
Tree # 7**Common Name**

Scientific NameSabal palmetto**DBH (in)** 14"**Condition** – Good**Native?** - Yes**Height (ft)** – 8' OA**Disposition** – To be removed**Canopy Spread (ft)** 8'

Tree #7 is a young size sable palm in a fair condition its upper canopy shows interveinal chlorosis and extreme burning on lower of fronds. This palm is a volunteer seedling probably from wildlife dispersal. This palm is currently proposed to be removed as part of the upcoming new construction activities.

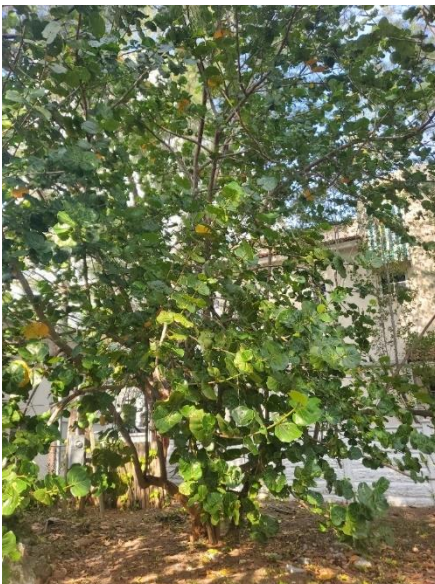
Tree #8**Common Name**

Scientific NameCoccoloba uvifera**DBH (in)** – 16 "**Condition** – Fair**Native?** - Yes**Height (ft)** – 25'**Disposition** - To be removed**Canopy Spread (ft)** 25'

Tree #8 is a young Seagrape tree located north side of the property this tree probably was dispersed from wildlife seeds. Tree is in fair condition has severe codominant leaders and included bark and has been severely damaged and deformed during previous storm events and is growing more like a bush with several trunks. This tree is in conflict with proposed new construction and is currently proposed to be removed and mitigated on site.

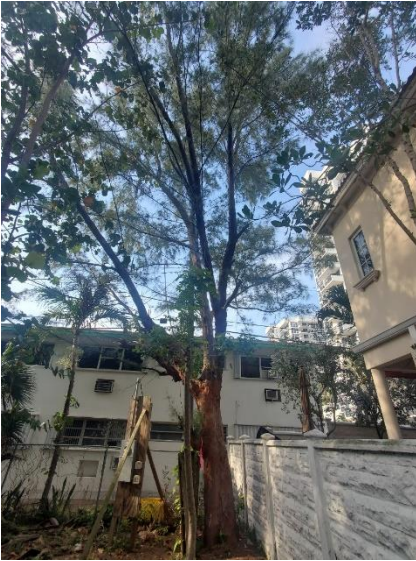
Tree # 9**Common Name**

Scientific Name*Casuarina equisetifolia***DBH (in) – 2 1 "****Condition – Poor****Native? - No****Height (ft) – 60'****Disposition – To be removed****Canopy Spread (ft) 40'****Invasive Exotic- YES**

Tree #9 is a large Australian Pine as per attached picture. This tree is an invasive exotic tree species as per FLEPPC Category I list of species. Tree is located north east side of the property on site. This Australian pine is in poor condition with three main co-dominant leaders compromising tree stability and risk of failing. Damage to adjacent property is highly probable. This tree is in conflict as well with the proposed new development and is proposed to be removed with no mitigation required.

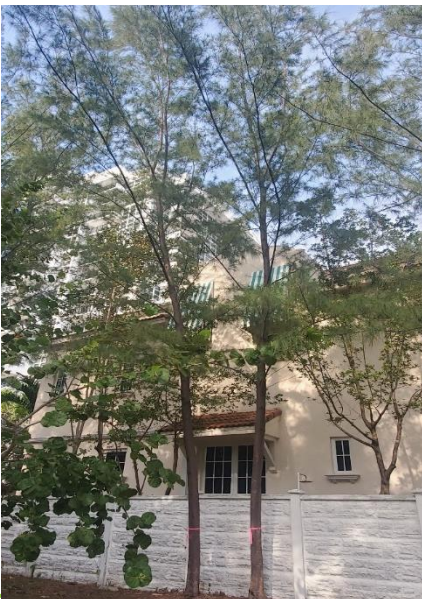
Tree # 10 & #11**Common Name**

Scientific Name*Casuarina equisetifolia***DBH (in) – 7 "****Condition – Poor****Native? - No****Height (ft) – 30'****Disposition – To be removed****Canopy Spread (ft) 20'****Invasive Exotic- YES**

Trees #10 & #11 are both Australian Pines invasive exotic tree species as per FLEPPC Category I list of species. Trees are located east side of the property on site. These Australian pines are seed dispersed by adjacent existing large Australian pine trees. Trees are in good condition with one single leader. Damage to adjacent property is highly probable. These trees are in conflict as well with the proposed new development and is proposed to be removed with no mitigation required.

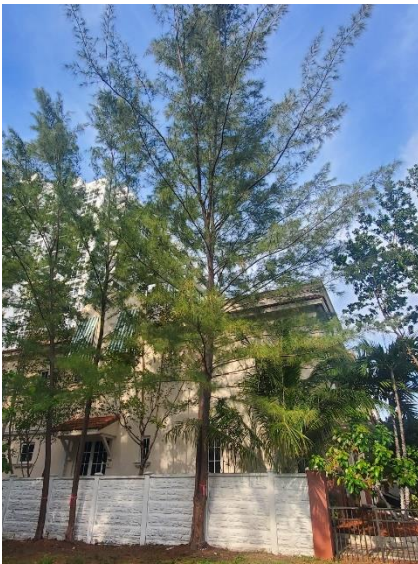
Tree # 12**Common Name**

Scientific Name*Casuarina equisetifolia***DBH (in) – 15 "****Condition – Good****Native? - No****Height (ft) – 40'****Disposition – To be removed****Canopy Spread (ft) 30'****Invasive Exotic- YES**

Tree #12 is an Australian Pine an invasive exotic tree species as per FLEPPC Category I list of species. Tree is located south side of the property on site. This Australian pine is in good condition with one main leader. Damage to adjacent property is highly probable. This tree is in conflict as well with the proposed new development and is proposed to be removed with no mitigation required.

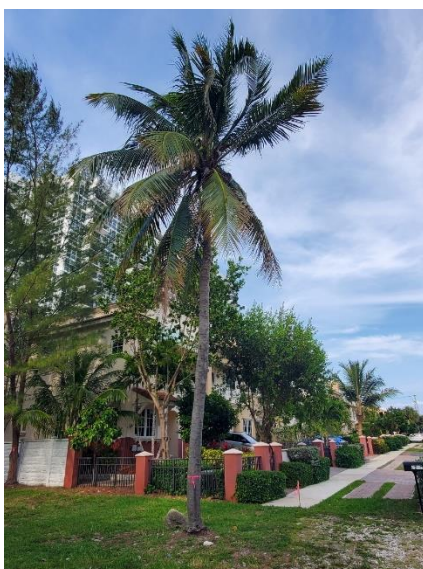
Tree # 13**Common Name**

Scientific Name*Cocos nucifera***DBH (in) – 10 "****Condition – Fair****Native? - No****Height (ft) – 30' OA****Disposition – To be removed****Canopy Spread (ft) 15'**

Tree #13 is a Coconut palm. This palm is located SE side of the property and is in fair condition its upper canopy shows interveinal chlorosis and extreme burning on lower of fronds. The trunk shows clear signs of tapering reducing its girth on the top and slightly vent sideways due to severe nutritional deficiencies. This palm has been severely neglected over the years due to lack of care fertilization and watering. This palm is currently proposed to be removed as part of the upcoming new construction activities and will be mitigated on site.
