**PZ25-12000009**

## Arborist Report- Development Project

### Tree Inspection(s) and Consulting Arborist Recommendations

**Property: 117 S. Riverside Dr, Pompano Beach, FL**

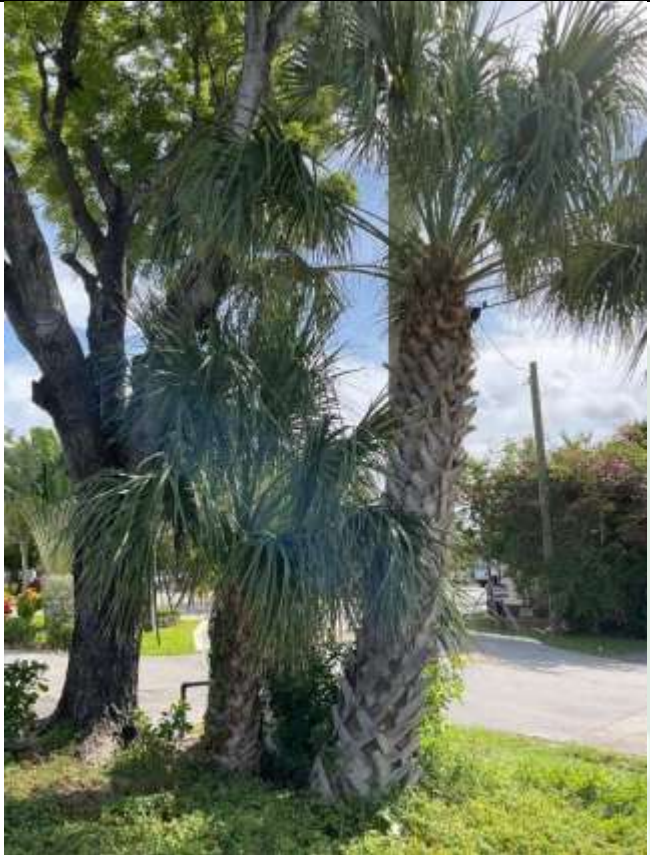
Tree/Survey #201 and #202 Sabal Palm, <i>Sabal palmetto</i>	PZ25-12000009

09/03/2025  These Sabal palms are growing adjacent to the power pole and under power lines. These are likely wildlife installed palms, not designed in landscape. They are in good condition, but have been over-pruned. They are in the construction footprint. The location is not conducive to transplanting the palms. The recommendation is to remove the palms.

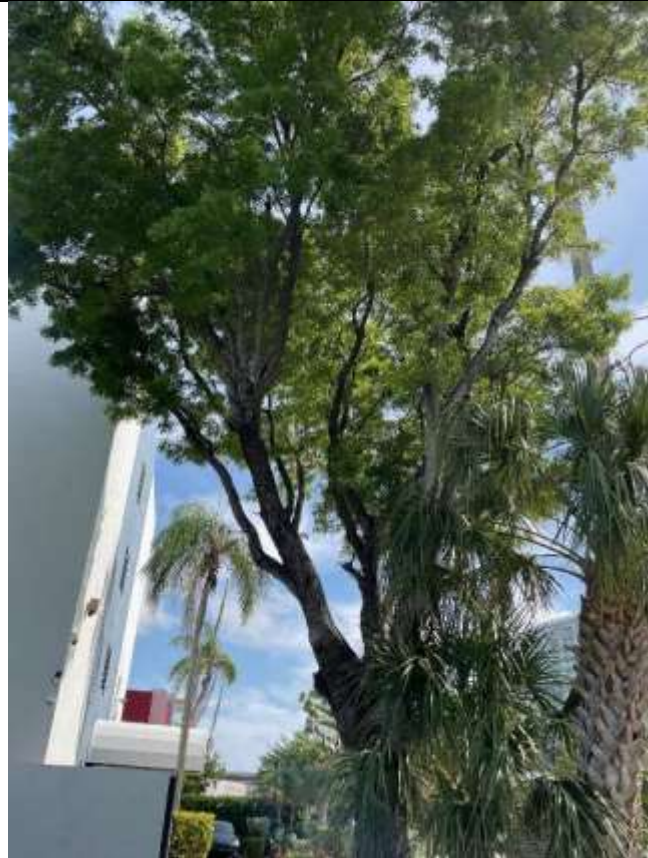
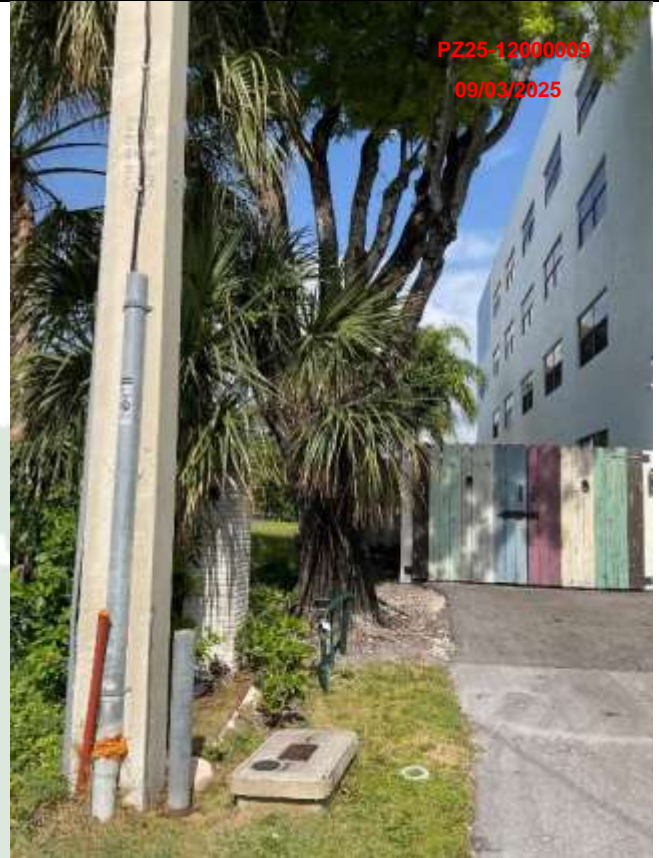
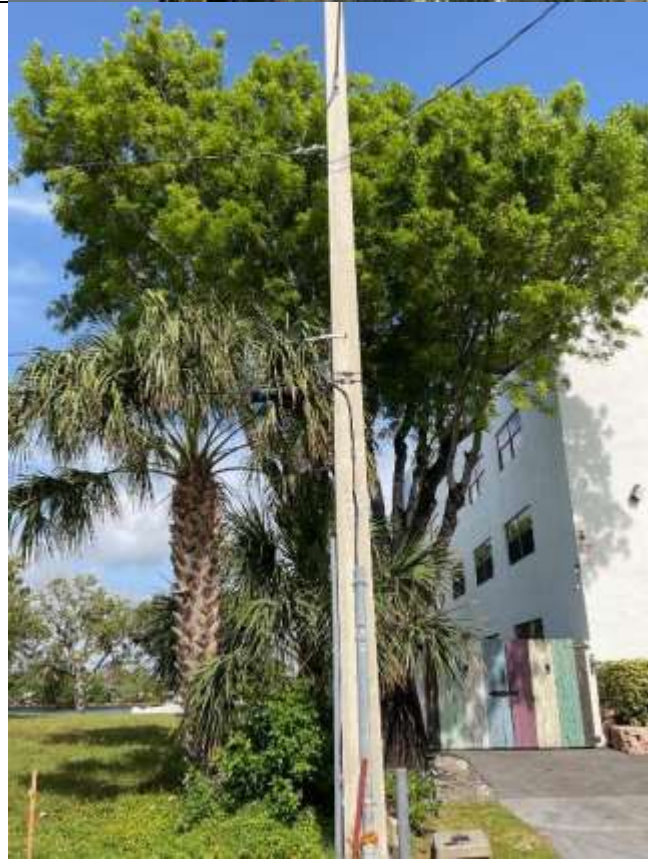
This Mahogany we think has trunk reaching across the property line. It is in fair to poor condition. The tree has been over-lifted, has exposed roots, and is damaging the adjacent pavement. There are overhead utilities in the canopy and underground utilities in the rootzone. The recommendation is for the tree to remain and be protected during construction.

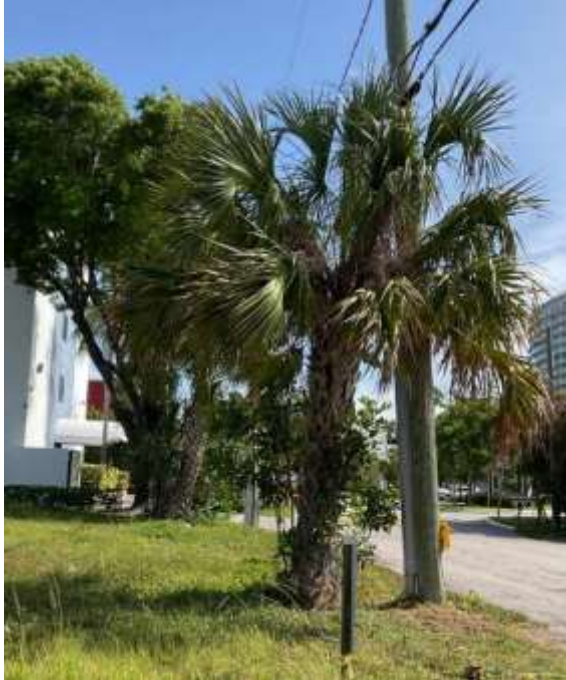
These Sabal palms are growing adjacent to the power poles and under power lines. These area likely wildlife installed. They are in good condition, but have been over-pruned. Tree #204 is in the construction footprint, with location not conducive to transplanting it. We recommend to remove palm #204. Tree #205 is outside the construction footprint, so we recommend for the palm to remain.

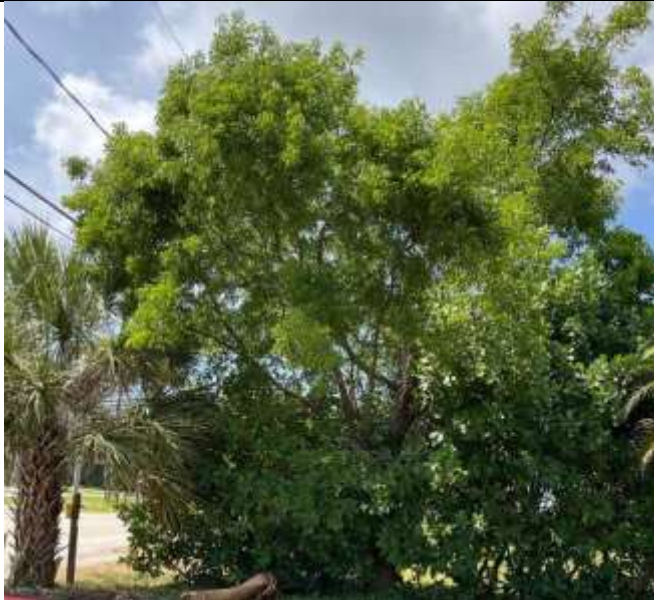
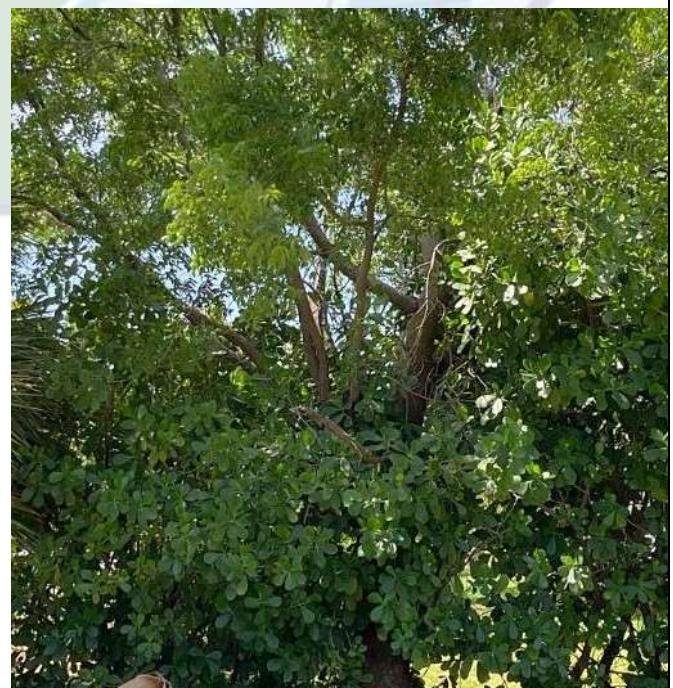
**Tree/Survey #206 Gumbo Limbo, *Bursera simaruba***

Tree # 206 is a Gumbo Limbo growing from within the perimeter Clusia hedge on the property line. It is in fair to poor condition, and is likely wildlife installed. It has been hatracked, or hedge-pruned, in the past. There are stub cuts and crossing limbs. There are utility lines near the canopy. The recommendation is to remove the tree, so the Clusia hedge can be maintained for better growth.

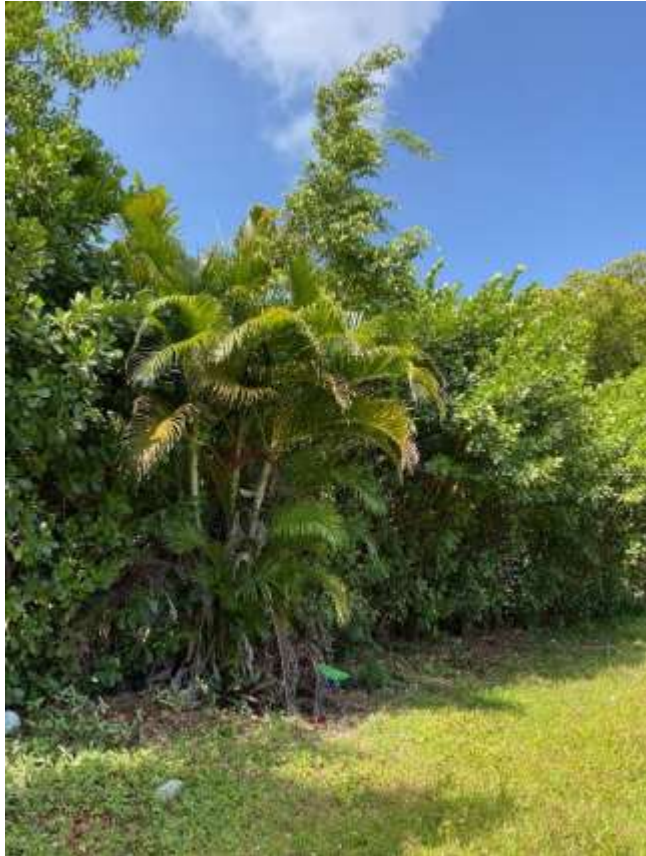
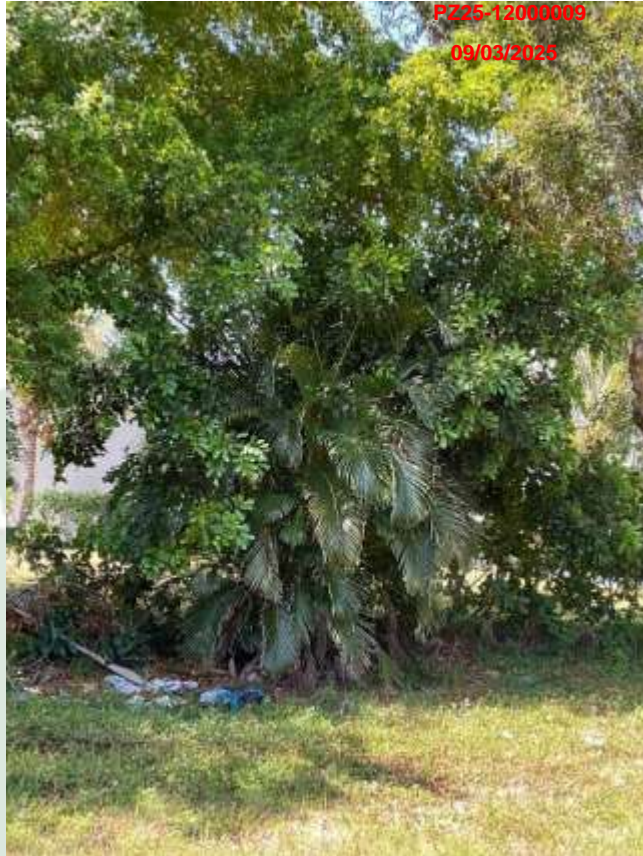
Tree/Survey #207 and #209 Areca Palm, <i>Dypsis lutescens</i>		DRC
Tree #207	Tree #209

Areca palms can be aggressive weeds, with them growing in disturbed and unmaintained sites. The palms in this hedge are likely wildlife installed, and are undesirable in this location. They have nutrient deficiencies and exhibit dieback and decline. The recommendation is to remove the palms.		
Tree #302 Weeping Fig, <i>Ficus benjamina</i>

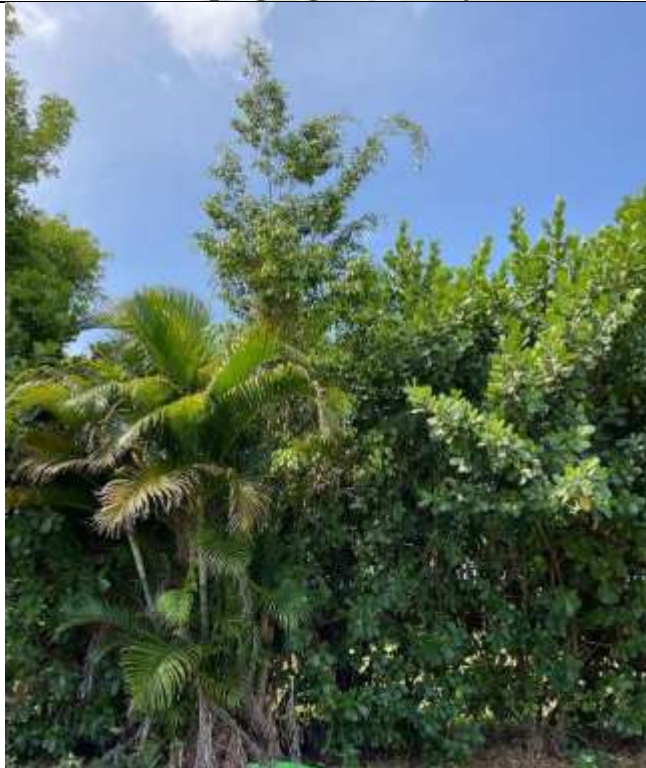
<p>Weeping Fig can be an aggressive weed, being wildlife installed in many disturbed and unmaintained sites. This one was either wildlife installed, or sprouted from previous hedge stumps. The recommendation is to remove the tree.</p>

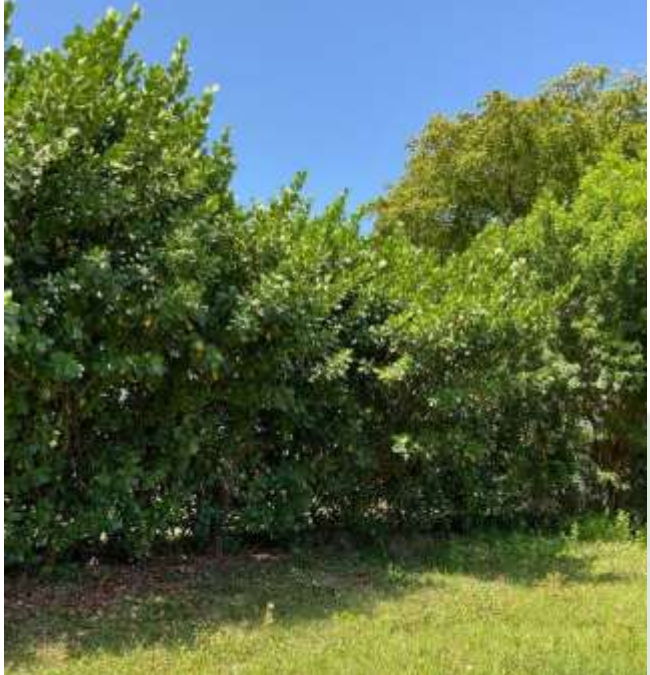
Tree #303 Autograph Tree, Pitch Apple Hedge, <i>Clusia rosea</i>	DRC

<p data-bbox="1252 191 1403 212">PZ25-12000009</p> <p data-bbox="1268 231 1386 252">09/03/2025</p> <p data-bbox="824 388 1451 604">The Clusia hedge on the property line ranges from 15 to 25' tall. It is overgrown and has not been maintained recently. It is in fair to good condition. The recommendation is for the hedge to remain and be maintained with proper pruning and weed/invasive plant removal.</p>
Tree #208 Brazilian Pepper, <i>Schinus terebinthifolia</i>

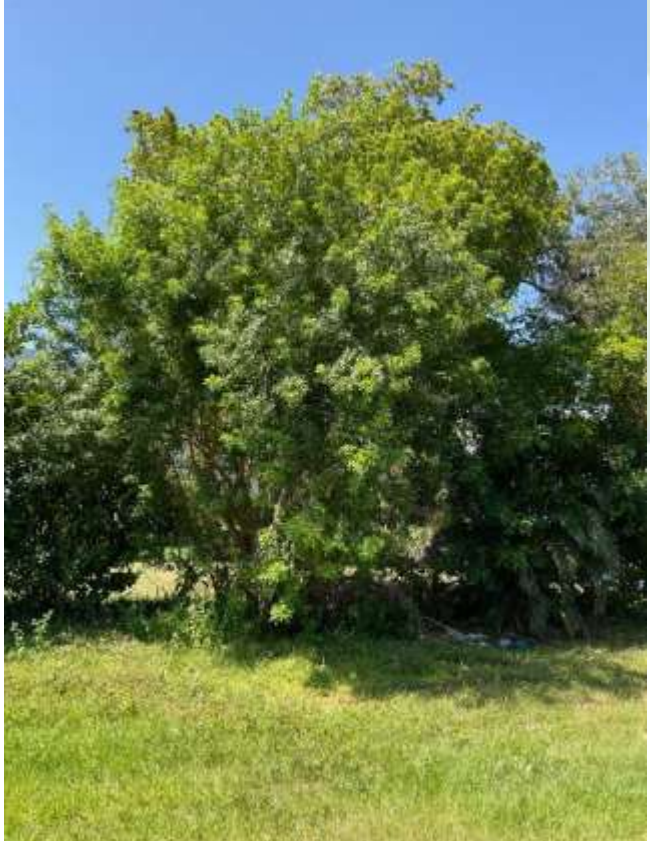
<p data-bbox="824 1211 1458 1388">Brazilian Pepper is a Category I invasive exotic plant. It grows in many locations, including open, rarely maintained areas like this hedge. The recommendation is to remove this plant with no mitigation required.</p>

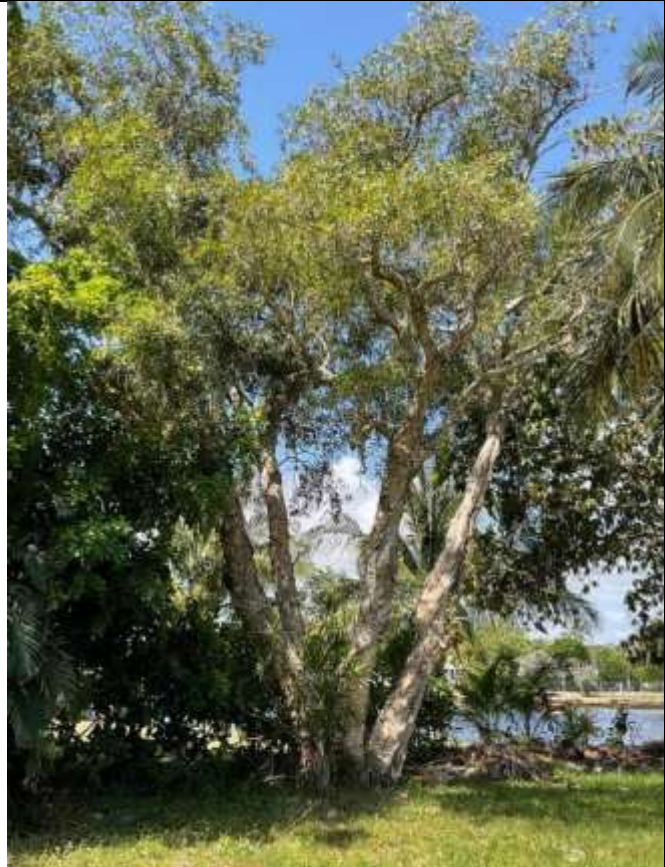
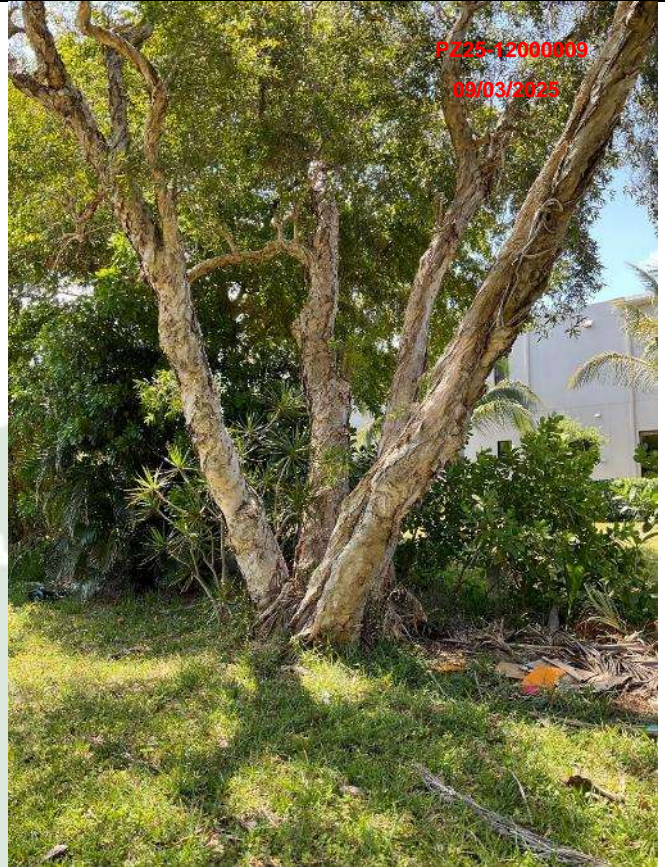
**Tree #210 Melaleuca, Punk Tree, *Melaleuca quinquenervia***

Melaleuca is a Category I invasive exotic plant. It grows in many locations, including open, rarely maintained areas like this hedge. The recommendation is to remove this plant with no mitigation required.

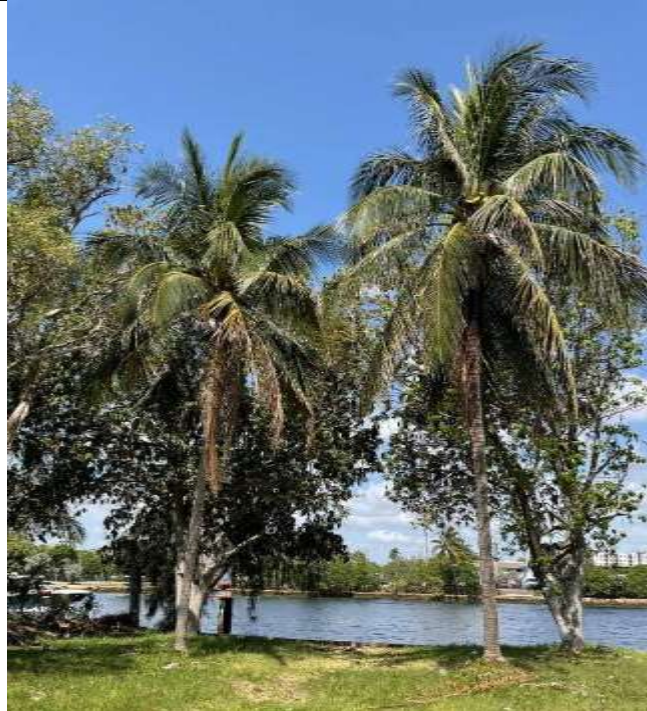
**Tree/Survey #211 and #212 Coconut Palm, *Cocos nucifera***

The Coconut palms are in good to fair condition. They are in the construction footprint. The recommendation is to remove or relocate the palms.

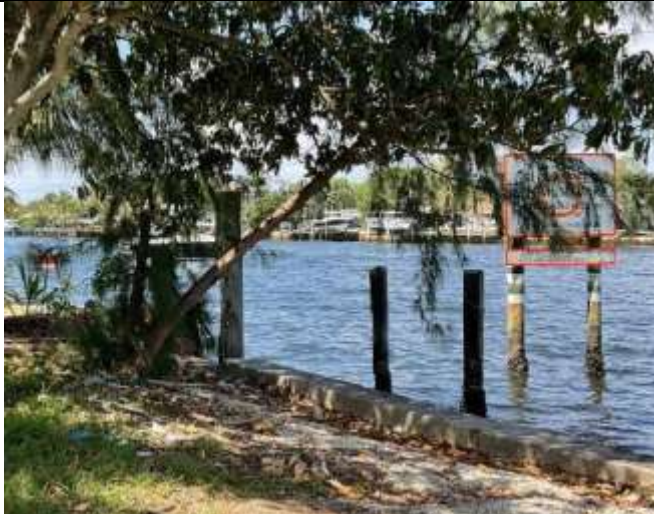
**Tree #214 Australian Pine, Beefwood, *Casuarina spp.***

Australian Pine is a Category I invasive exotic plant. It grows in many locations, including open, rarely maintained areas. The recommendation is to remove this plant with no mitigation required.

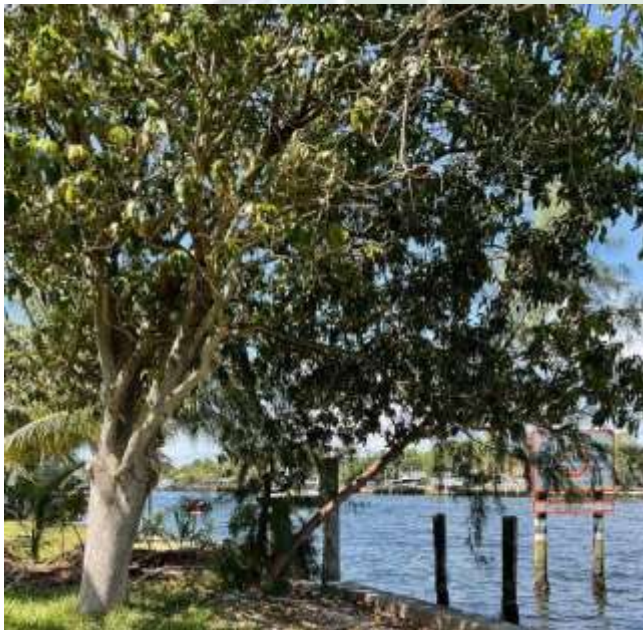
Tree #213

These three Mango trees are in fair to poor condition. They all exhibit dieback, decline, and salt damage. They have been damaged by previous trimming and storm damages. They are in the construction footprint. The recommendation is to remove these Mango trees.

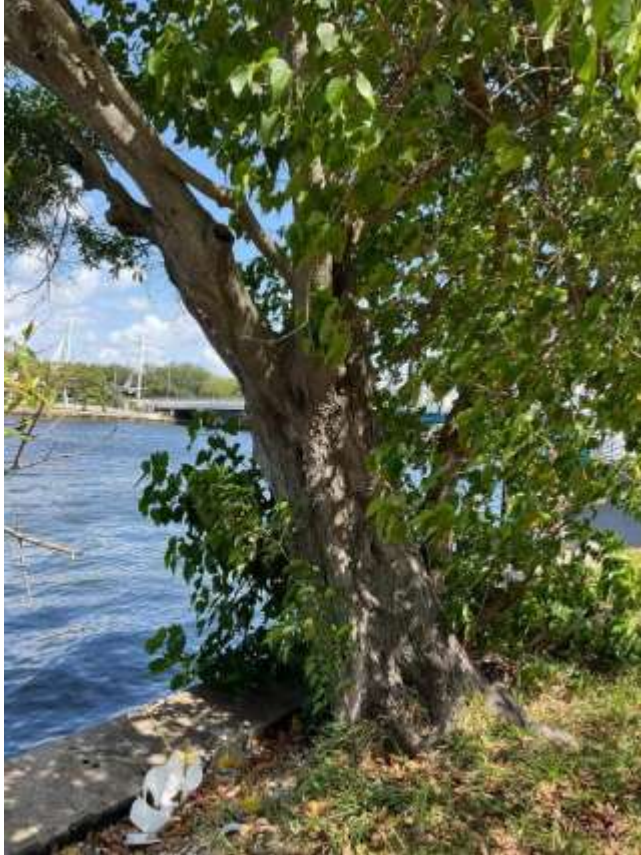
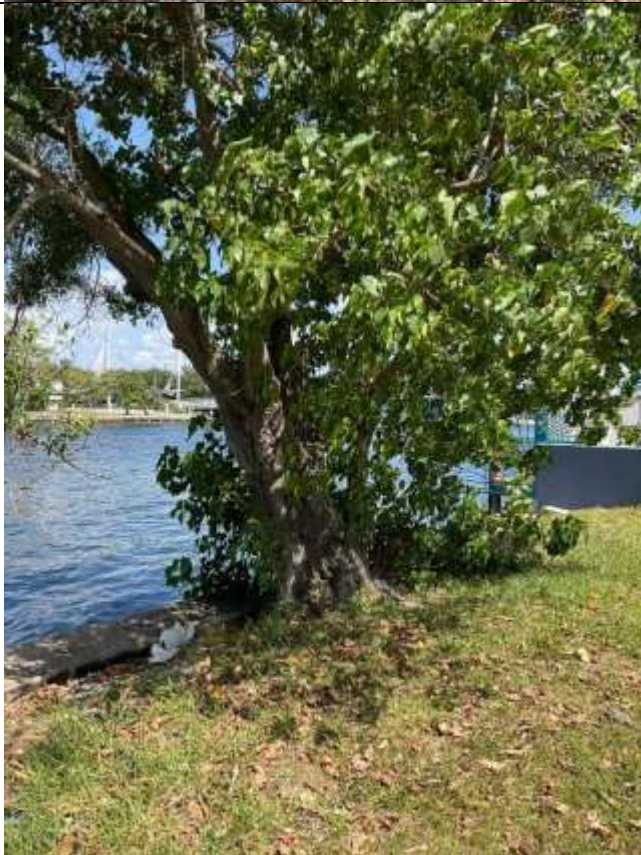
**Tree/Survey #217 Willow Busic, *Sideroxylon salicifolium* and #304 Seaside Mahoe, *Thespesia populnea***

Tree #217, Willow Busic is in poor condition. It exhibits dieback and decline, and included bark. It has been hatracked and is leaning. It is in the construction footprint, so the recommendation is to remove the tree.

Tree #304 is growing from the root crown area of the Willow Busic. Seaside Mahoe is a Category I invasive exotic plant. It is wildlife installed and then grows near other trees and plants in many locations, including open, rarely maintained areas. The recommendation is to remove this plant with no mitigation required.

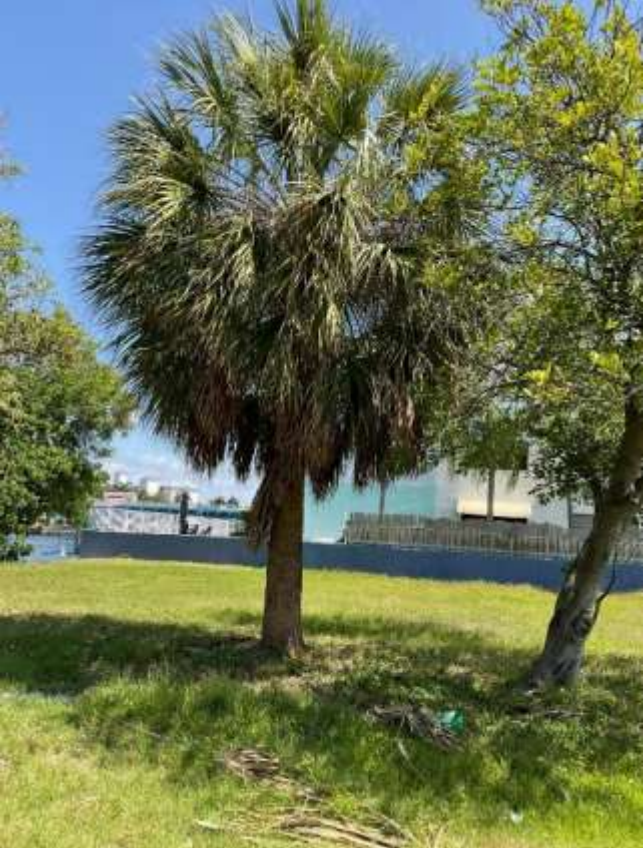
Tree/Survey #218 Sabal Palm, <i>Sabal palmetto</i>	DRC

<p data-bbox="1248 191 1403 212">PZ25-12000009</p> <p data-bbox="1265 231 1386 252">09/03/2025</p> <p data-bbox="824 527 1455 632">This Sabal palm is in good condition. It is in the construction footprint. The recommendation is to remove or relocate the palm.</p>

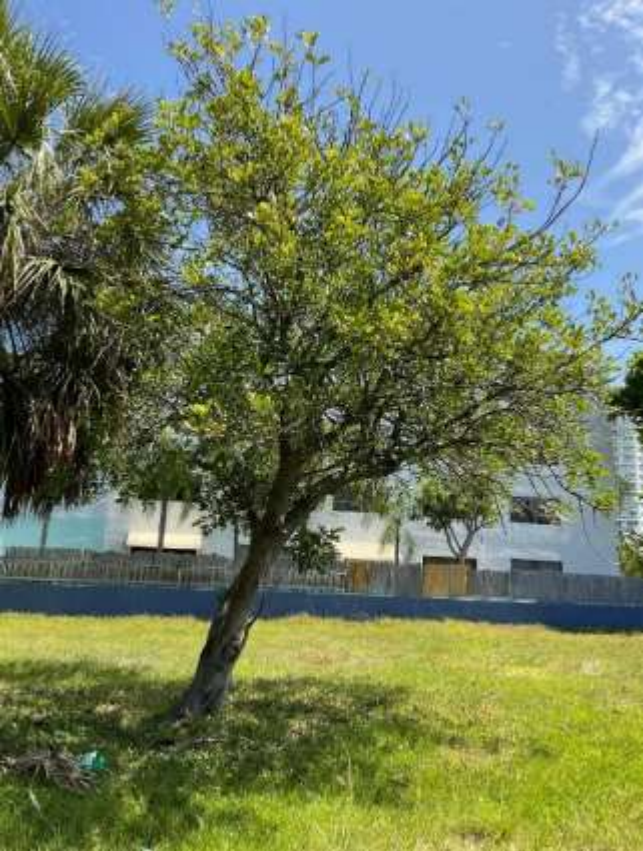
Tree/Survey #219 Carrotwood, <i>Cupaniopsis anacardioides</i>

<p data-bbox="824 1402 1461 1545">Carrotwood is a Category I invasive exotic plant. It grows in many locations, including open, rarely maintained areas. The recommendation is to remove this plant with no mitigation required.</p>

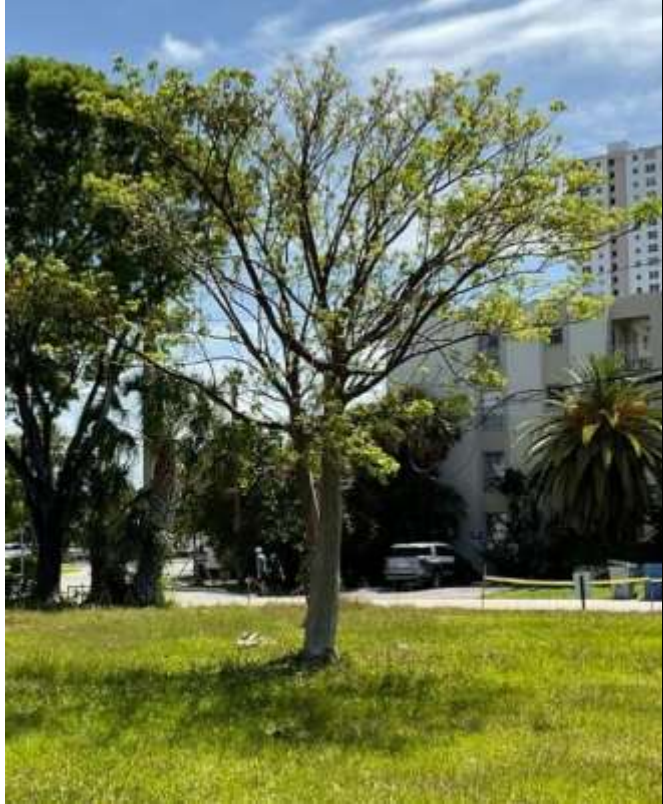
This Gumbo Limbo is in fair to poor condition. It exhibits dieback and decline, and has included bark in the branch junctures. It is in the construction footprint. The recommendation is to remove the tree.
