872 McNab Rd., Pompano Beach, FL 33060

July 27, 2023

ARBORIST REPORT 872 McNab Rd. Pompano Beach, FL 33030

Treage LLC was contacted by Andres Montero of AMLA Studio in July 2023 to conduct a Certified Arborist Report at 872 McNab Rd., Pompano Beach, FL.

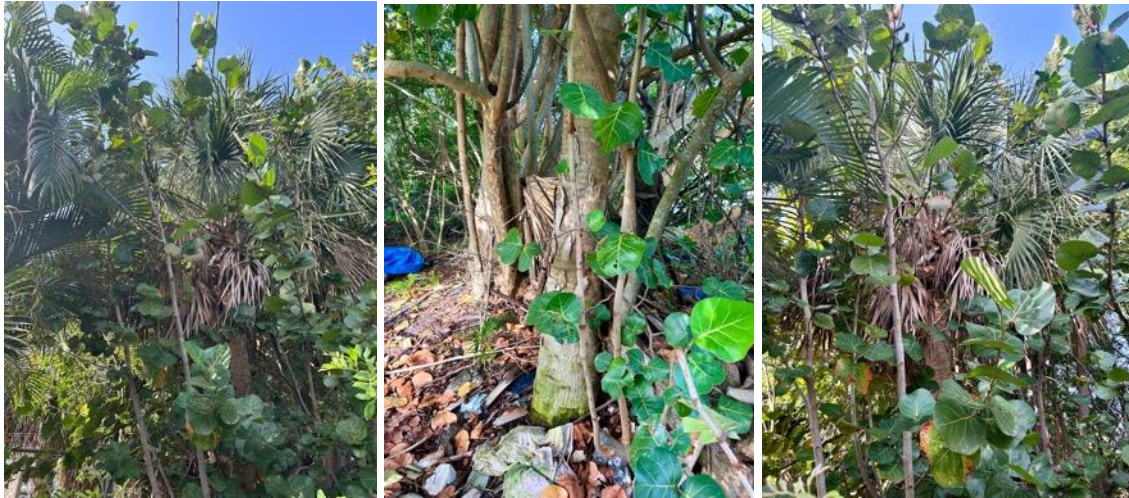
Tree #3 – *Sabal palmetto*, Sabal Palm – this tree is located on the southeast side of the property within 4' of the chain link fence separating the adjacent property. It is very crowded and overgrown but otherwise in fair condition. It will require a permit if it is to be removed, or protection during construction per measures below. As an alternative, it is a possible candidate for relocation.

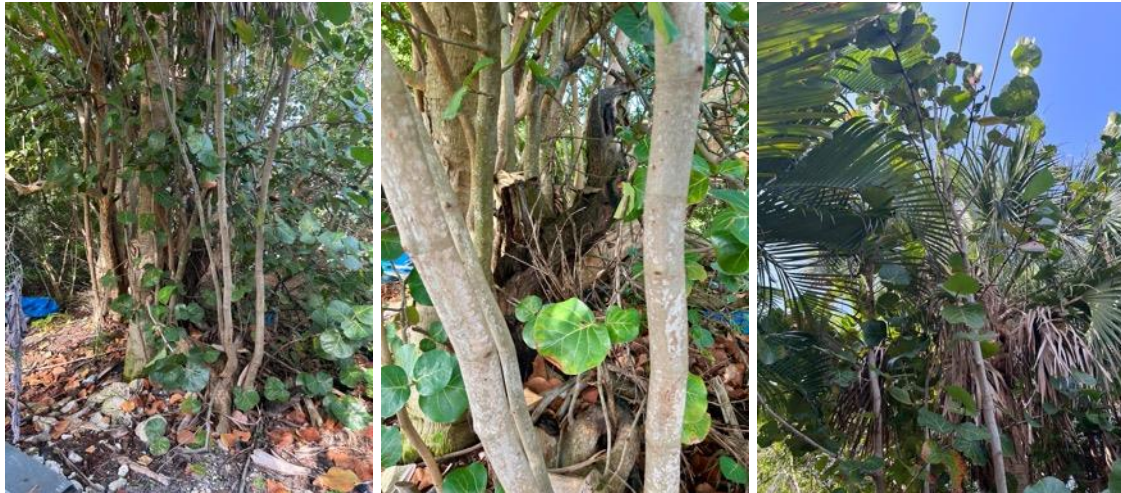
Tree #4 – *Coccoloba uvifera*, Seagrape – this tree is growing directly west of Tree #3. It has a large dead/decayed trunk that terminates at approximately 5' height and only small upright sprouts remaining. This tree is very crowded and overgrown and it has a poor branching structure. Overall, it is in moderate to poor condition.

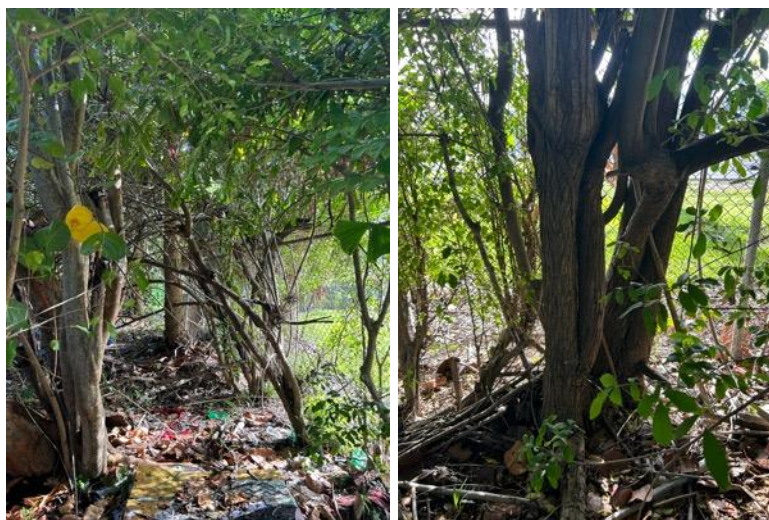
Tree #9 – *Schinus terebinthifolia*, Brazilian Pepper – this tree is growing slightly south of Tree #8 along the fence line. It is very overgrown, crowded, and in moderate condition. It is a Nuisance Species that will require removal with a no-fee permit.

Tree #10 – *Schinus terebinthifolia*, Brazilian Pepper – this tree is growing slightly south of Tree #9 along the fence line. It is very overgrown, crowded, and in moderate condition. It is a Nuisance Species that will require removal with a no-fee permit.

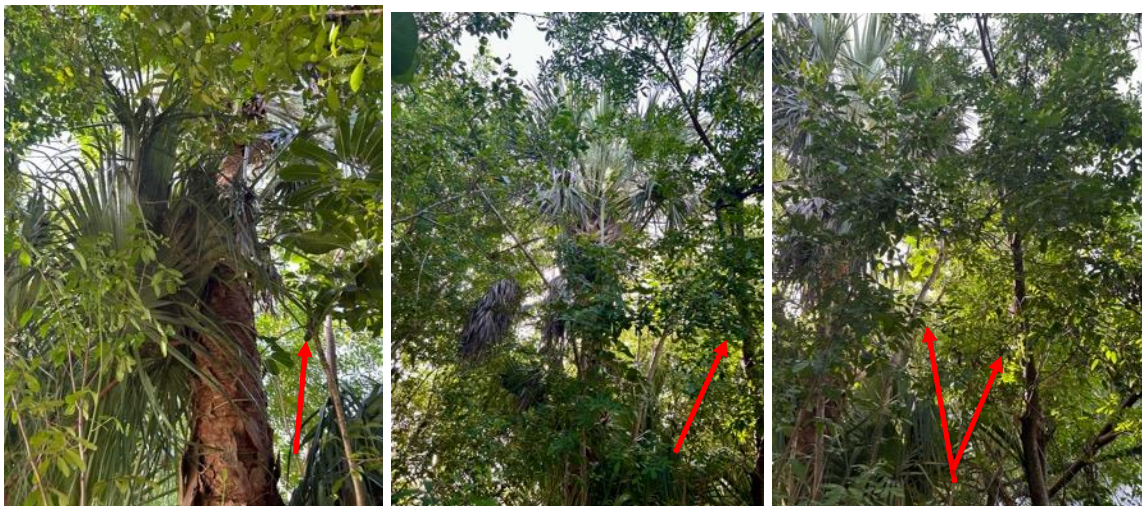
Tree #14 – *Schefflera actinophylla*, Umbrella Tree – this tree is growing on the west side of, and against, Tree #13. It is very crowded with a weak structure as a result. This is a Nuisance Species that requires removal with a no-fee permit.

Tree #15 – *Schinus terebinthifolia*, Brazilian Pepper – this tree is growing slightly west of Trees #13-14 along the west fence line. It is crowded, overgrown, and in moderate condition. It is a Nuisance Species that will require removal with a no-fee permit.

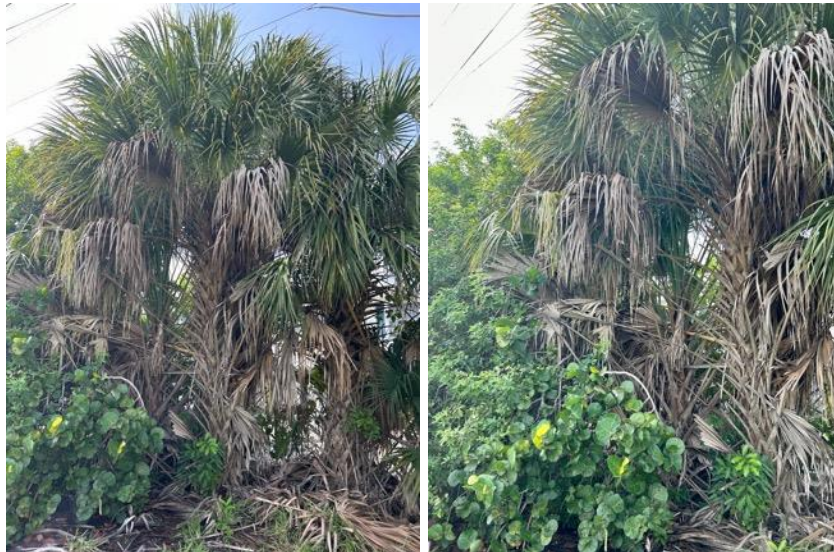
Tree #21 – *Sabal palmetto*, Sabal Palm – this tree is growing in the middle of a cluster of Sabals along the fence line with Trees #19-20. Its trunk is barely visible due to extreme crowding. It does have its boots still present. This tree could remain with protection during construction, but it is growing in close proximity to utility lines. As an alternative, it may be a decent candidate for relocation onsite per specifications below. Otherwise, it will require a permit and mitigation if it is removed.

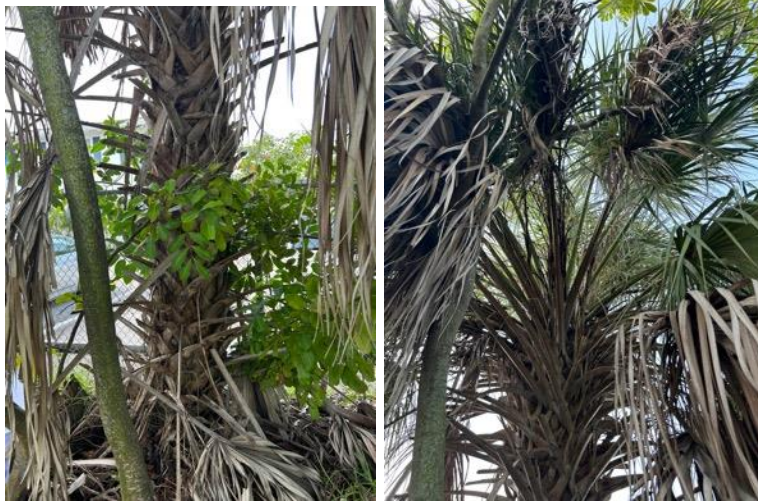
Tree #28 – *Sabal palmetto*, Sabal Palm – this tree is growing against the fence just west of Tree #27. It is crowded, overgrown, and unmaintained, and it still has its boots intact, but overall it is in fair condition. It is a decent candidate to remain due to its location and compact root zone. If it is removed, it will require a permit and mitigation.

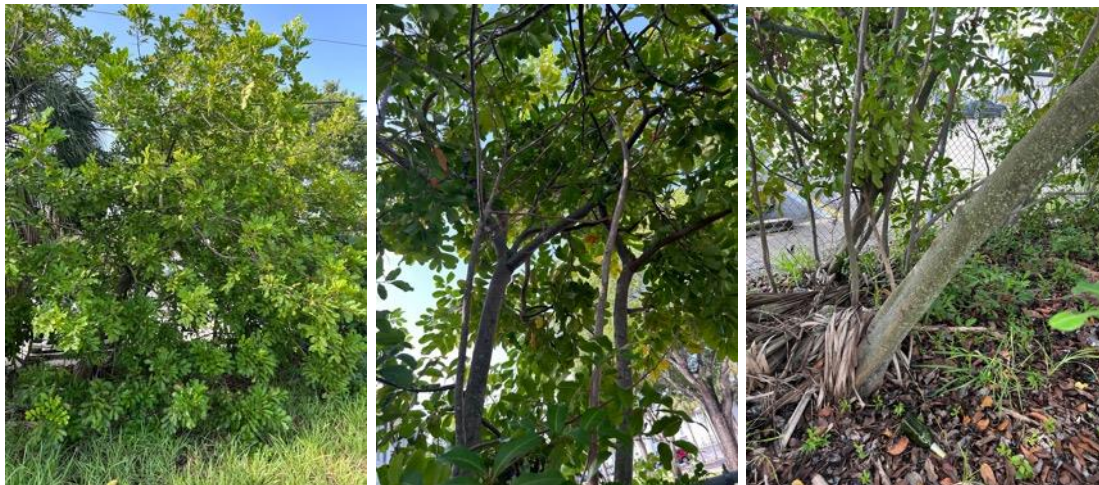
Tree #29 - *Cupaniopsis anacardioides*, Carrotwood – this tree is growing just west of Tree #28 near the property line. It is crowded and leaning in poor condition. This is a Nuisance Species that requires removal with a no-fee permit.

Tree #30 - *Cupaniopsis anacardioides*, Carrotwood – this tree is growing just behind Tree #29 near the property line. It is crowded and in poor condition with small tears present. This is a Nuisance Species that requires removal with a no-fee permit.

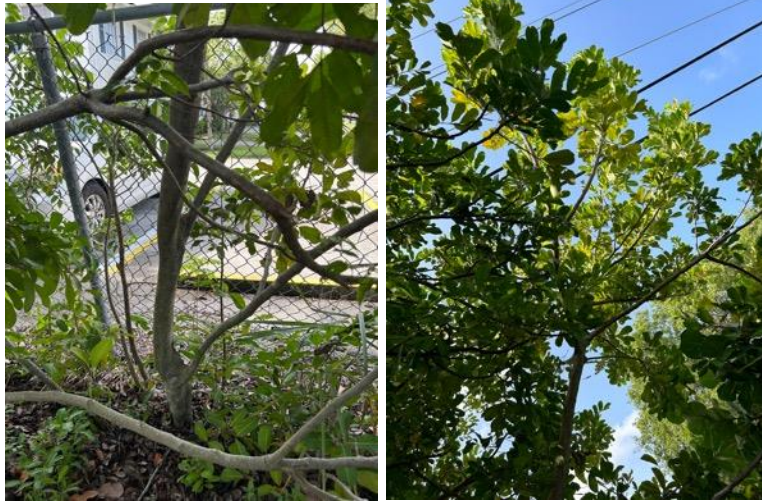
Tree #31 - *Cupaniopsis anacardioides*, Carrotwood – this tree is growing just west of Tree #30 near the property line. It is crowded and in poor condition. This is a Nuisance Species that requires removal with a no-fee permit.
