ARBORIST REPORT 872 McNab Rd. Pompano Beach, FL 33030

Treage LLC was contacted by Andres Montero of AMLA Studio in July 2023 to conduct a Certified Arborist Report at 872 McNab Rd., Pompano Beach, FL.

A site visit was conducted on July 24, 2023. A Level 2 inspection of all trees was conducted and documented with photographs. Measurements of DBH, height, and canopy were taken and recorded, and the condition of each tree was noted as Good, Fair, Moderate or Poor. Tree measurements were taken as follows: caliper was recorded with a metal Spencer ProTape; height and canopy were estimated from the ground, or with a Stanley Power Lock metal tape when necessary; and overall condition was done by visual inspection from ground level. Critical Root Zone (CRZ) and Tree Protection Zone (TPZ) were determined based on ANSI A-300 Standards for the *Management of Trees and Shrubs During Site Planning, Site Development and Site Construction*.

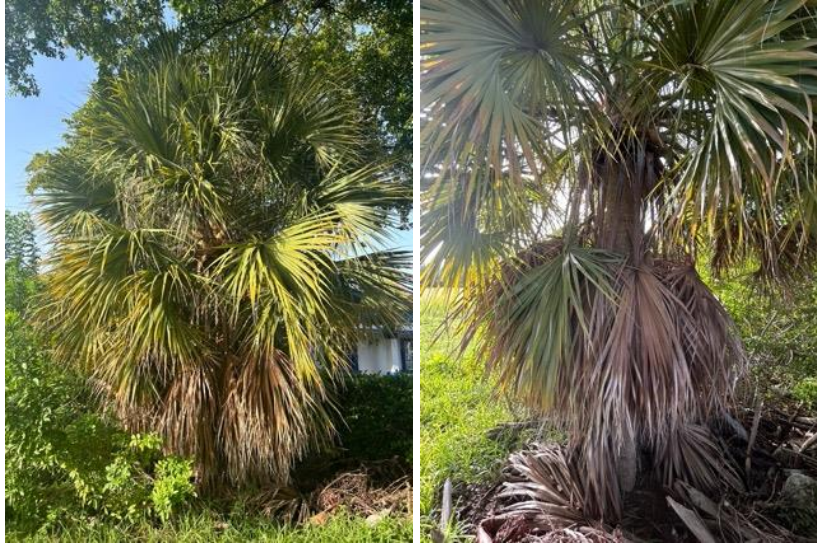
Tree #1 – *Sabal palmetto*, Sabal Palm – this tree is located on the northwest side of the site near the property line. It is crowded, overgrown, and unmaintained, but overall is in fair condition. It will require a permit if it is to be removed, or protection during construction per measures below. As an alternative, it is a decent candidate for relocation.

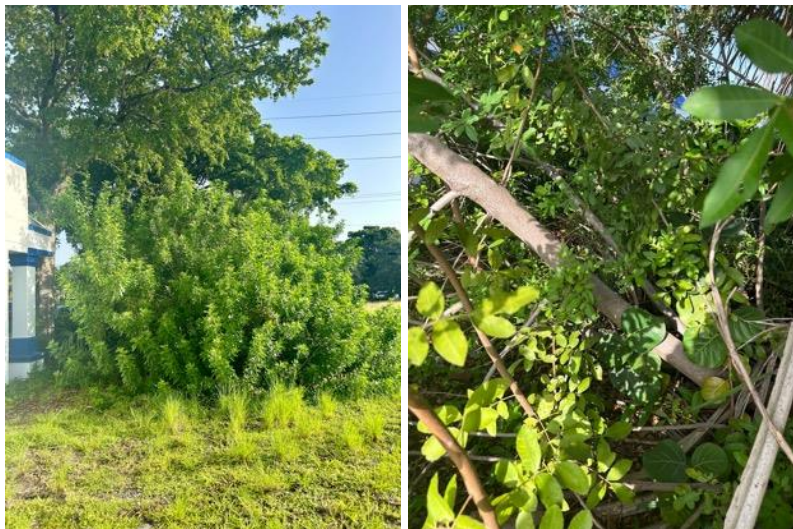
Tree #2 – *Schinus terebinthifolia*, Brazilian Pepper – this tree is growing directly south of Tree #1. It consists of multiple small trunks/sprouts and is very overgrown. This is considered a Nuisance Species that must be removed with a no-fee permit.

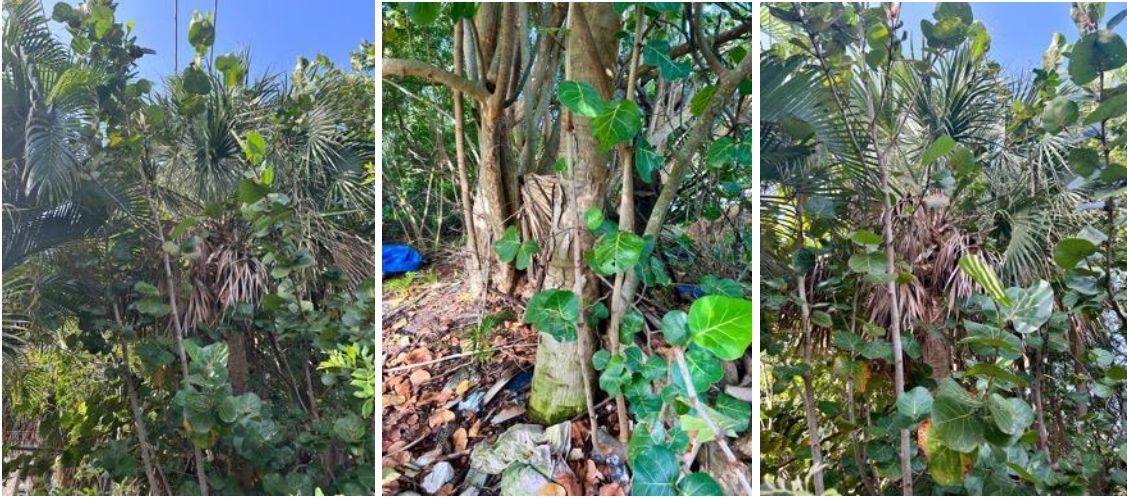
Tree #3 – *Sabal palmetto*, Sabal Palm – this tree is located on the southeast side of the property within 4' of the chain link fence separating the adjacent property. It is very crowded and overgrown but otherwise in fair condition. It will require a permit if it is to be removed, or protection during construction per measures below. As an alternative, it is a possible candidate for relocation.

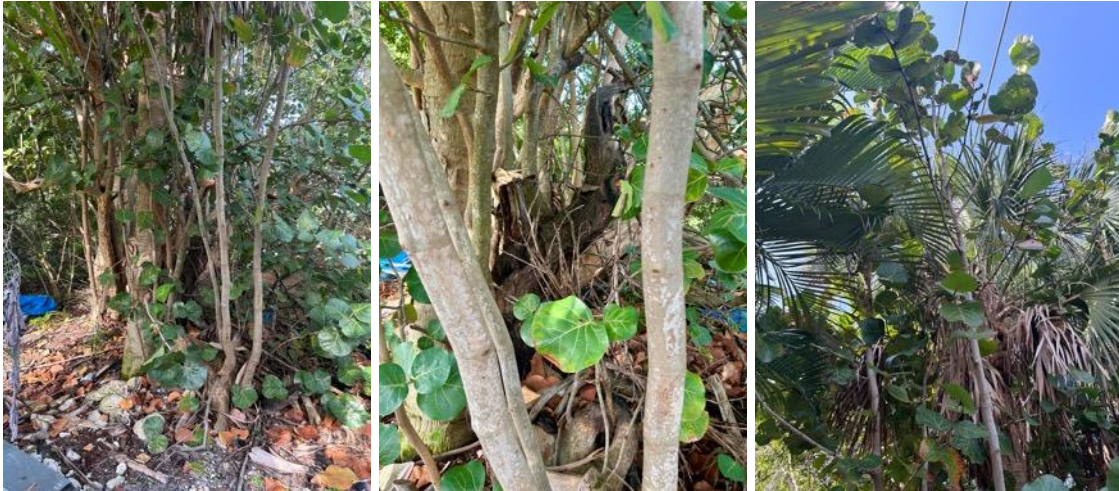
Tree #4 – *Coccoloba uvifera*, Seagrape – this tree is growing directly west of Tree #3. It has a large dead/decayed trunk that terminates at approximately 5' height and only small upright sprouts remaining. This tree is very crowded and overgrown and it has a poor branching structure. Overall, it is in moderate to poor condition.

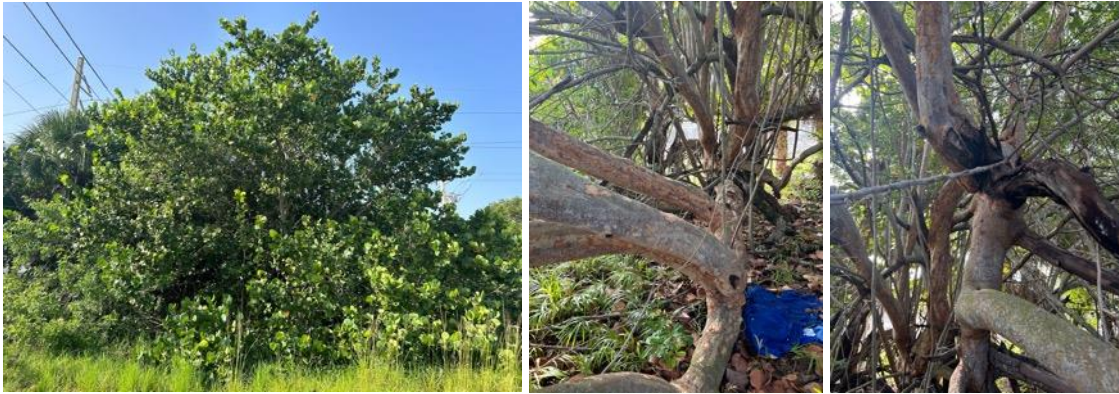
Tree #5 – *Coccoloba uvifera*, Seagrape – this tree is growing slightly southwest of Tree #4. There are 6 upright trunks on the east side of the tree and 2 large trunks that are leaning heavily to the west. This is assumed to be 1 tree that fell horizontally and is resprouting vertically from the base, although it could possibly be 2 separate trees growing against each other. It is very crowded and overgrown with areas of significant decay. Overall, this tree is in moderate condition. It is recommended for canopy cleaning/maintenance pruning and further evaluation to determine its disposition.

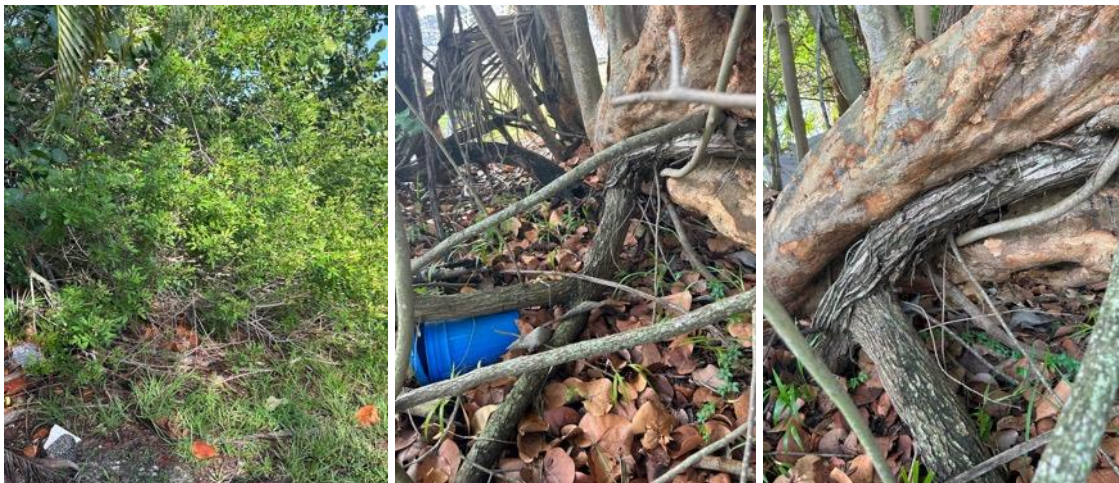
Tree #6 – *Schinus terebinthifolia*, Brazilian Pepper – this tree is growing next to and against/in contact with Tree #5. It is very overgrown, crowded, and in poor condition. It is a Nuisance Species that will require removal with a no-fee permit.

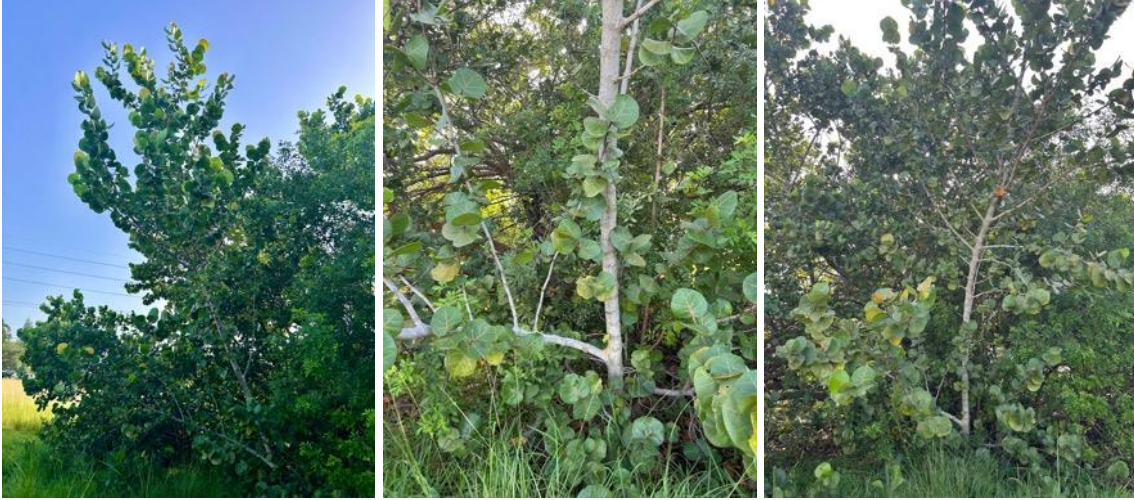
Tree #7 – *Coccoloba uvifera*, Seagrape – this is a small volunteer growing on the west side of the overgrown cluster of vegetation containing Trees #4-6. It is crowded and leaning as a result with an overall weak structure/growth habit. This tree is in moderate condition. It will require a permit if it is to be removed, or protection during construction per measures below. As an alternative, it is a possible candidate for relocation.

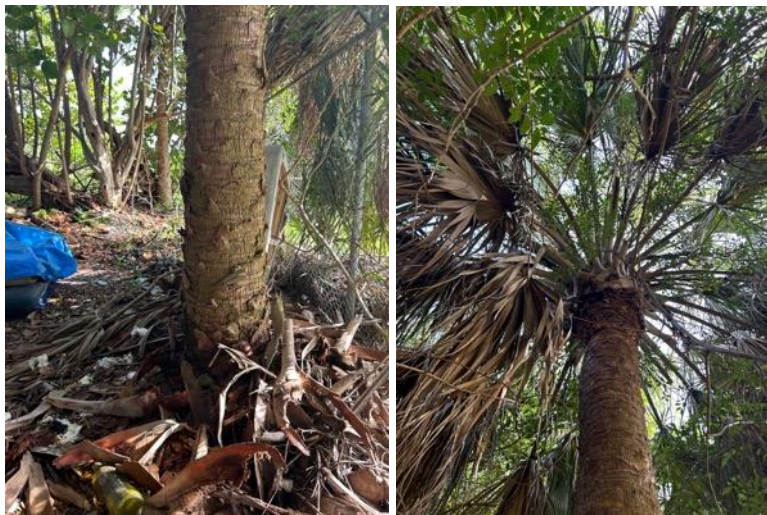
Tree #8 – *Sabal palmetto*, Sabal Palm – this palm is growing within 3.5' of the chain link fence slightly south of Tree #3. It is very crowded and overgrown, but otherwise in fair condition. It will require a permit if it is to be removed, or protection during construction per measures below. As an alternative, it is a possible candidate for relocation.

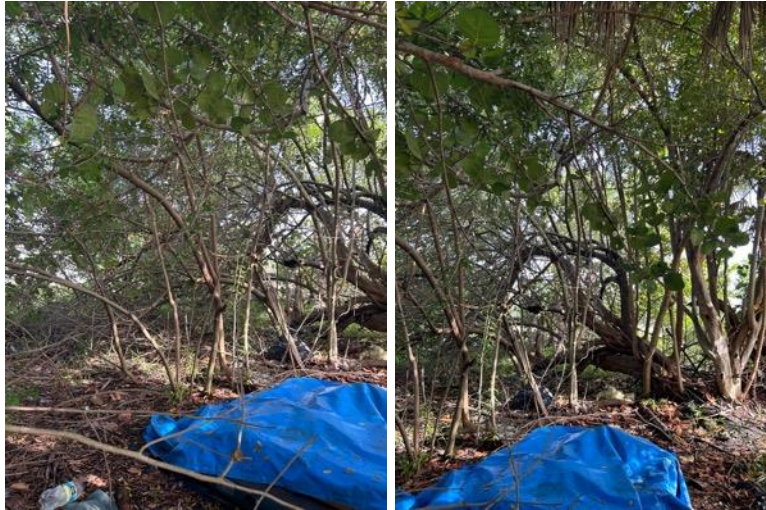
Note: there are several small Brazilian Pepper volunteers, all under 3" DBH, growing under the canopy of Tree #5. They are under regulation size and were not individually counted. These are Nuisance Species that should be eligible for removal without a separate permit (to be confirmed by the City).

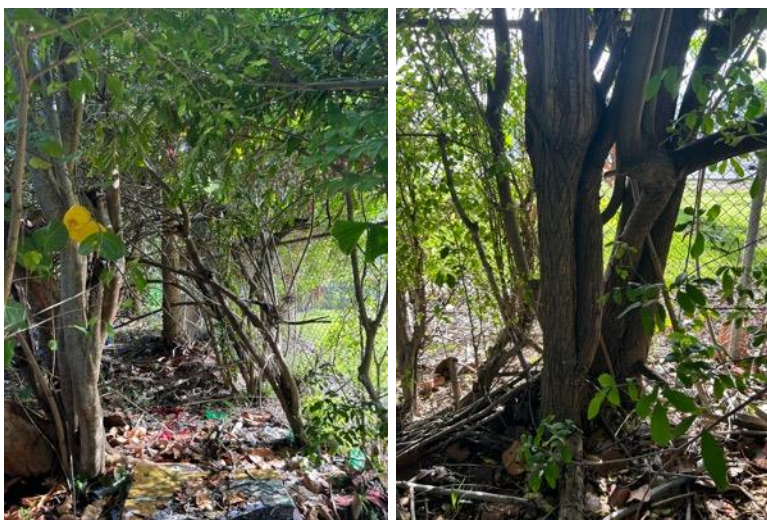
Tree #9 – *Schinus terebinthifolia*, Brazilian Pepper – this tree is growing slightly south of Tree #8 along the fence line. It is very overgrown, crowded, and in moderate condition. It is a Nuisance Species that will require removal with a no-fee permit.

Tree #10 – *Schinus terebinthifolia*, Brazilian Pepper – this tree is growing slightly south of Tree #9 along the fence line. It is very overgrown, crowded, and in moderate condition. It is a Nuisance Species that will require removal with a no-fee permit.

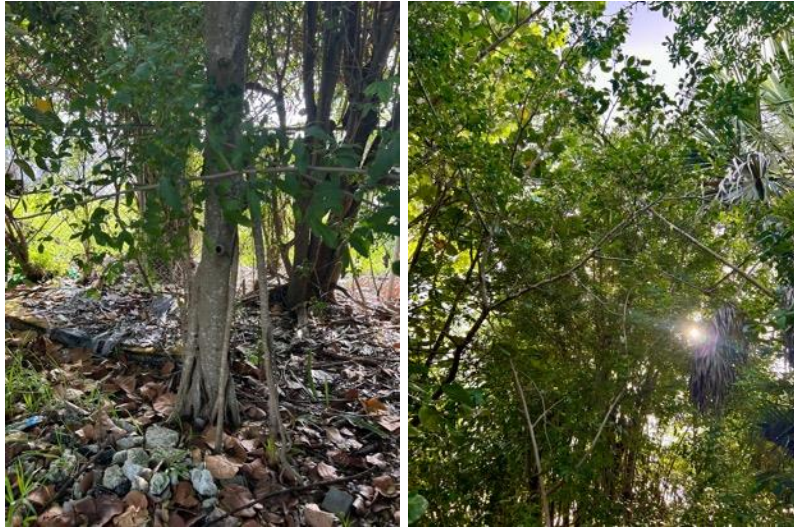
Tree #11 – *Ficus benjamina*, Weeping Fig – this tree is located slightly west of Tree #10. It is very crowded and overgrown and leaning somewhat as a result. Overall, it is in moderate condition. It will require a permit if it is removed, or protection during construction per measures below if it remains.

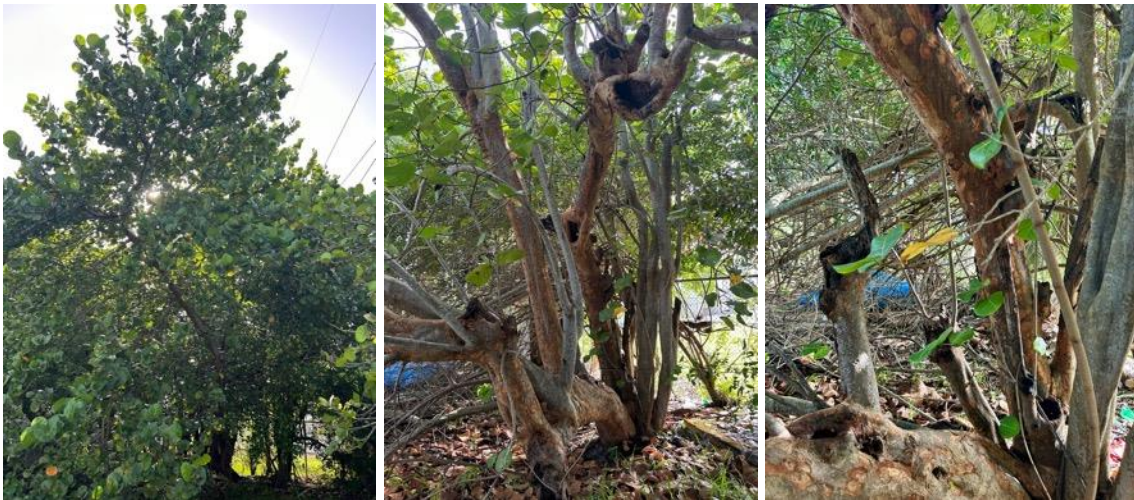
Tree #12 – *Coccoloba uvifera*, Seagrape – this large tree is growing slightly northwest of Tree #10 near the southeast corner of the property. It consists of multiple trunks, the majority of which have poor cuts and tears with deadwood and decay present. Overall, this tree is in borderline fair condition. It is recommended for canopy cleaning/maintenance pruning and further evaluation to determine its disposition.

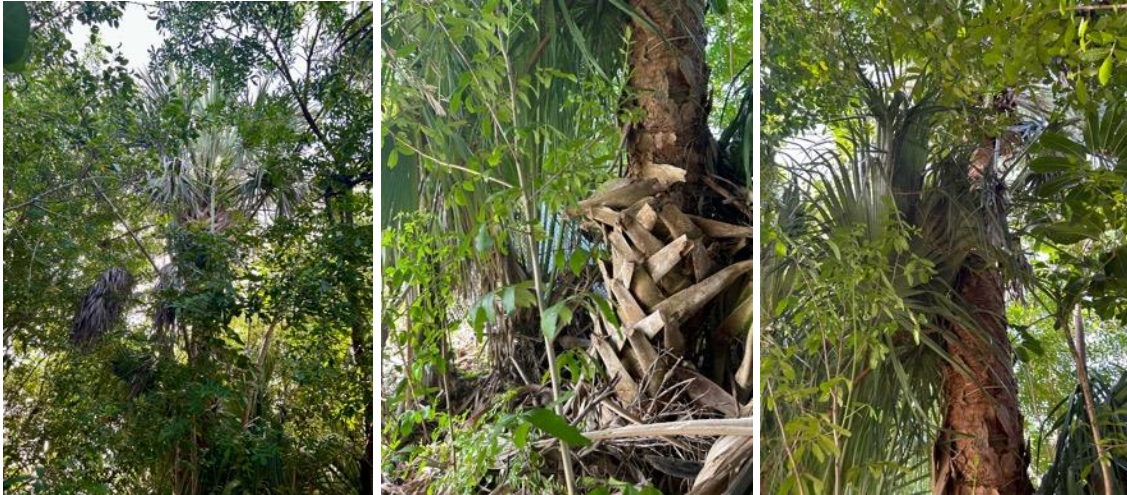
Tree #13 – *Sabal palmetto*, Sabal Palm – this palm is growing in the southeast corner of the property. It is very crowded and overgrown and difficult to access, and it has partial boots remaining, so the DBH had to be estimated. Overall, this tree appears to be in fair condition. It is a decent candidate to remain with protection due to its location along the fence. Otherwise, it will require a permit if it is to be removed. There is a small seedling/volunteer Sabal next to it that is under regulation size.

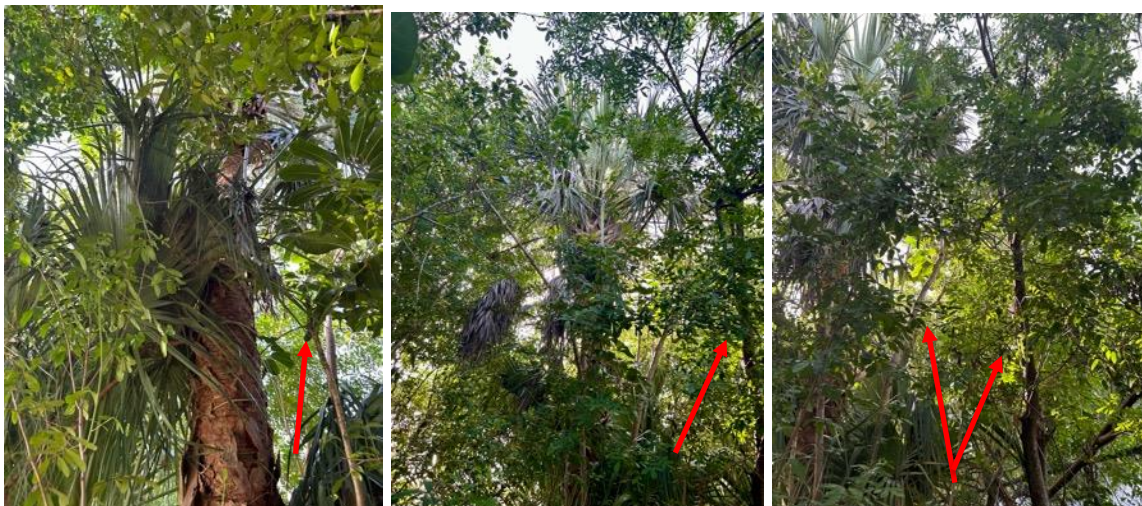
Tree #14 – *Schefflera actinophylla*, Umbrella Tree – this tree is growing on the west side of, and against, Tree #13. It is very crowded with a weak structure as a result. This is a Nuisance Species that requires removal with a no-fee permit.

Tree #15 – *Schinus terebinthifolia*, Brazilian Pepper – this tree is growing slightly west of Trees #13-14 along the west fence line. It is crowded, overgrown, and in moderate condition. It is a Nuisance Species that will require removal with a no-fee permit.

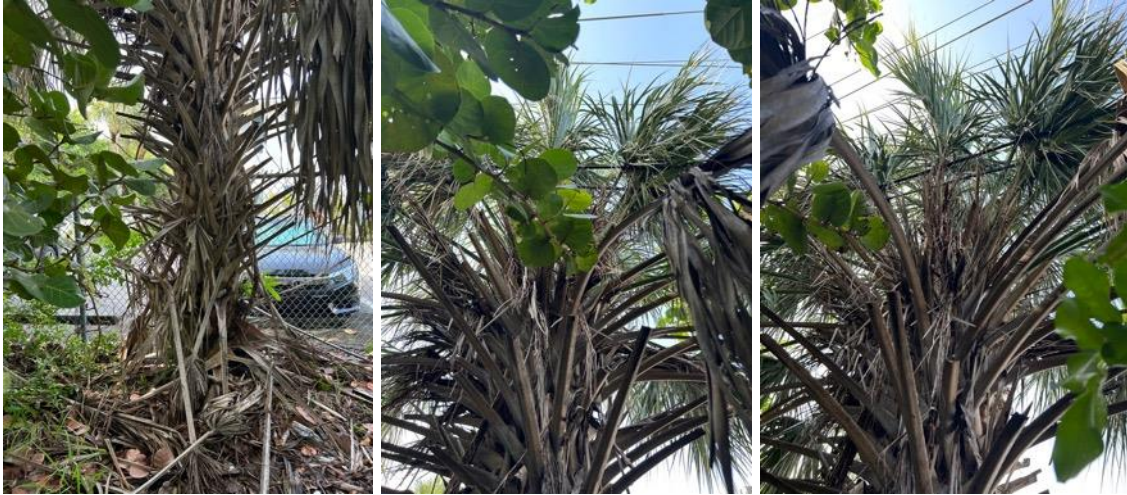
Tree #16 – *Sabal palmetto*, Sabal Palm – this tree is located along the south fenceline slightly west of Tree #15 and south of Tree #12. It is crowded and overgrown and in close proximity to the utility lines. Overall, it is in fair condition. It is a decent candidate to remain with maintenance pruning/canopy cleaning, however it is in proximity of utility lines so this should be taken into account. If it is removed, it will require a permit and mitigation.

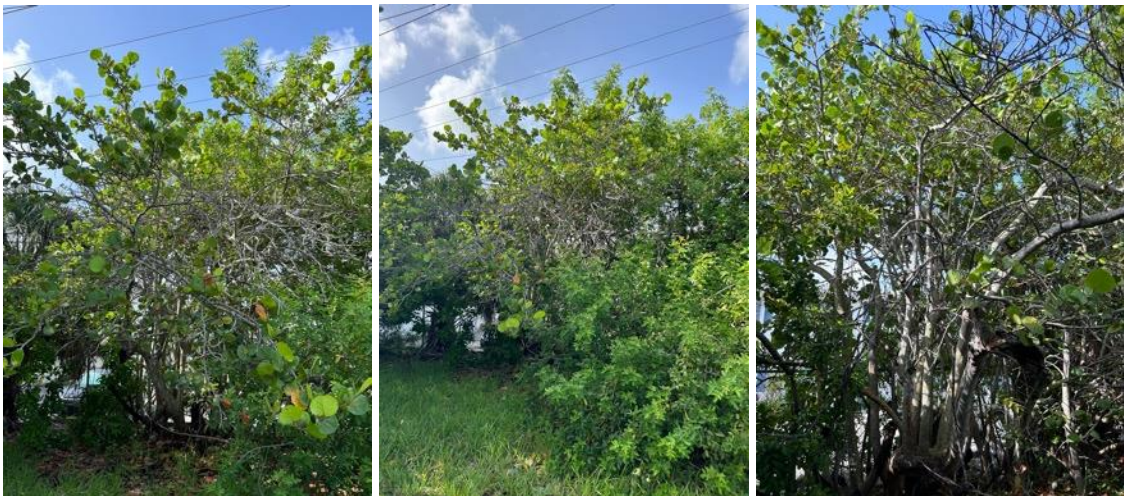
Tree #17 – *Coccoloba uvifera*, Seagrape – this refers to an overgrown cluster of Seagrape located slightly west of Tree #16 along the fence line. It consists of multiple small diameter trunks/sprouts. It has a poor branching structure with moderate deadwood and significant decay present, and it is growing in close proximity to utility wires. This tree is recommended for maintenance pruning/canopy cleaning and subsequent further evaluation to determine its disposition. It will require a permit and mitigation if it is removed.

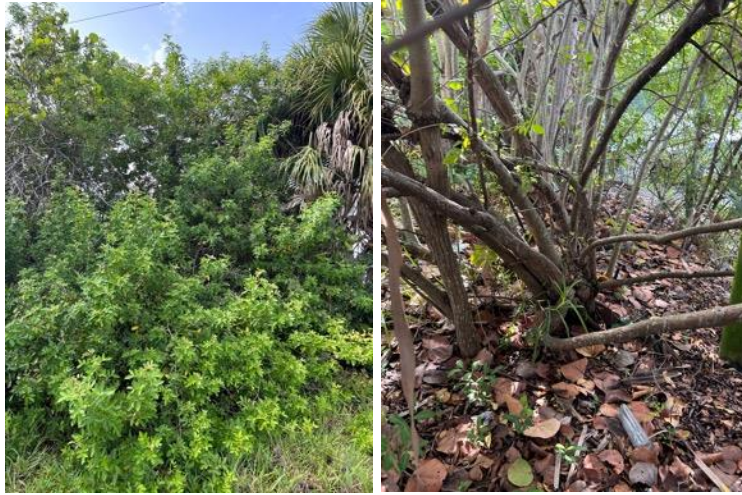
Tree #18 – *Schinus terebinthifolia*, Brazilian Pepper – this tree is growing just west of Tree #17. It is overgrown, unmaintained, and is a Nuisance Species that must be removed with a no-fee permit.

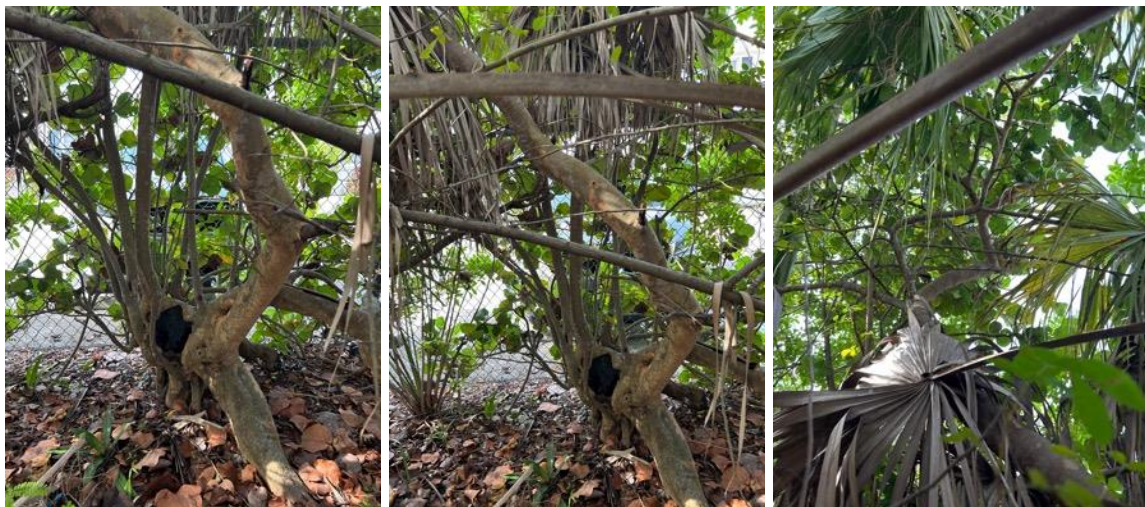
Tree #19 – *Coccoloba uvifera*, Seagrape – this tree is growing against the fence just west of Tree #18. There is one limb that bends and extends backward over the neighboring property and otherwise there are only small sprouts originating above a decay cavity at the base of the trunk. Overall, this tree is in poor condition. It is most likely a good candidate for removal due to its condition.

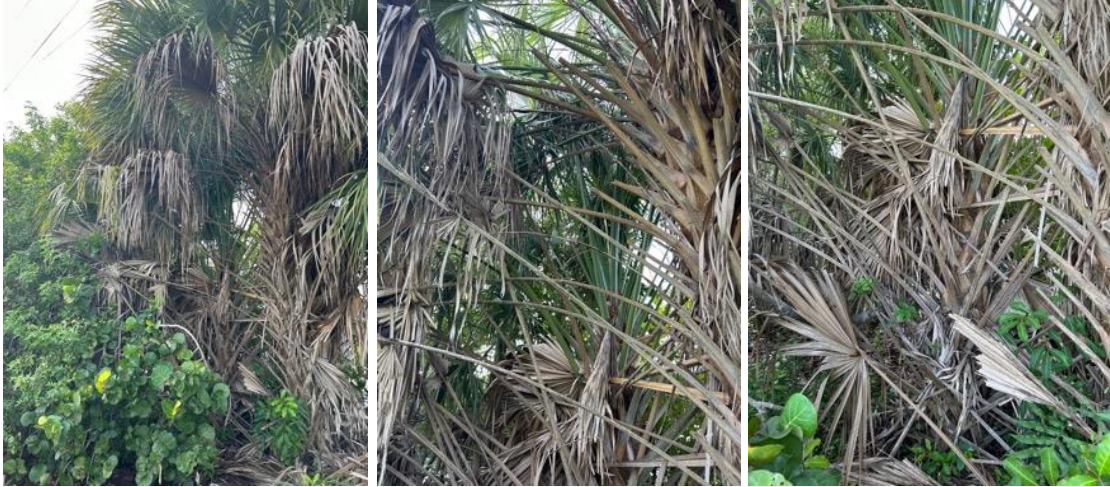
Tree #20 – *Sabal palmetto*, Sabal Palm – this tree is growing against Tree #19 in a cluster of Sabal Palms. It is extremely crowded. It does not appear to have any clear trunk at 4.5' height, so it may be eligible for removal without a permit, to be confirmed by the City.

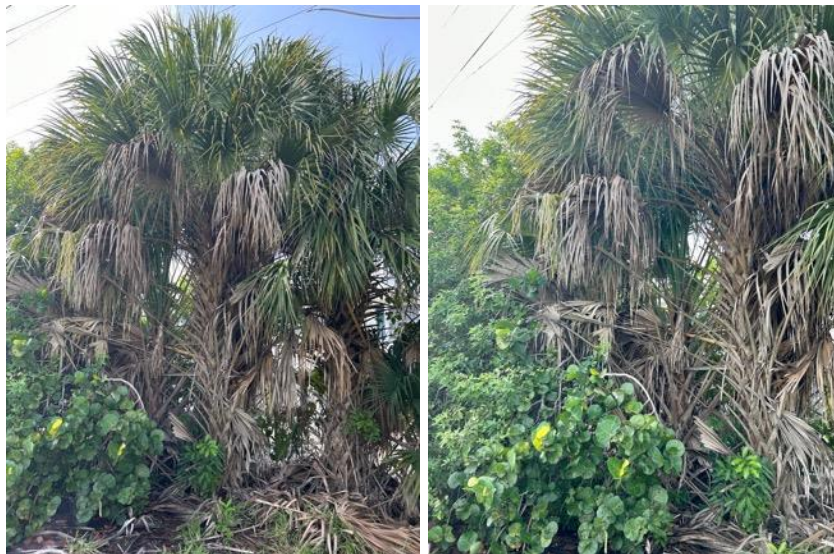
Tree #21 – *Sabal palmetto*, Sabal Palm – this tree is growing in the middle of a cluster of Sabals along the fence line with Trees #19-20. Its trunk is barely visible due to extreme crowding. It does have its boots still present. This tree could remain with protection during construction, but it is growing in close proximity to utility lines. As an alternative, it may be a decent candidate for relocation onsite per specifications below. Otherwise, it will require a permit and mitigation if it is removed.

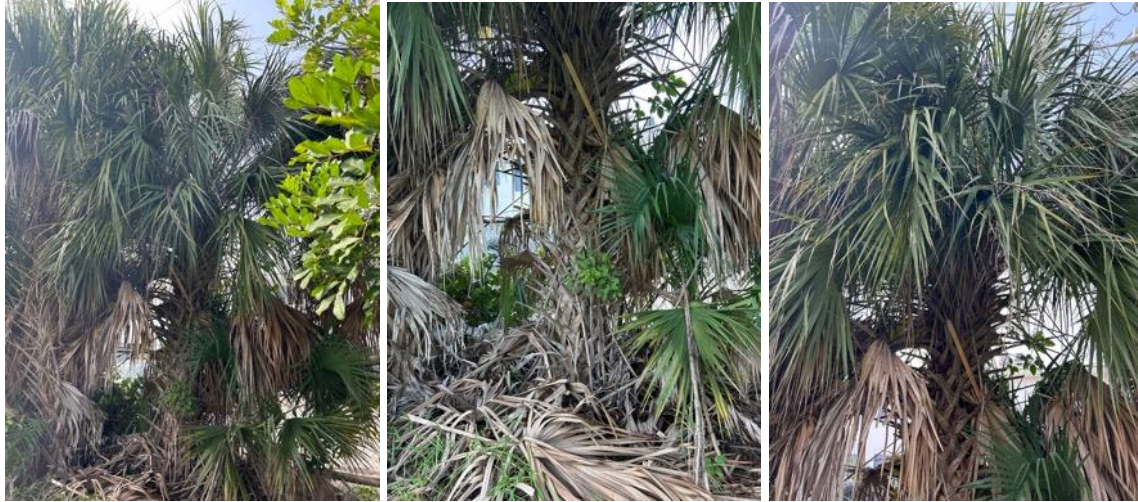
Tree #22 – *Sabal palmetto*, Sabal Palm – this palm is growing on the west side of the cluster with Trees #20-21. It is very crowded, overgrown and unmaintained. It is in borderline fair condition. This tree could remain with protection during construction, but it is growing in very crowded conditions and very close to utility lines. As an alternative, it may be a decent candidate for relocation onsite; see relocation specifications below. Otherwise, it will require a permit and mitigation if it is removed.

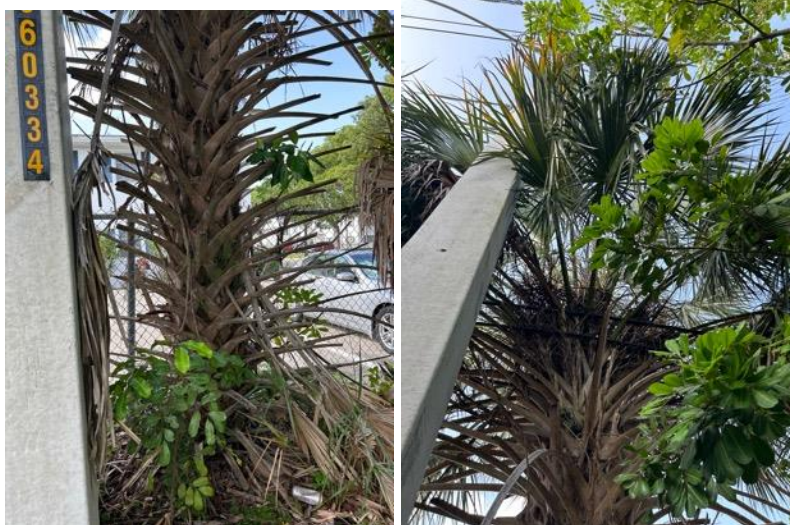
Tree #23 – *Sabal palmetto*, Sabal Palm – this tree is growing just west of Tree #22 and a utility pole near the south fence line. It is very crowded but otherwise in fair condition. It is growing among the adjacent utility lines. It still has its boots present. This tree could remain with protection during construction, but it is growing in very close proximity to a utility pole/utility lines. As an alternative, it may be a decent candidate for relocation onsite per specifications below. Otherwise, it will require a permit and mitigation if it is removed.

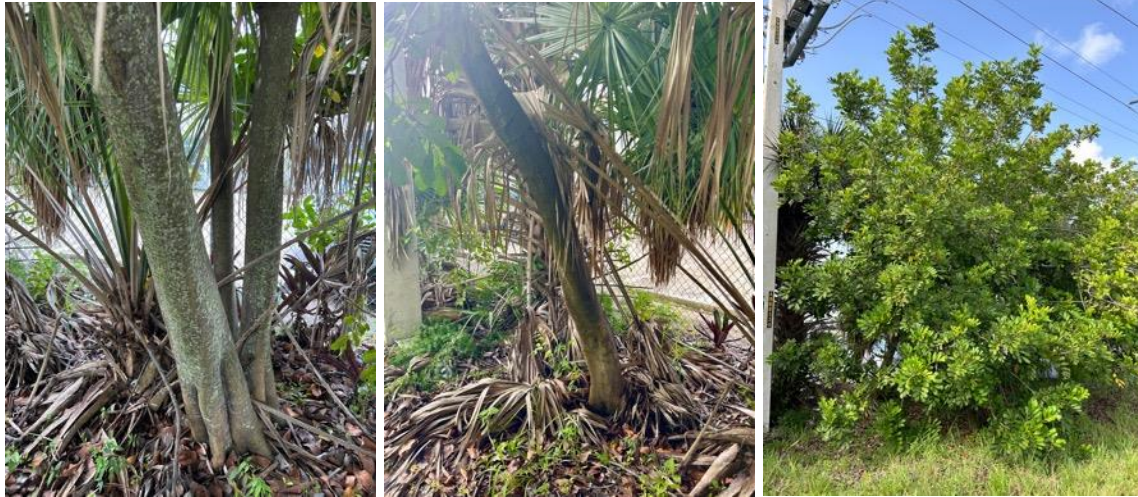
Tree #24 - *Cupaniopsis anacardioides*, Carrotwood – this tree is growing against the south fence line just west of Tree #23. It is crowded, overgrown, leaning and in poor condition. This is a Nuisance Species that requires removal with a no-fee permit.

Tree #25 - *Cupaniopsis anacardioides*, Carrotwood – this tree is growing against the south fence line just west of Tree #24. It consists of multiple trunks and is crowded, overgrown and leaning. This is a Nuisance Species that requires removal with a no-fee permit.

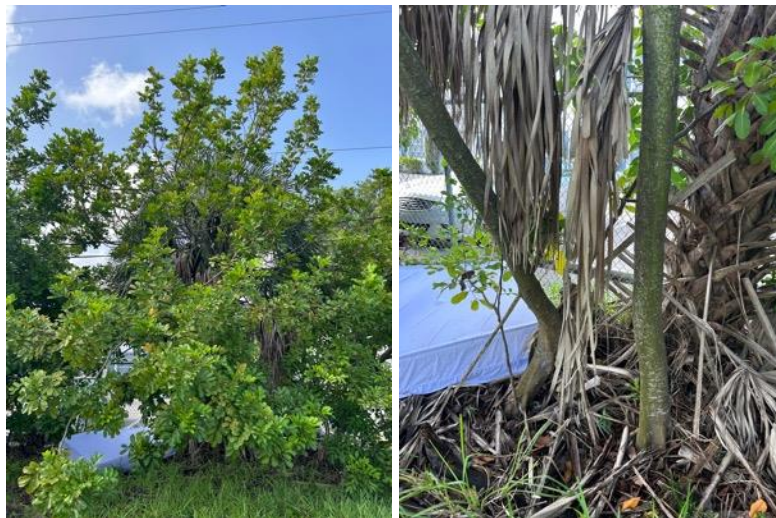
Tree #26-27 - *Cupaniopsis anacardioides*, Carrotwood – this refers to 2 small Carrotwood trees growing just west of Tree #25. They are crowded and leaning as a result. These are a Nuisance Species that require removal with a no-fee permit.

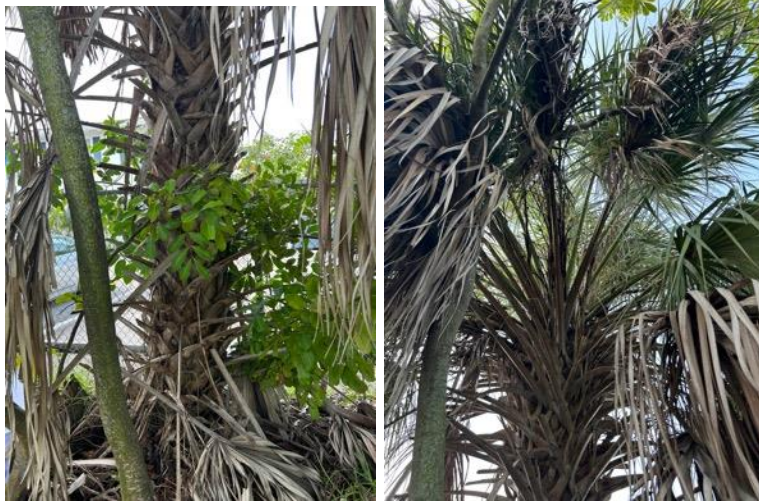
Tree #28 – *Sabal palmetto*, Sabal Palm – this tree is growing against the fence just west of Tree #27. It is crowded, overgrown, and unmaintained, and it still has its boots intact, but overall it is in fair condition. It is a decent candidate to remain due to its location and compact root zone. If it is removed, it will require a permit and mitigation.

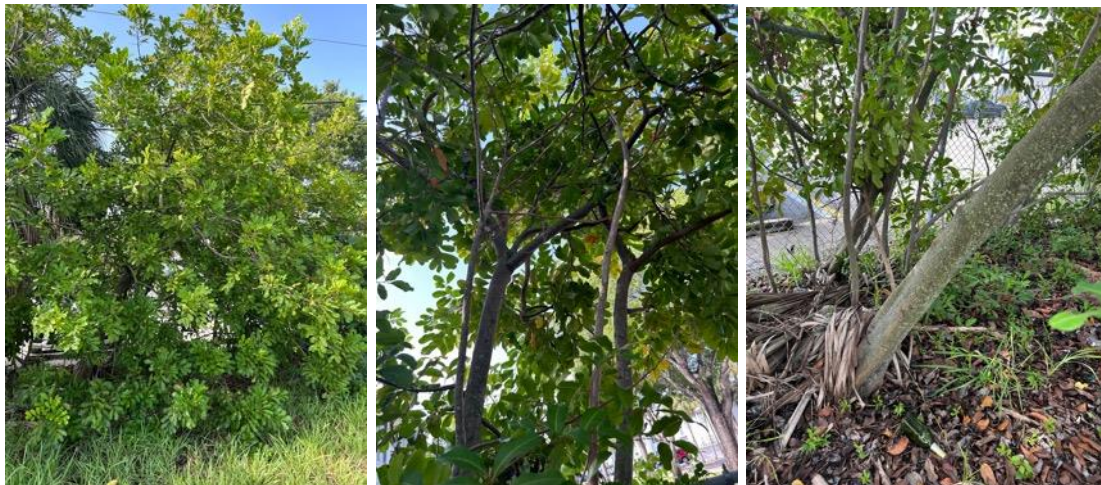
Tree #29 - *Cupaniopsis anacardioides*, Carrotwood – this tree is growing just west of Tree #28 near the property line. It is crowded and leaning in poor condition. This is a Nuisance Species that requires removal with a no-fee permit.

Tree #30 - *Cupaniopsis anacardioides*, Carrotwood – this tree is growing just behind Tree #29 near the property line. It is crowded and in poor condition with small tears present. This is a Nuisance Species that requires removal with a no-fee permit.

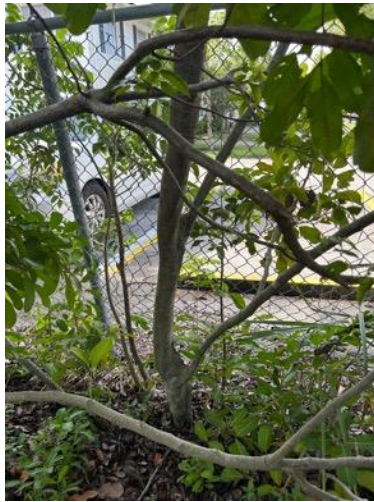
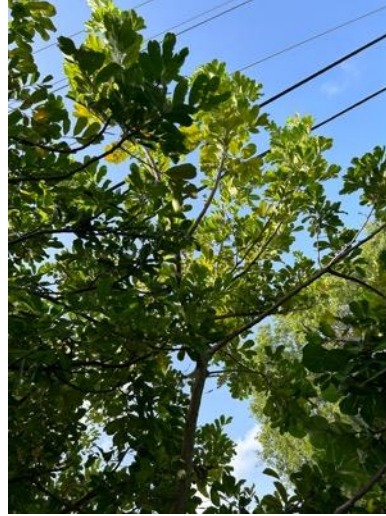
Tree #31 - *Cupaniopsis anacardioides*, Carrotwood – this tree is growing just west of Tree #30 near the property line. It is crowded and in poor condition. This is a Nuisance Species that requires removal with a no-fee permit.

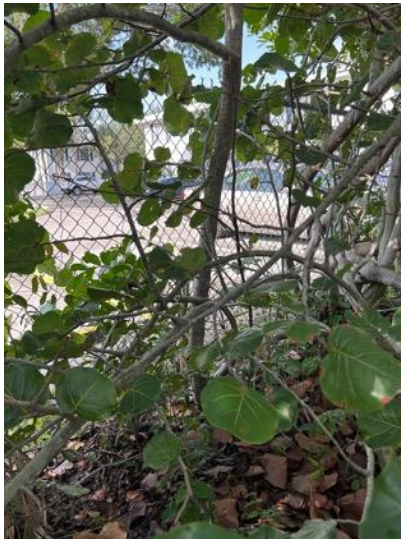
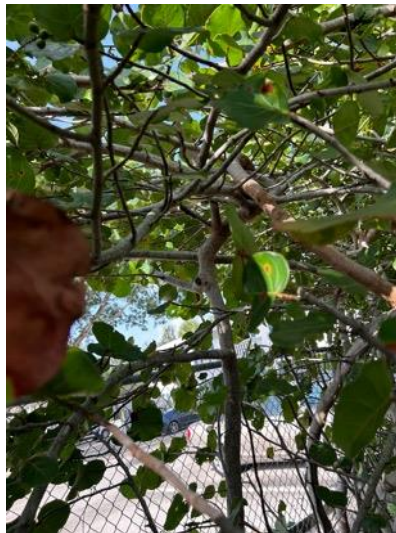
Tree #32 – *Coccoloba uvifera*, Seagrape – this is a small individual that is likely a volunteer. It has a poor branching structure and weak growth habit due to very crowded conditions. It has a single trunk that bends at nearly a 90 degree angle at approximately 5' height and its maximum height is 10'. This tree is just over regulation size, so it will most likely require a permit and mitigation for removal.

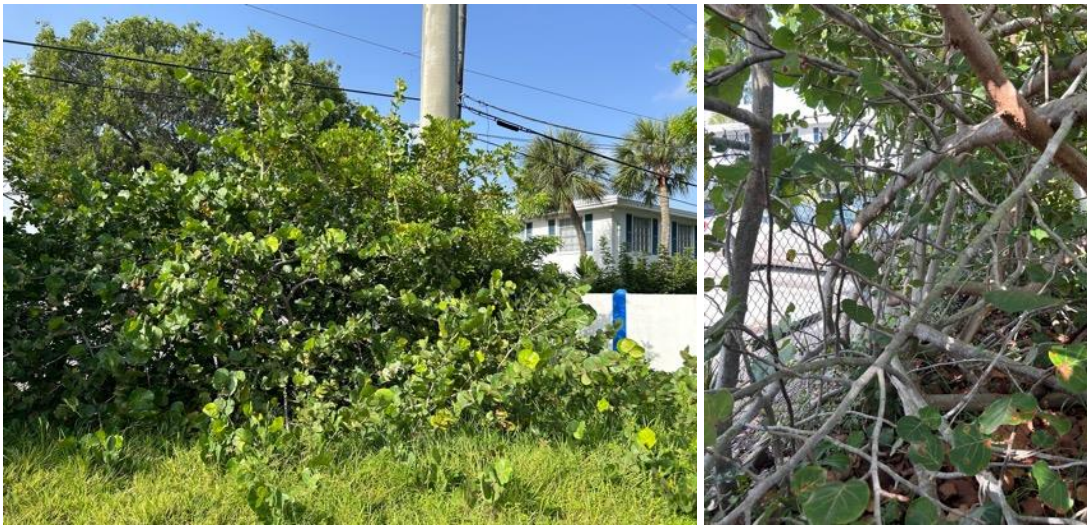
Tree #33 – *Coccoloba uvifera*, Seagrape – this cluster is located near the southwest corner of the property just west of Tree #32. It consists of multiple small diameter sprouts growing mostly horizontally due to crowding; there are only 2 sprouts over regulation height. It is crowded, overgrown and unmaintained. Overall, it is in moderate condition. It will require protection during construction and is recommended for maintenance pruning/cleaning if it remains; otherwise, it will require a permit and mitigation if it is removed.

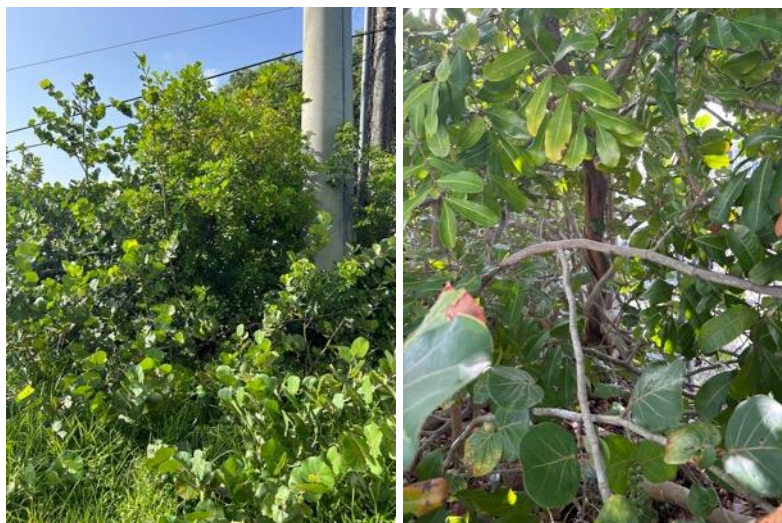
Tree #34 - *Cupaniopsis anacardioides*, Carrotwood – this tree is growing on the southwest side of the property near the fence line. It is crowded and overgrown with a weak structure. This is a Nuisance Species that requires removal with a no-fee permit.

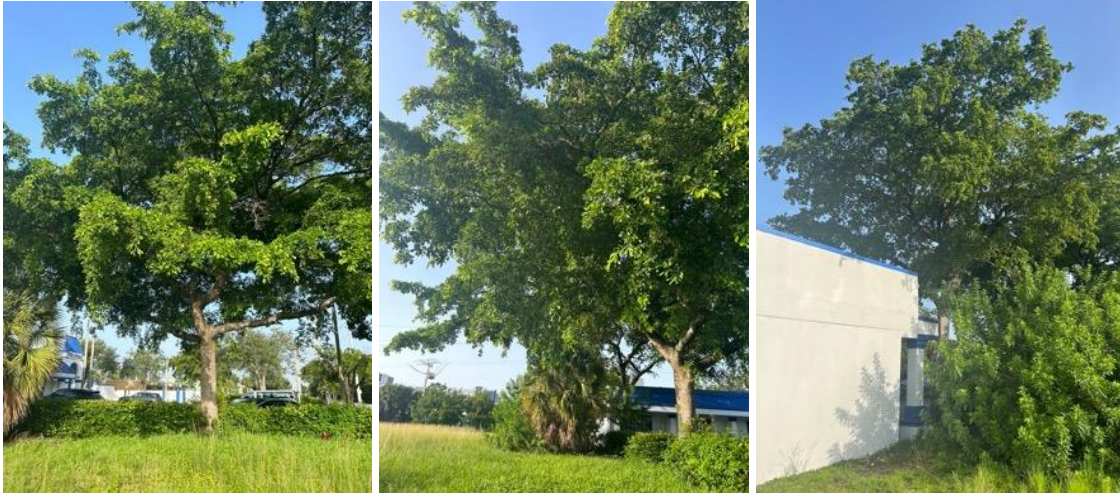
***Bucida buceras*, Black Olive** – there are 2 Black Olive trees located on the property to the west adjacent to the northwest side of this property. Both trees are within 10' or less of the property line, so it is likely that their CRZ's extend approximately 5' or more over the property line. They are not expected to be impacted but protection measures below apply during any work, including staging and access, within their TPZs. If any canopy pruning is required for clearance, it must be in accordance with ANSI Standards and pruning specifications below.

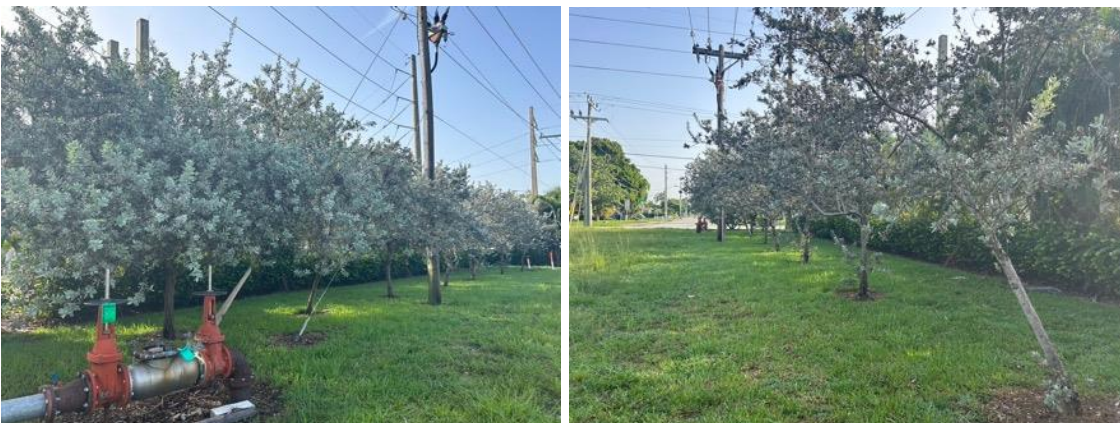
***Conocarpus erectus* var. *sericeus*, Silver Buttonwood** – this refers to a row of 7 somewhat recently planted Silver Buttonwoods located on the property to the east. They are not expected to be impacted and their TPZ's should not extend over the property line, but protection measures below apply.
