Arborist Report

Alliance Gateway Industrial, SW 27th Avenue
Pompano Beach

10/13/2022

PZ22-12000009

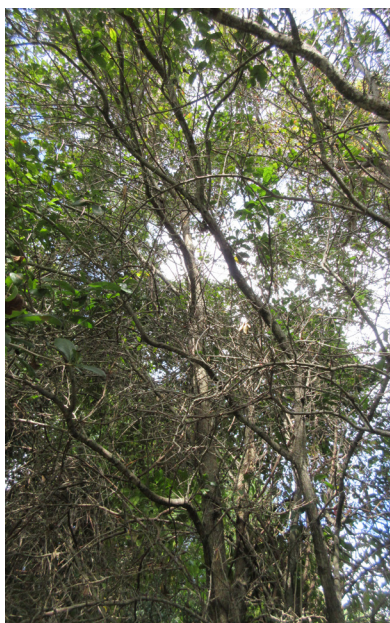
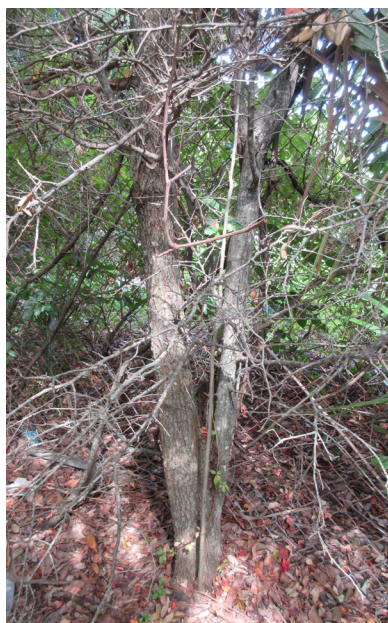
Tree #1 is a Live Oak located in the northwest corner of the property. It is in fair condition. The trunk divides into two with included bark. There is interior deadwood and galls are on the twigs. The canopy is thin and asymmetrical. The tree is competing with the nearby vegetation.

This tree has not been incorporated into the landscape plan and will therefore be removed.

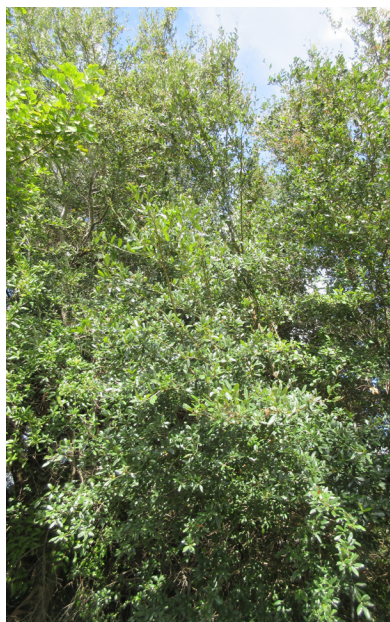
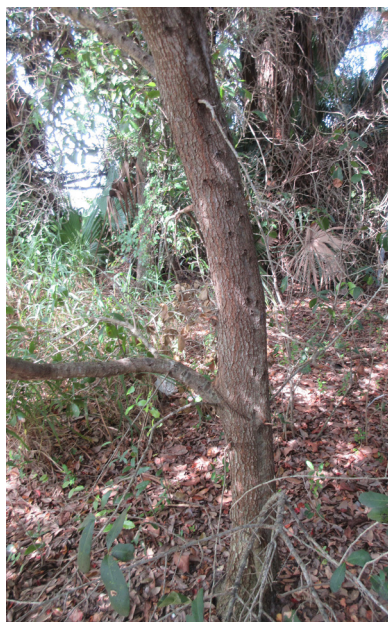
Tree #2 is a Live Oak located on the northwest corner of the property. It is in good condition. There is interior deadwood. The canopy is asymmetrical. The tree is competing with the nearby vegetation.

This tree has not been incorporated into the landscape plan and will therefore be removed.

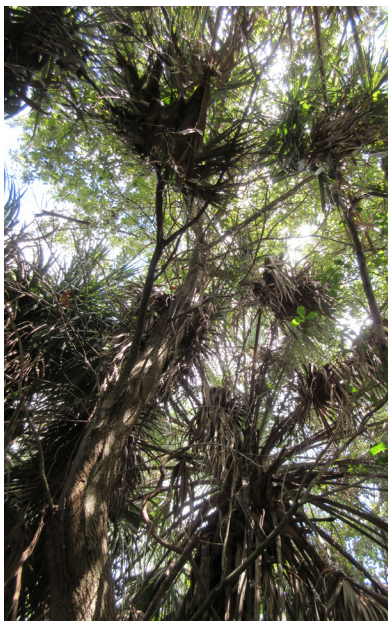
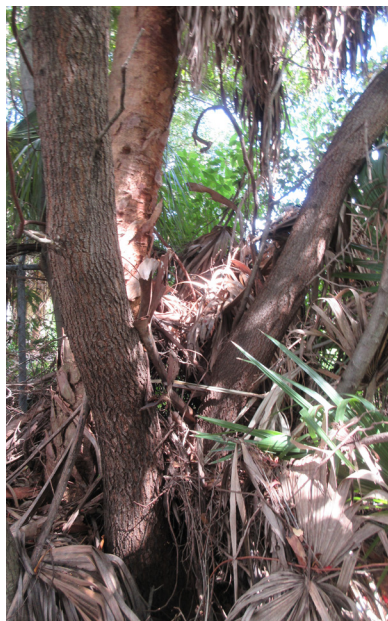
Tree #3 is a Live Oak located in the northwest corner of the property. It is in fair condition. The tree is double-trunked with included bark. There is interior deadwood. The tree is competing with the nearby vegetation.

This tree has not been incorporated into the landscape plan and will therefore be removed.

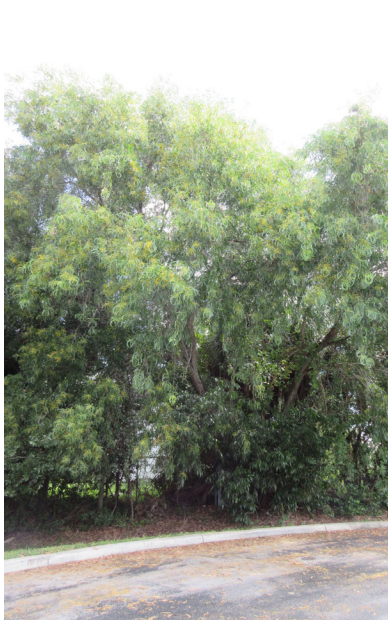
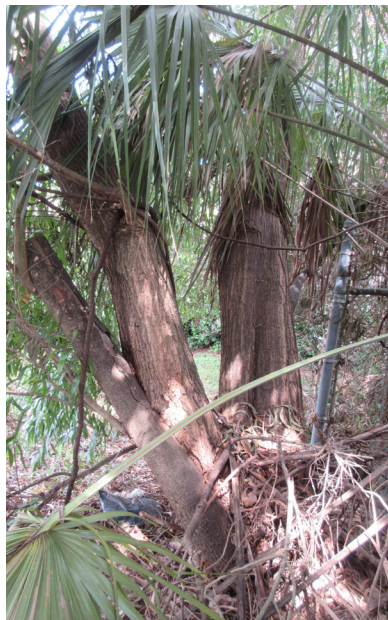
Tree #4 is an Earleaf Acacia located in the northwest corner of the property. It is double-trunked with a spreading canopy. There is a large branch stub present.

This species is highly invasive in South Florida and this tree will therefore need to be removed.

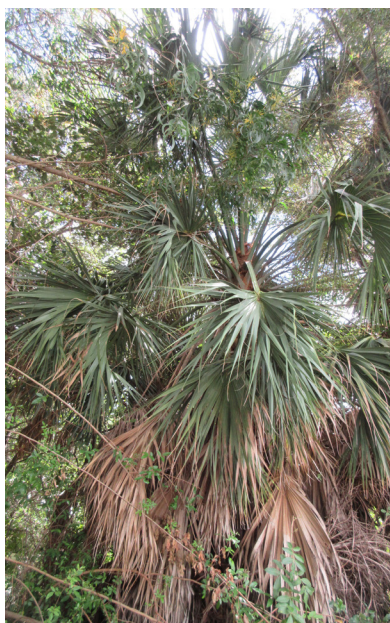
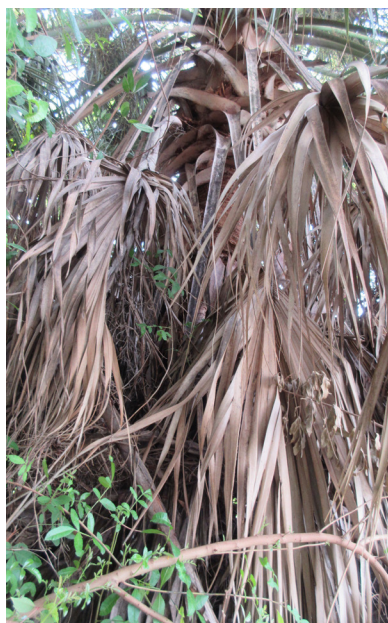
Tree #5 is a Sabal Palm located in the northwest corner of the property. It is in good condition. There are lower dead fronds. The tree is competing with the nearby vegetation.

This tree has not been incorporated into the landscape plan and will therefore be removed.

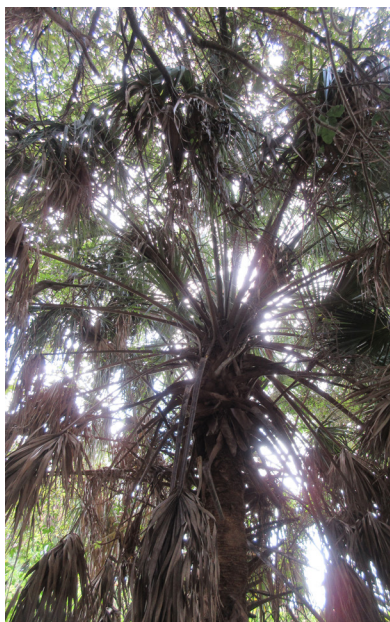
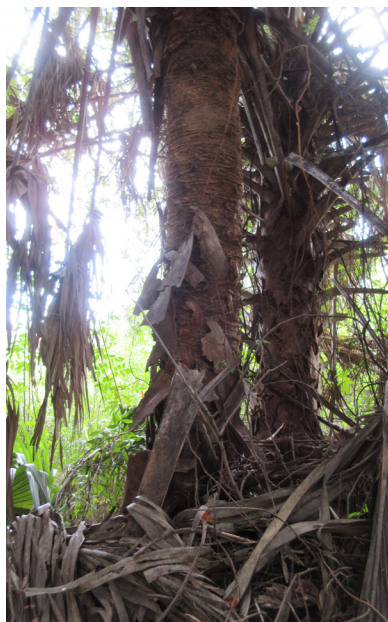
Tree #6 is a Sabal Palm located in the northwest corner of the property. It is in fair condition. The canopy is thin and there are lower dead fronds. The tree is competing with the nearby vegetation.

This tree has not been incorporated into the landscape plan and will therefore be removed.

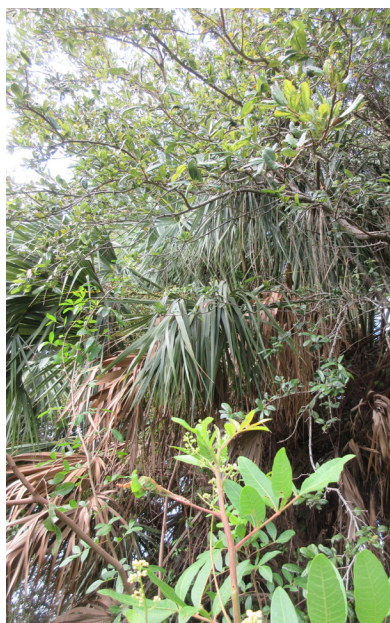
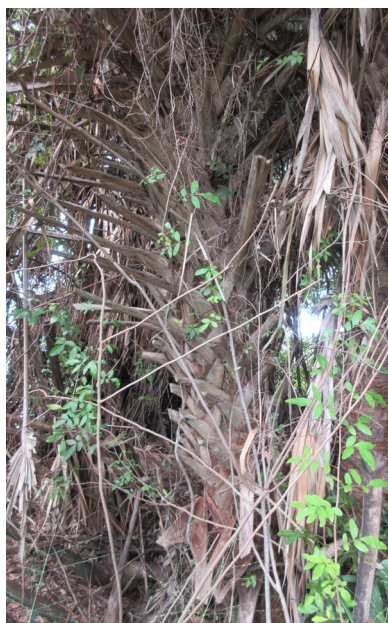
Tree #7 is a Sabal Palm located in the northwest corner of the property. It is in fair condition. The canopy is thin and there are lower dead fronds. The tree is competing with the nearby vegetation.

This tree has not been incorporated into the landscape plan and will therefore be removed.

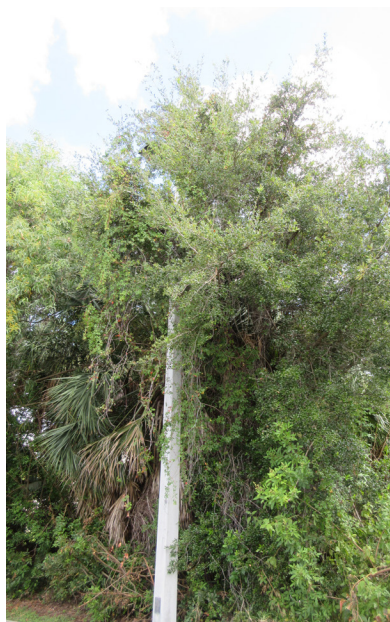
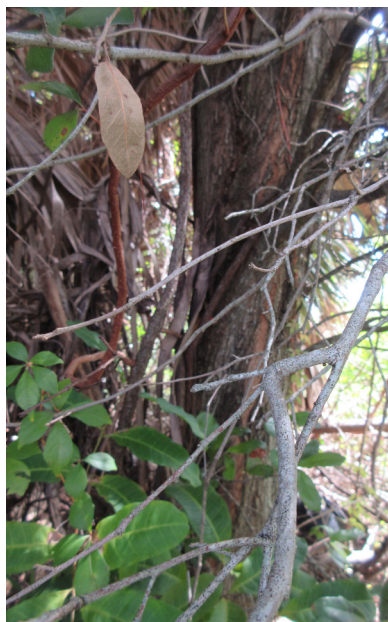
Tree #8 is a Live Oak located on the northwest corner of the property. It is in good condition. Vines are growing into the canopy and there is included bark between the limbs.

This tree has not been incorporated into the landscape plan and will therefore be removed.

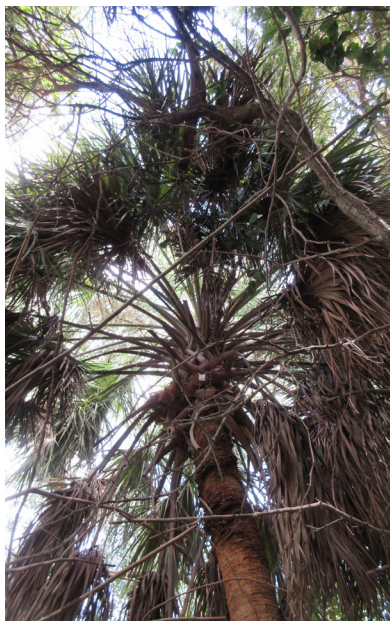
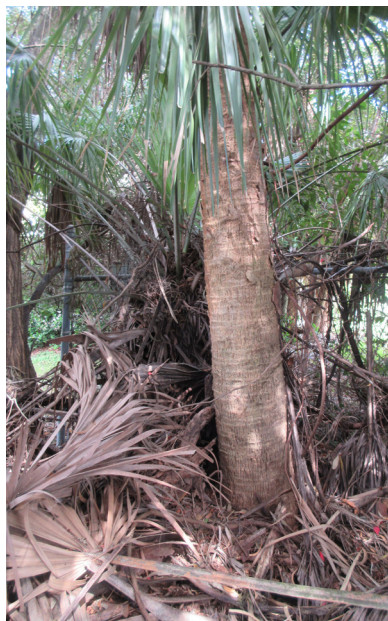
Tree #9 is a Sabal Palm located in the northwest corner of the property. It is in fair condition. The canopy is thin and there are lower dead fronds. The tree is competing with the nearby vegetation.

This tree has not been incorporated into the landscape plan and will therefore be removed.

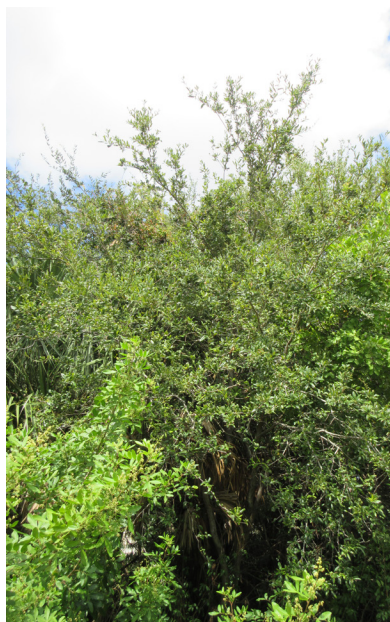
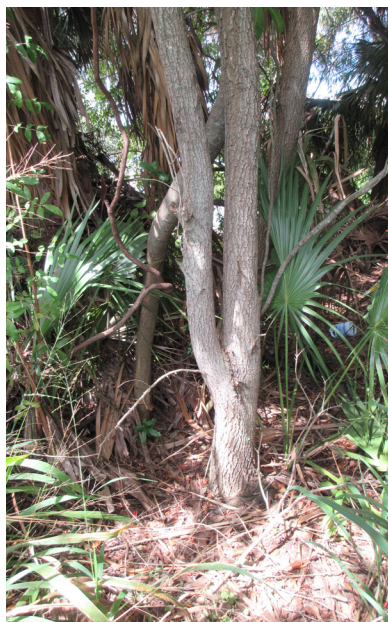
Tree #10 is a Live Oak located in the northwest corner of the property. It is in fair condition. The trunk divides into two with included bark. The canopy is asymmetrical and the tree is competing with the nearby vegetation.

This tree has not been incorporated into the landscape plan and will therefore be removed.

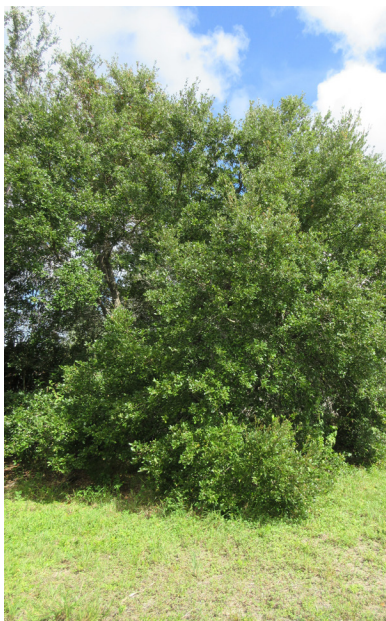
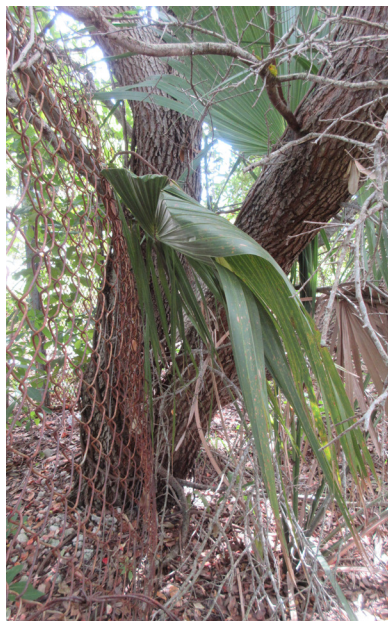
Tree #11 is a Live Oak located in the northwest corner of the property. The tree is in good condition. It is multi-trunked with included bark. There is chainlink fencing embedded in the trunk. The canopy is dense and spreading.

This tree has not been incorporated into the landscape plan and will therefore be removed.

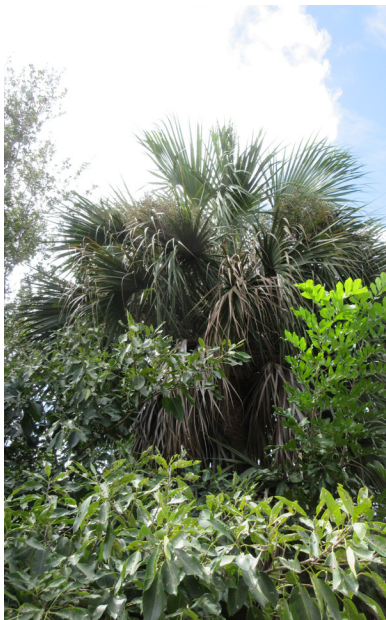
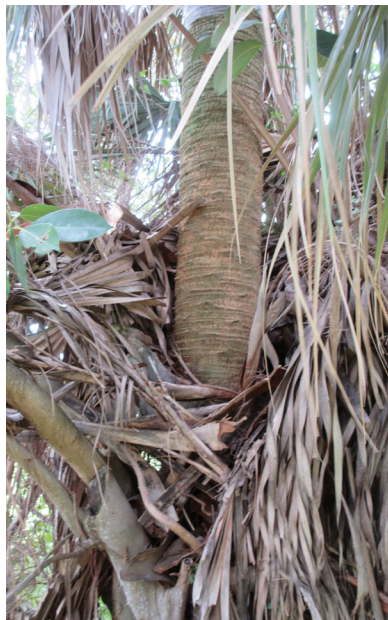
Tree #12 is a Sabal Palm located towards the northwest corner of the property. It is in fair condition. There are lower dead fronds. The tree is competing with the surrounding vegetation.

This tree has not been incorporated into the landscape plan and will therefore be removed.

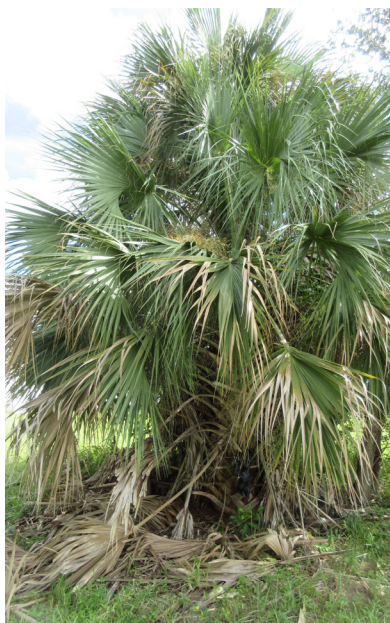
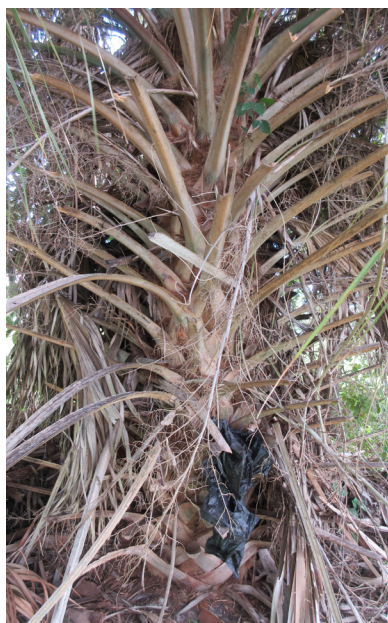
Tree #13 is a Sabal Palm located towards the northwest corner of the property. It is in good condition with a dense canopy. There are some lower dead fronds.

This tree has not been incorporated into the landscape plan and will therefore be removed.

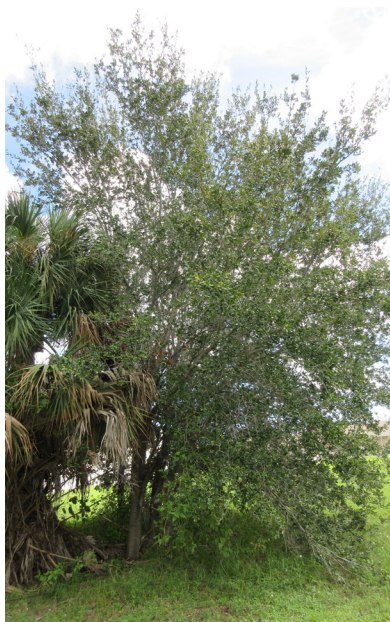
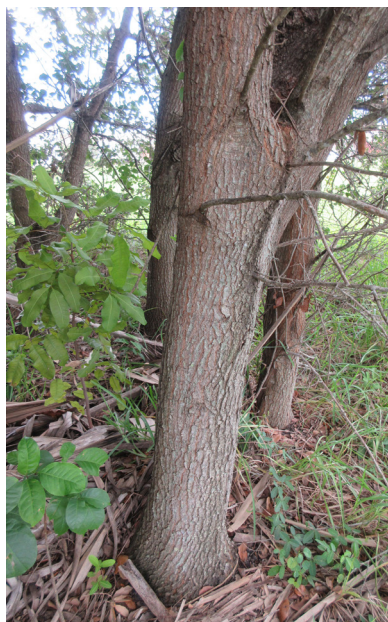
Tree #14 is a Live Oak located towards the northwest corner of the property. It is in fair condition. There is included bark between the limbs. The canopy is asymmetrical and the tree is competing with the nearby vegetation. There is interior deadwood. There are pest issues affecting the leaves.

This tree has not been incorporated into the landscape plan and will therefore be removed.

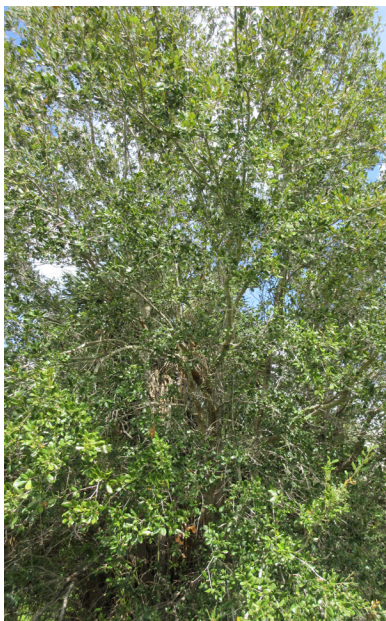
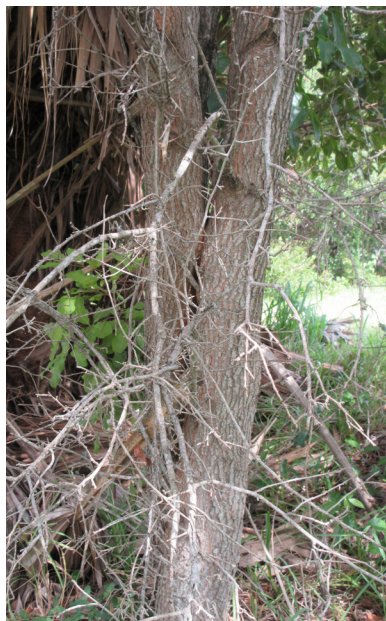
Tree #15 is a Live Oak located towards the northwest corner of the property. It is in fair condition. The tree is double trunked with crossing limbs. There is included bark between the limbs. The canopy is asymmetrical and the tree is competing with the nearby vegetation. There is interior deadwood. There are pest issues affecting the leaves.

This tree has not been incorporated into the landscape plan and will therefore be removed.

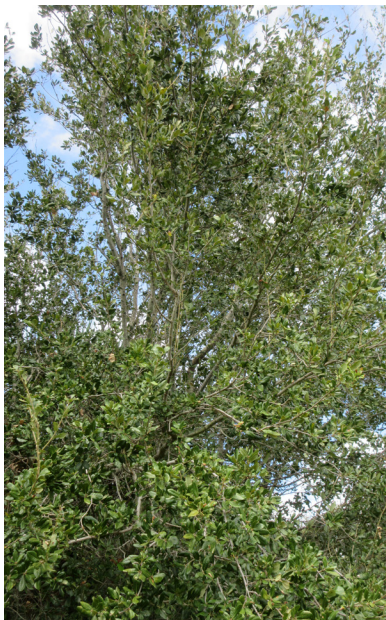
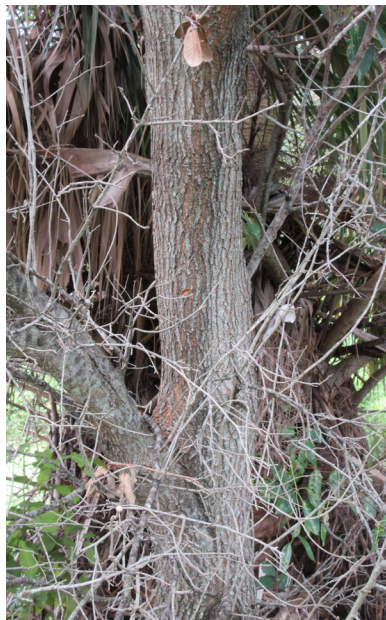
Tree #16 is a Live Oak located towards the northwest corner of the property. It is in fair condition. There is included bark between the limbs. The canopy is asymmetrical and the tree is competing with the nearby vegetation. There is interior deadwood. There are pest issues affecting the leaves.

This tree has not been incorporated into the landscape plan and will therefore be removed.

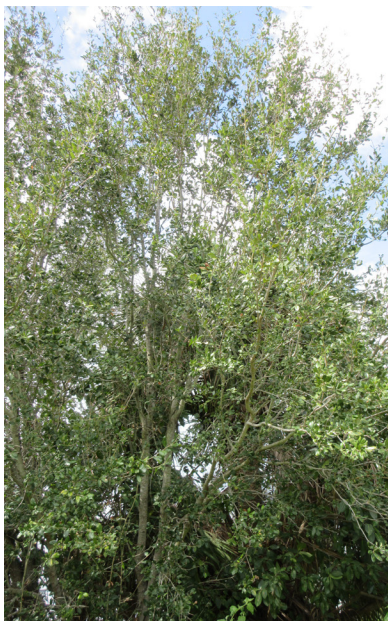
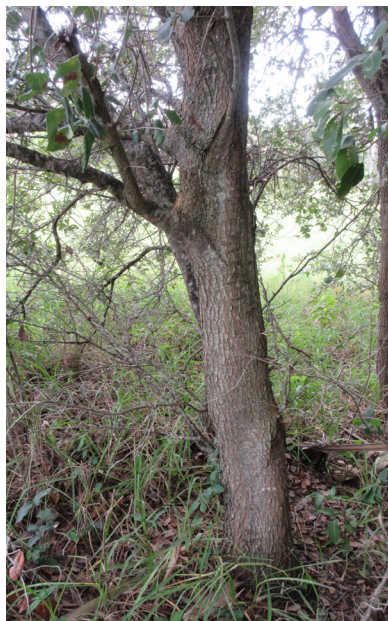
Tree #17 is a Live Oak located towards the northwest corner of the property. It is in fair condition. There is included bark between the limbs. The canopy is asymmetrical and the tree is competing with the nearby vegetation. There is interior deadwood. There are pest issues affecting the leaves.

This tree has not been incorporated into the landscape plan and will therefore be removed.

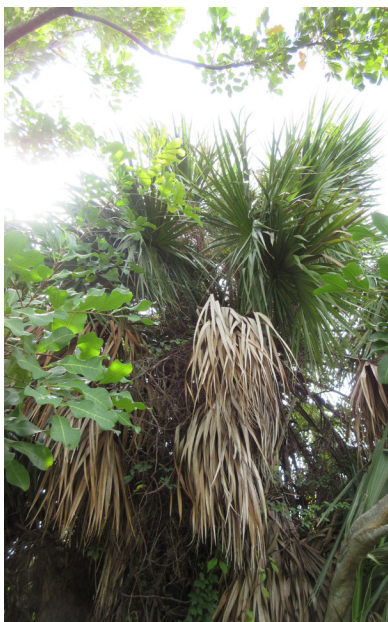
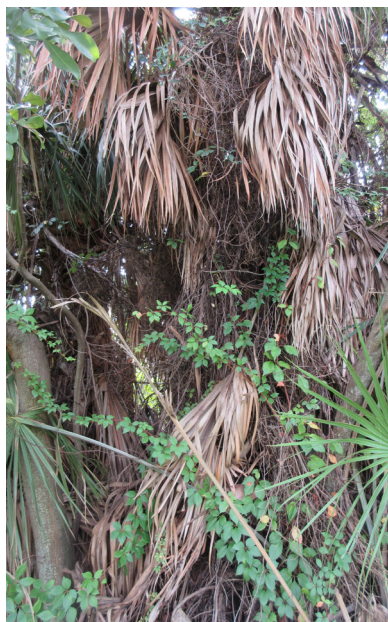
Tree #18 is a Sabal Palm located on the south side of the property. It is in fair condition. It has a thin canopy and many lower dead fronds. The tree is competing with the nearby vegetation.

This tree has not been incorporated into the landscape plan and will therefore be removed.

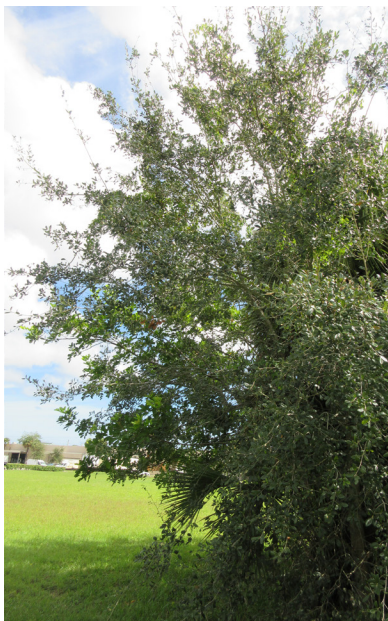
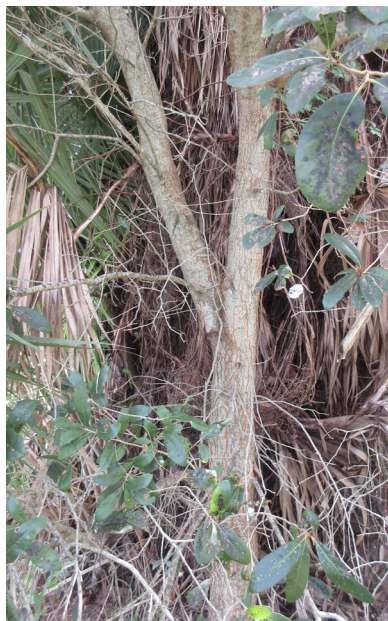
Tree #19 is a Live Oak located on the south side of the property. It is in fair condition. The trunk divides into two with included bark. The canopy is asymmetrical. The tree is competing with the nearby vegetation.

This tree has not been incorporated into the landscape plan and will therefore be removed.

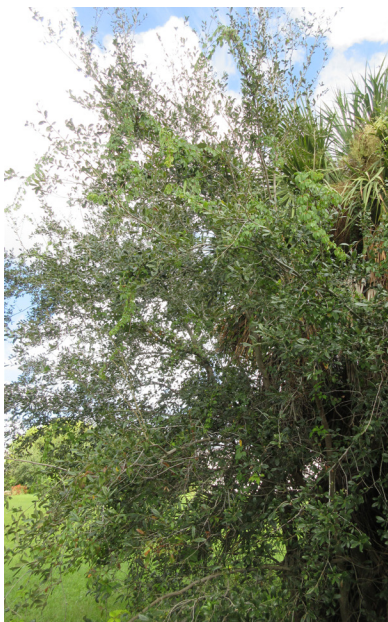
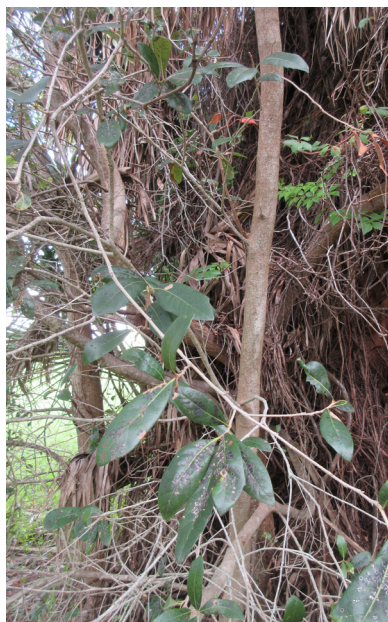
Tree #20 is a small Live Oak located on the south side of the property. It is in fair condition. The canopy is asymmetrical. The tree is competing with the nearby vegetation.

This tree has not been incorporated into the landscape plan and will therefore be removed.

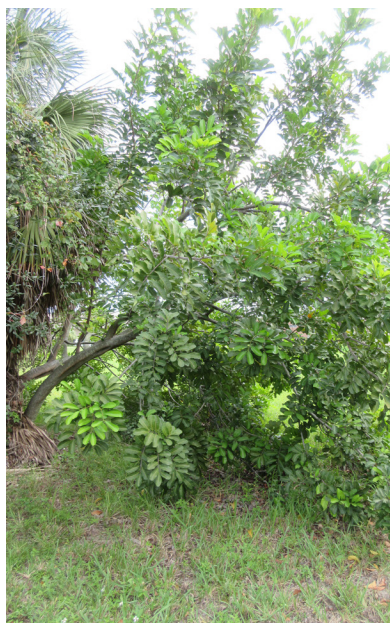
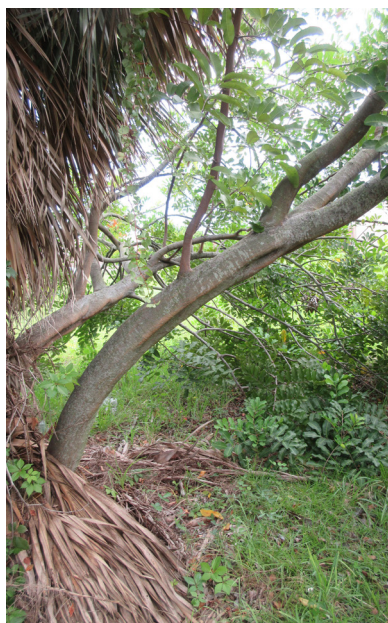
Tree #21 is a Carrotwood located on the south side of the property. The tree is in fair condition with poor form. The trunk is growing at a sharp angle.

This species is highly invasive in South Florida and this tree will therefore need to be removed.

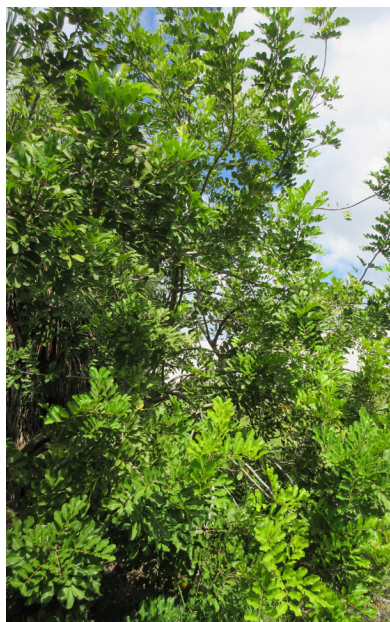
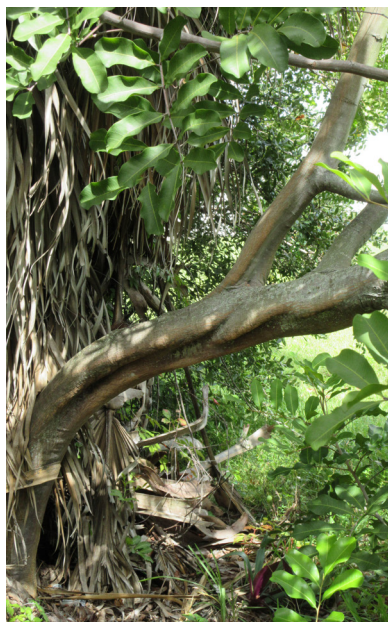
Tree #22 is a Carrotwood located on the south side of the property. The tree is in fair condition with poor form. The trunk is growing at a sharp angle.

This species is highly invasive in South Florida and this tree will therefore need to be removed.

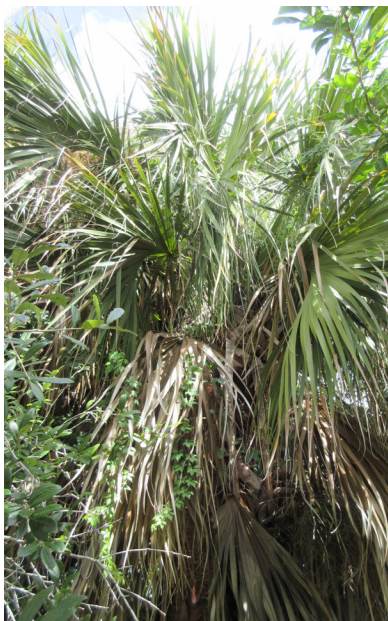
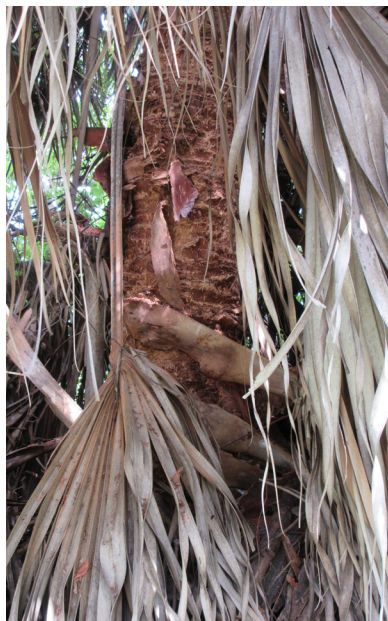
Tree #23 is a Sabal Palm located on the south side of the property. It is in fair condition with a small canopy and lower dead fronds. The tree is competing with the nearby vegetation.

This tree has not been incorporated into the landscape plan and will therefore be removed.

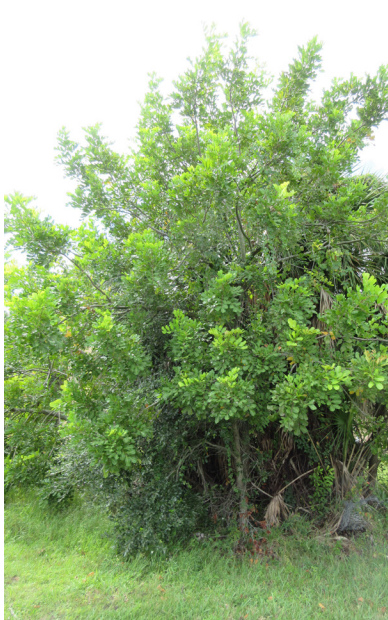
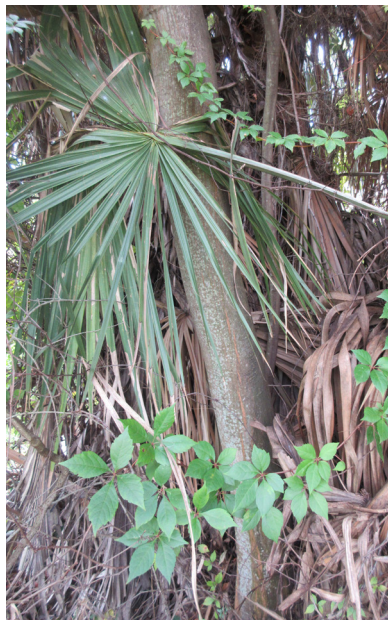
Tree #24 is a Carrotwood located on the south side of the property. It is in good condition and is growing vigorously. It has a nice form and dense canopy.

This species is highly invasive in South Florida and this tree will therefore need to be removed.

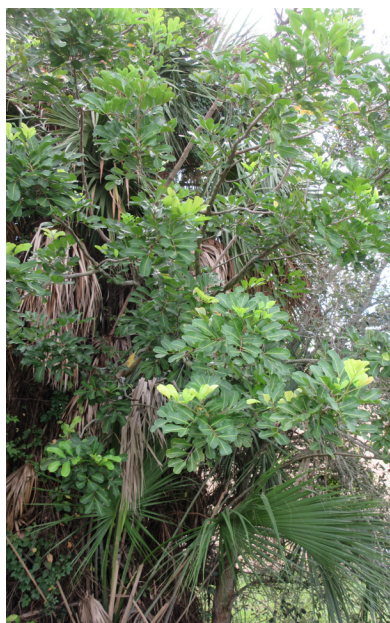
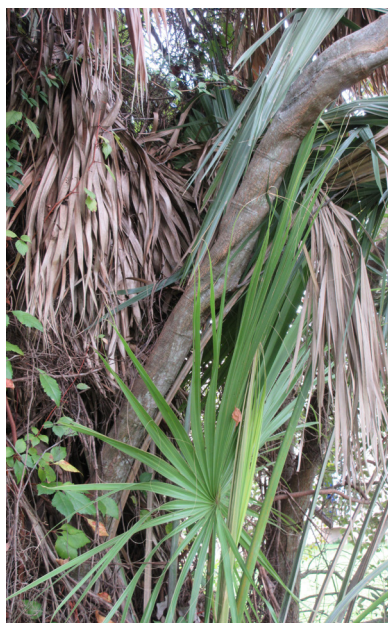
Tree #25 is a Carrotwood located on the south side of the property. It is in fair condition and is competing with the nearby vegetation.

This species is highly invasive in South Florida and this tree will therefore need to be removed.

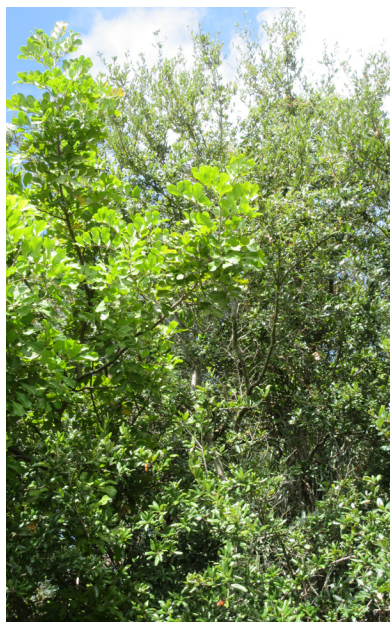
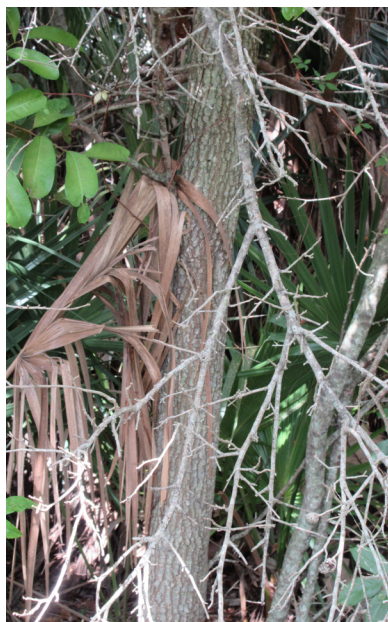
Tree #26 is a Live Oak located in the northwest corner of the property. It is in good condition. There is interior deadwood. The tree is competing with the nearby vegetation.

This tree has not been incorporated into the landscape plan and will therefore be removed.

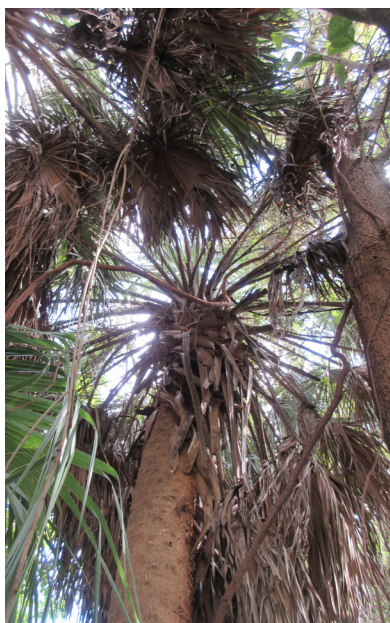
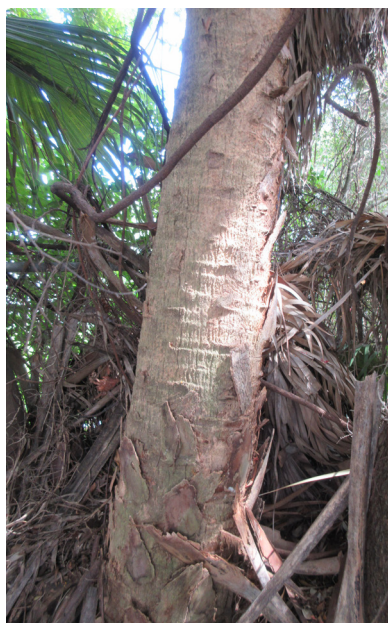
Tree #27 is a Sabal Palm located in the northwest corner of the property. The tree is in poor condition. There are few live fronds and many dead fronds. The tree is competing with the nearby vegetation.

This tree has not been incorporated into the landscape plan and will therefore be removed.
