jgomez@logicaservices.com**Re: Arboricultural Consulting Services for 324 Northwest 6th Street, Pompano Beach, Florida**

I visited the above-mentioned property on Tuesday, May 16th, to evaluate +/- 24 trees, take photographs (Specimen sized trees only), calculate Rule 14-10 appraisal values, perform relocation evaluations, and note any defects.

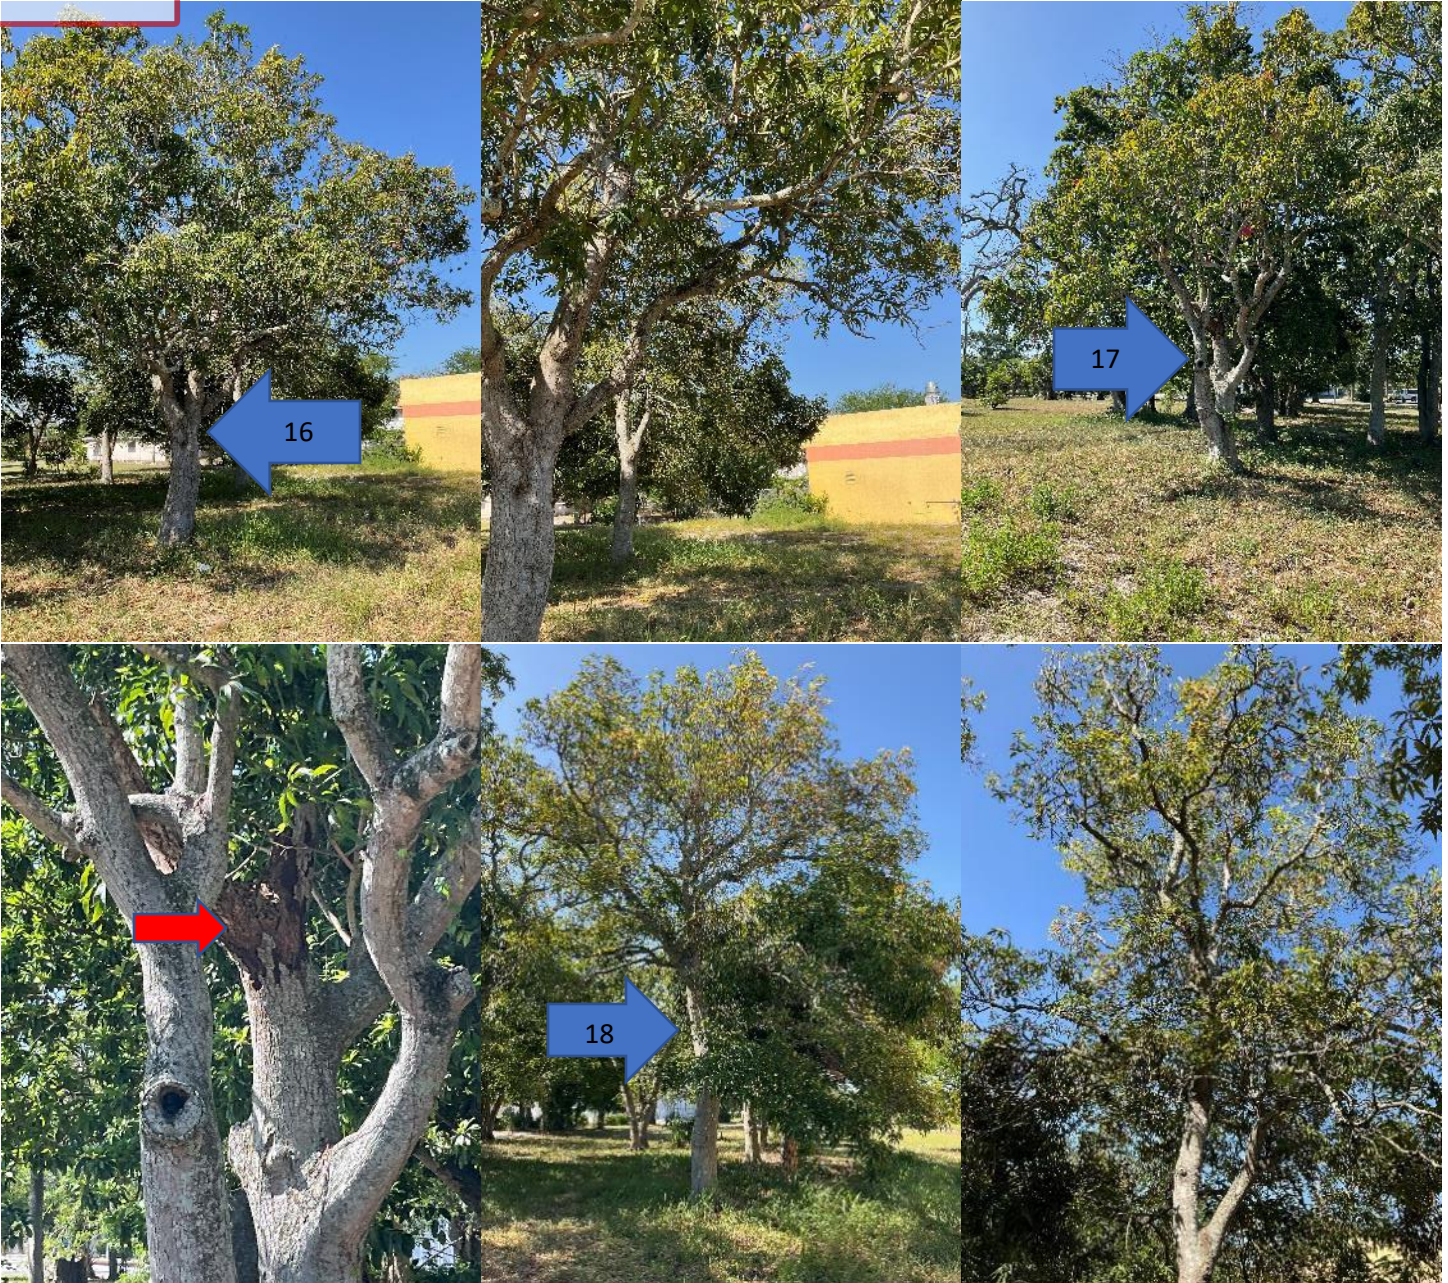
Trees 16, 17, & 18

Mango Trees (*Mangifera indica*), facing south and west. Note poor structure, deadwood, and canopy dieback for Tree #16, poor structure, deadwood, canopy dieback, visual evidence of decay (red arrow), and canopy crowding for Tree #17, and poor structure, canopy dieback, chlorotic foliage, and deadwood for Tree #18.

10	Green Buttonwood	<i>Conocarpus erectus</i>	14	7	4		Fair	57%	\$ 306.38	Y	Trunk wound	
11	Montgomery Palm	<i>Veitchia arecina</i>	17	6	6	12	Fair	52%	\$ 302.12	N	Nutrient deficiencies	
12	Silver Buttonwood	<i>Conocarpus erectus var. sericeus</i>	18	12	8		Fair	48%	\$ 1,116.00	N	Poor structure, visual evidence of decay, unbalanced crown	
13	Montgomery Palm	<i>Veitchia arecina</i>	26	7	8	19	Fair	54%	\$ 489.51	N	Nutrient deficiencies	
14	Montgomery Palm	<i>Veitchia arecina</i>	16	6	6	14	Fair	54%	\$ 306.18	N	Nutrient deficiencies	
14a	Silver Buttonwood	<i>Conocarpus erectus var. sericeus</i>	14	12	5		Fair	54%	\$ 486.00	N	Poor structure, heading cut	
14b	Montgomery Palm	<i>Veitchia arecina</i>	17	6	7	13	Fair	52%	\$ 305.76	N	Nutrient deficiencies	
15	Sabal Palm	<i>Sabal palmetto</i>	24	8	15	20	Good	70%	\$ 192.50	Y		
16	Mango	<i>Mangifera indica</i>	32	24	21		Fair	54%	\$ 2,677.46	N	Poor structure, deadwood, canopy dieback

17	Mango	<i>Mangifera indica</i>	26	18	27		Poor	40%	\$ 2,473.30	N	Poor structure, deadwood, canopy dieback, visual evidence of decay, canopy crowding	
18	Mango	<i>Mangifera indica</i>	35	25	18		Fair	53%	\$ 2,225.97	N	Poor structure, canopy dieback, chlorotic foliage, deadwood	
19	Mango	<i>Mangifera indica</i>	28	15	14		Fair	52%	\$ 1,728.98	N	Poor structure, deadwood, canopy crowding	
20	Sapodilla	<i>Manilkara zapota</i>	39	27	23		Fair	55%	\$ 2,770.63	N	Visual evidence of decay, storm damage, large trunk wound, deadwood	
21	Sabal Palm	<i>Sabal palmetto</i>	14	8	8	5	Good	70%	\$ 192.50	Y	Immature palm	
22	Mango	<i>Mangifera indica</i>	33	24	23		Fair	53%	\$ 2,844.29	N	Poor structure, canopy dieback, storm damage, canopy crowding	
23	Mango	<i>Mangifera indica</i>	31	26	18		Fair	50%	\$ 2,099.97	N	Poor structure, large diameter deadwood, canopy dieback	
24	Mango	<i>Mangifera indica</i>	15	12	8		Poor	30%	\$ 559.99	N	Poor structure, storm damage, visual evidence of decay, canopy crowding

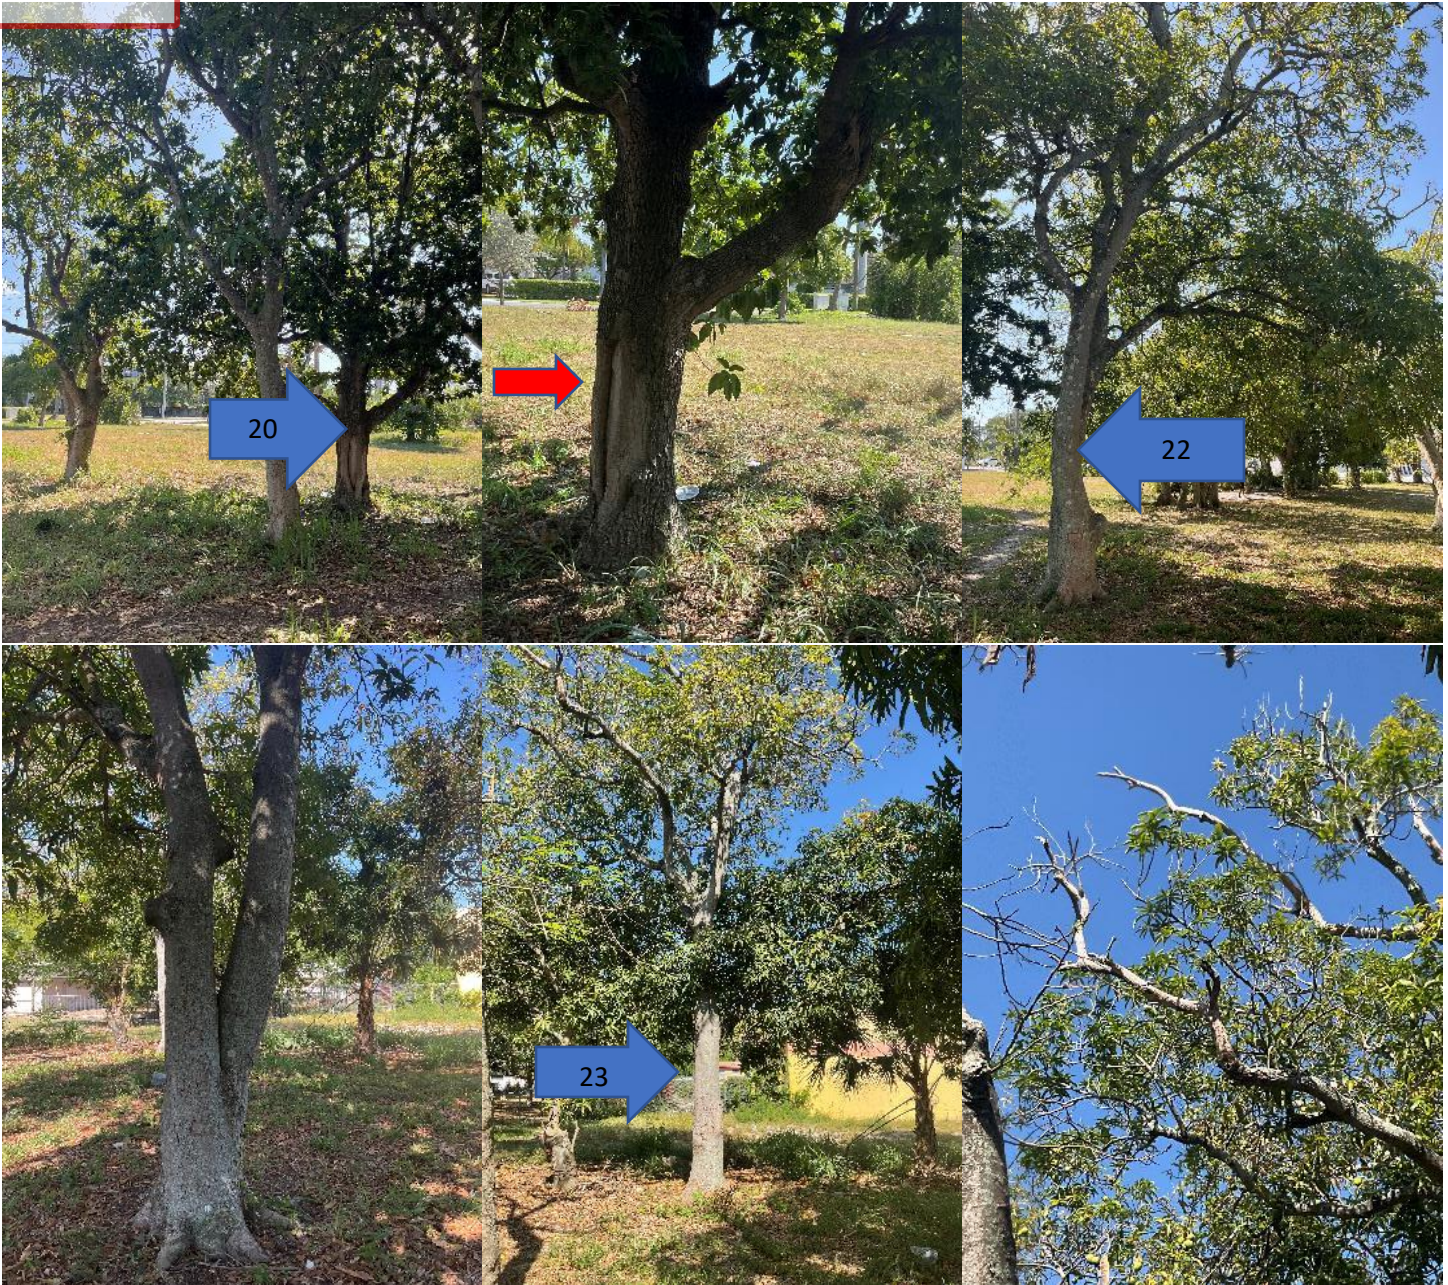
Trees 20, 22, & 23

Sapodilla (*Manilkara zapota*) Tree #20, and Mango Trees (*Mangifera indica*) Tree #'s 22 & 23 facing east, south, and west. Note visual evidence of decay, storm damage, large trunk wound (red arrow), and deadwood for Tree #20, poor structure, canopy dieback, storm damage, and canopy crowding for Tree #22, and poor structure, large diameter deadwood, and canopy dieback for Tree #23.
