Foliage Expressions LLC  
PZ24-12000008  
Guillermo Salazar M.S.  
09/18/2024

## Arborist Report

3225 NE 5th St,  
Pompano Beach, FL  
33062

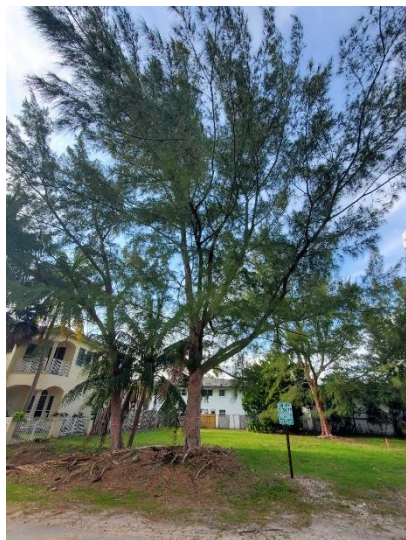
## Tree # 1

Condition – Poor

Tree #1 is an Australian Pine an invasive exotic tree species as per FLEPPC Category I list of species. Tree is located south side of the property on site. This Australian pine is in poor condition with many co-dominant leaders compromising tree stability and risk of failing. This tree is in conflict as well with the proposed new development and is proposed to be removed with no mitigation required.

Disposition – To be removed

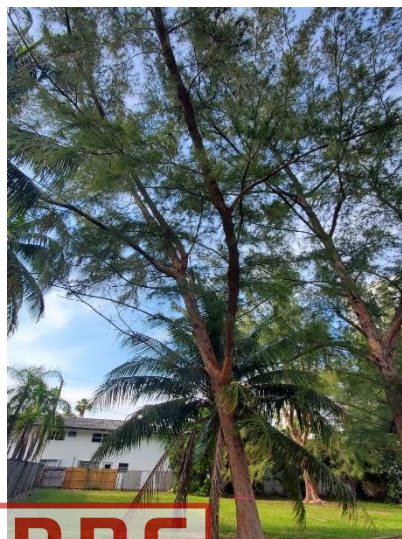
## Tree # 2

Condition – Poor

Tree #2 is an Australian Pine is an invasive exotic tree species as per FLEPPC Category I list of species. Tree is located south side of the property on site. This Australian pine is in poor condition with two main co-dominant leaders compromising tree stability and risk of failing. This tree is in conflict as well with the proposed new development and is proposed to be removed with no mitigation required.

Disposition – To be removed

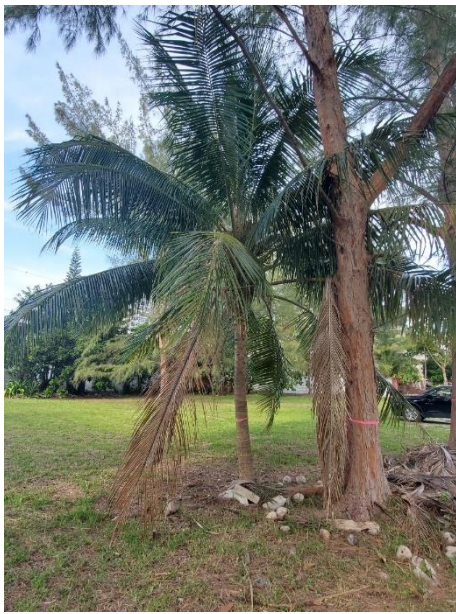
## Tree # 3

Condition – fair

Tree #3 is a Coconut palm. This palm is in fair condition its upper canopy shows interveinal chlorosis and extreme burning on lower of fronds. The trunk shows clear signs of tapering reducing its girth on the top and slightly vent sideways due to severe nutritional deficiencies. This palm has been severely neglected over the years due to lack of care fertilization and watering. This palm is currently proposed to be removed as part of the upcoming new construction activities and will be mitigated on site.

Disposition – To be removed

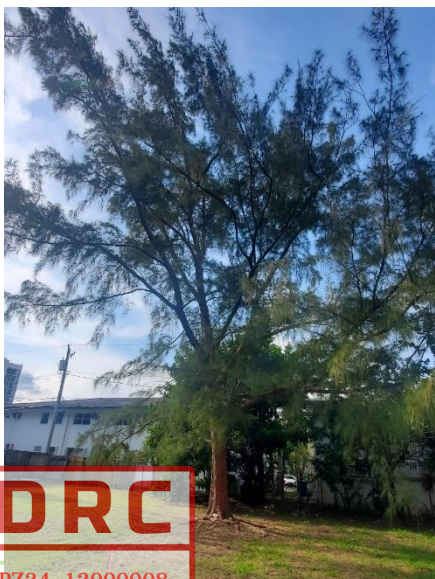
## Tree # 4

Condition – Poor

Tree #4 is an Australian Pine is an invasive exotic tree species as per FLEPPC Category I list of species. Tree is located in the middle of the lot north side of the property on site. This Australian pine is in poor condition with three main co-dominant leaders compromising tree stability and risk of failing. This tree is in conflict as well with the proposed new development and is proposed to be removed with no mitigation required.

Disposition – To be removed

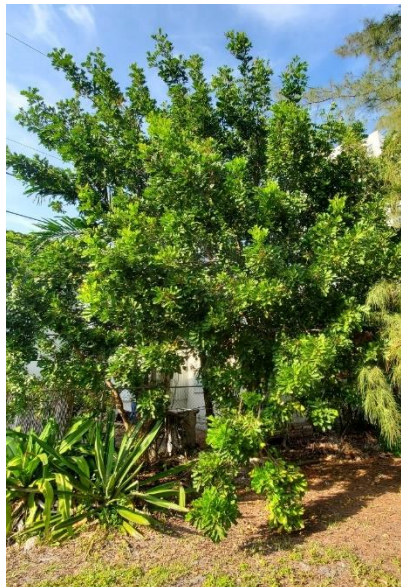
## Tree #5

Condition – Good Native? - No

Tree #5 is a Carrotwood tree a very highly invasive exotic tree category 1 as per FLEPPC latest list. This tree is located N side of the property. This tree is probably a seedling of other invasive exotics found in this property or adjacent neighbors. Therefore, immediate removal is recommended and current disposition as per site development is to be removed with no mitigation required.

Disposition - To be removed

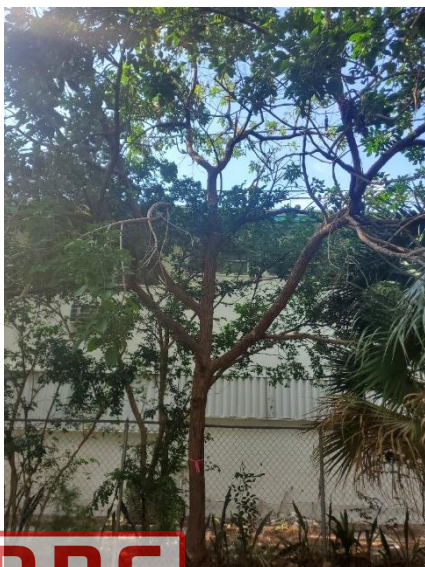
## Tree #6

Condition – Good

Tree #6 is an individual single trunk Bischofia tree category I invasive exotic this tree is located middle of the property side of the property along landscape buffer area facing Ingraham Hwy and is currently proposed to remain on site. This tree is a Miami Dade county Prohibited species and an invasive exotic pest plant list category I as per FLEPPC and is highly encouraged to be removed in the future to prevent any spread throughout the property.

Disposition – To be removed

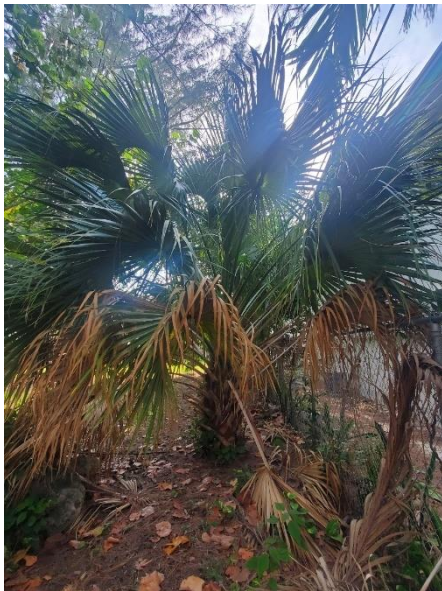
Tree #7  
 Common Name  
 Sabal Palm  
 PZ24-12000008  
 09/18/2024

Tree #7 is a young size sable palm in a fair condition its upper canopy shows interveinal chlorosis and extreme burning on lower of fronds. This palm is a volunteer seedling probably from wildlife dispersal. This palm is currently proposed to be removed as part of the upcoming new construction activities.

Condition – Good

Disposition – To be removed

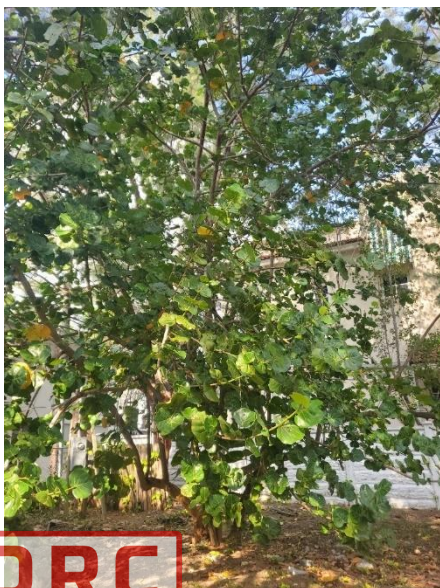
## Tree #8

Condition – Fair

Tree #8 is a young Seagrape tree located north side of the property this tree probably was dispersed from wildlife seeds. Tree is in fair condition has severe codominant leaders and included bark and has been severely damaged and deformed during previous storm events and is growing more like a bush with several trunks. This tree is in conflict with proposed new construction and is currently proposed to be removed and mitigated on site.

Disposition - To be removed

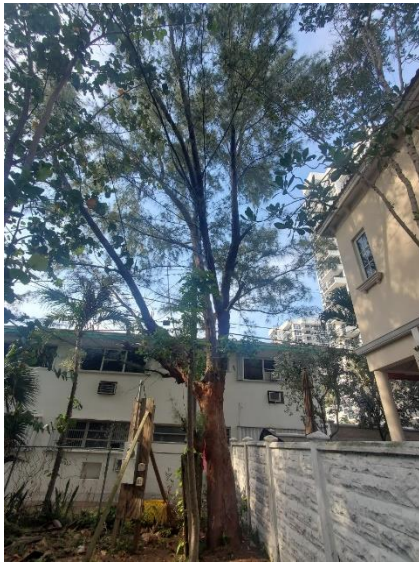
## Tree # 9

Tree #9 is a large Australian Pine as per attached picture. This tree is an invasive exotic tree species as per FLEPPC Category I list of species. Tree is located north east side of the property on site. This Australian pine is in poor condition with three main co-dominant leaders compromising tree stability and risk of failing. Damage to adjacent property is highly probable. This tree is in conflict as well with the proposed new development and is proposed to be removed with no mitigation required.

Condition – Poor

Disposition – To be removed

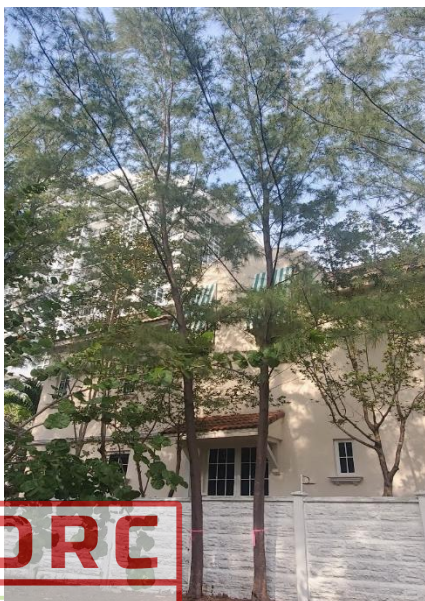
## Tree # 10 &amp; #11

Trees #10 & #11 are both Australian Pines invasive exotic tree species as per FLEPPC Category I list of species. Trees are located east side of the property on site. These Australian pines are seed dispersed by adjacent existing large Australian pine trees. Trees are in good condition with one single leader. Damage to adjacent property is highly probable. These trees are in conflict as well with the proposed new development and is proposed to be removed with no mitigation required.

Condition – Poor

Disposition – To be removed

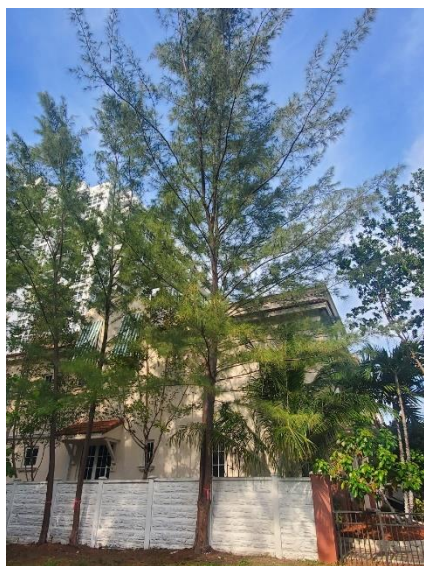
Tree # 12  
Common Name

Tree #12 is an Australian Pine an invasive exotic tree species as per FLEPPC Category I list of species. Tree is located south side of the property on site. This Australian pine is in good condition with one main leader. Damage to adjacent property is highly probable. This tree is in conflict as well with the proposed new development and is proposed to be removed with no mitigation required.

Condition – Good

Disposition – To be removed

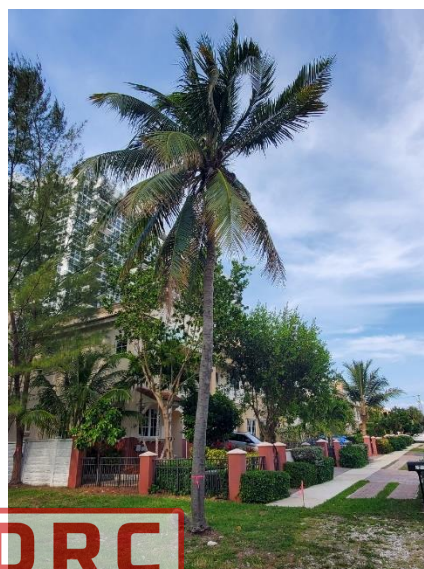
## Tree # 13

Tree #13 is a Coconut palm. This palm is located SE side of the property and is in fair condition its upper canopy shows interveinal chlorosis and extreme burning on lower of fronds. The trunk shows clear signs of tapering reducing its girth on the top and slightly vent sideways due to severe nutritional deficiencies. This palm has been severely neglected over the years due to lack of care fertilization and watering. This palm is currently proposed to be removed as part of the upcoming new construction activities and will be mitigated on site.

Condition – Fair

Disposition – To be removed
