## Rahim Vedaee

February 6, 2025  
2281 NW 16<sup>th</sup> Street  
Pompano Beach, FL

An Arborist Report/Tree disposition was conducted for the above referenced property. During our inspection, twenty-three (23) specimen size trees were located on the property. Below is a detailed report of the one tree that are located on the property.

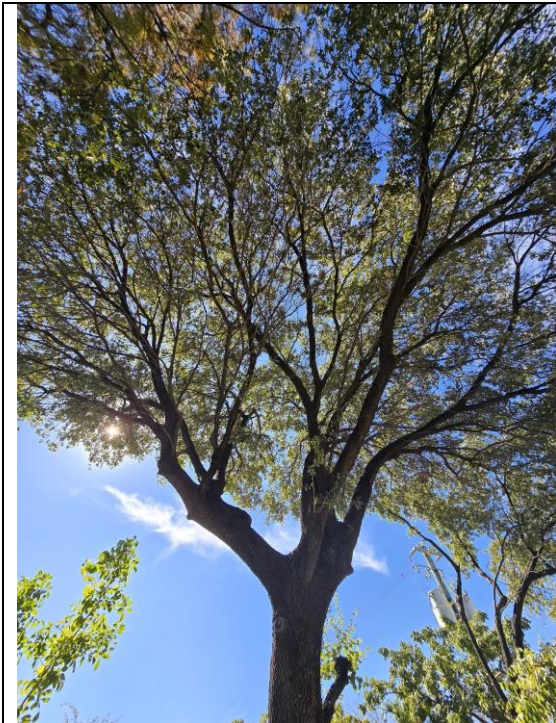
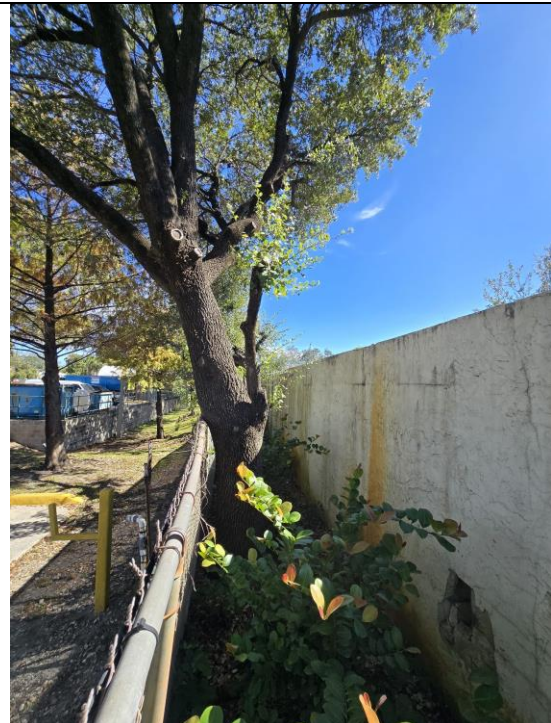
Tree #97 Live Oak (*Quercus Virginiana*)

**Tree #97** Live Oak (*Quercus Virginiana*) DBH 24", HT 45', SP 35', Cond 54% Appraisal \$4,301.94  
 This tree is located on the neighboring property growing agents the divider fence. This tree is growing with a lean with the anchoring roots pushing agents the neighboring wall. Some dead, and decayed branches could be seen throughout the trees canopy.

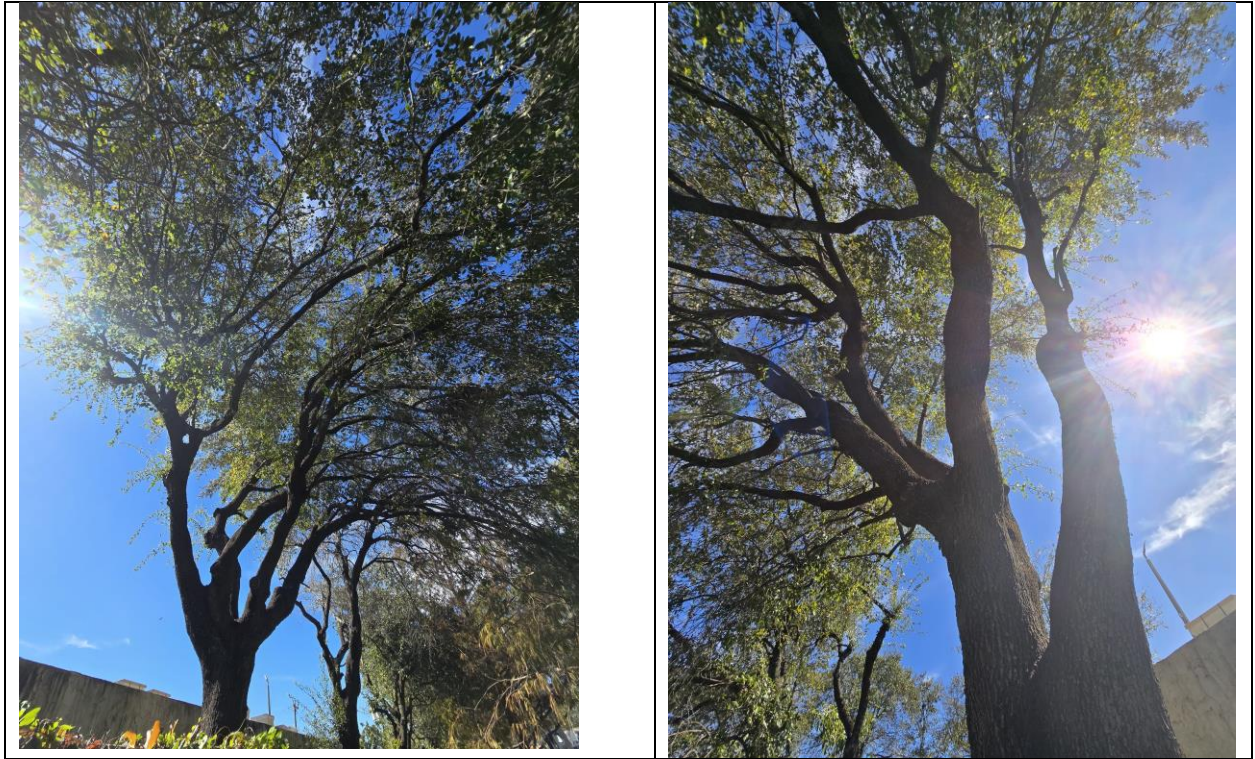
Tree #104 Live Oak (*Quercus Virginiana*)

**Tree #104** Live Oak (*Quercus Virginiana*) DBH 24", HT 40', SP 45', Cond 55% Appraisal \$4,381.61  
This tree is located on the neighboring property growing between the divider fence and neighboring wall. This tree has a lopsided canopy with the all the canopy on the southside being removed. This tree has codominant stems with Some dead and decayed branches could be seen throughout this lopsided canopy.

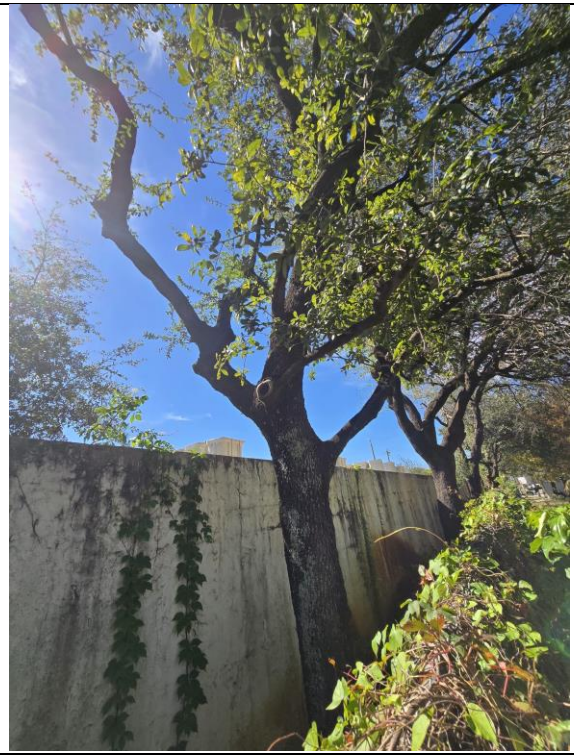
Tree #105 Live Oak (*Quercus Virginiana*)

**Tree #105** Live Oak (*Quercus Virginiana*) DBH 18", HT 30', SP 30', Cond 45% Appraisal \$2,688.71  
This tree is located on the neighboring property growing between the divider fence and neighboring wall. This tree has a lopsided canopy with the all the canopy on the southside being removed. This tree entire tree is chlorotic with many dead, decayed and broken branches.

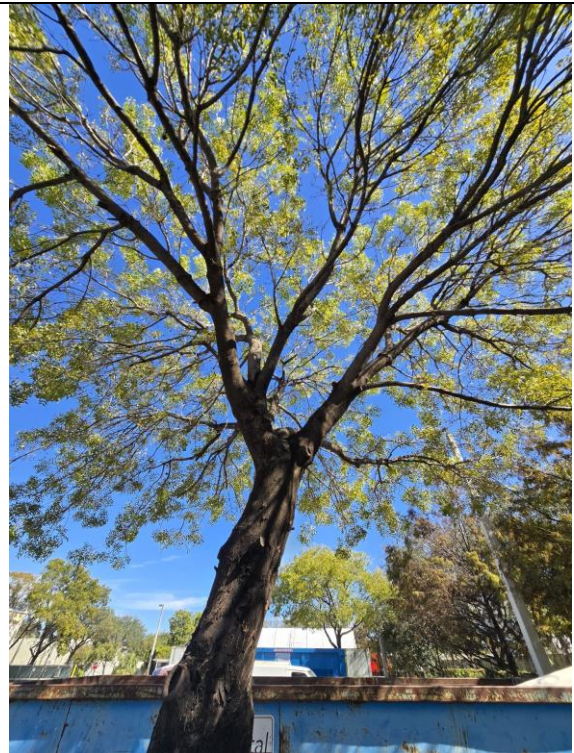
**Tree #112** Mahogany (*Swietenia mahagoni*) DBH 20'', HT 30', SP 40', Cond 60% Appraisal \$3,528  
 This tree is located in a parking island. This tree has codominant stems with some dead, cross, broken and fused branches being visible in the trees canopy. this tree is suffering from a nutritional deficiency with the entire canopy being chlorotic.

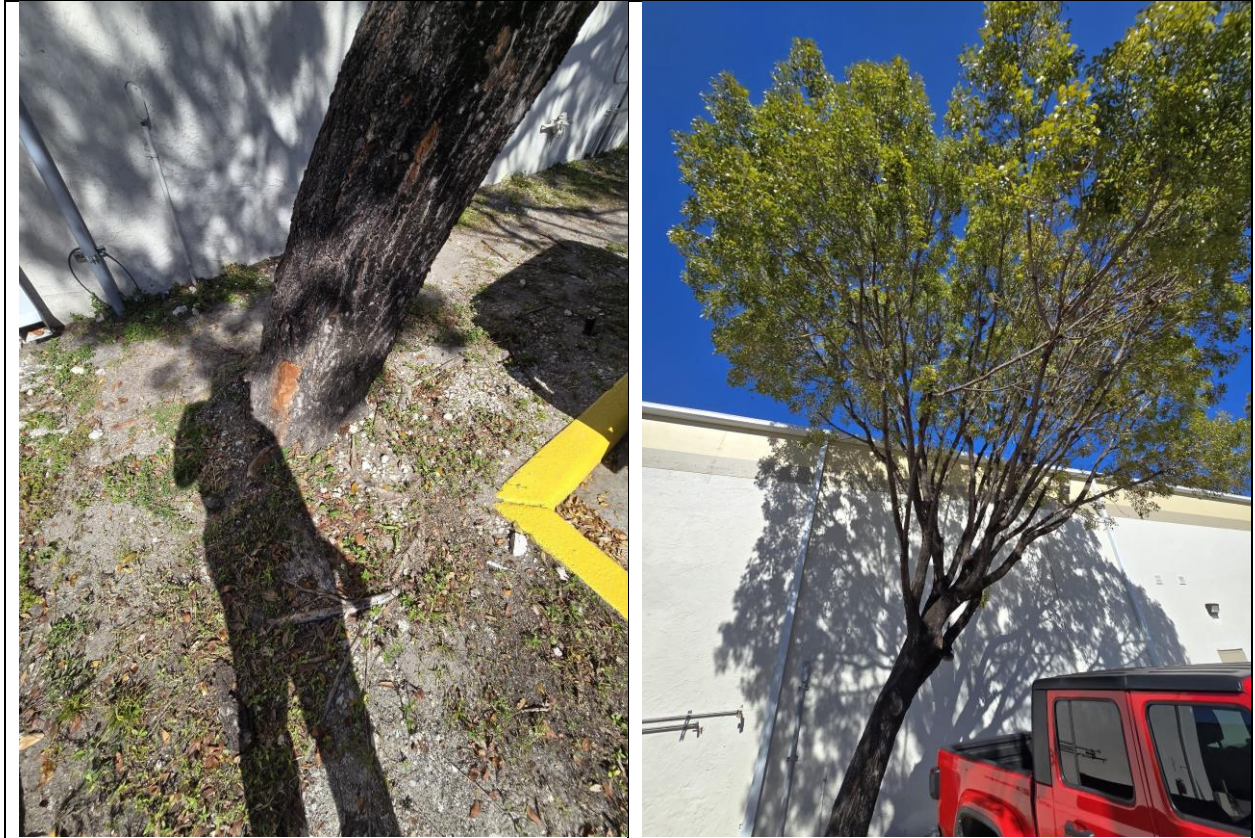
Tree #113 Mahogany (*Swietenia mahagoni*)

**Tree #113** Mahogany (*Swietenia mahagoni*) DBH 18", HT 30', SP 40', Cond 55% Appraisal \$2,910.6

This tree is located in front of building 2200. This tree has several codominant stems with majority of the canopy being concentrated at the top. The tree is growing with a sever lean due to its close proximity to the building. Nutritional deficiency was visible throughout the canopy a with the entire canopy being chlorotic.

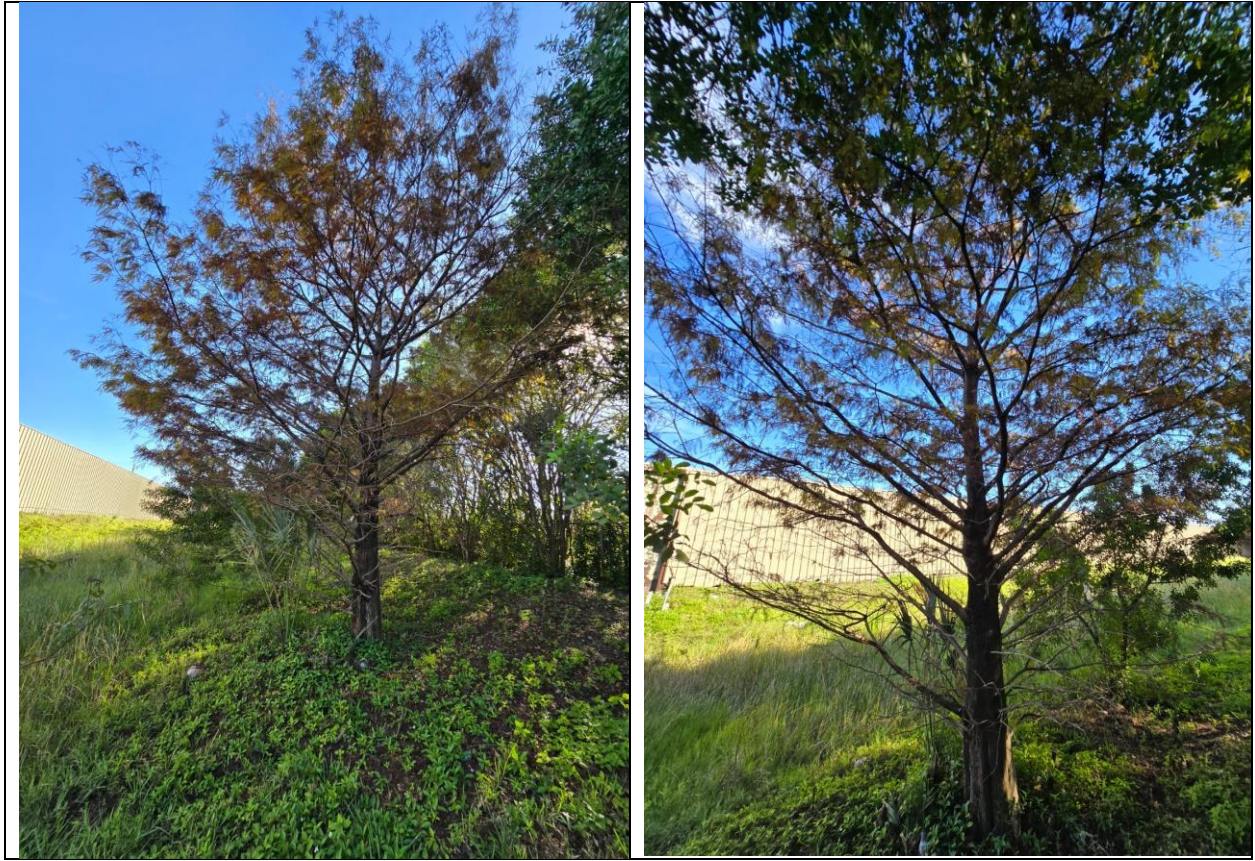
Tree #182 Bald Cypress (*Taxodium distichum*)

**Tree #182** Bald Cypress (*Taxodium distichum*) DBH 18", HT 25', SP 25', Cond 65% Appraisal \$2,193.75

This tree is located on the west side of the property inside a retention area. Some dead and broken branches could be seen throughout the trees canopy. Overall this tree is healthy with no signs of insects and diseases.
