ATLAS SAFETY & SECURITY DESIGN, INC.

RE: Oldcastle Coastal Facility – 1200 NW 18<sup>th</sup> St., Pompano Beach, CPTED/Security Public Safety Plan

I have been contracted to review the drawings for security and Crime Prevention Through Environmental Design (CPTED) features in the proposed Oldcastle Bonsal Facility site plan update that is being considered for permitting by the City of Pompano Beach.

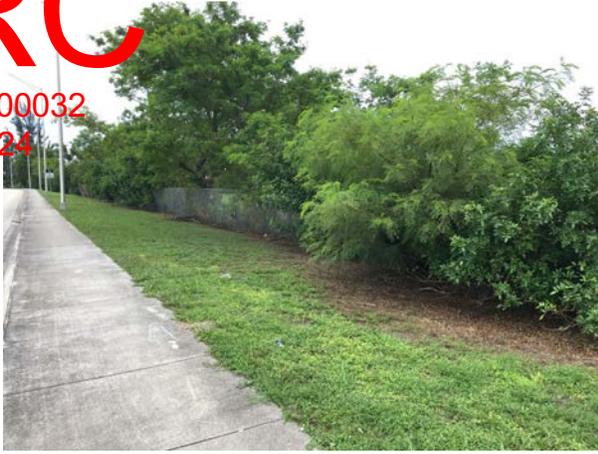
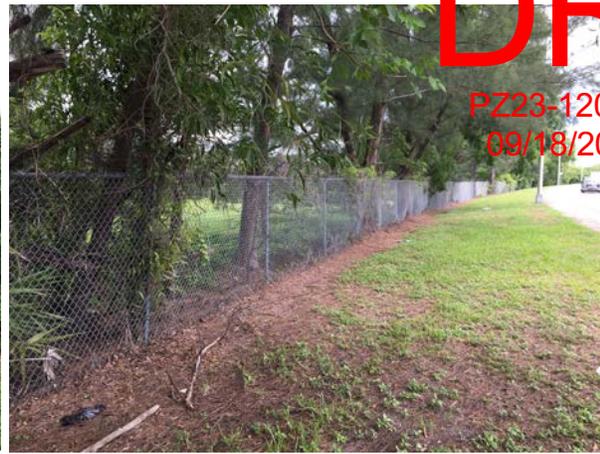
The west boundary on Andrews Avenue is chain link fencing and overgrown shrubs and non-native Australian Pine.

Territorial Reinforcement /Boundary definition – Fencing and Plantings – The existing six-foot high chain link fencing requires extensive repair and maintenance on the north, south, and east sides. Plantings should be maintained to be no higher than the fence line and the boundaries. Tree canopies should be maintained clear under 8 feet, with a trunk six inches in diameter or greater. If new saplings are planted, do not mutilate them to comply with the canopy requirement until they are mature trees with a six inch diameter trunk or greater, and if the tree canopies are blocking the field of vision.

The west border definition will be improved with an attractive picket metal code compliant fencing with plantings, and a vehicle gate. It is recommended that as the site is improved to accommodate a sidewalk connection, and new monumental sign, and additional stripping at the entrance of onto Andrews Avenue will be added to direct the heavy trucks and rigs.

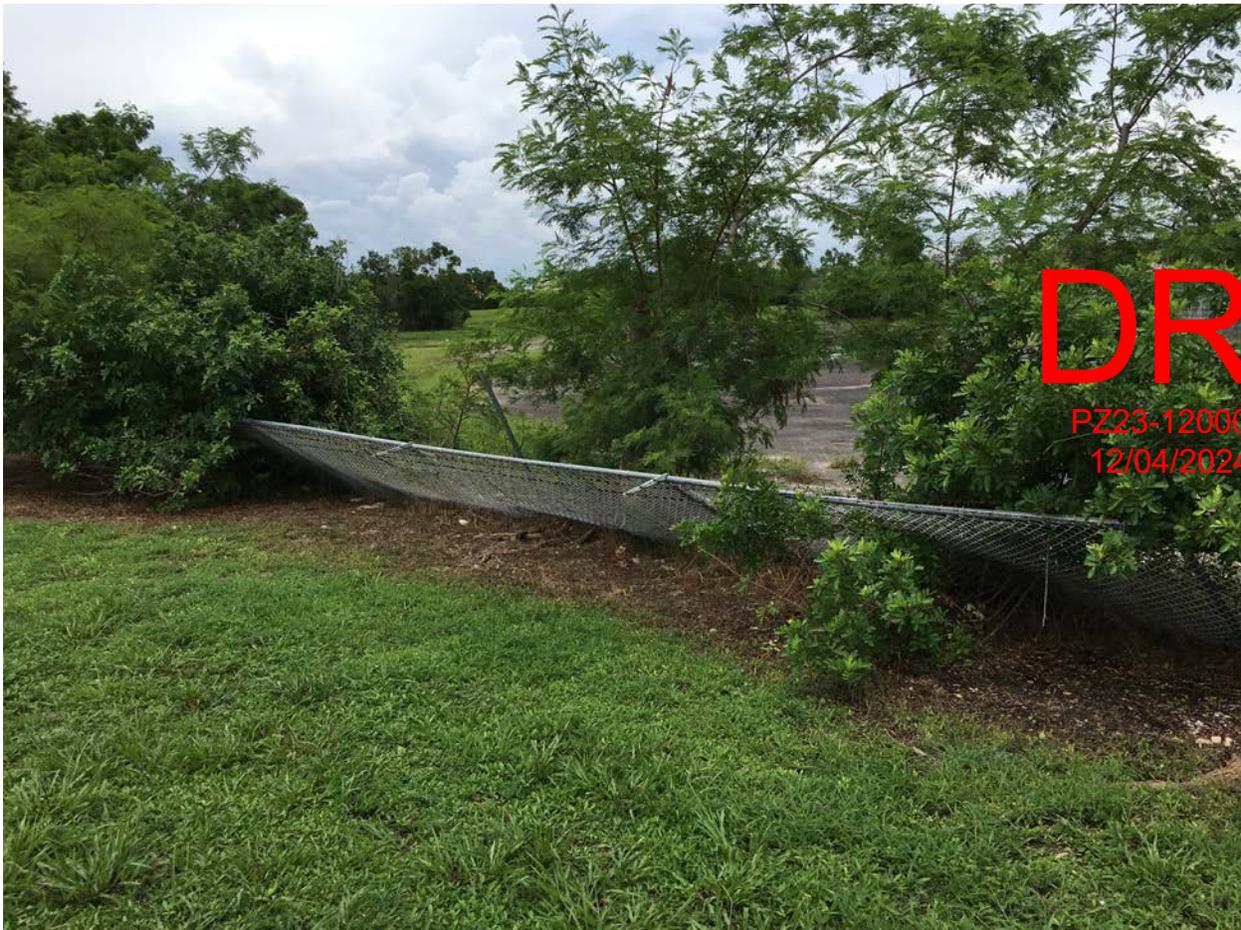
The West Boundary has sections of the chain link fence that are damaged and lying down.

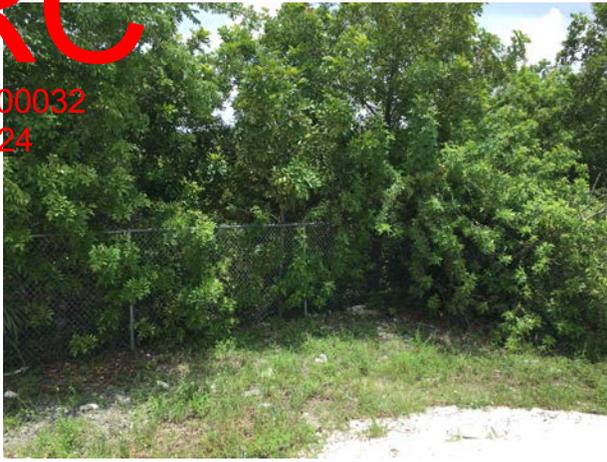
The East boundary is six-foot chain link with overgrown shrub.

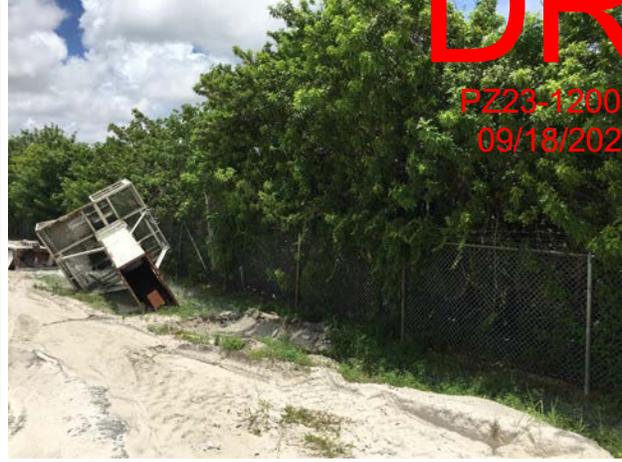
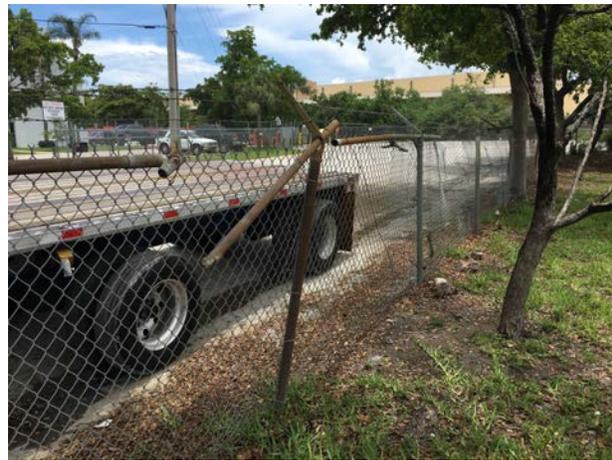
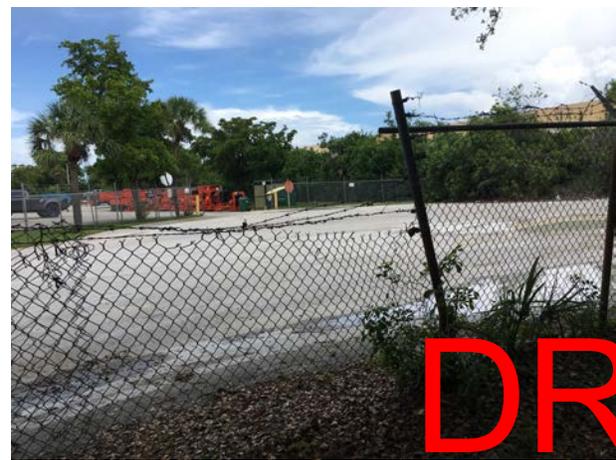
The North boundary is presently the primary access and egress points to the plantation NW 18<sup>th</sup> Street. There are two gates openings. Both gates are left open and have been damaged and non-operational. The barbed wire on the top of the chain link fencing has been damaged and not consistent.

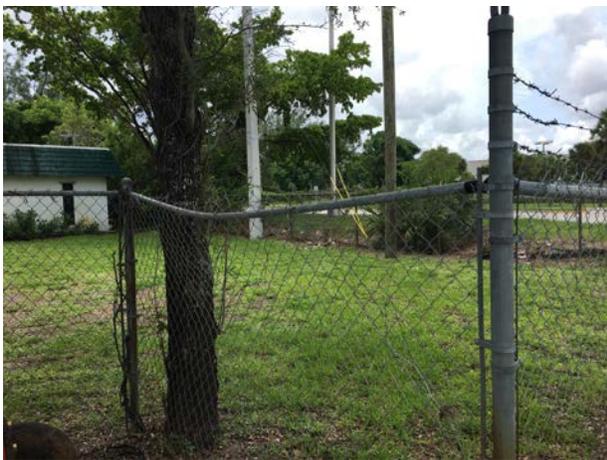
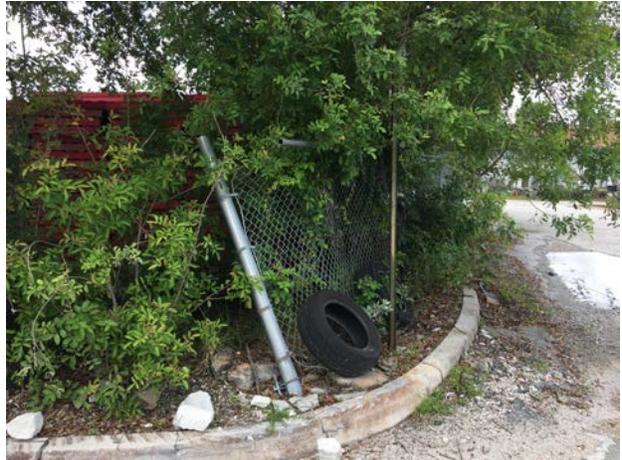
The north boundary fencing is heavily damaged.

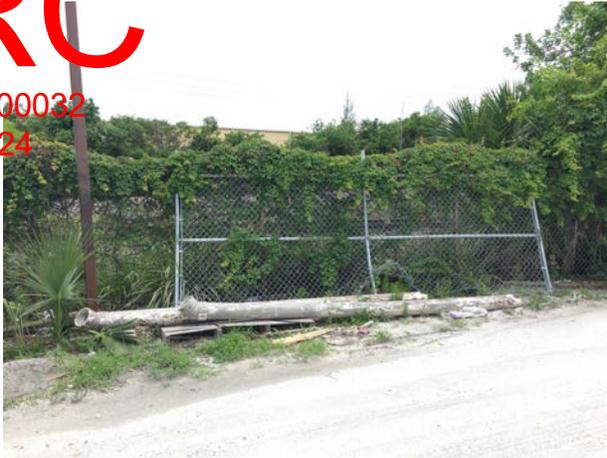
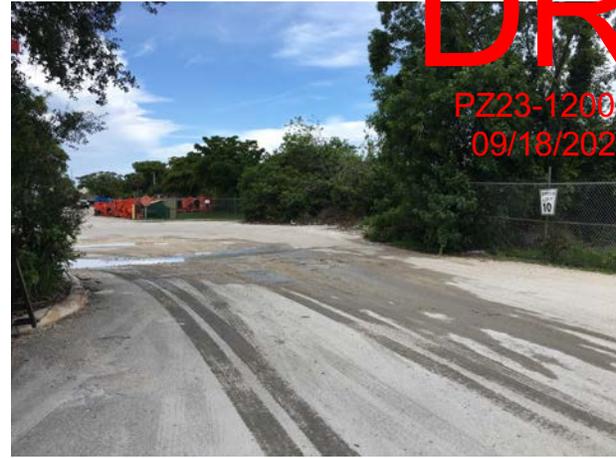
The northeast gate has been knocked off the tracks and lays against the east perimeter fence. The open access allows trucks with aggregate product to enter in the site, but also has no barriers to keep trespassers out.

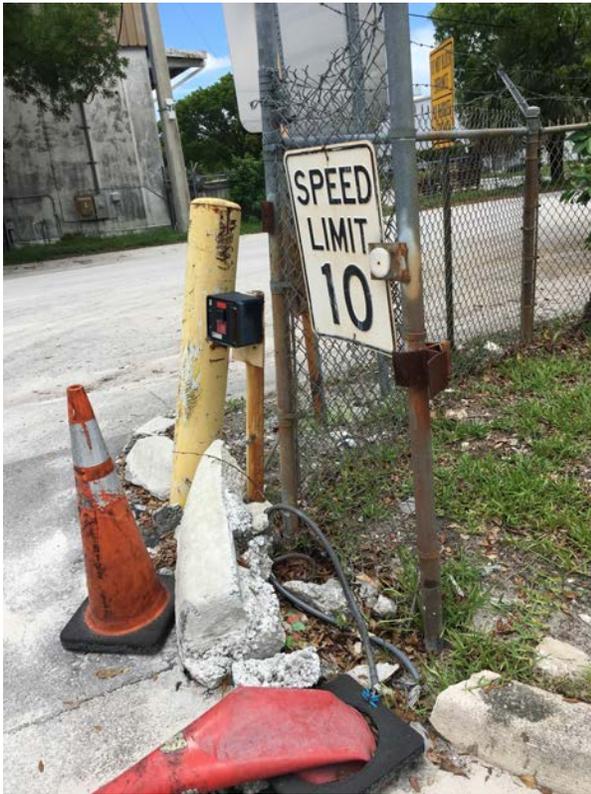
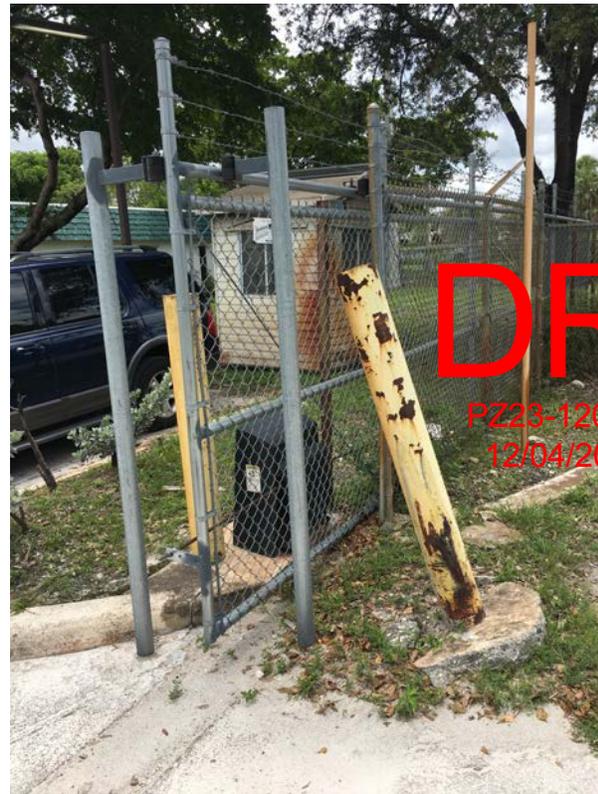
The Northwest gate is the primary entrance for administration, employee vehicles. The gate is non-functional and is in disrepair.

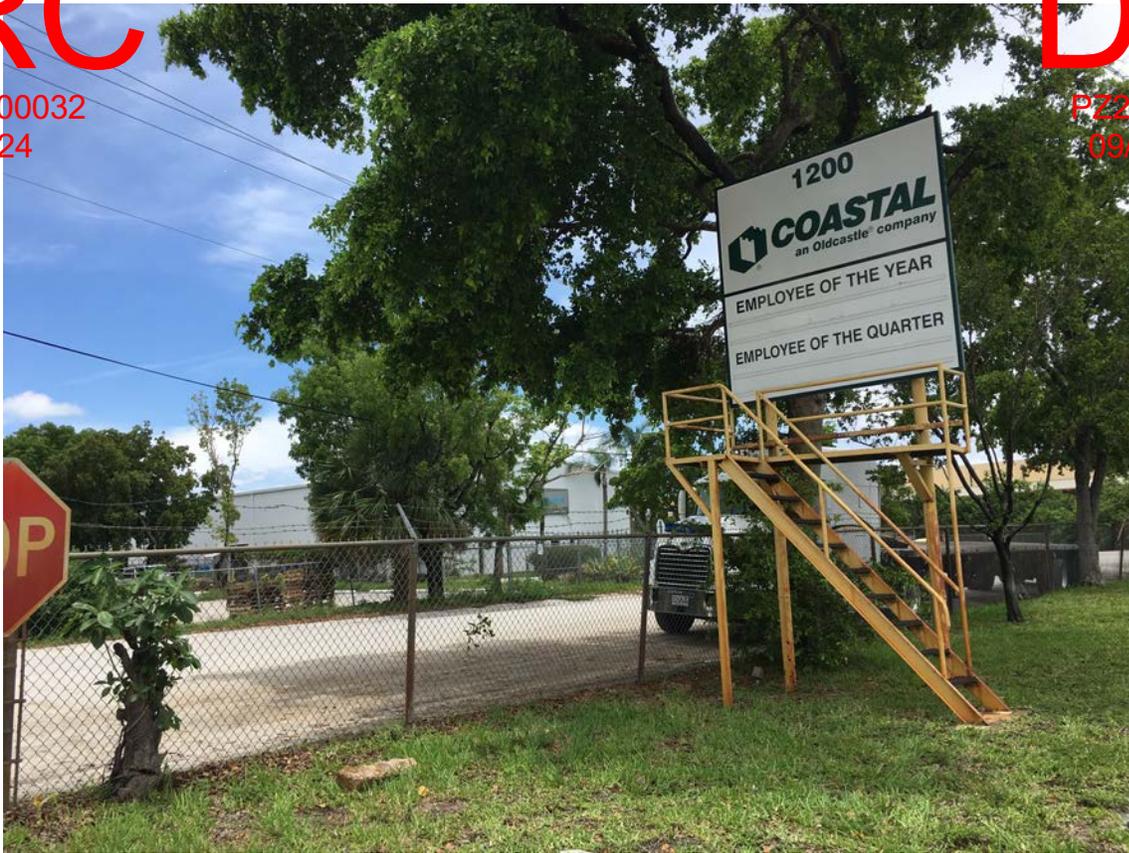
The north boundary on NW 18<sup>th</sup> Street has the marquee sign for the plant. It is difficult to see from the main road, Andrews Avenue.

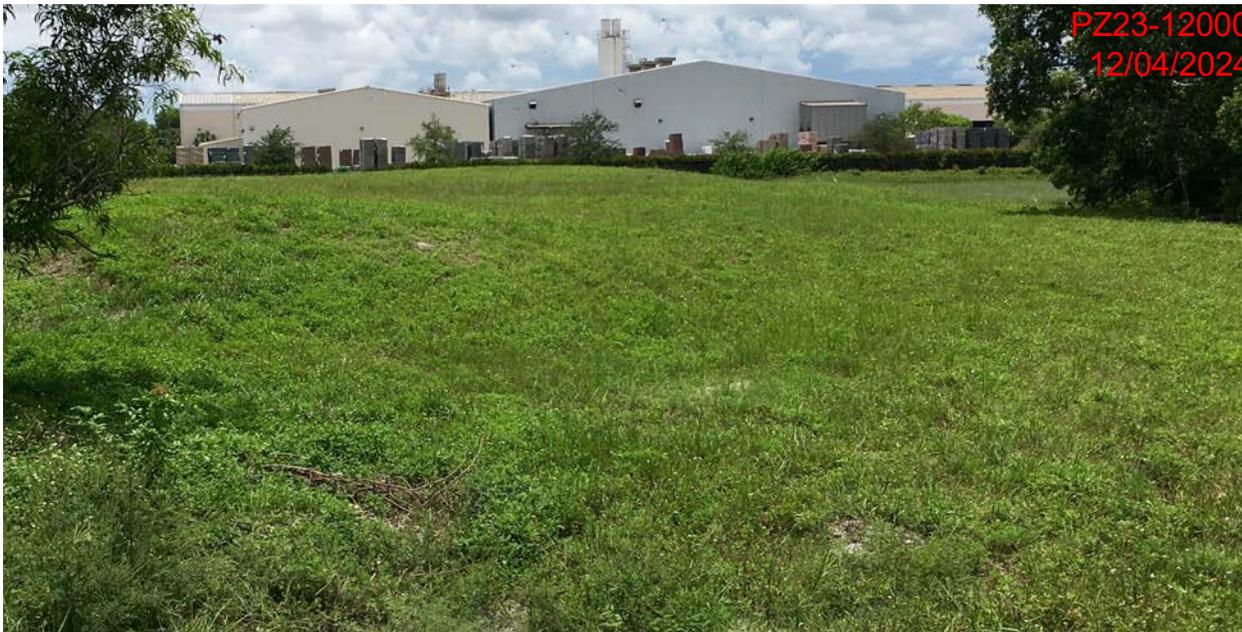
The South boundary is open real estate between the Bonsal Plant and the Oldcastle Distribution Center.

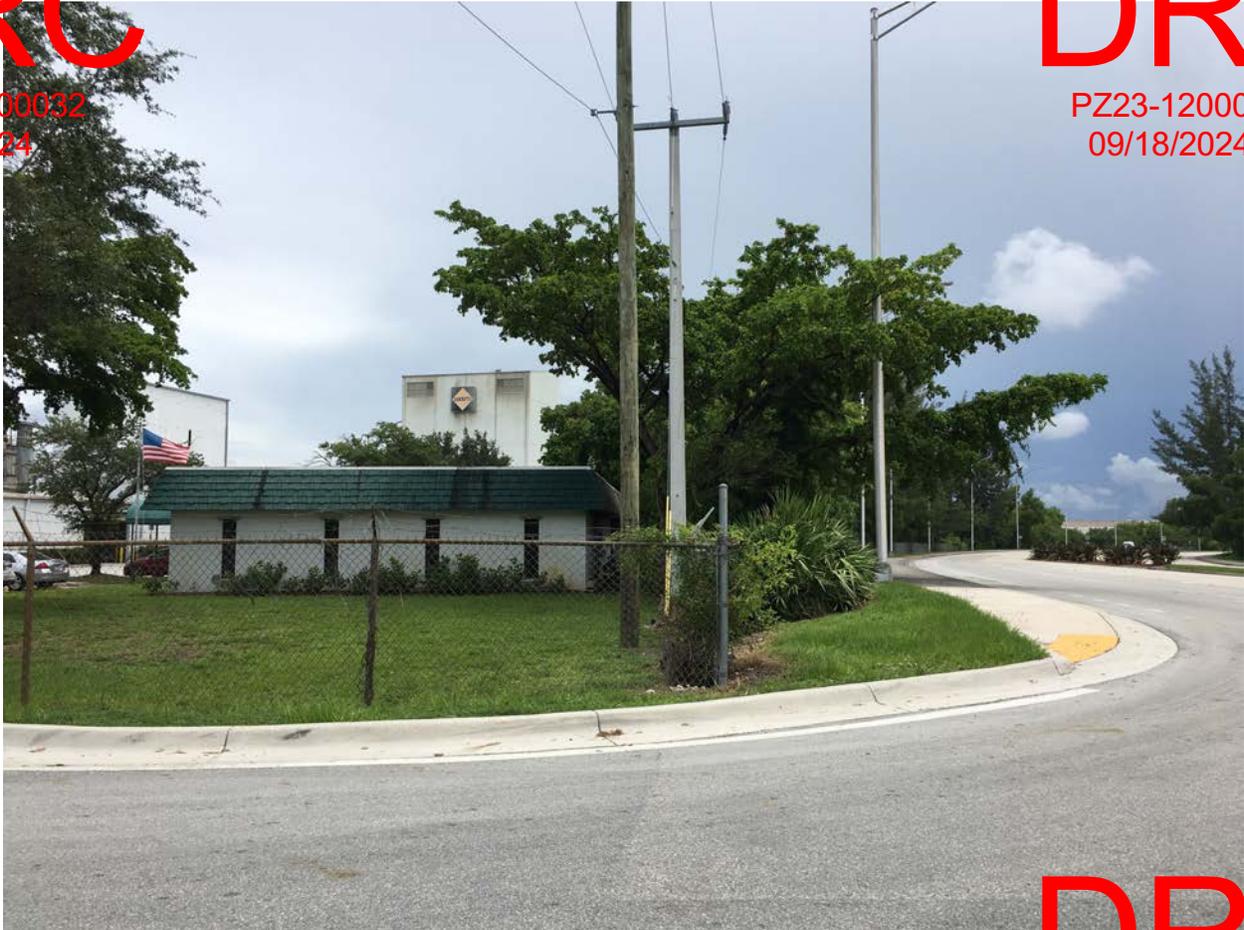
There are no controls for vehicles once trucks turn on 18<sup>h</sup> Street. There are no barriers controlling access to the parking lot and site on the north side.

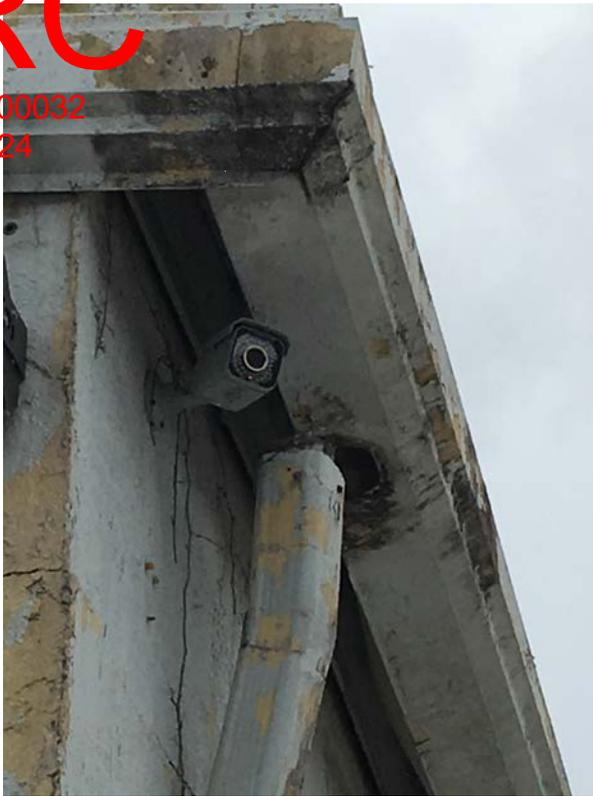
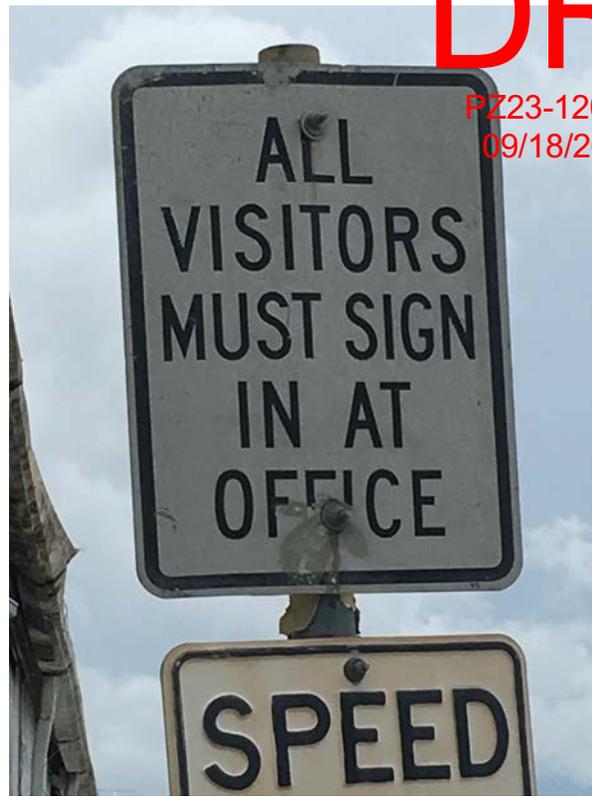
Natural surveillance of the north parking lot and northwest vehicle entrance is achievable from the windows of the administrative offices if staff is present. There is no mechanical surveillance being used on the property, on the site or inside the plant or administrative spaces. While remnants of an old CCTV system were there, it is not functional. Access to the site are not controlled by gates because of the high volume of truck traffic daily, so to prevent theft, vandalism, pilferage, or illegal dumping, vehicles and persons entering the site should be under mechanical surveillance.

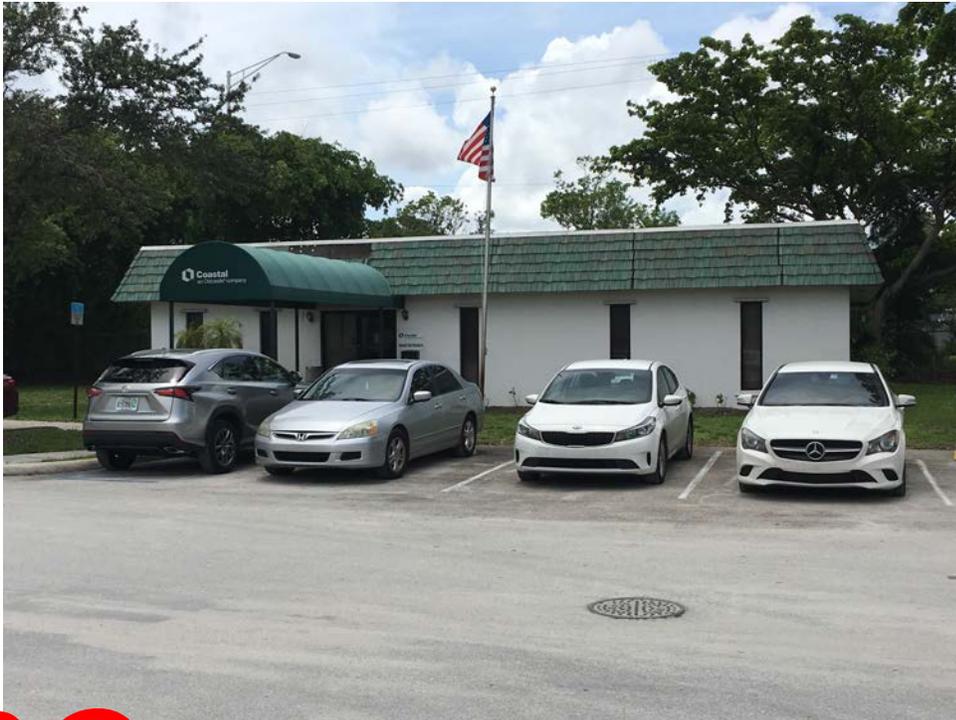
The business office entrance faces east and the north side of the site.

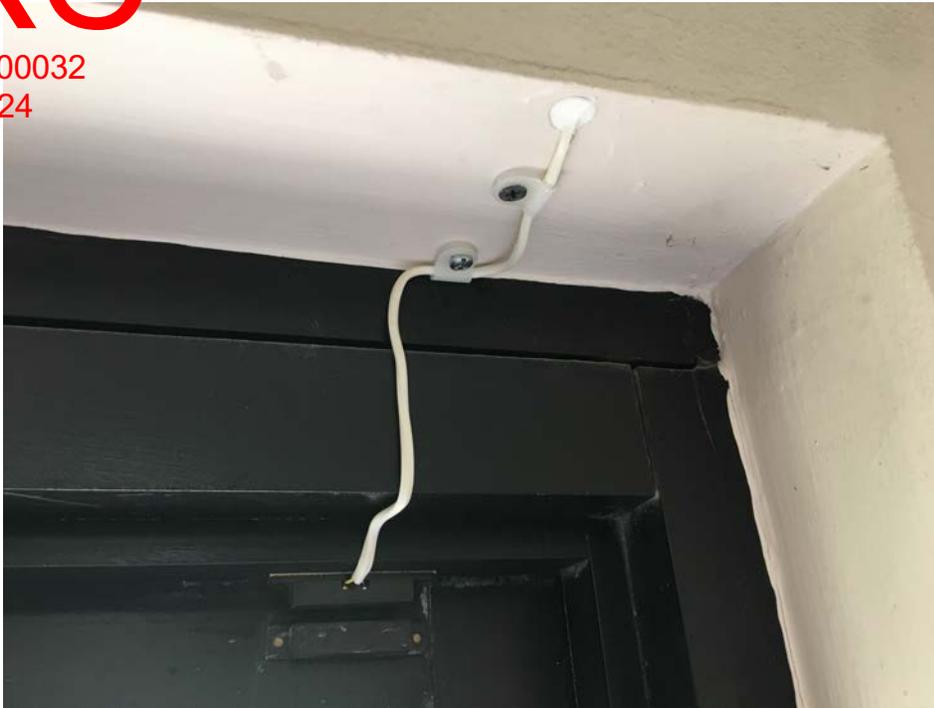
The office has a make shift security system that is monitored but needs to be updated. There is no exterior light along the east side of the business office.

Facility access control – The existing admin office building has a security burglar alarm system, with intrusion detection devices (motion sensors), and have the doors alarmed with door position switches (DPS). It is recommended that the existing building doors get rewired in a professional manner with no wires exposed, and if wires cannot be brought through the door frames, then have the wiring in security conduit. Since the factory plant is operating 24/7 their doors will be left open during operating hours, however the continual presence of staff should discourage and opportunity for criminal activity. The Alarm Company is Tyco/ADT and their service can be easily expanded to include the interior space protection alarms, the door position switches, and the proposed video surveillance system and video monitoring for the site.

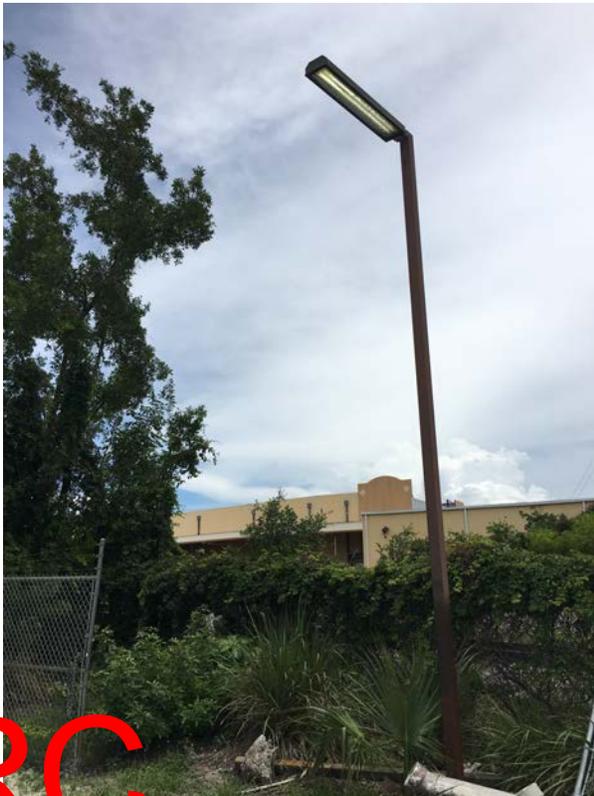
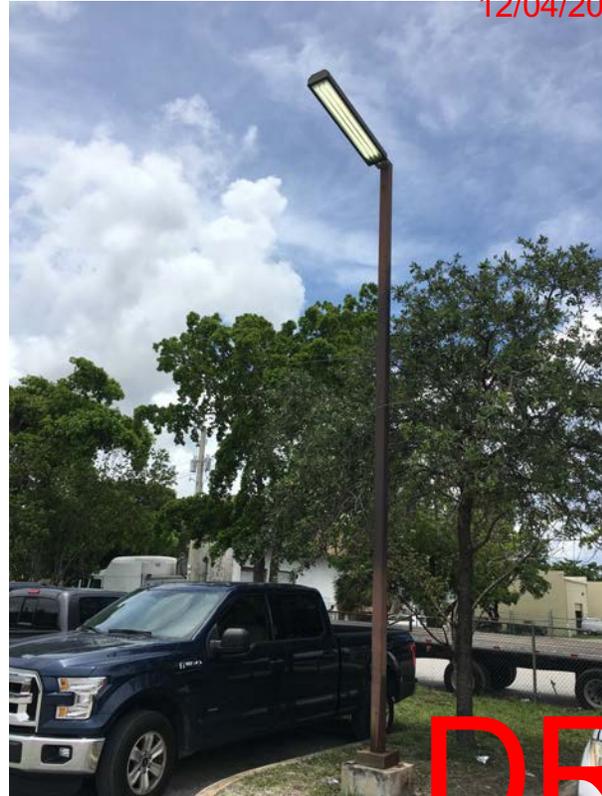
The pole lighting actually uses florescent tubes, and was turned on during daylight hours.

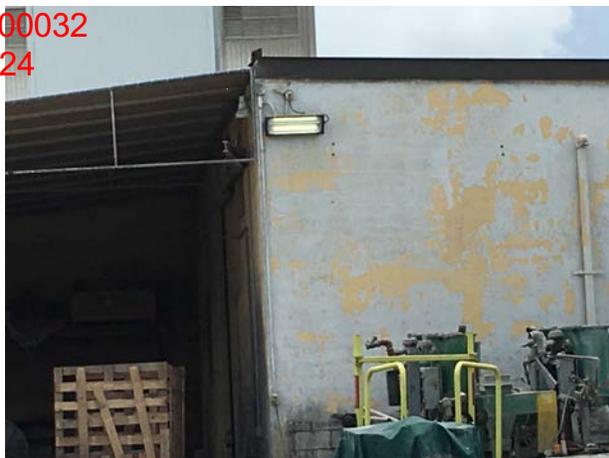
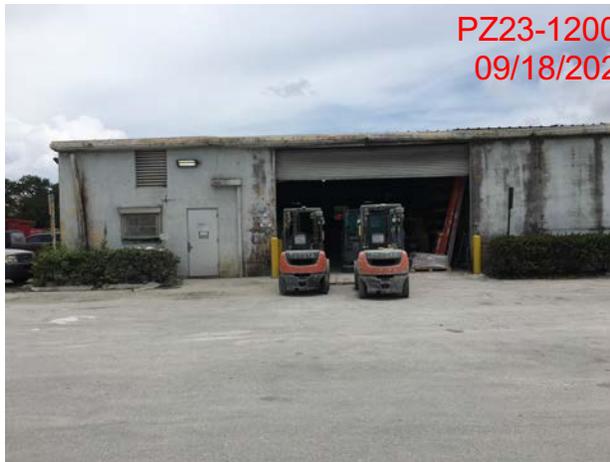
The exterior building lighting is florescent tubes, which are inadequate to properly light the grounds.

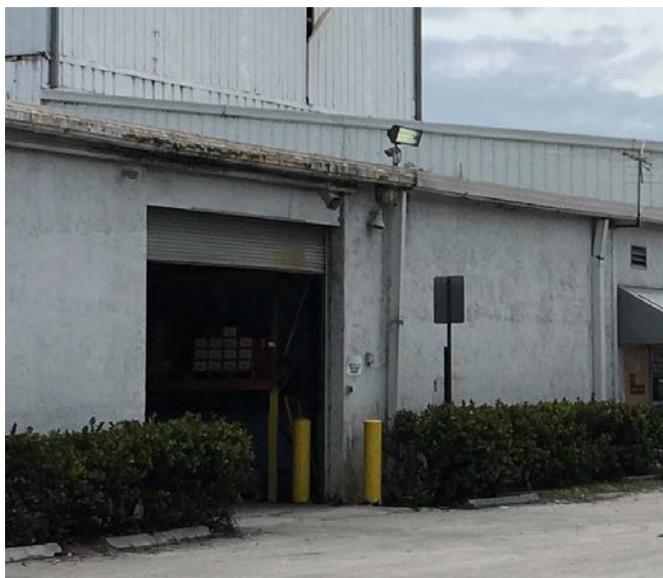
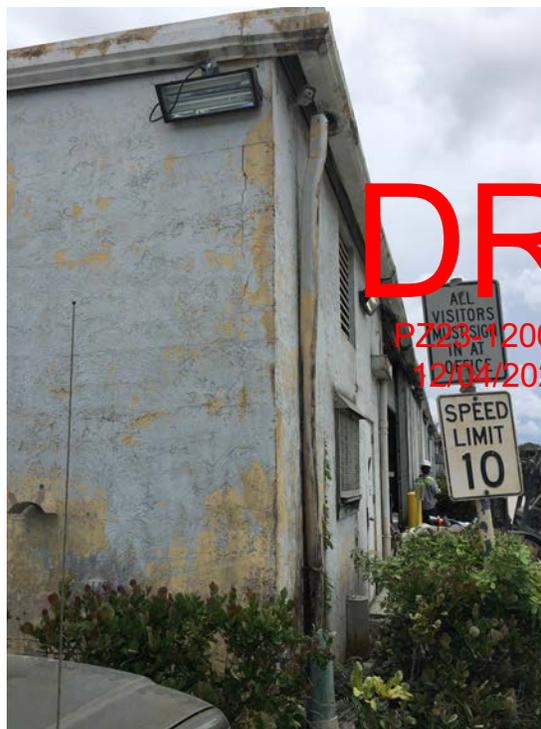
The exterior lighting using florescent tubes as the light source was inefficient and not effective to evenly light the site and building exterior.

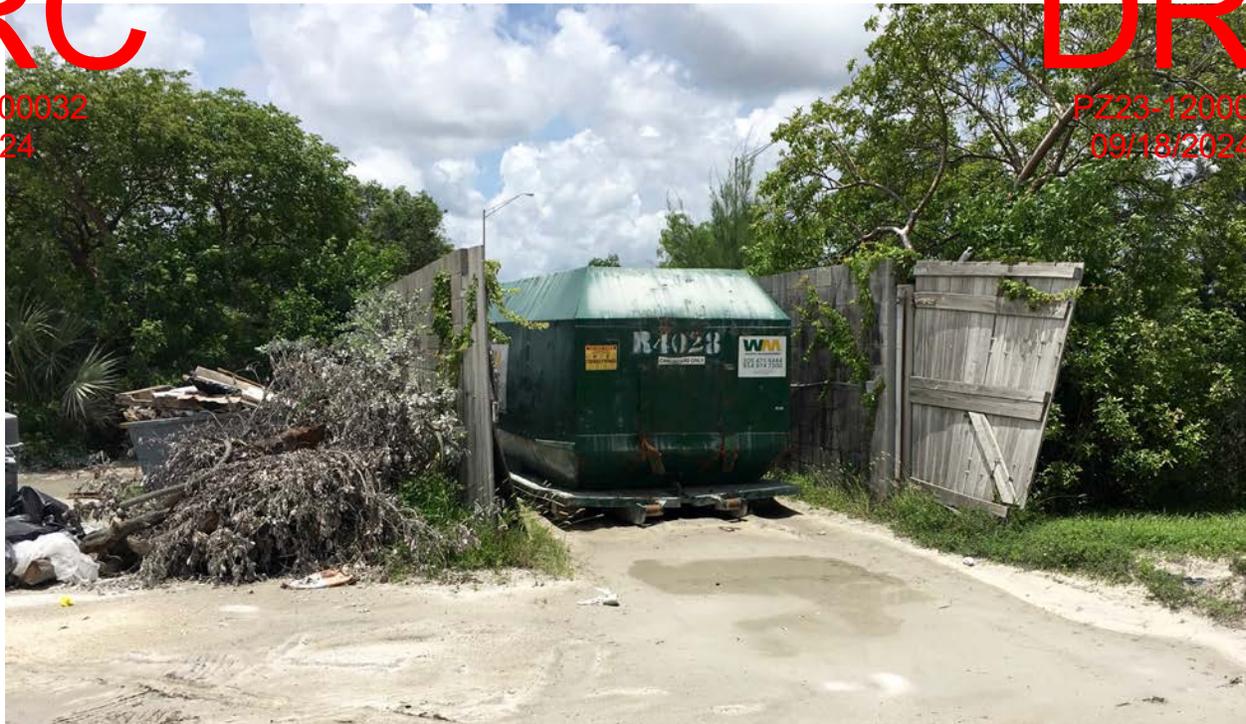
The exterior dumpster area is located in the south part of the yard area across from the Plant. The screening needs to be in working order, and lockable, and the area cleaned up. The dumpster is not set down on a concrete pad. There is no drainage capacity. The wooden gates and shielding are damaged and does not close properly. There is no locking capability to prevent outsiders from outside persons dumping trash.

The new proposed dumpster area should be on a concrete pad that can withstand picking up and dropping down by a garbage truck. There should be bollards/bumpers to prevent the truck from hitting the dumpster enclosure. The dumpster should be shielded on three sides with a screening that complies with zoning regulations. Swing gates that are locked should be used to protect the dumpster from illegal or unwanted dumpster diving or dumping. The front screening should be raised so that a person in the dumpster area can be observed from the outside. The gates should be lockable so they can be secured when not being used. If there is any trespassing in the exterior site areas, the person will stand out and be observed and challenged.

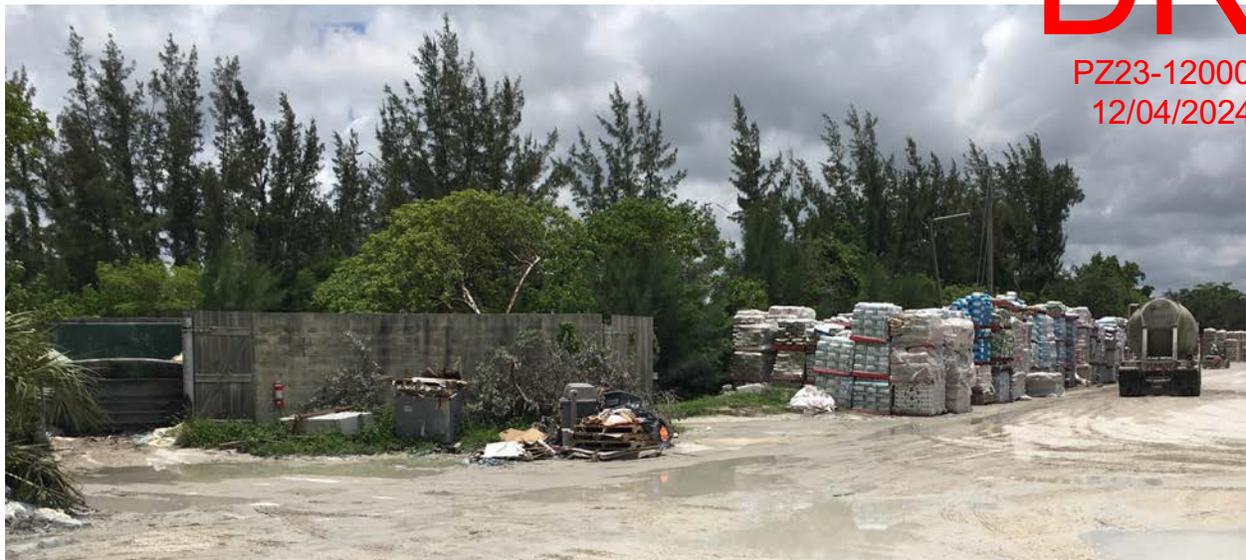
There appears to be some dumping just adjacent to the dumpster. In the new site plan the dumpster will be designed to have compliant surrounding shielding and be secured.
