**Re: Arboricultural Consulting Services for 324 Northwest 6<sup>th</sup> Street, Pompano Beach, Florida**

I visited the above-mentioned property on Tuesday, May 16<sup>th</sup>, to evaluate +/- 24 trees, take photographs (Specimen sized trees only), calculate Rule 14-10 appraisal values, perform relocation evaluations, and note any defects.

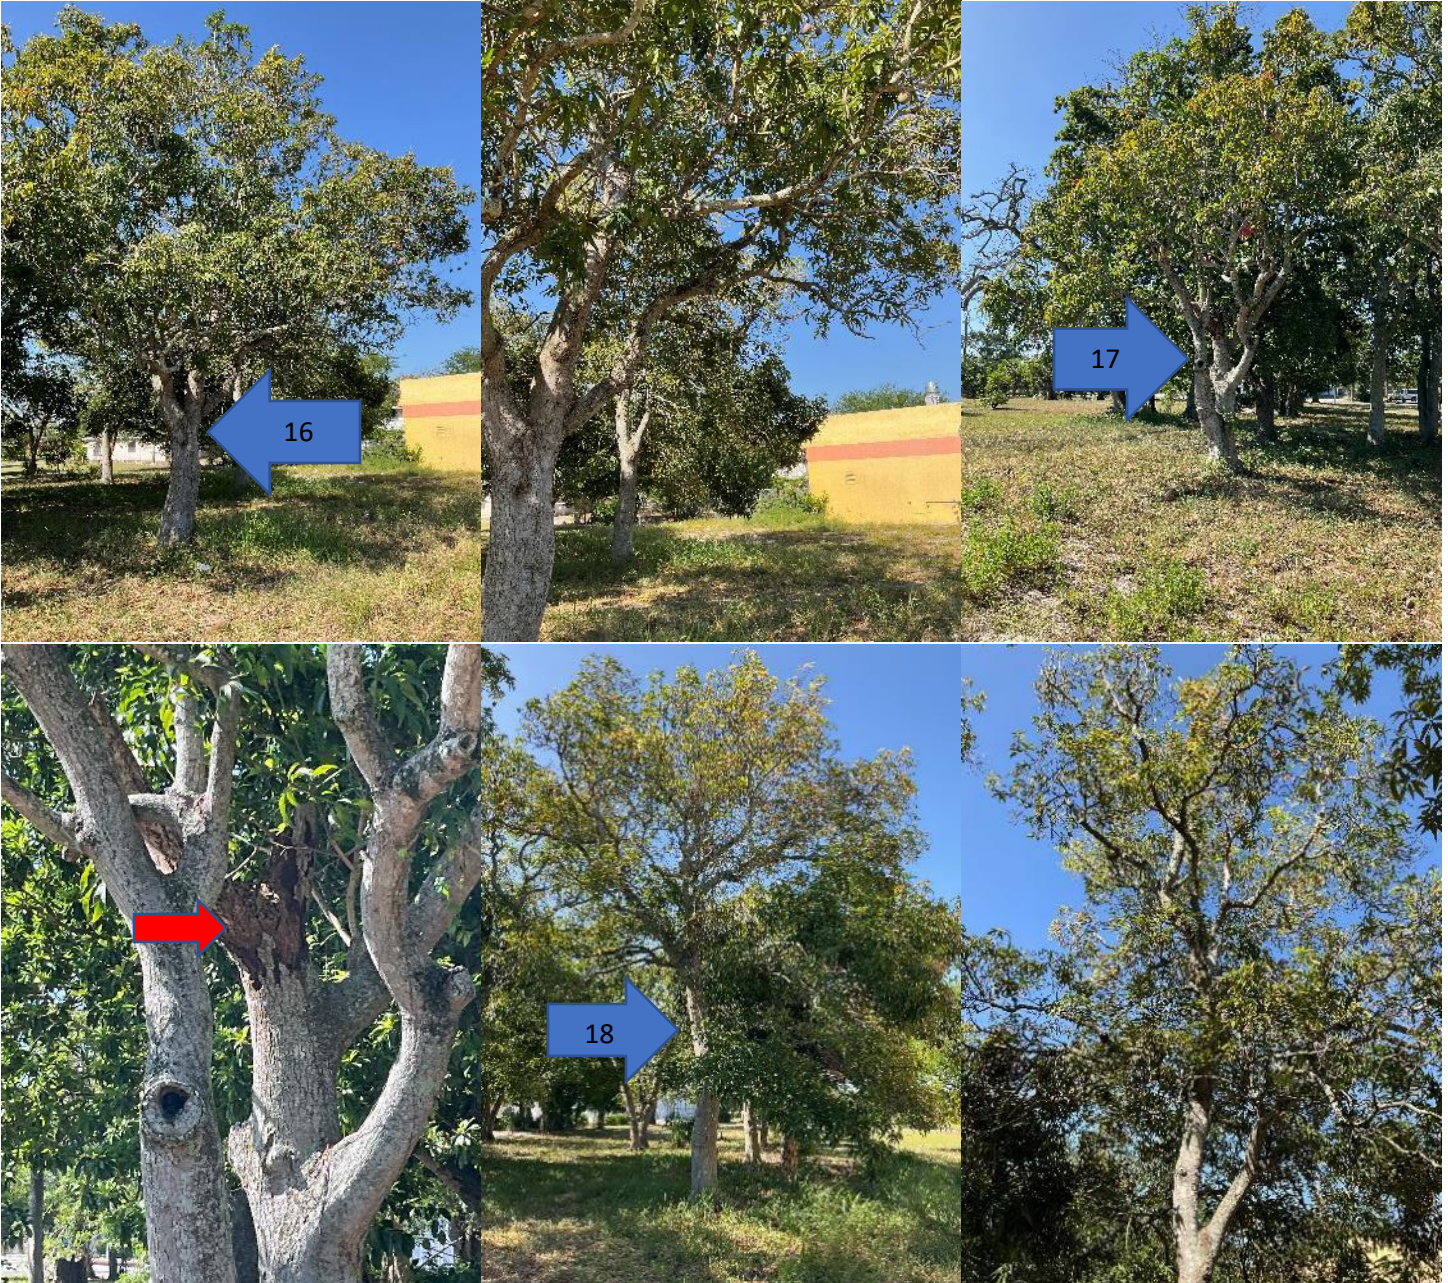
## Trees 16, 17, &amp; 18

Mango Trees (*Mangifera indica*), facing south and west. Note poor structure, deadwood, and canopy dieback for Tree #16, poor structure, deadwood, canopy dieback, visual evidence of decay (red arrow), and canopy crowding for Tree #17, and poor structure, canopy dieback, chlorotic foliage, and deadwood for Tree #18.

10	Green Buttonwood	<i>Conocarpus erectus</i>	14	7	4		Fair	57%	\$ 306.38	Y	Trunk wound
11	Montgomery Palm	<i>Veitchia arecina</i>	17	6	6	12	Fair	52%	\$ 302.12	N	Nutrient deficiencies
12	Silver Buttonwood	<i>Conocarpus erectus var. sericeus</i>	18	12	8		Fair	48%	\$ 1,116.00	N	Poor structure, visual evidence of decay, unbalanced crown
13	Montgomery Palm	<i>Veitchia arecina</i>	26	7	8	19	Fair	54%	\$ 489.51	N	Nutrient deficiencies
14	Montgomery Palm	<i>Veitchia arecina</i>	16	6	6	14	Fair	54%	\$ 306.18	N	Nutrient deficiencies
14a	Silver Buttonwood	<i>Conocarpus erectus var. sericeus</i>	14	12	5		Fair	54%	\$ 486.00	N	Poor structure, heading cut
14b	Montgomery Palm	<i>Veitchia arecina</i>	17	6	7	13	Fair	52%	\$ 305.76	N	Nutrient deficiencies
15	Sabal Palm	<i>Sabal palmetto</i>	24	8	15	20	Good	70%	\$ 192.50	Y	
16	Mango	<i>Mangifera indica</i>	32	24	21		Fair	54%	\$ 2,677.46	N	Poor structure, deadwood, canopy dieback

17	Mango	<i>Mangifera indica</i>	26	18	27		Poor	40%	\$ 2,473.30	N	Poor structure, deadwood, canopy dieback, visual evidence of decay, canopy crowding
18	Mango	<i>Mangifera indica</i>	35	25	18		Fair	53%	\$ 2,225.97	N	Poor structure, canopy dieback, chlorotic foliage, deadwood
19	Mango	<i>Mangifera indica</i>	28	15	14		Fair	52%	\$ 1,728.98	N	Poor structure, deadwood, canopy crowding
20	Sapodilla	<i>Manilkara zapota</i>	39	27	23		Fair	55%	\$ 2,770.63	N	Visual evidence of decay, storm damage, large trunk wound, deadwood
21	Sabal Palm	<i>Sabal palmetto</i>	14	8	8	5	Good	70%	\$ 192.50	Y	Immature palm
22	Mango	<i>Mangifera indica</i>	33	24	23		Fair	53%	\$ 2,844.29	N	Poor structure, canopy dieback, storm damage, canopy crowding
23	Mango	<i>Mangifera indica</i>	31	26	18		Fair	50%	\$ 2,099.97	N	Poor structure, large diameter deadwood, canopy dieback
24	Mango	<i>Mangifera indica</i>	15	12	8		Poor	30%	\$ 559.99	N	Poor structure, storm damage, visual evidence of decay, canopy crowding

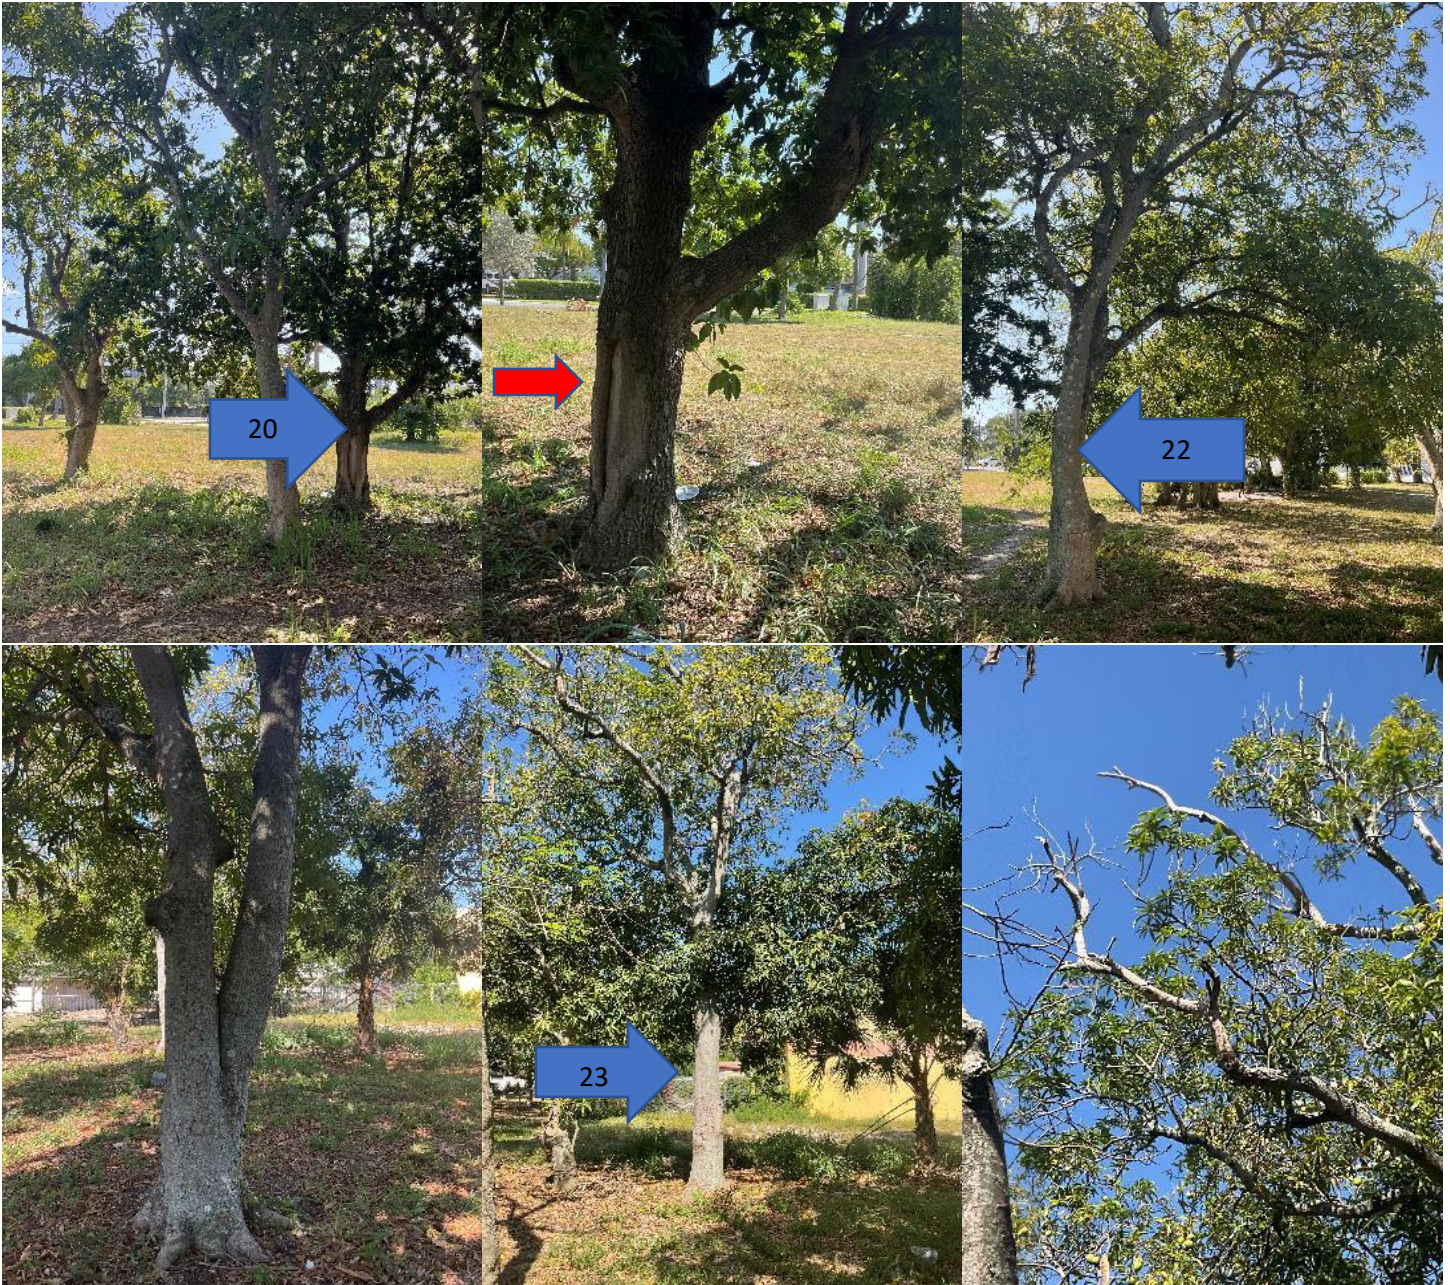
## Trees 20, 22, &amp; 23

Sapodilla (*Manilkara zapota*) Tree #20, and Mango Trees (*Mangifera indica*) Tree #'s 22 & 23 facing east, south, and west. Note visual evidence of decay, storm damage, large trunk wound (red arrow), and deadwood for Tree #20, poor structure, canopy dieback, storm damage, and canopy crowding for Tree #22, and poor structure, large diameter deadwood, and canopy dieback for Tree #23.
