Arborist Report

325 NW 10th St & 324 NW 11St
Pompano Beach, FL 33060, USA

10/17/23

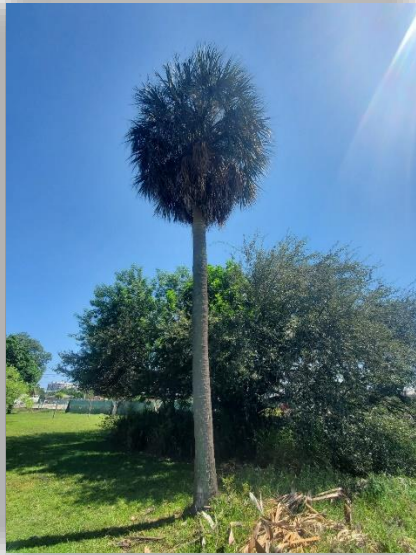
Tree # 1**Common Name**

Scientific NameSabal palmetto**DBH (in) – 12 "****Height (ft) – 20' OA****Canopy Spread (ft) 9'****Condition – Fair****Native? - Yes****Disposition – To be removed**

Tree #1 is a large size sable palm located north side of parcel #5 and it is in a fair condition its upper canopy shows interveinal chlorosis and extreme burning on lower of fronds. This palm has been severely neglected over the years due to lack of care, trimming, fertilization and watering. This palm is currently proposed to be removed as part of the upcoming new construction activities and will be mitigated on site.

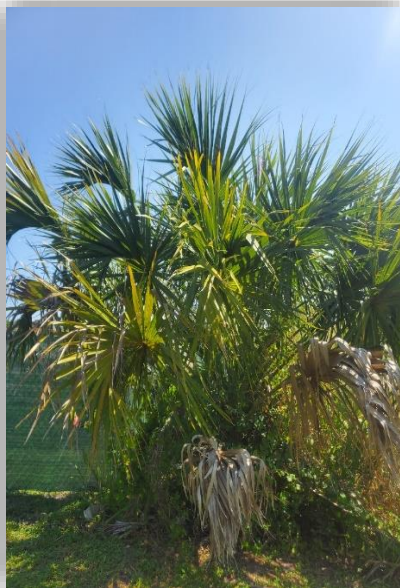
Tree # 2**Common Name**

Scientific NameSabal palmetto**DBH (in) – 10 "****Height (ft) – 10' OA****Canopy Spread (ft) 9'****Condition – Fair****Native? - Yes****Disposition – To be removed**

Tree #2 is a young volunteer sable palm in a fair condition located inside parcel 4 east side of the lot. This palm upper canopy shows interveinal chlorosis and extreme burning on lower of fronds. This palm has been severely neglected over the years due to lack of care fertilization and watering. This palm is currently proposed to be removed as part of the upcoming new construction activities and will be mitigated on site.

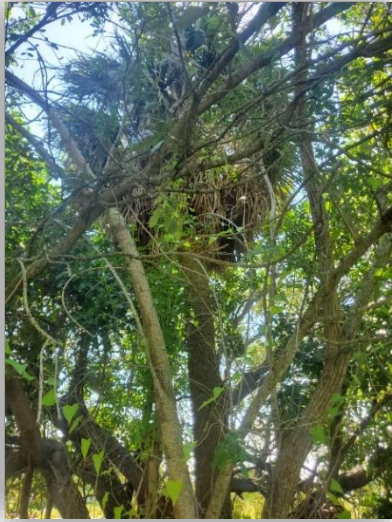
Tree # 3**Common Name**

Scientific NameSabal palmetto**DBH (in) – 14"****Height (ft) – 20' OA****Canopy Spread (ft) 9'****Condition – Poor****Native? - Yes****Disposition – To be removed**

Tree #3 is a large size sable palm located on parcel #5 in the middle of the lot. This palm is in a poor condition its upper canopy shows interveinal chlorosis and extreme burning on lower of fronds. In addition, this palm grew in a very tight space intertwined with adjacent tree Live oak tree #4. This palm has been severely neglected over the years due to lack of care fertilization and watering. This palm is currently proposed to be removed as part of the upcoming new construction activities and will be mitigated on site.

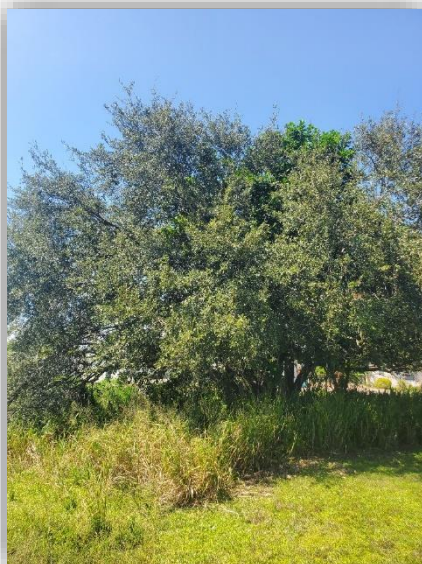
Tree #4**Common Name**

Scientific NameQuercus virginiana**DBH (in) – 32"****Height (ft) – 20'****Canopy Spread (ft) 18'****Condition – Fair****Native? - Yes****Disposition – To be removed**

Tree #4 is a multi-trunk native Live oak probably a seed spread Oak that grew in the middle of parcel #5. This Live Oak tree has an overall condition of 50% has several co-dominant leaders an multi trunk weakly attached and poor compartmentalization due to lack of maintenance and past hurricane storm events. This tree is currently in conflict with proposed new development and will be removed and mitigated on site.

Live Oak Tree 6" cal 20'-22' OA HT – Field Grown

- Becker's Tree farm \$1,350
- All Green Nursery \$800.00
- Marshall Tree Farm \$1,100

Average price: \$1,083 x 2.5 = \$2,708.33

\$2,708.33 / 6" (replacement tree) = \$451.38 per diameter inch

32" Live oak (casualty tree) x \$451.38 (replacement tree) = \$14,444.16

\$14,444.16 x diminution of 50% condition = \$7,222.08

Mitigation cost = \$7,222.08**DRC**
