RE: Oldcastle Coastal Facility – 1200 NW 18<sup>th</sup> St., Pompano Beach, CPTED/Security Public Safety Plan

I have been contracted to review the drawings for security and Crime Prevention Through Environmental Design (CPTED) features in the proposed Oldcastle Bonsal Facility site plan update that is being considered for permitting by the City of Pompano Beach.

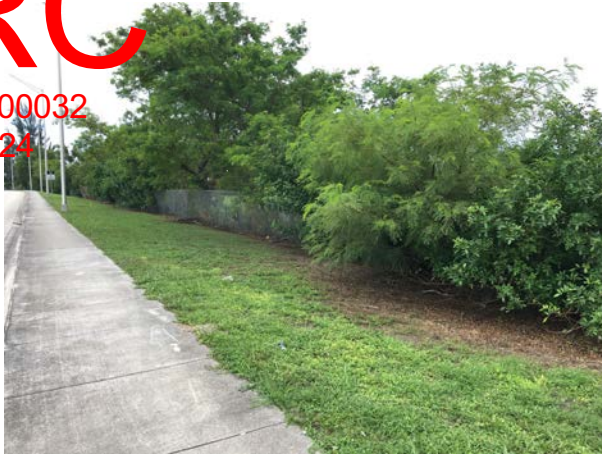
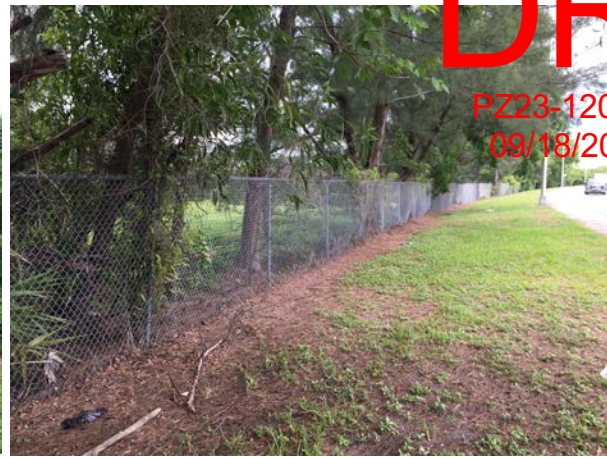
The west boundary on Andrews Avenue is chain link fencing and overgrown shrubs and non-native Australian Pine.

The west border definition will be improved with an attractive picket metal code compliant fencing with plantings, and a vehicle gate. It is recommended that as the site is improved to accommodate a sidewalk connection, and new monumental sign, and additional stripping at the entrance of onto Andrews Avenue will be added to direct the heavy trucks and rigs.

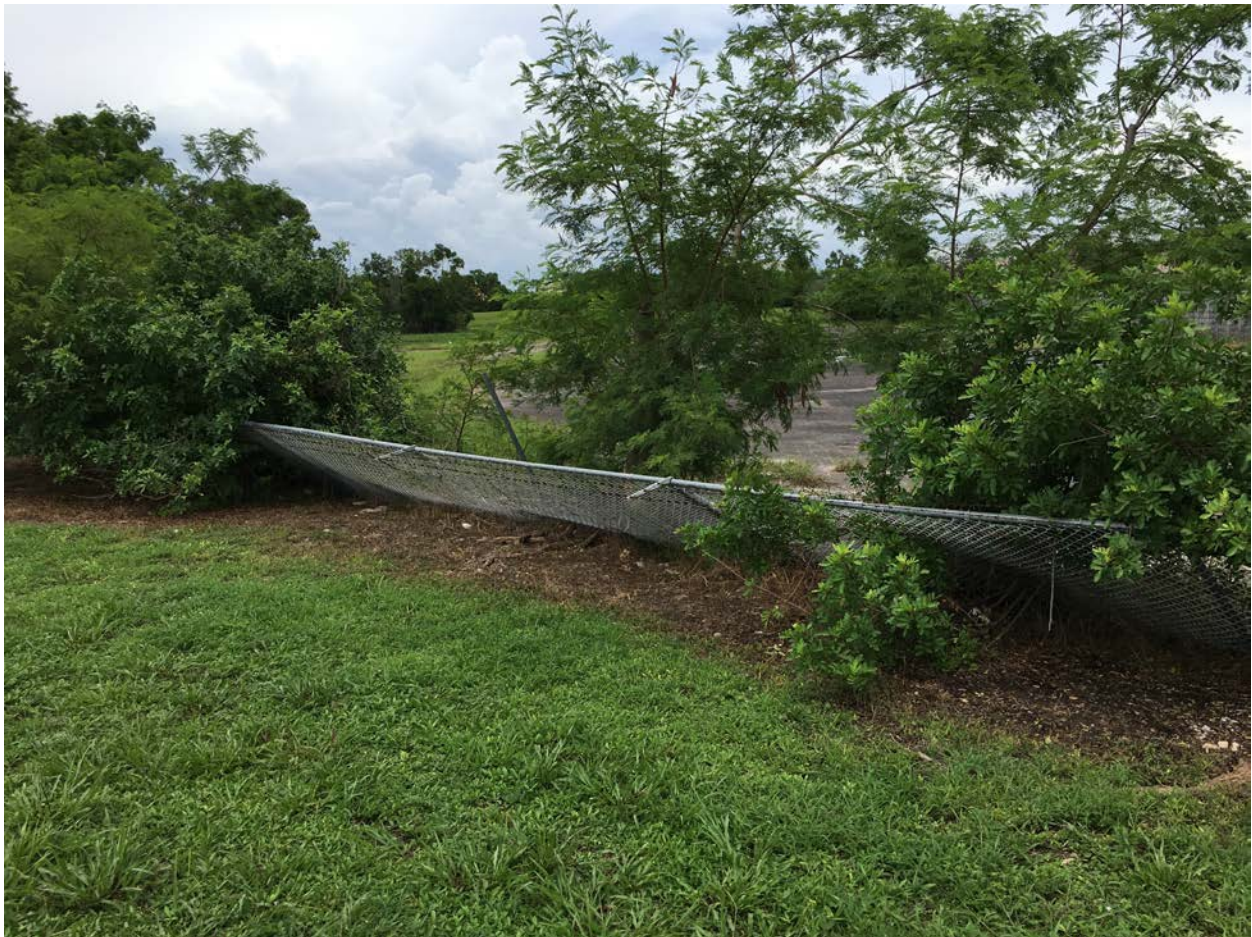
The West Boundary has sections of the chain link fence that are damaged and lying down.

Territorial Reinforcement /Boundary definition – Fencing and Plantings – The existing six-foot high chain link fencing requires extensive repair and maintenance on the north, south, and east sides. Plantings should be maintained to be no higher than the fence line and the boundaries. Tree canopies should be maintained clear under 8 feet, with a trunk six inches in diameter or greater. If new saplings are planted, do not mutilate them to comply with the canopy requirement until they are mature trees with a six inch diameter trunk or greater, and if the tree canopies are blocking the field of vision.

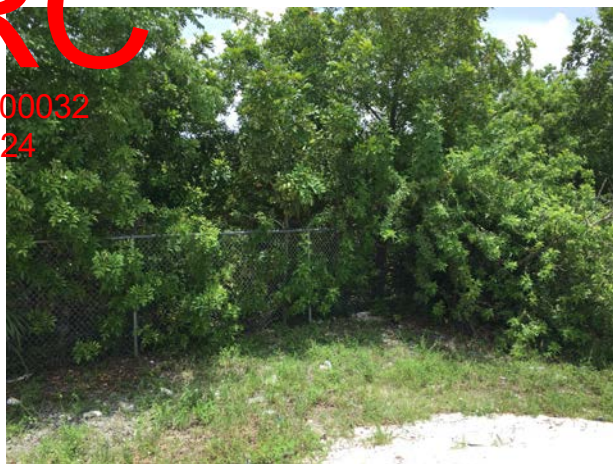
The East boundary is six-foot chain link with overgrown shrub.

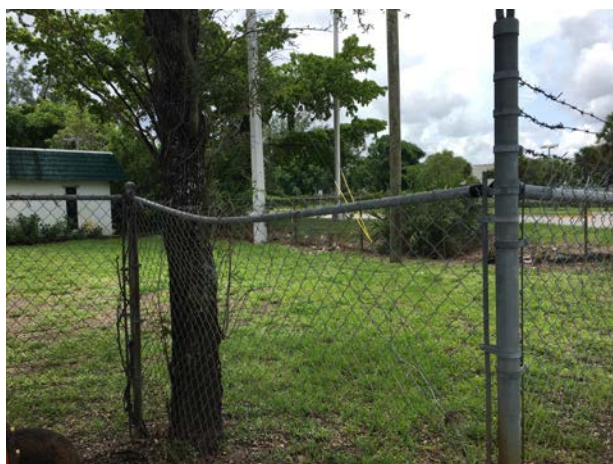
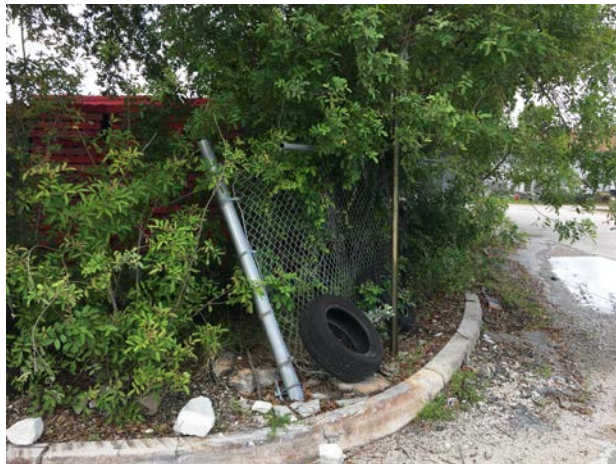
The north boundary fencing is heavily damaged.

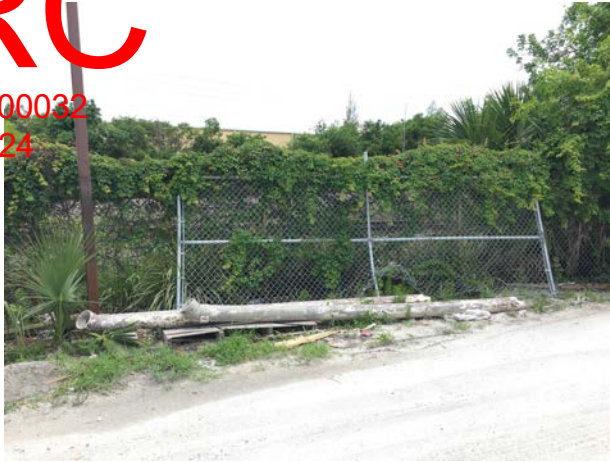
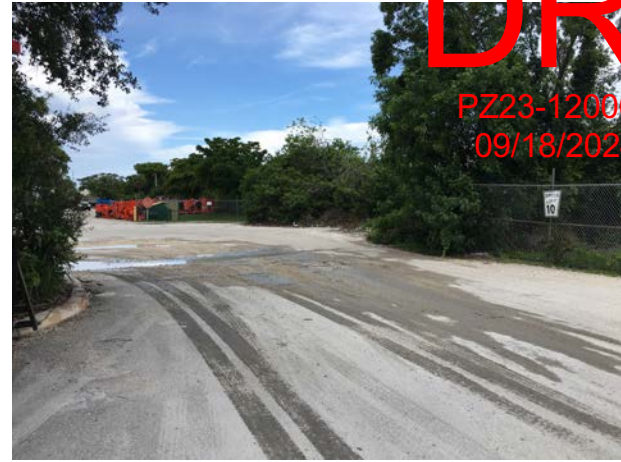
The northeast gate has been knocked off the tracks and lays against the east perimeter fence. The open access allows trucks with aggregate product to enter in the site, but also has no barriers to keep trespassers out.

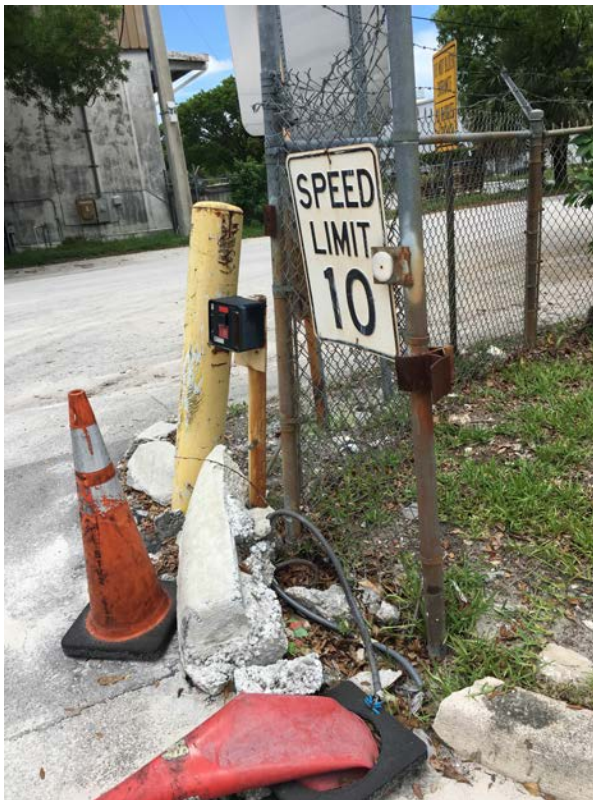
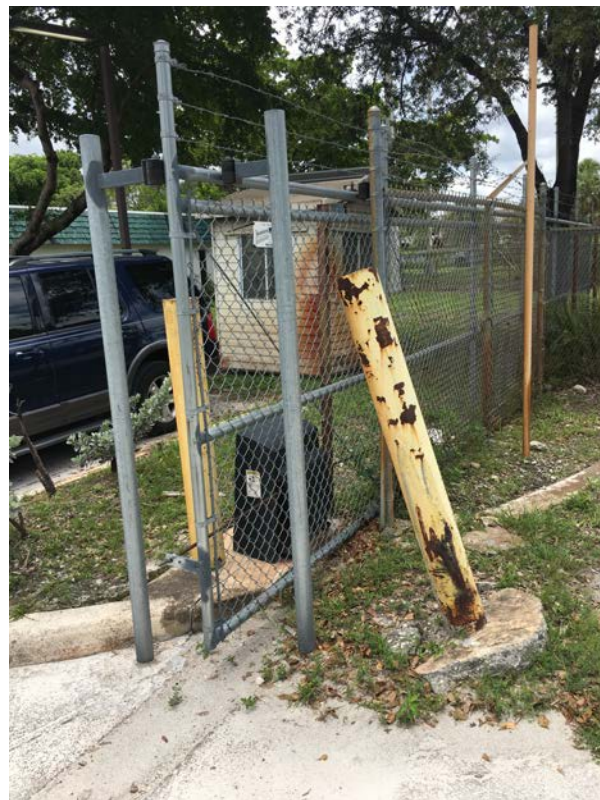
The Northwest gate is the primary entrance for administration, employee vehicles. The gate is non-functional and is in disrepair.

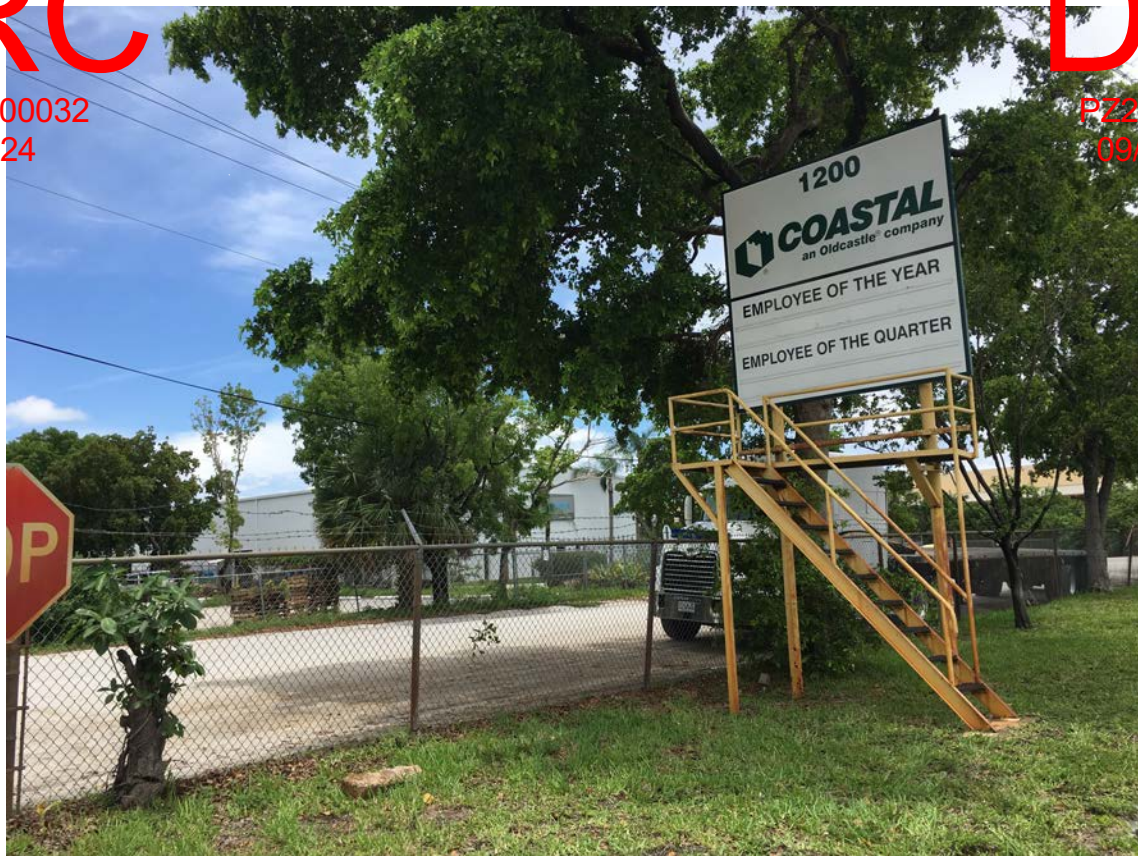
The north boundary on NW 18<sup>th</sup> Street has the marquee sign for the plant. It is difficult to see from the main road, Andrews Avenue.

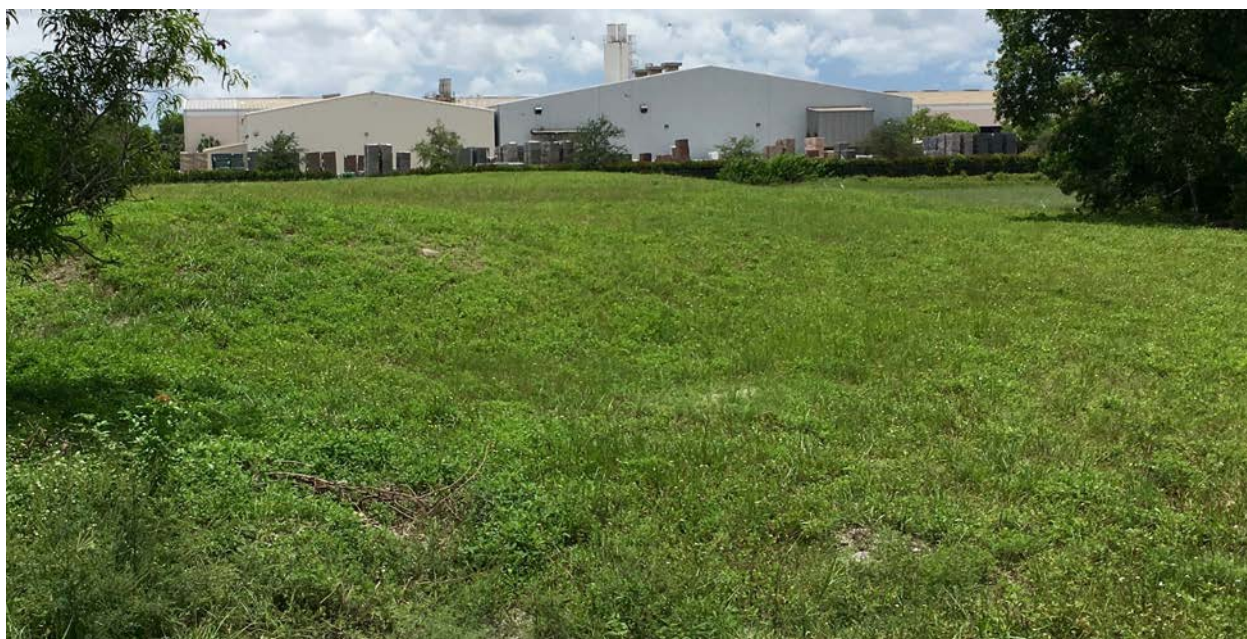
The South boundary is open real estate between the Bonsal Plant and the Oldcastle Distribution Center.

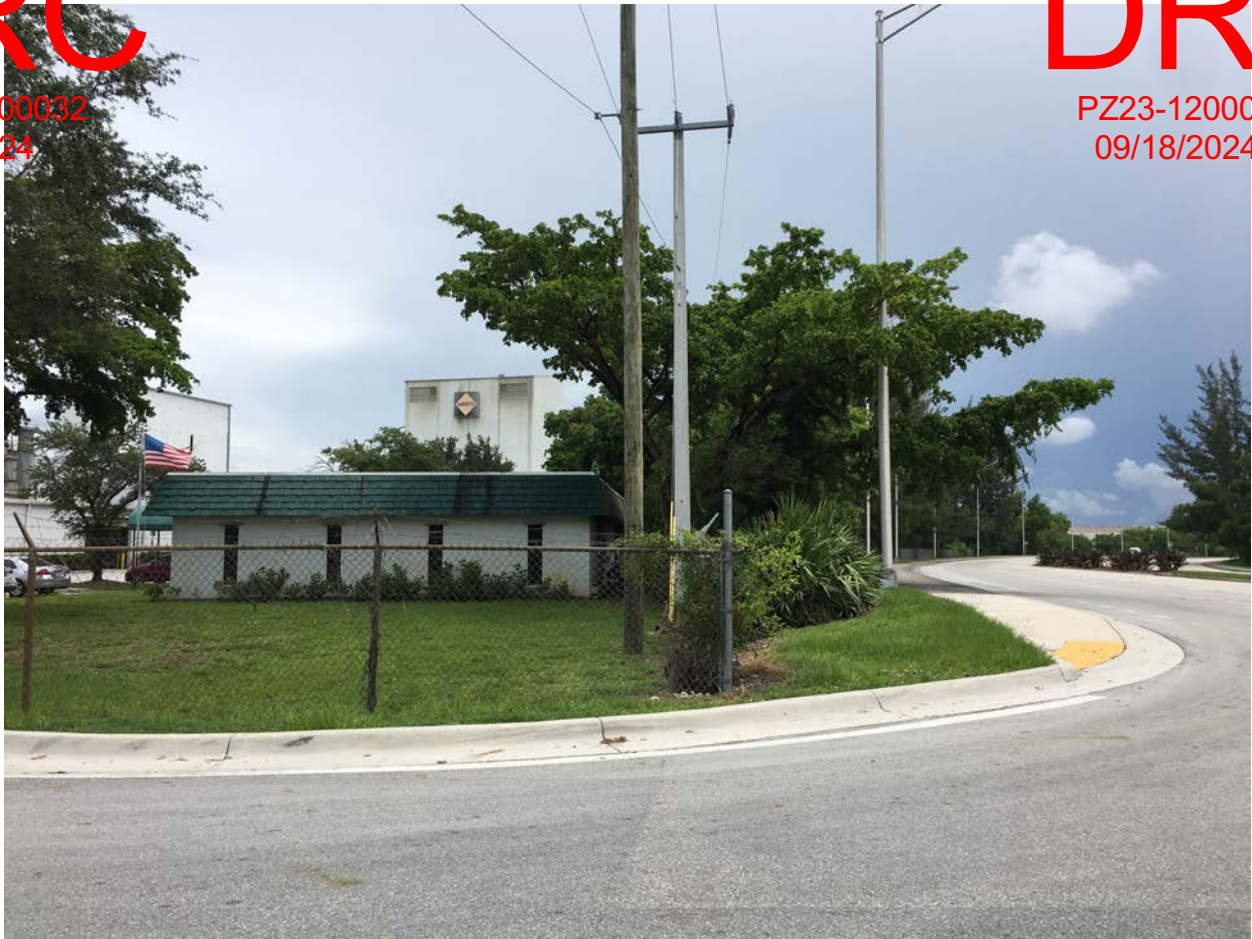
There are no controls for vehicles once trucks turn on 18<sup>h</sup> Street. There are no barriers controlling access to the parking lot and site on the north side.

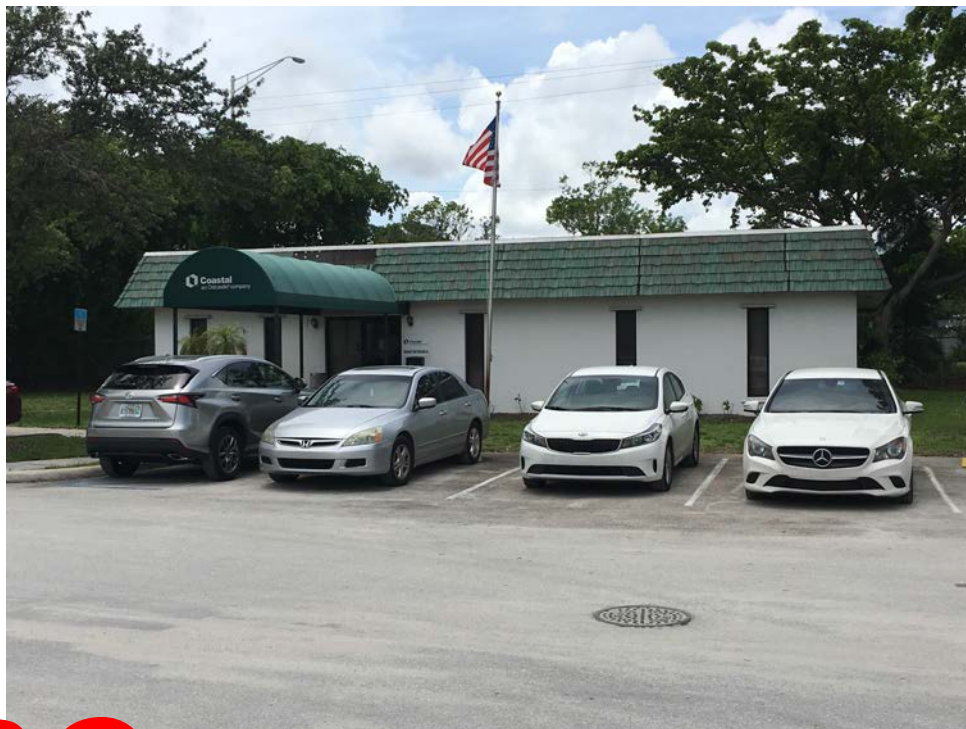
Natural surveillance of the north parking lot and northwest vehicle entrance is achievable from the windows of the administrative offices if staff is present. There is no mechanical surveillance being used on the property, on the site or inside the plant or administrative spaces. While remnants of an old CCTV system were there, it is not functional. Access to the site are not controlled by gates because of the high volume of truck traffic daily, so to prevent theft, vandalism, pilferage, or illegal dumping, vehicles and persons entering the site should be under mechanical surveillance.

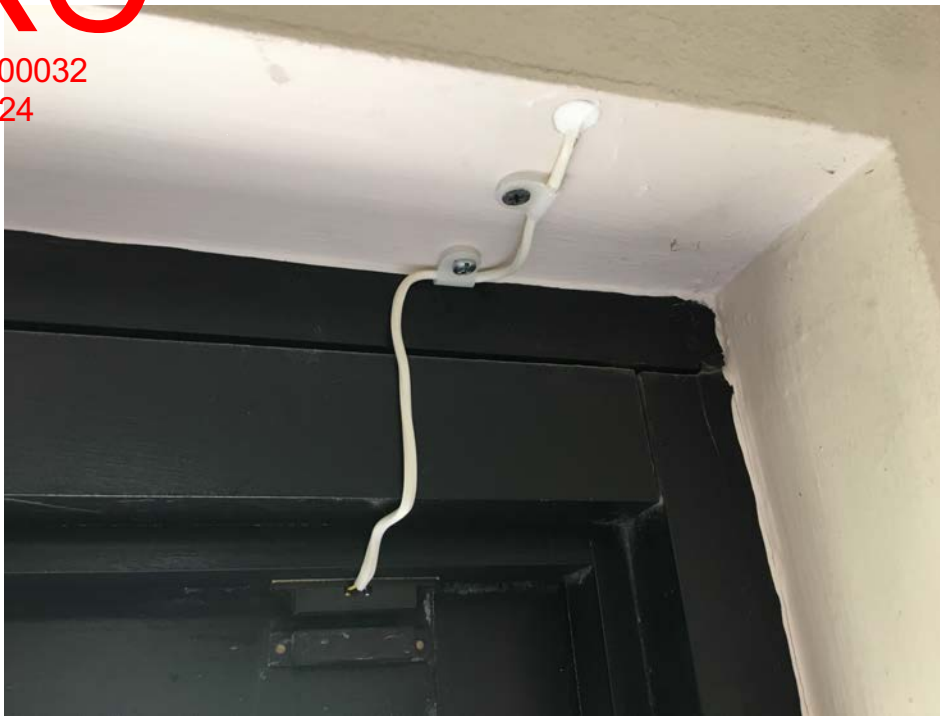
The office has a make shift security system that is monitored but needs to be updated. There is no exterior light along the east side of the business office.

Facility access control – The existing admin office building has a security burglar alarm system, with intrusion detection devices (motion sensors), and have the doors alarmed with door position switches (DPS). It is recommended that the existing building doors get rewired in a professional manner with no wires exposed, and if wires cannot be brought through the door frames, then have the wiring in security conduit. Since the factory plant is operating 24/7 their doors will be left open during operating hours, however the continual presence of staff should discourage and opportunity for criminal activity. The Alarm Company is Tyco/ADT and their service can be easily expanded to include the interior space protection alarms, the door position switches, and the proposed video surveillance system and video monitoring for the site.

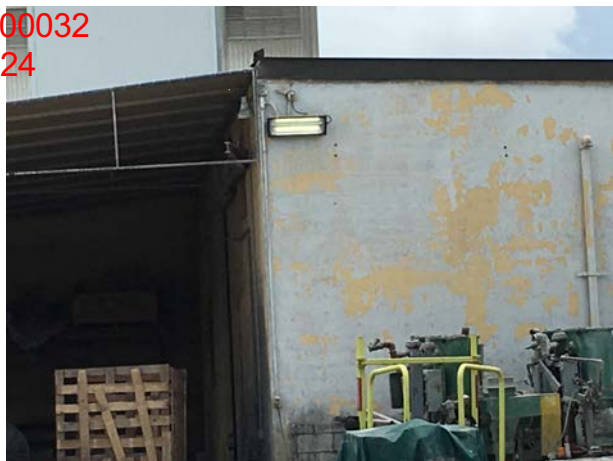
The pole lighting actually uses florescent tubes, and was turned on during daylight hours.

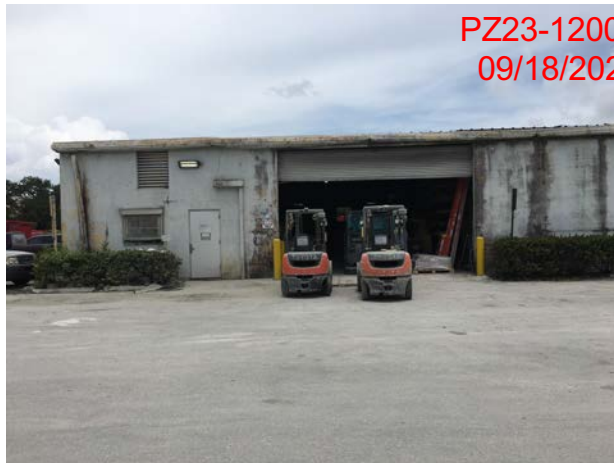
The exterior building lighting is florescent tubes, which are inadequate to properly light the grounds.

Building exterior lighting – The newly renovated and retrofitted lighting plan is providing adequate illuminate to the exterior of the buildings, the stock areas, the exterior yard area, and vehicular entrances for good visibility and accountability. Additional lighting is needed on all sides of the plant, and the three vehicle entrances to complete the lighting goals.

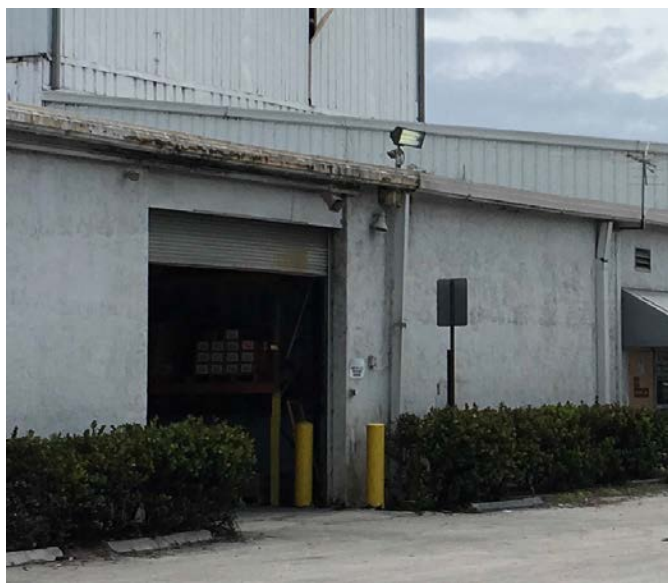
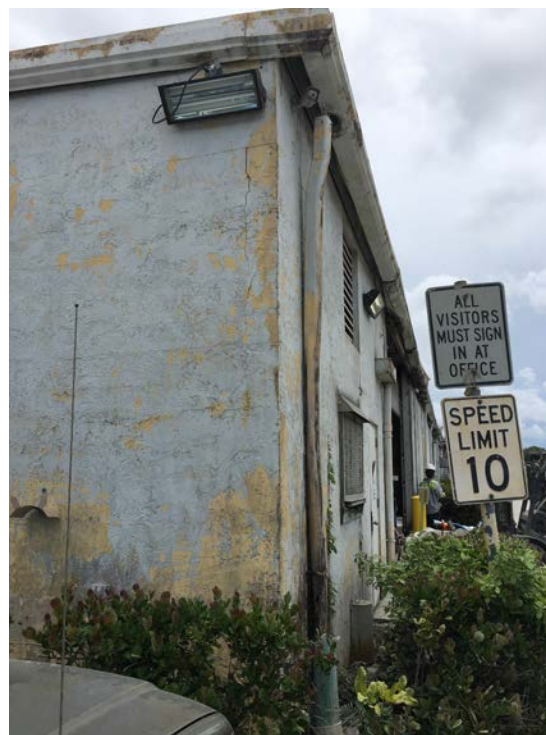
The exterior lighting using florescent tubes as the light source was inefficient and not effective to evenly light the site and building exterior.

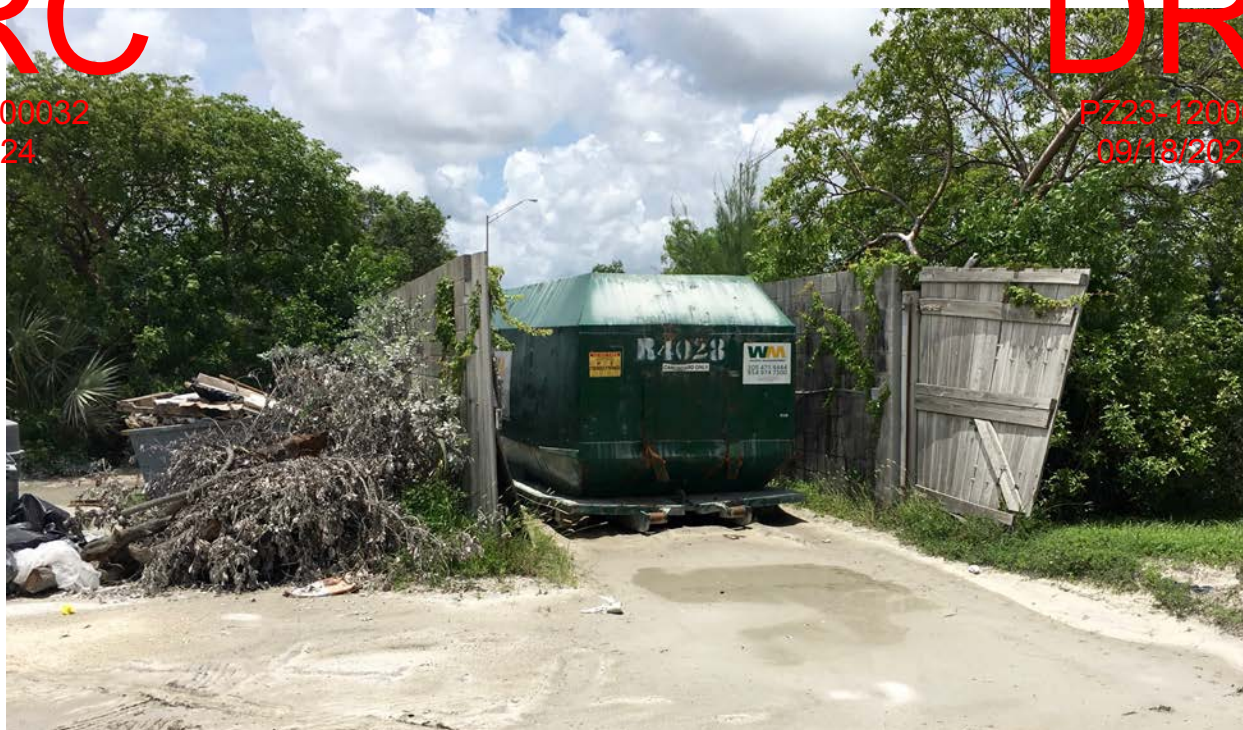
The exterior dumpster area is located in the south part of the yard area across from the Plant. The screening needs to be in working order, and lockable, and the area cleaned up. The dumpster is not set down on a concrete pad. There is no drainage capacity. The wooden gates and shielding are damaged and does not close properly. There is no locking capability to prevent outsiders from outside persons dumping trash.

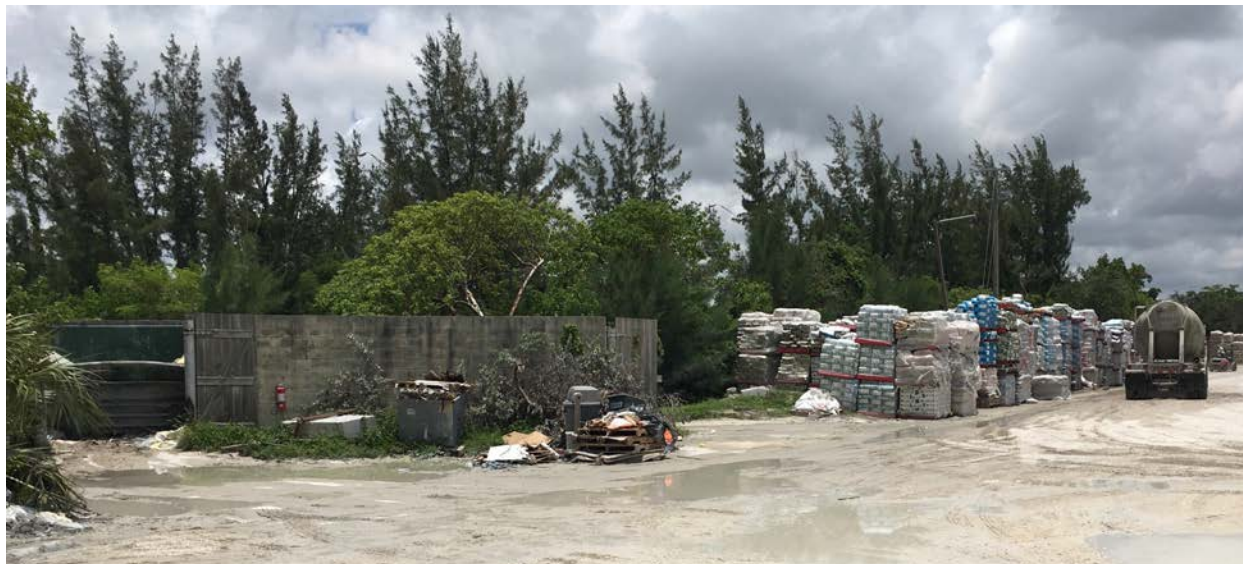
There appears to be some dumping just adjacent to the dumpster. In the new site plan the dumpster will be designed to have compliant surrounding shielding and be secured.

The new proposed dumpster area should be on a concrete pad that can withstand picking up and dropping down by a garbage truck. There should be bollards/bumpers to prevent the truck from hitting the dumpster enclosure. The dumpster should be shielded on three sides with a screening that complies with zoning regulations. Swing gates that are locked should be used to protect the dumpster from illegal or unwanted dumpster diving or dumping. The front screening should be raised so that a person in the dumpster area can be observed from the outside. The gates should be lockable so they can be secured when not being used. If there is any trespassing in the exterior site areas, the person will stand out and be observed and challenged.
