February 9, 2025
1220 SW 12th Ave
Pompano Beach, FL

An Arborist Report/Tree disposition was conducted for the above referenced property. During our inspection, four (4) specimen size trees were located on the property. Below is a detailed report of the one tree that are located on the property.

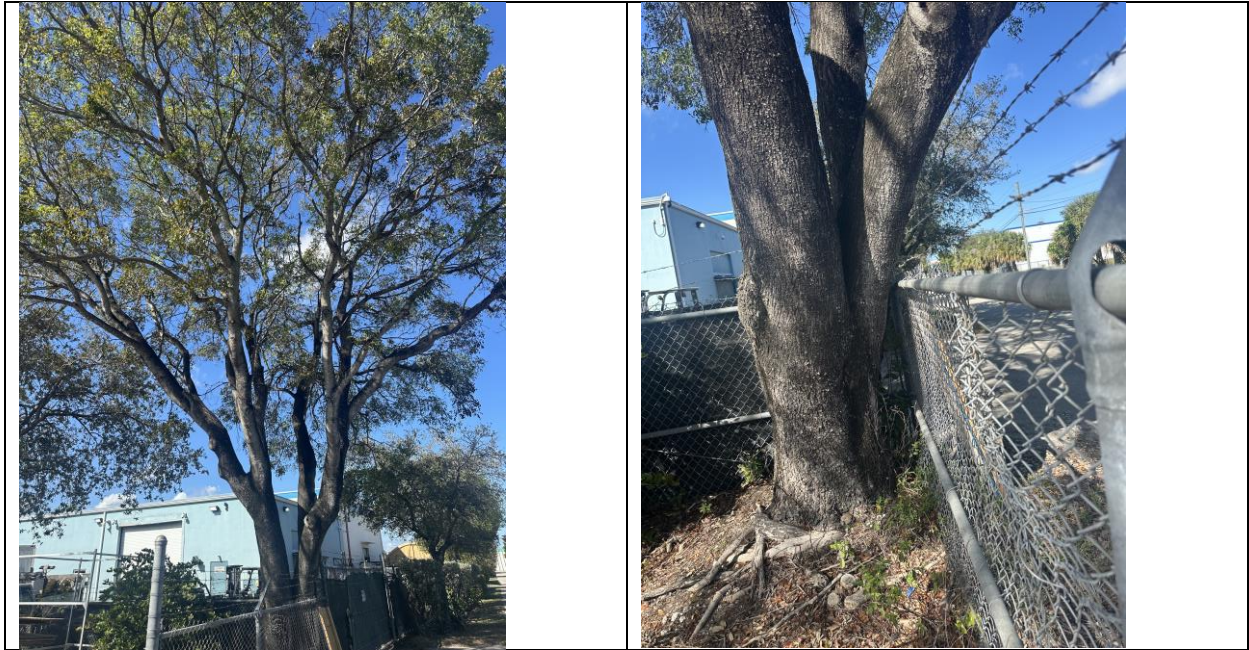
Tree #26 Mahogany (*Swietenia mahagoni*) DBH 29", HT 40', SP 34', Cond 50% Appraisal \$4,263

This tree is located on the North east side of the property. This tree has codominant stems with included bark. Bark inclusions can result in cracked trunks and broken trees. One of the Stems is pushing agents the fence. Girdling roots were also observed, Girdling roots are roots that wrap around a tree's trunk, restricting the flow of water and nutrients. The trees shows signs of stress with die back the tips and many dead, broken branches being visible throughout the trees canopy.

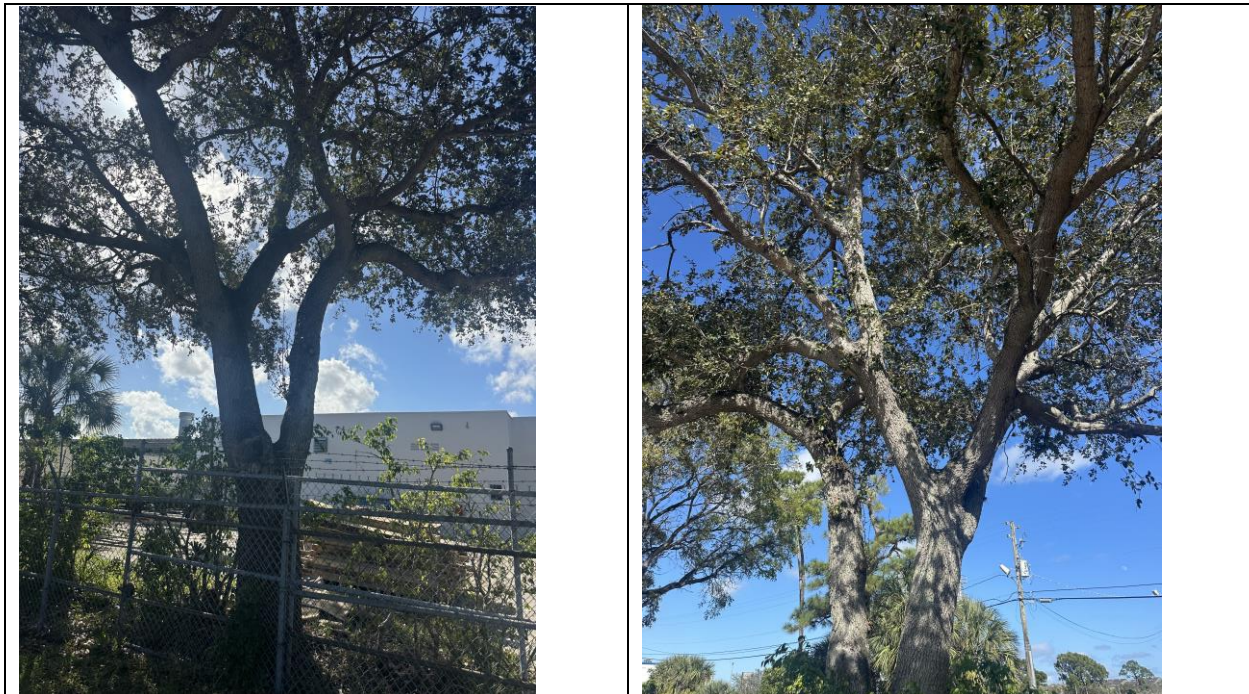
Tree #27 Live Oak (*Quercus Virginiana*) DBH 26", HT 40', SP33', Cond 60% Appraisal \$5,178.26
 This tree is located on the east side of the property. Trees foot flare is pushing agents the fence causing the fence to bow out. Some dead, and decayed branches could be seen throughout the trees canopy. an old pruning wound could be seen on the east side of the trunk where the tree appears to have properly compartmentalized.
