Arborist Report- Development Project

Tree Inspection(s) and Consulting Arborist Recommendations

Report Date: May 11, 2025; revised 05/12/25

Property: 117 S. Riverside Dr, Pompano Beach, FL

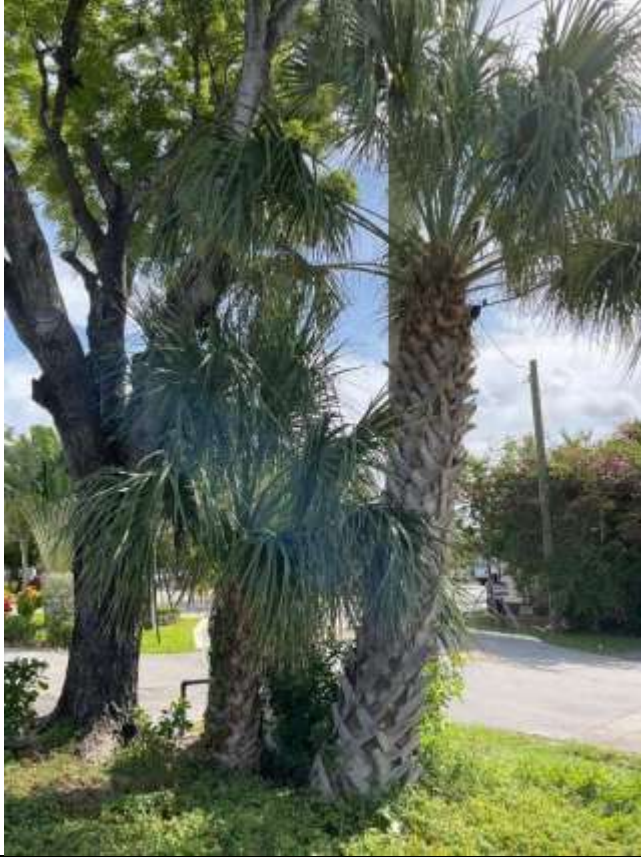
Tree/Survey #201 and #202 Sabal Palm, *Sabal palmetto*

These Sabal palms are growing adjacent to the power pole and under power lines. These are likely wildlife installed palms, not designed in landscape. They are in good condition, but have been over-pruned. They are in the construction footprint. The location is not conducive to transplanting the palms. The recommendation is to remove the palms.

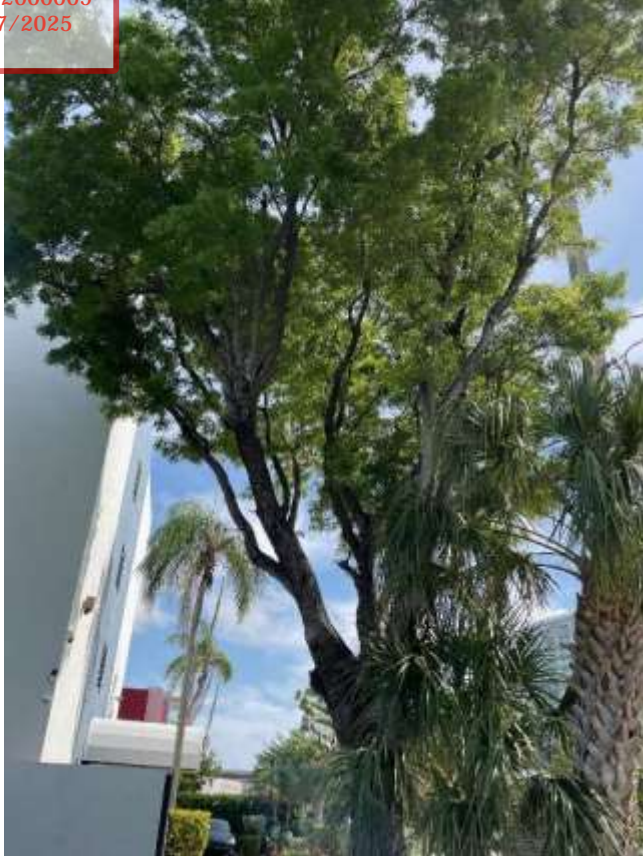
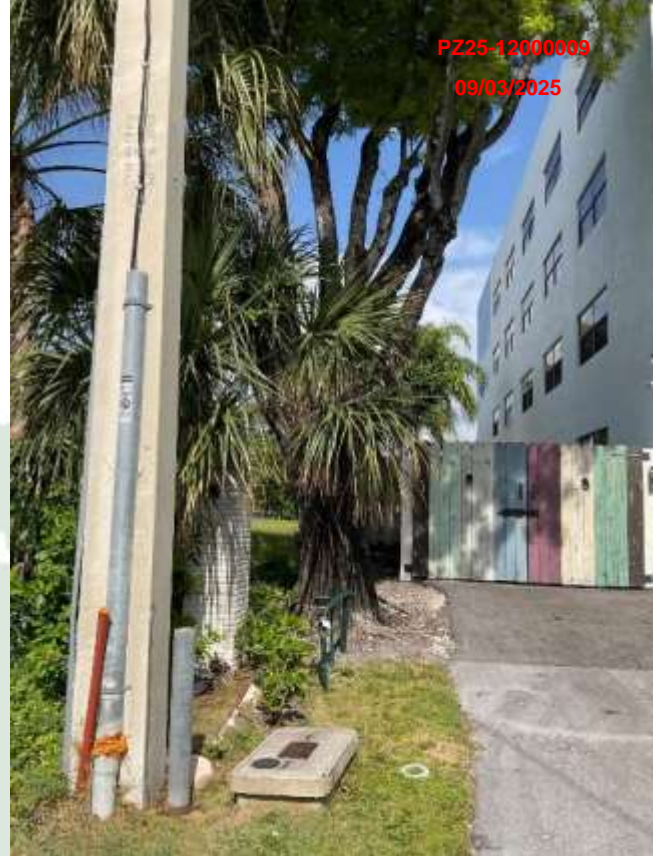
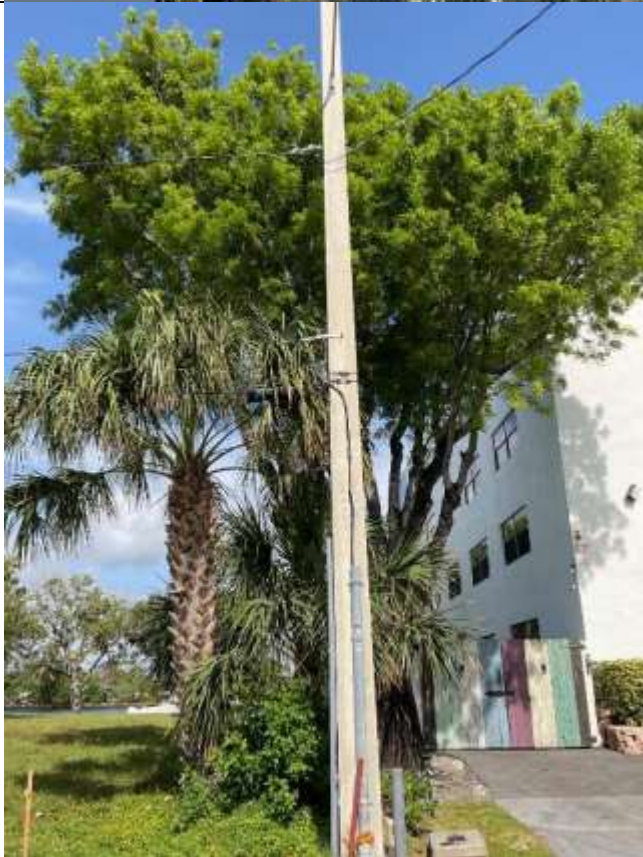
This Mahogany we think has trunk reaching across the property line. It is in fair to poor condition. The tree has been over-lifted, has exposed roots, and is damaging the adjacent pavement. There are overhead utilities in the canopy and underground utilities in the rootzone. The recommendation is for the tree to remain and be protected during construction.

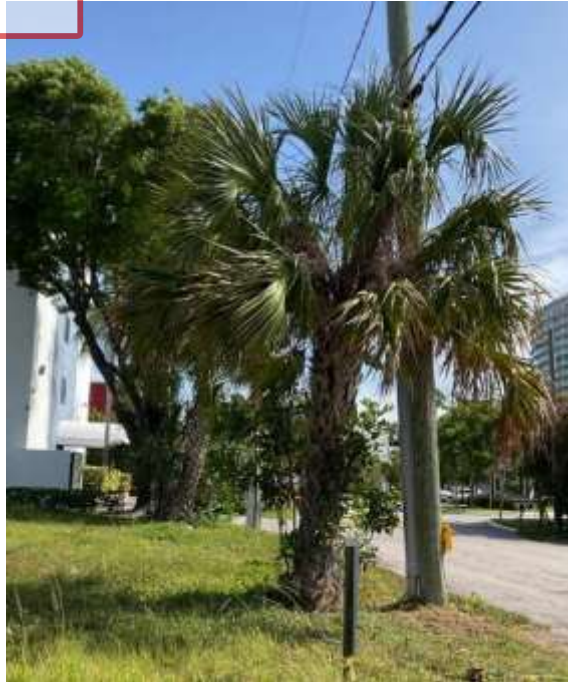
Tree/Survey #204 and #205 Sabal Palm, *Sabal palmetto*

These Sabal palms are growing adjacent to the power poles and under power lines. These area likely wildlife installed. They are in good condition, but have been over-pruned. Tree #204 is in the construction footprint, with location not conducive to transplanting it. We recommend to remove palm #204. Tree #205 is outside the construction footprint, so we recommend for the palm to remain.

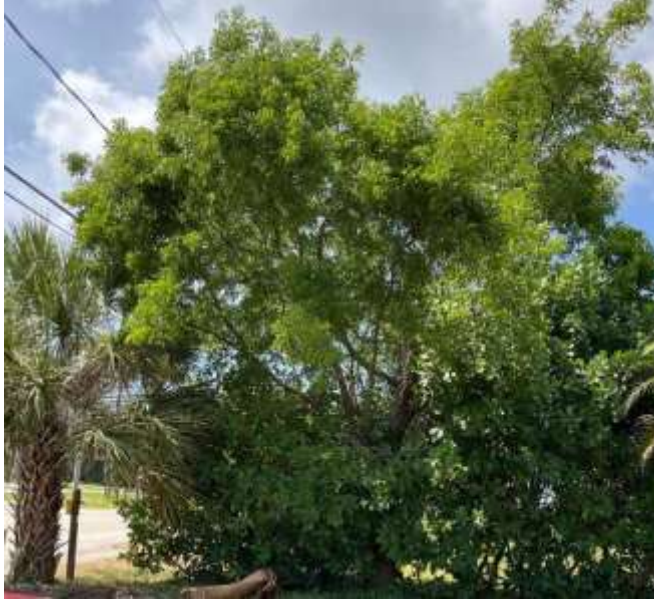
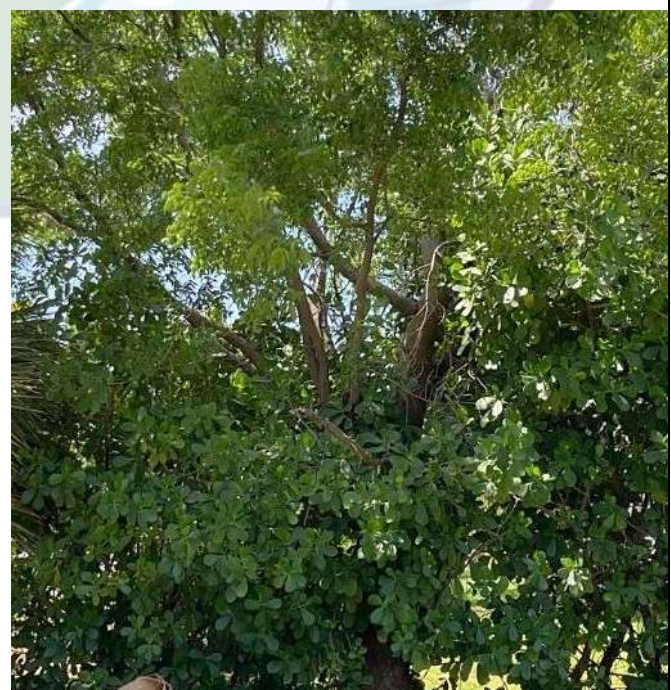
Tree/Survey #206 Gumbo Limbo, *Bursera simaruba*

Tree # 206 is a Gumbo Limbo growing from within the perimeter Clusia hedge on the property line. It is in fair to poor condition, and is likely wildlife installed. It has been hatracked, or hedge-pruned, in the past. There are stub cuts and crossing limbs. There are utility lines near the canopy. The recommendation is to remove the tree, so the Clusia hedge can be maintained for better growth.

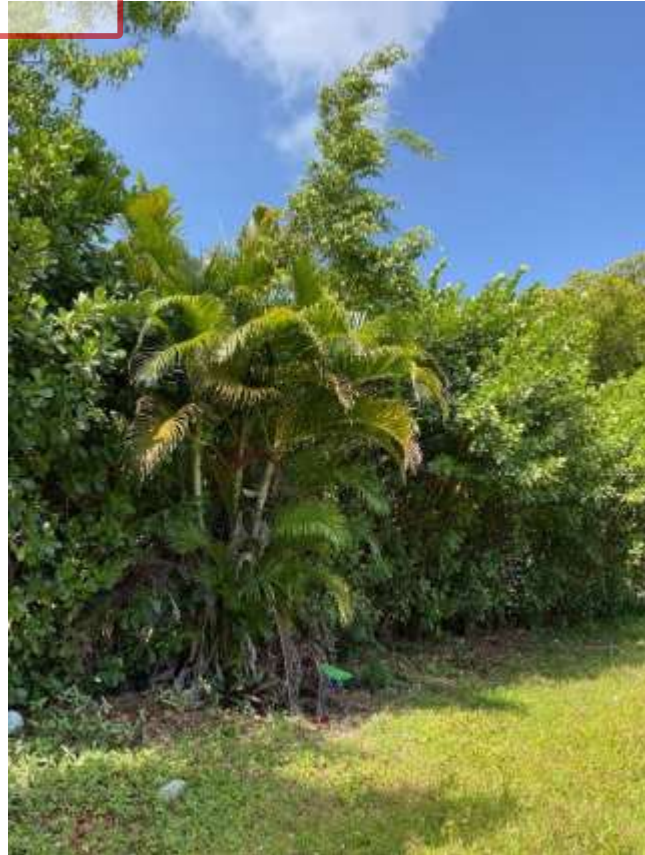
Tree/Survey #207 and #209 Areca Palm, *Dypsis lutescens*

Areca palms can be aggressive weeds, with them growing in disturbed and unmaintained sites. The palms in this hedge are likely wildlife installed, and are undesirable in this location. They have nutrient deficiencies and exhibit dieback and decline. The recommendation is to remove the palms.

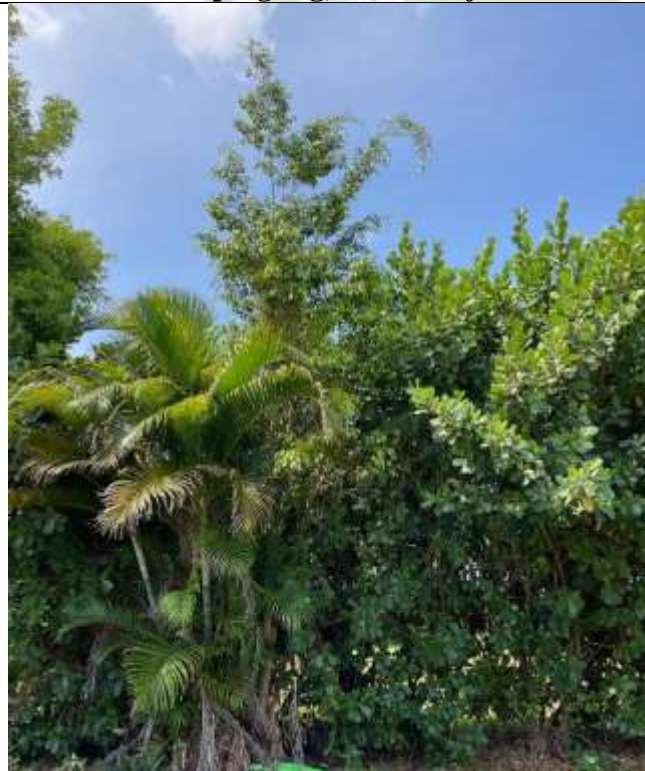
Tree #302 Weeping Fig, *Ficus benjamina*

Weeping Fig can be an aggressive weed, being wildlife installed in many disturbed and unmaintained sites. This one was either wildlife installed, or sprouted from previous hedge stumps. The recommendation is to remove the tree.

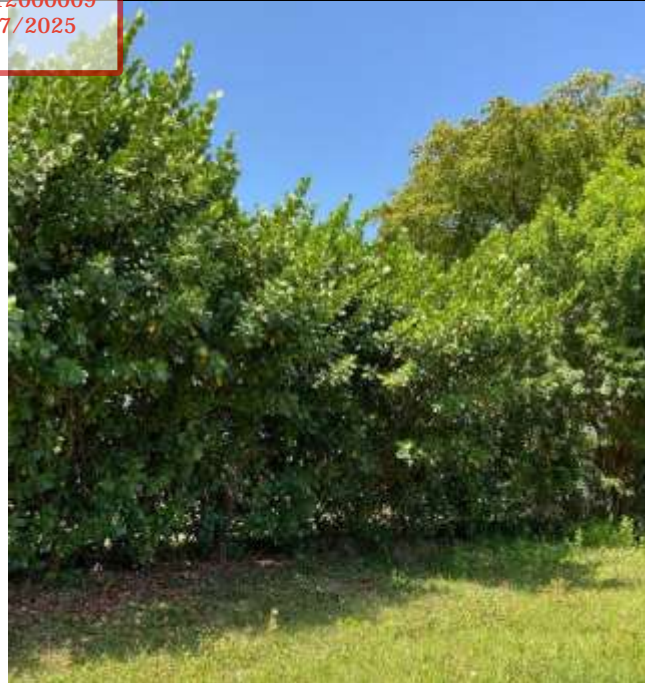
Tree #303 Autograph Tree, Pitch Apple Hedge, *Clusia rosea*

The Clusia hedge on the property line ranges from 15 to 25' tall. It is overgrown and has not been maintained recently. It is in fair to good condition. The recommendation is for the hedge to remain and be maintained with proper pruning and weed/invasive plant removal.

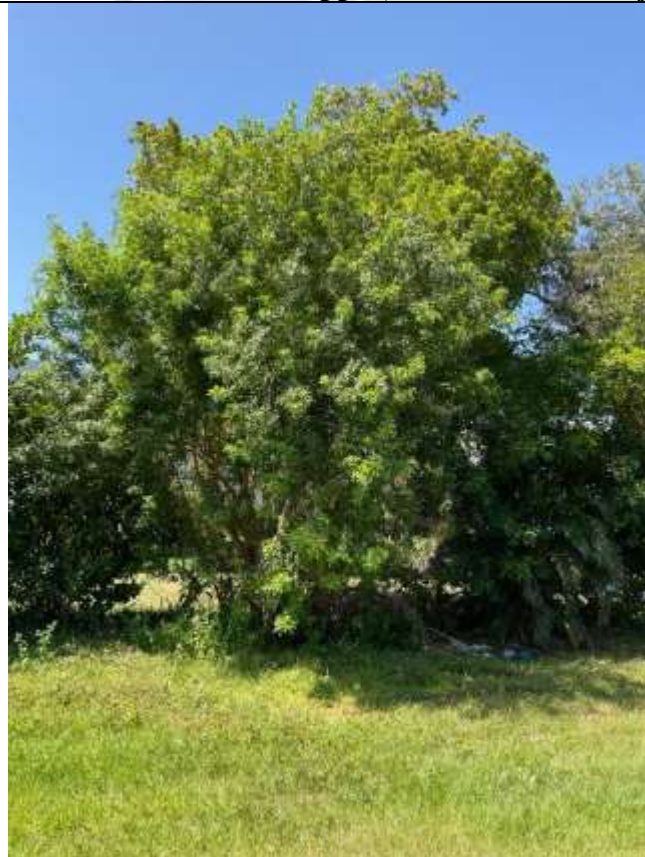
Tree #208 Brazilian Pepper, *Schinus terebinthifolia*

Brazilian Pepper is a Category I invasive exotic plant. It grows in many locations, including open, rarely maintained areas like this hedge. The recommendation is to remove this plant with no mitigation required.

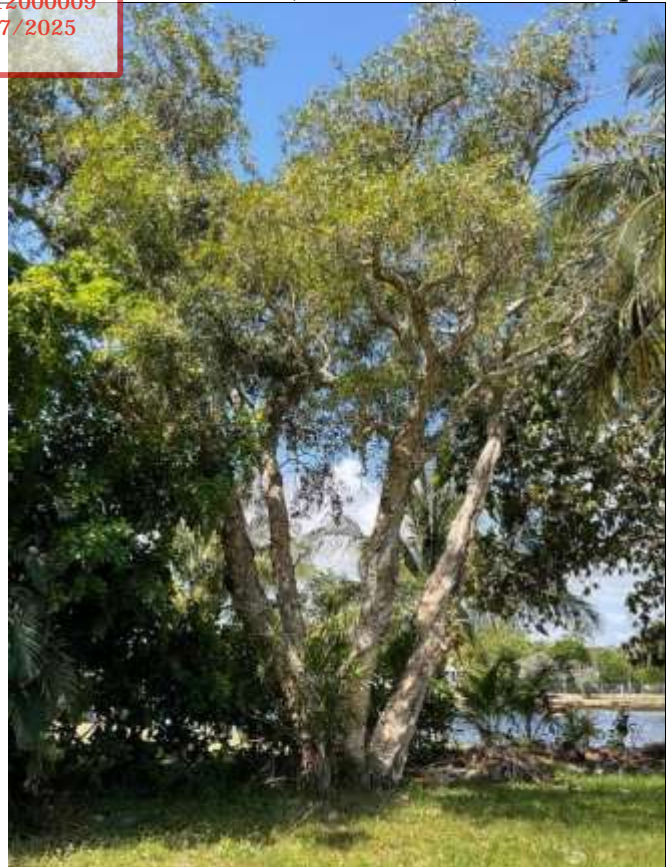
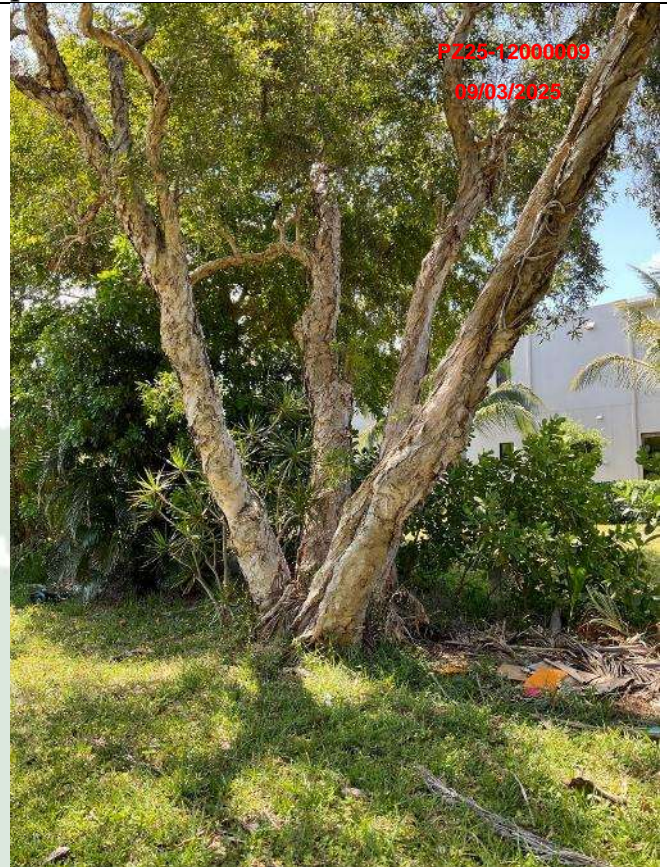
Tree #210 Melaleuca, Punk Tree, *Melaleuca quinquenervia*

Melaleuca is a Category I invasive exotic plant. It grows in many locations, including open, rarely maintained areas like this hedge. The recommendation is to remove this plant with no mitigation required.

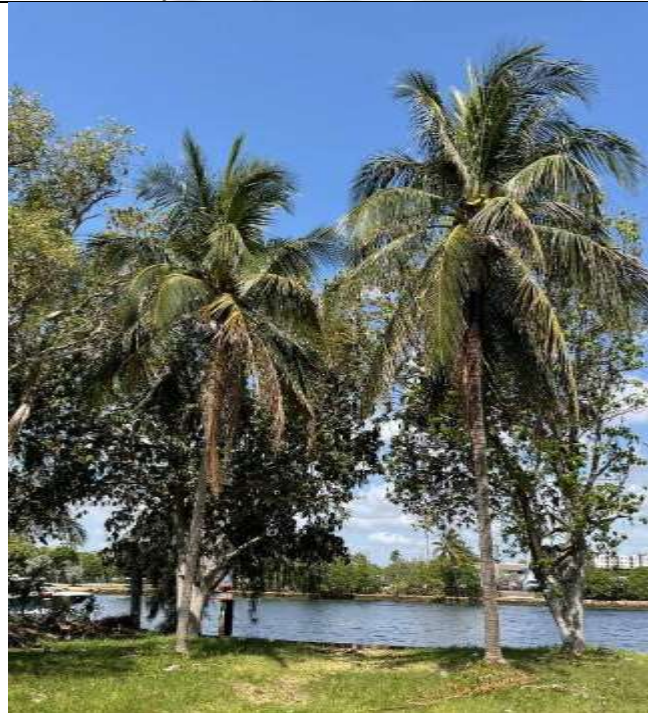
Tree/Survey #211 and #212 Coconut Palm, *Cocos nucifera*

The Coconut palms are in good to fair condition. They are in the construction footprint. The recommendation is to remove or relocate the palms.

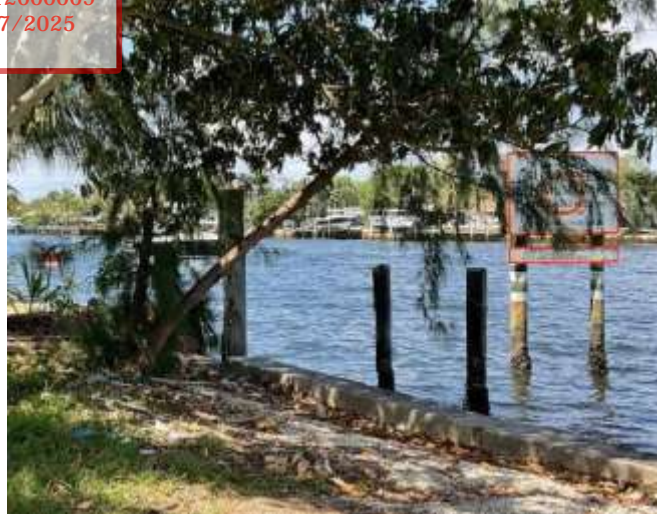
Tree #214 Australian Pine, Beefwood, *Casuarina spp.*

Australian Pine is a Category I invasive exotic plant. It grows in many locations, including open, rarely maintained areas. The recommendation is to remove this plant with no mitigation required.

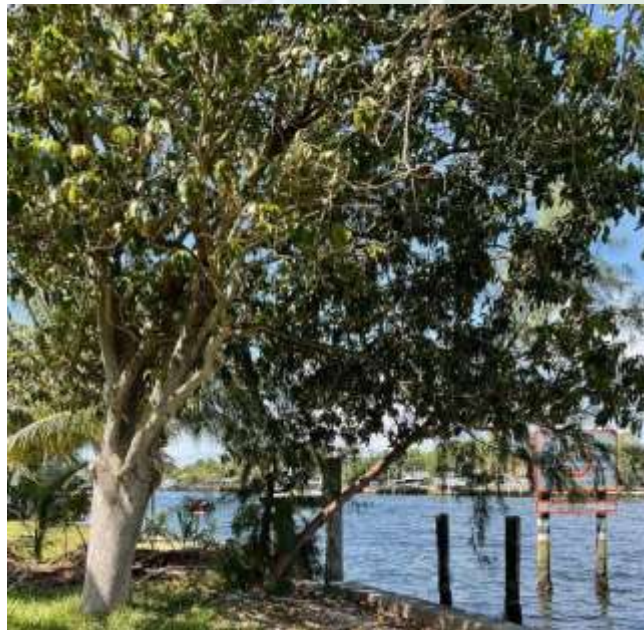
Tree #213

These three Mango trees are in fair to poor condition. They all exhibit dieback, decline, and salt damage. They have been damaged by previous trimming and storm damages. They are in the construction footprint. The recommendation is to remove these Mango trees.

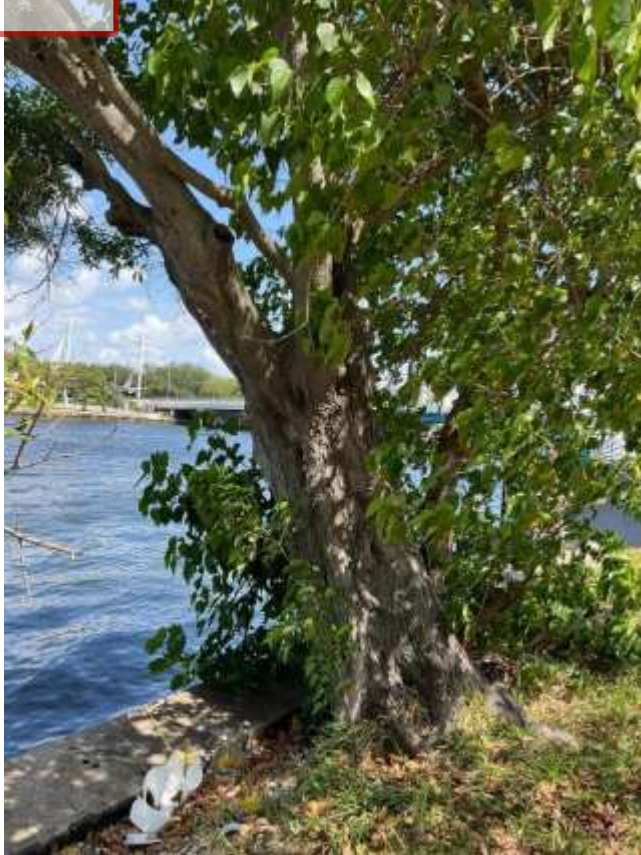
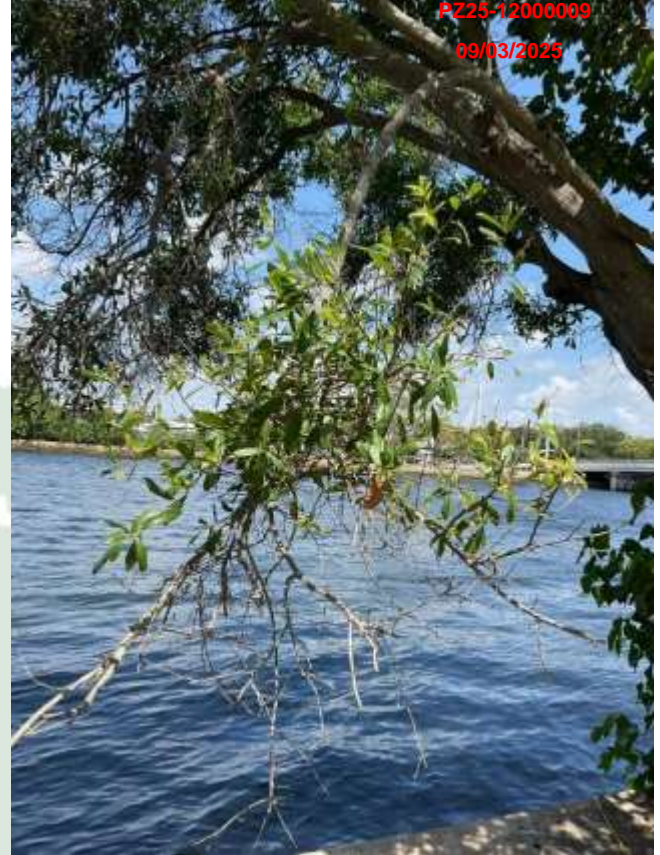
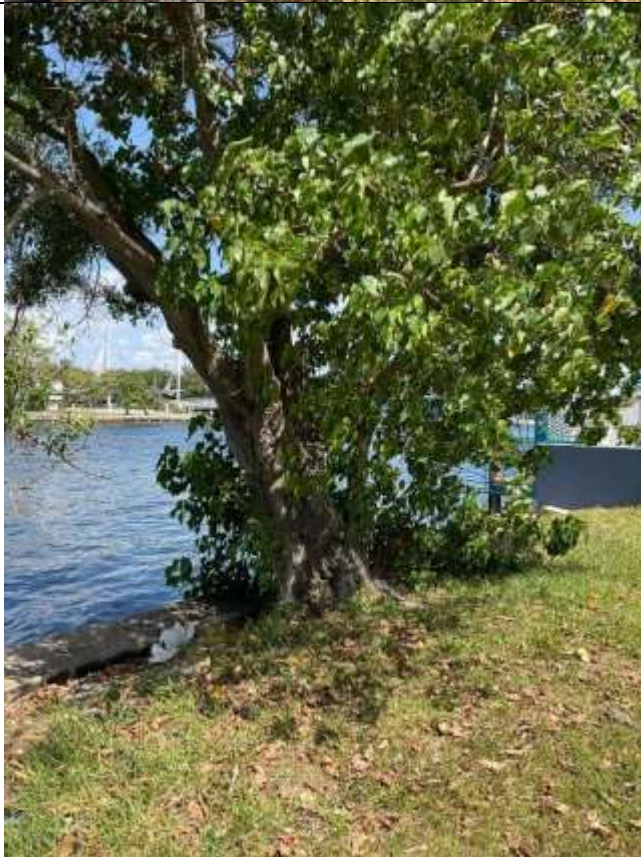
Tree #217, Willow Busic is in poor condition. It exhibits dieback and decline, and included bark. It has been hatracked and is leaning. It is in the construction footprint, so the recommendation is to remove the tree.

Tree #304 is growing from the root crown area of the Willow Busic. Seaside Mahoe is a Category I invasive exotic plant. It is wildlife installed and then grows near other trees and plants in many locations, including open, rarely maintained areas. The recommendation is to remove this plant with no mitigation required.

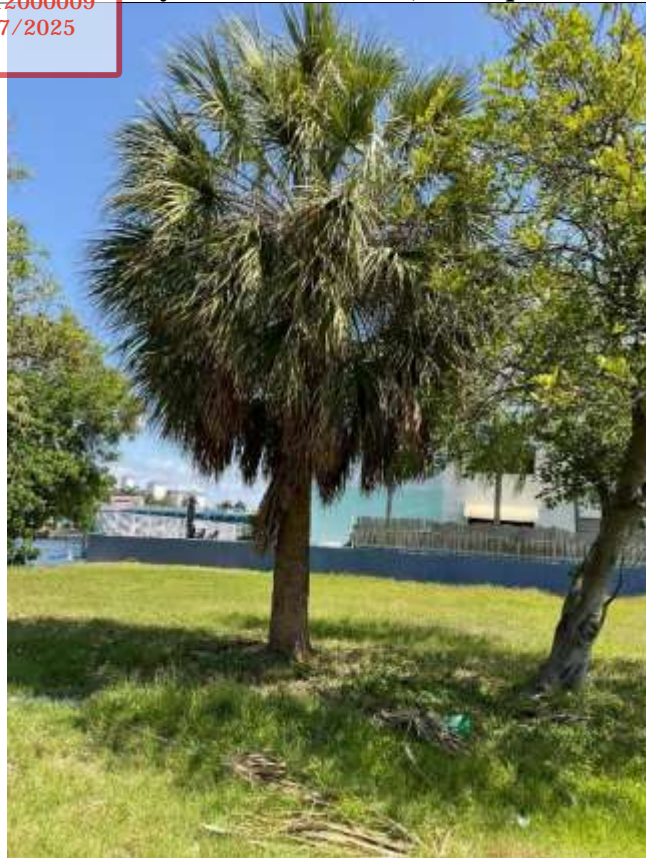
Tree/Survey #218 Sabal Palm, *Sabal palmetto*

This Sabal palm is in good condition. It is in the construction footprint. The recommendation is to remove or relocate the palm.

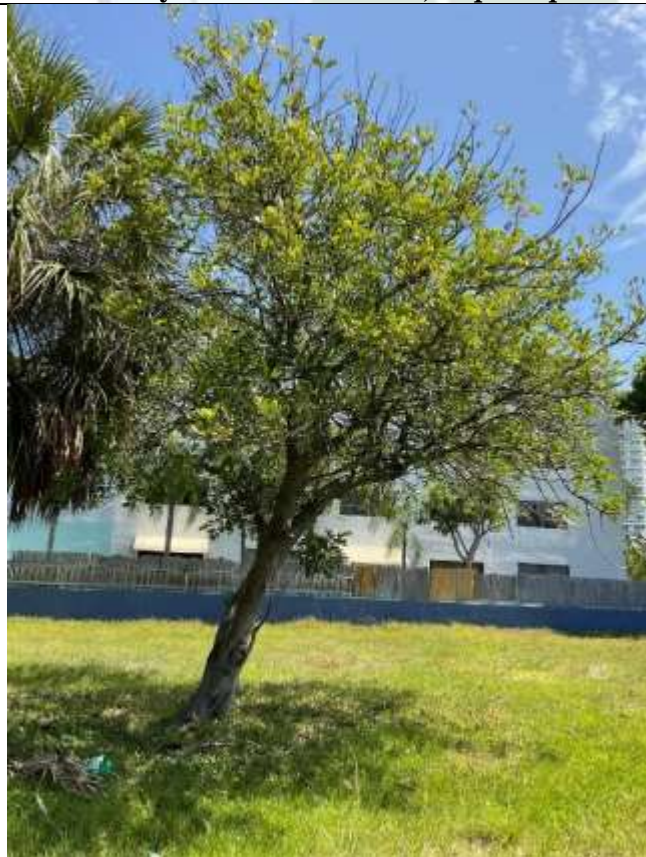
Tree/Survey #219 Carrotwood, *Cupaniopsis anacardioides*

Carrotwood is a Category I invasive exotic plant. It grows in many locations, including open, rarely maintained areas. The recommendation is to remove this plant with no mitigation required.

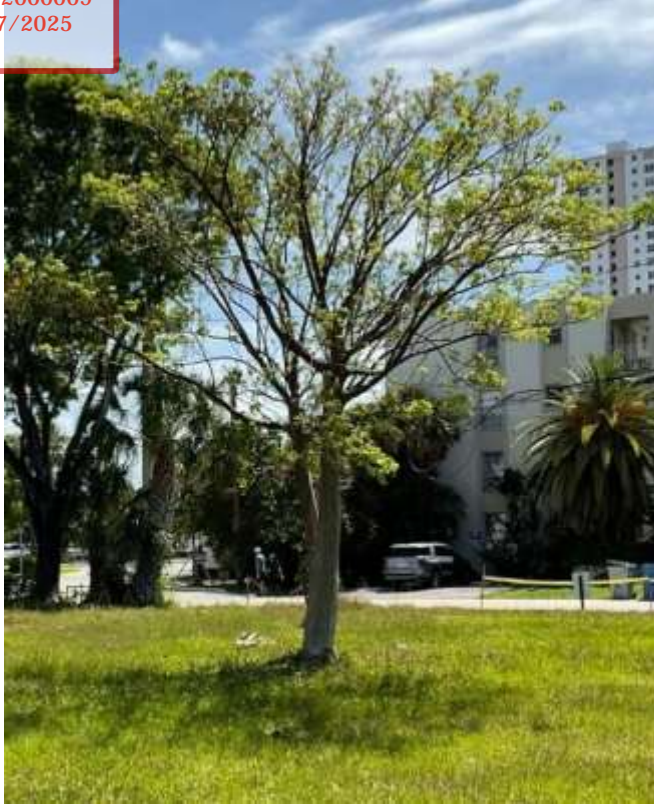
This Gumbo Limbo is in fair to poor condition. It exhibits dieback and decline, and has included bark in the branch junctures. It is in the construction footprint. The recommendation is to remove the tree.
