February 6, 2025
2281 NW 16th Street
Pompano Beach, FL

An Arborist Report/Tree disposition was conducted for the above referenced property. During our inspection, twenty-three (23) specimen size trees were located on the property. Below is a detailed report of the one tree that are located on the property.

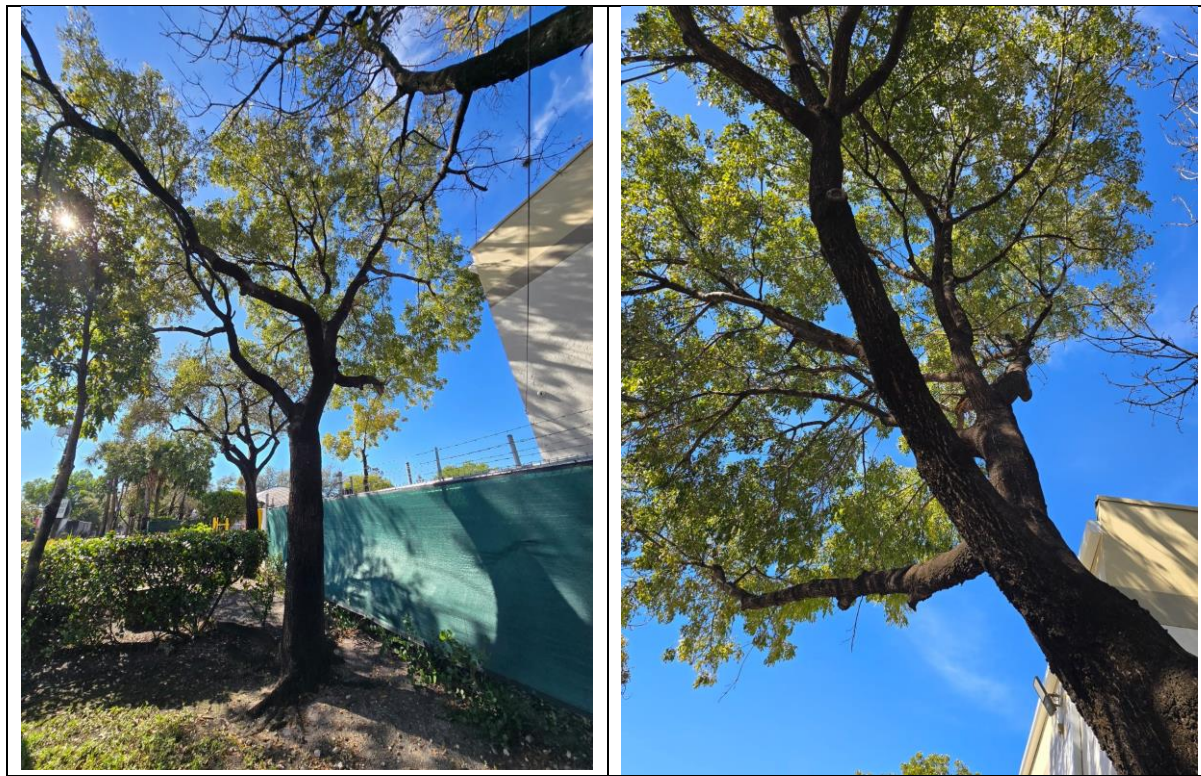
Tree **#58** Mahogany (*Swietenia mahagoni*)

Tree #58 Mahogany (*Swietenia mahagoni*) DBH 24", HT 30', SP 30', Cond 49% Appraisal \$3,457.44
This tree is located on the east side of the property. This tree has a sparse and chlorotic canopy, with many dead and decayed limbs being visible. There are many other large maturing trees near by restricting the amount of sun light causing a reduction for the tree to photosynthesis properly.
