200 N. Federal Hwy., Pompano Beach, FL 33062

ARBORIST REPORT

200 N. Federal Hwy.
Pompano Beach, Fl 33062

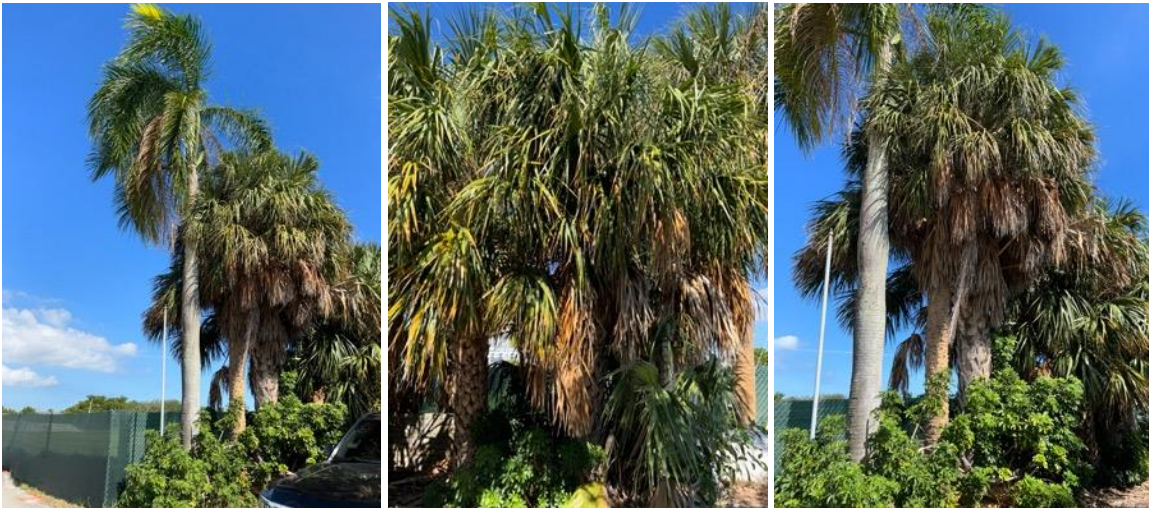
Tree #1 – *Roystonea regia*, Royal Palm – this tree is located in the northwest corner of the property adjacent to the parking lot and next to the ROW. It is crowded with minor chlorosis and a slightly undersized canopy. Overall, it is in fair condition and is proposed for removal.

Tree #2 – *Sabal palmetto*, Sabal Palm – this tree is located directly east of Tree #1. It is very crowded with a pronounced curve in the upper trunk due to the crowded conditions. It is in fair condition and is proposed for removal.

Tree #3 – *Sabal palmetto*, Sabal Palm – this tree is located directly east of Tree #2 on the northeast side of the property. It is very crowded and has live fronds only on one side of the trunk due to severe crowding. It is in poor condition and is proposed for removal.

Tree #4 – *Sabal palmetto*, Sabal Palm – this tree is located directly east of Tree #3. It is very crowded and overgrown but otherwise is in fair condition. This tree is proposed for removal.

Tree #5 – *Sabal palmetto*, Sabal Palm – this tree is located directly east of Tree #4. It is very crowded and overgrown but otherwise is in fair condition. It is proposed for removal.

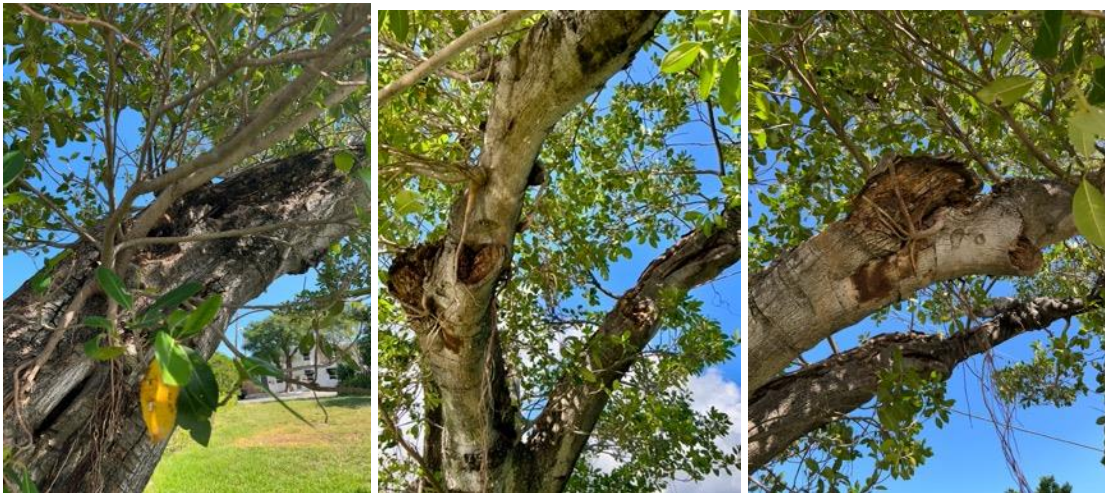
Tree #25 – *Ficus aurea*, Strangler Fig – this tree is located on the north side of the main parking lot near the entrance to the small parking lot (Lot 17, Block 5). It has extensive internal decay at the base of the trunk and in all remaining scaffold limbs. There is decayed wood, apparent termite damage, and fruiting fungal bodies present. Based on a Level 2 inspection and using the ISA Risk Rating matrix, this tree constitutes a high risk and there are no mitigation options that can reduce its risk to moderate or less; therefore, it is recommended for consideration for removal without a permit or mitigation per FS 163.045.

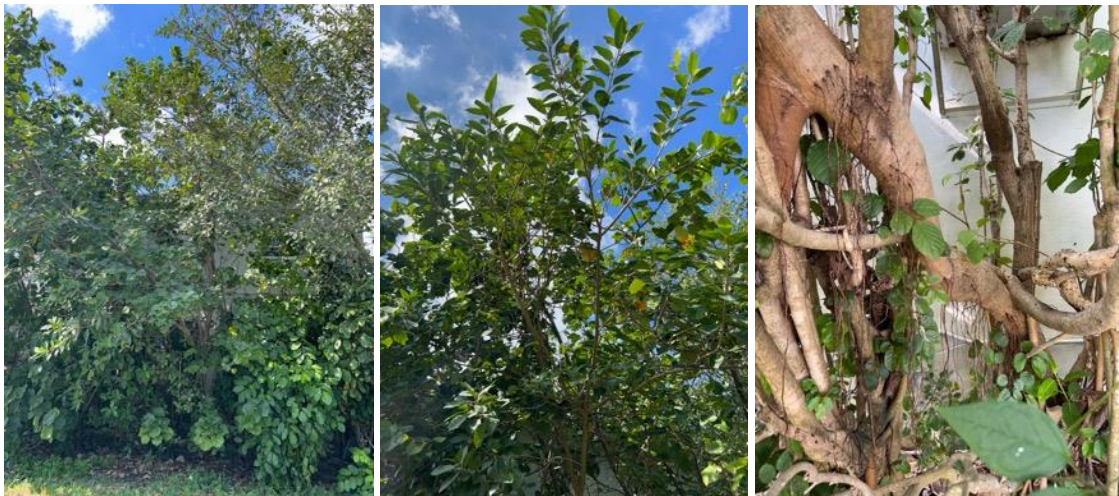
Tree #28 – *Ficus aurea*, Strangler Fig – this is a small volunteer that is growing in an overgrown cluster of Sea Hibiscus on the east side of the existing back building. It is crowded and leaning and has a weak growth habit/structure as a result. It is in poor condition and will be removed.

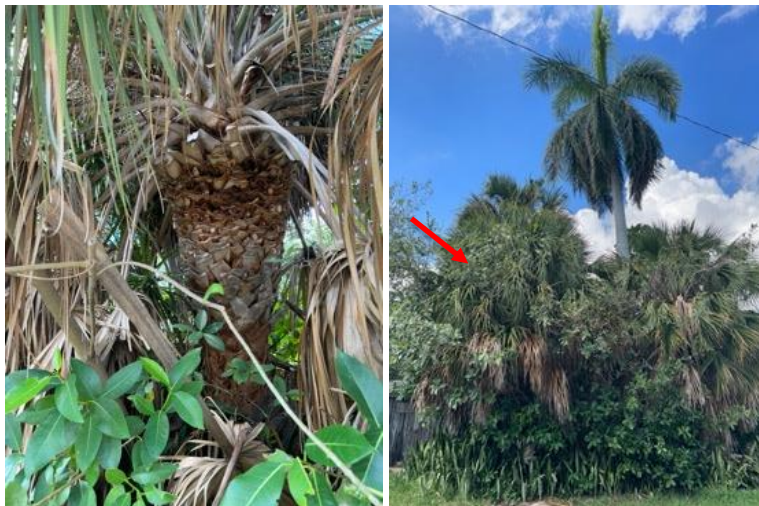
Tree #30 – *Sabal palmetto*, Sabal Palm – this tree is located directly in front of Tree #21 on the east side of the property. It is very crowded, overgrown with vines, and unmaintained. Overall, it is in fair condition and is proposed for removal.

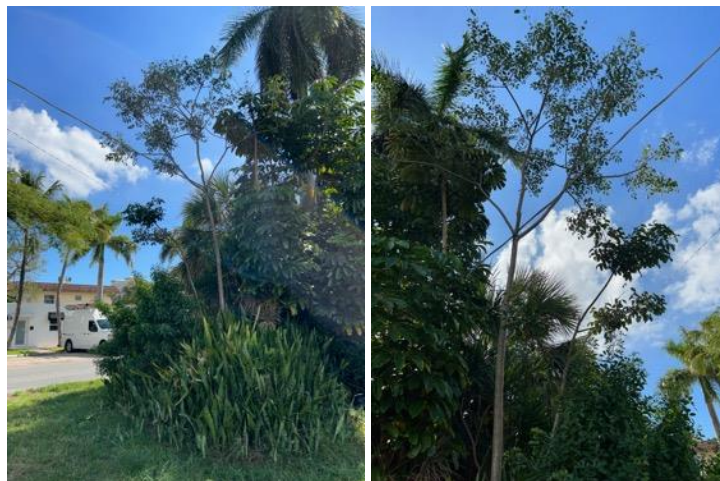
Tree #32 – *Bursera simarouba*, Gumbo Limbo – this tree is located on the north side of the cluster of overgrown vegetation on the east side of the property (north of Trees #20 and 23). It is crowded and overgrown with a slightly weak structure, and it is growing among utility wires. Overall, it is in fair condition and is proposed for removal.

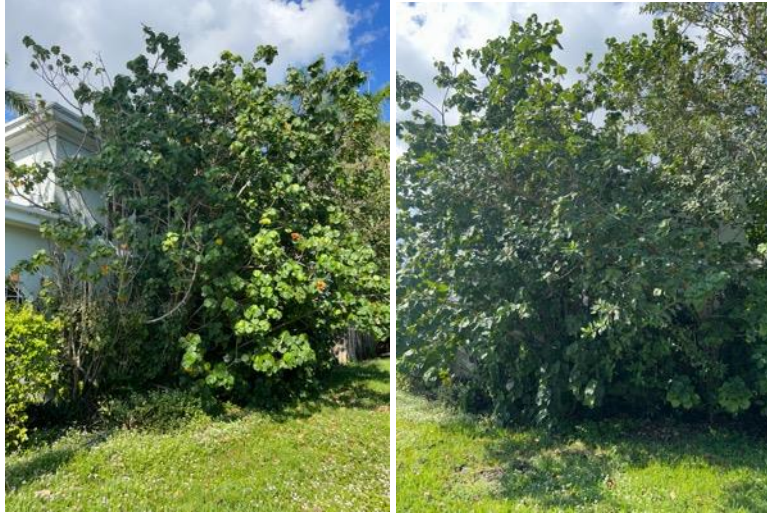
***Hibiscus tiliaceus*, Sea Hibiscus** – this refers to a large overgrown cluster of Sea Hibiscus located on the east side of the property against the southeast side of the back building. There appear to be 2 distinct individual clusters present. They are crowded, overgrown and unmaintained, and in overall moderate condition. This is more of an overgrown shrub than a tree, so it is recommended for removal without mitigation to be confirmed by the City.

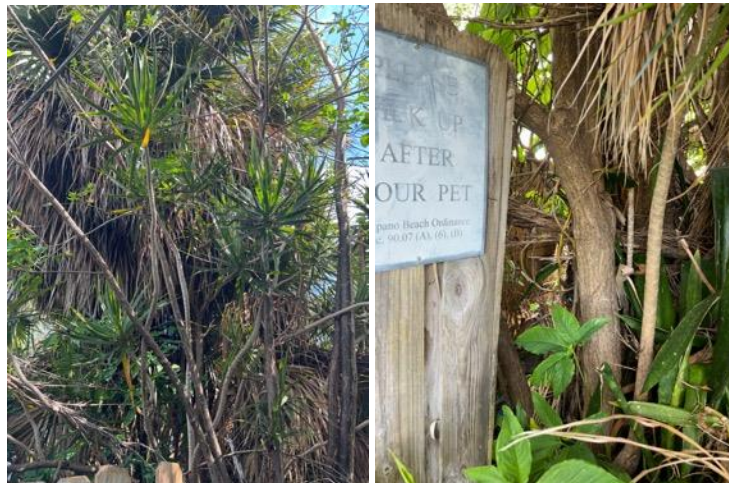
***Dracaena reflexa*, Dracaena** – there is a small cluster of Dracaena located on the southwest side of the cluster of vegetation on the east side of the property (adjacent to Tree #21). It is crowded and overgrown. It is more of an overgrown shrub than a tree, so it is recommended for removal without a permit or mitigation, to be confirmed by the City.
