Foliage Expressions LLC

Arborist Report

3225 NE 5th St,
Pompano Beach, FL
33062

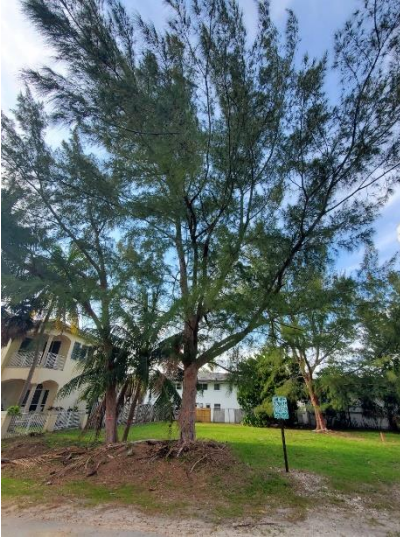
Tree # 1

Condition – Poor

Tree #1 is an Australian Pine an invasive exotic tree species as per FLEPPC Category I list of species. Tree is located south side of the property on site. This Australian pine is in poor condition with many co-dominant leaders compromising tree stability and risk of failing. This tree is in conflict as well with the proposed new development and is proposed to be removed with no mitigation required.

Disposition – To be removed

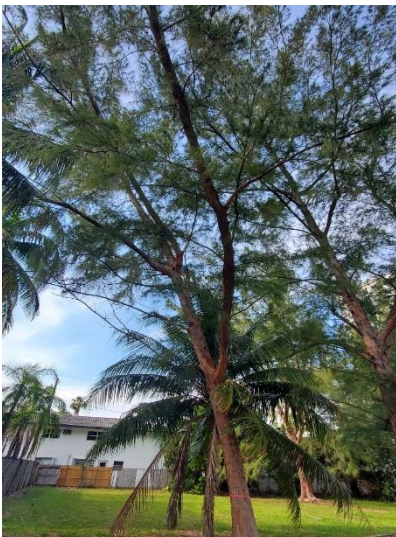
Tree # 2

Condition – Poor

Tree #2 is an Australian Pine is an invasive exotic tree species as per FLEPPC Category I list of species. Tree is located south side of the property on site. This Australian pine is in poor condition with two main co-dominant leaders compromising tree stability and risk of failing. This tree is in conflict as well with the proposed new development and is proposed to be removed with no mitigation required.

Disposition – To be removed

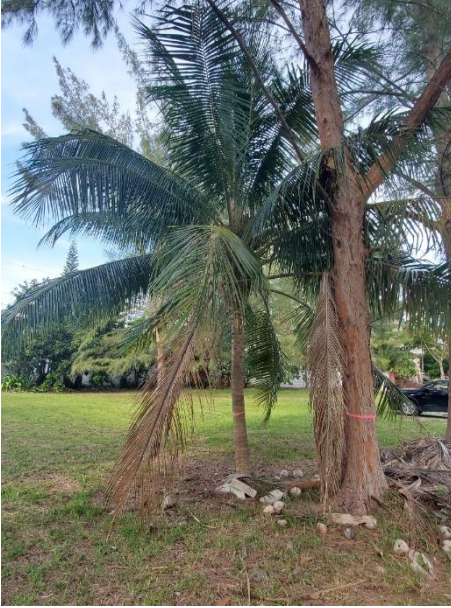
Tree # 3

Condition – fair

Tree #3 is a Coconut palm. This palm is in fair condition its upper canopy shows interveinal chlorosis and extreme burning on lower of fronds. The trunk shows clear signs of tapering reducing its girth on the top and slightly vent sideways due to severe nutritional deficiencies. This palm has been severely neglected over the years due to lack of care fertilization and watering. This palm is currently proposed to be removed as part of the upcoming new construction activities and will be mitigated on site.

Disposition – To be removed

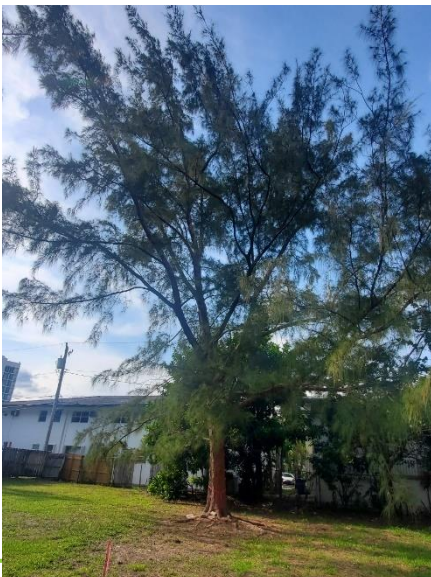
Tree # 4

Condition – Poor

Tree #4 is an Australian Pine is an invasive exotic tree species as per FLEPPC Category I list of species. Tree is located in the middle of the lot north side of the property on site. This Australian pine is in poor condition with three main co-dominant leaders compromising tree stability and risk of failing. This tree is in conflict as well with the proposed new development and is proposed to be removed with no mitigation required.

Disposition – To be removed

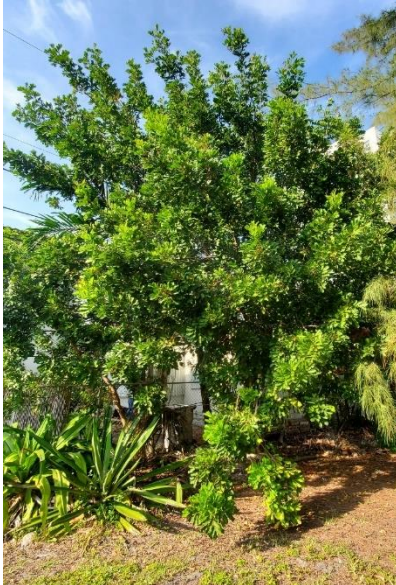
Tree #5 is a Carrotwood tree a very highly invasive exotic tree category 1 as per FLEPPC latest list. This tree is located N side of the property. This tree is probably a seedling of other invasive exotics found in this property or adjacent neighbors. Therefore, immediate removal is recommended and current disposition as per site development is to be removed with no mitigation required.

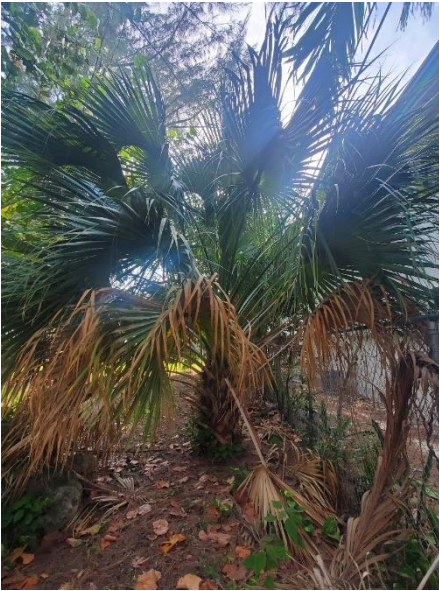
Tree #7 is a young size sable palm in a fair condition its upper canopy shows interveinal chlorosis and extreme burning on lower of fronds. This palm is a volunteer seedling probably from wildlife dispersal. This palm is currently proposed to be removed as part of the upcoming new construction activities.

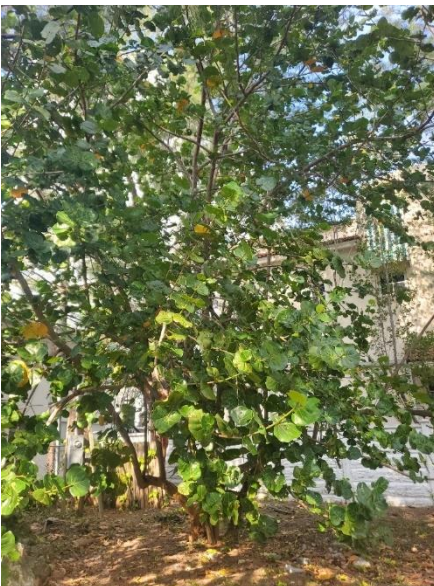
Tree #8 is a young Seagrape tree located north side of the property this tree probably was dispersed from wildlife seeds. Tree is in fair condition has severe codominant leaders and included bark and has been severely damaged and deformed during previous storm events and is growing more like a bush with several trunks. This tree is in conflict with proposed new construction and is currently proposed to be removed and mitigated on site.

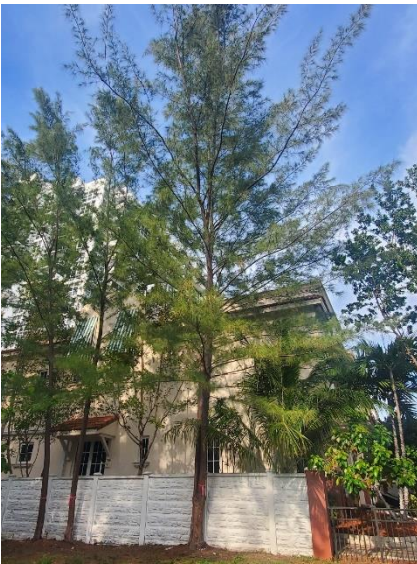
Tree #12 is an Australian Pine an invasive exotic tree species as per FLEPPC Category I list of species. Tree is located south side of the property on site. This Australian pine is in good condition with one main leader. Damage to adjacent property is highly probable. This tree is in conflict as well with the proposed new development and is proposed to be removed with no mitigation required.

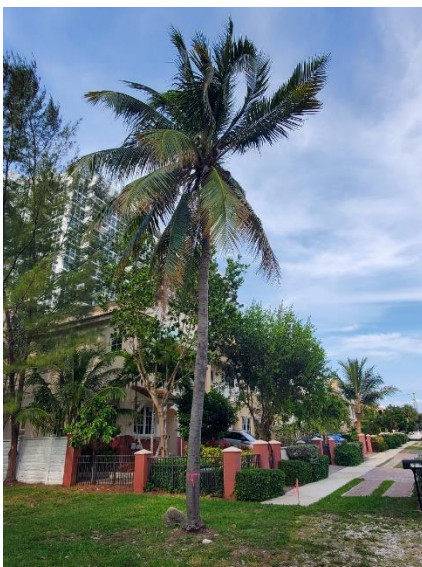
Tree #13 is a Coconut palm. This palm is located SE side of the property and is in fair condition its upper canopy shows interveinal chlorosis and extreme burning on lower of fronds. The trunk shows clear signs of tapering reducing its girth on the top and slightly vent sideways due to severe nutritional deficiencies. This palm has been severely neglected over the years due to lack of care fertilization and watering. This palm is currently proposed to be removed as part of the upcoming new construction activities and will be mitigated on site.
