## Pre-Renovation Report of Building Material Survey, Sampling and Evaluation of Asbestos-Containing Materials

Denny's

2671 North Federal Highway

October 26, 2018

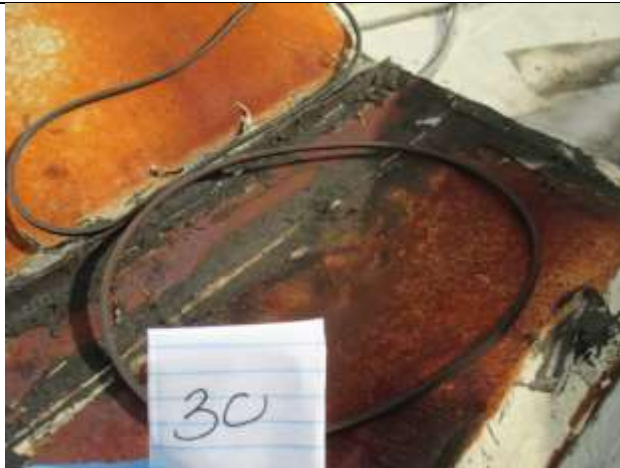
| Sample Number | HA | Location | Description of Suspect Material | Asbestos Content % |
|---|---|---|---|---|
| 4545-69 | 30 | Flat Roof Northwest Area Unit | Black Mastic at Air-Conditioning Units | 10% Chrysotile |
| 4545-70 | 30 | Flat Roof Northwest Area Unit | Black Mastic at Air-Conditioning Units | ND |

| Homogenous Area (HA) Material | Location | Percentage/ Type | Material Condition/ Friability | Approximate Quantity | Category |
|---|---|---|---|---|---|
| HA 30: Black Mastic on Air-Conditioning Units | Northwest Area Units on Flat Roof | ND-10% Chrysotile | Fair/<br>Non-Friable | 20 SF | Category II NESHAPs |

HA 30- Black Mastic on Air-Conditioning Unit  
**Asbestos Containing Material**

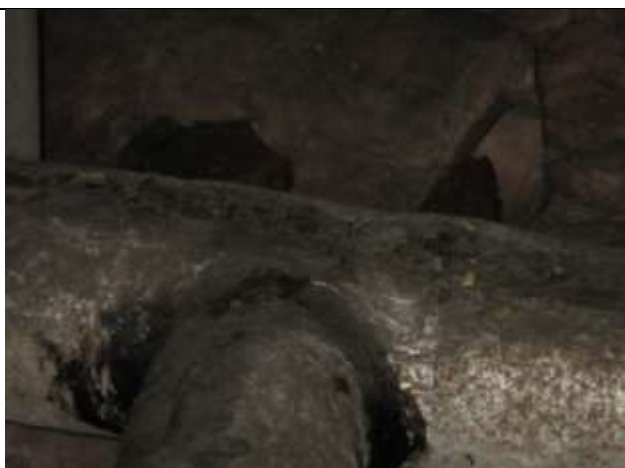
| Homogenous Area (HA) Material | Location | Percentage/ Type | Material Condition/ Friability | Approximate Quantity | Category |
|---|---|---|---|---|---|
| Inaccessible Black Duct Mastic | Above Drywall System Ceilings | Presumed | Unknown | Unknown | Category II NESHAPs |

Black Mastic Above Drywall System Ceiling  
**Assumed Asbestos Containing Material**
