Arboriculture Tree Report

400 Sunset Dr, Pompano Beach

To: Ali Nazem
Email: alinazem@rocketmail.com**Date:** March 18th, 2024
Phone: 786.747.6868**Prepared by:** Trea Jones
International Society of Arboriculture Certified Arborist**Certification of Performance**

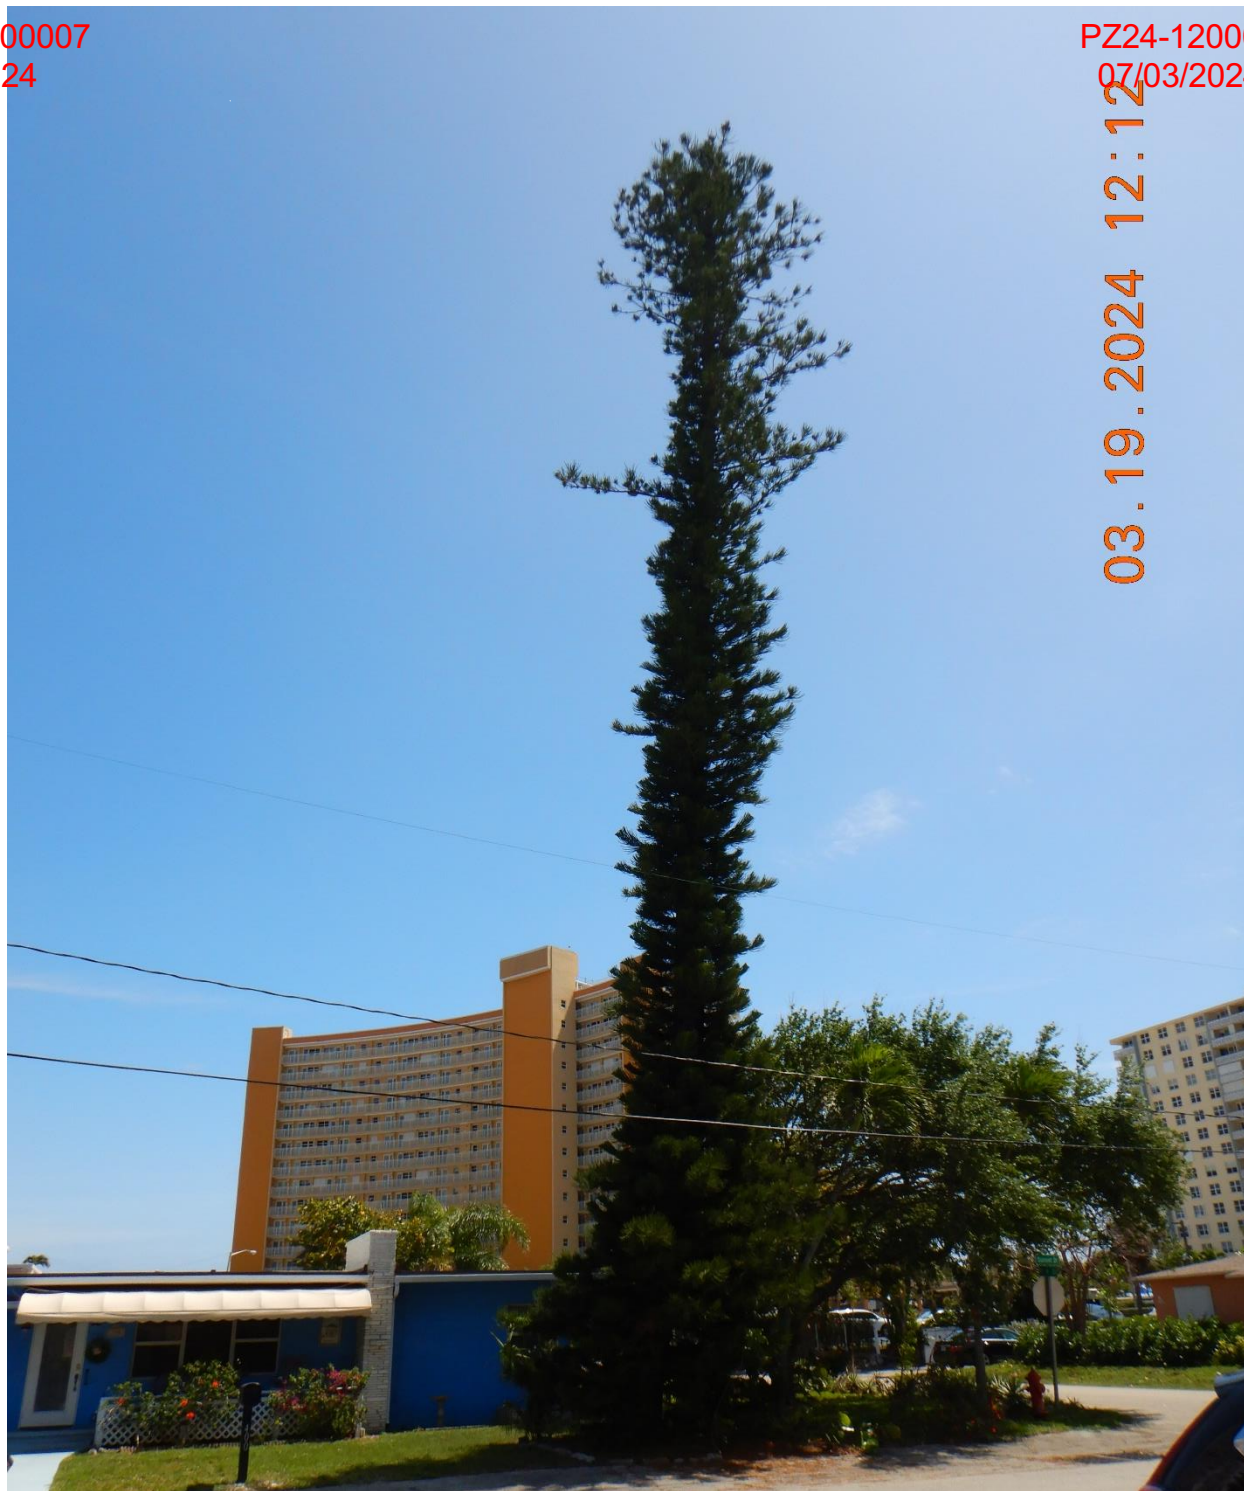
Tree #	Common name	Botanical name	DBH	Height OA	Height c/t	Canopy size	Condition	Price per in / ft	Value before Diminution	Value	Notes
1	Norfolk Island Pine	<i>Araucaria heterophylla</i>	22	60		12x12	60%	\$85.00	\$1,870.00	\$1,122.00

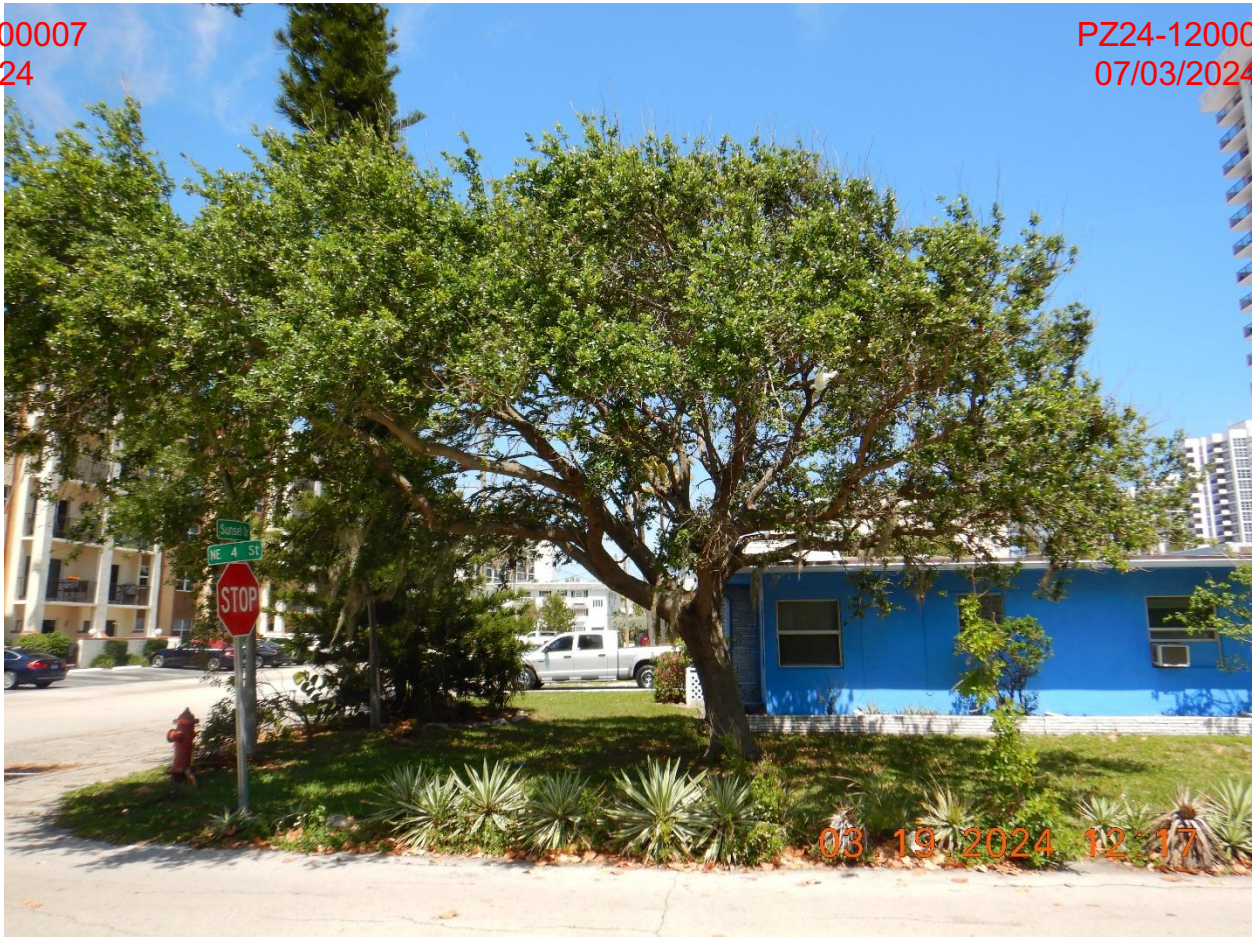
Tree #	Common name	Botanical name	DBH	Height OA	Height c/t	Canopy size	Condition	Price per in / ft	Value before Diminution	Value	Notes
2	Live oak	<i>Quercus virginiana</i>	19	25		40x35	60%	\$177.08	\$3,364.52	\$2,018.71	Co-dom branch union, tip decline

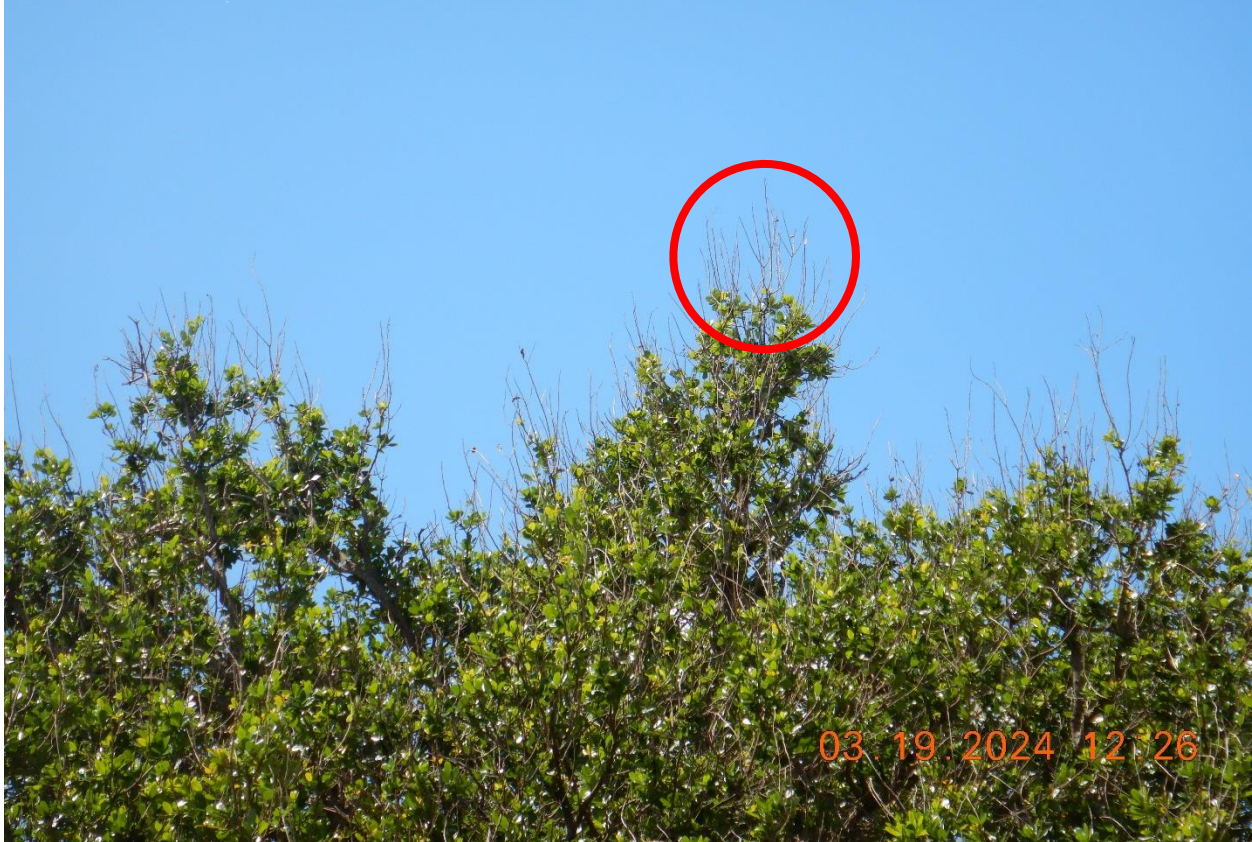
#2

Slight tip decline, an indication of a potential root-related problem.

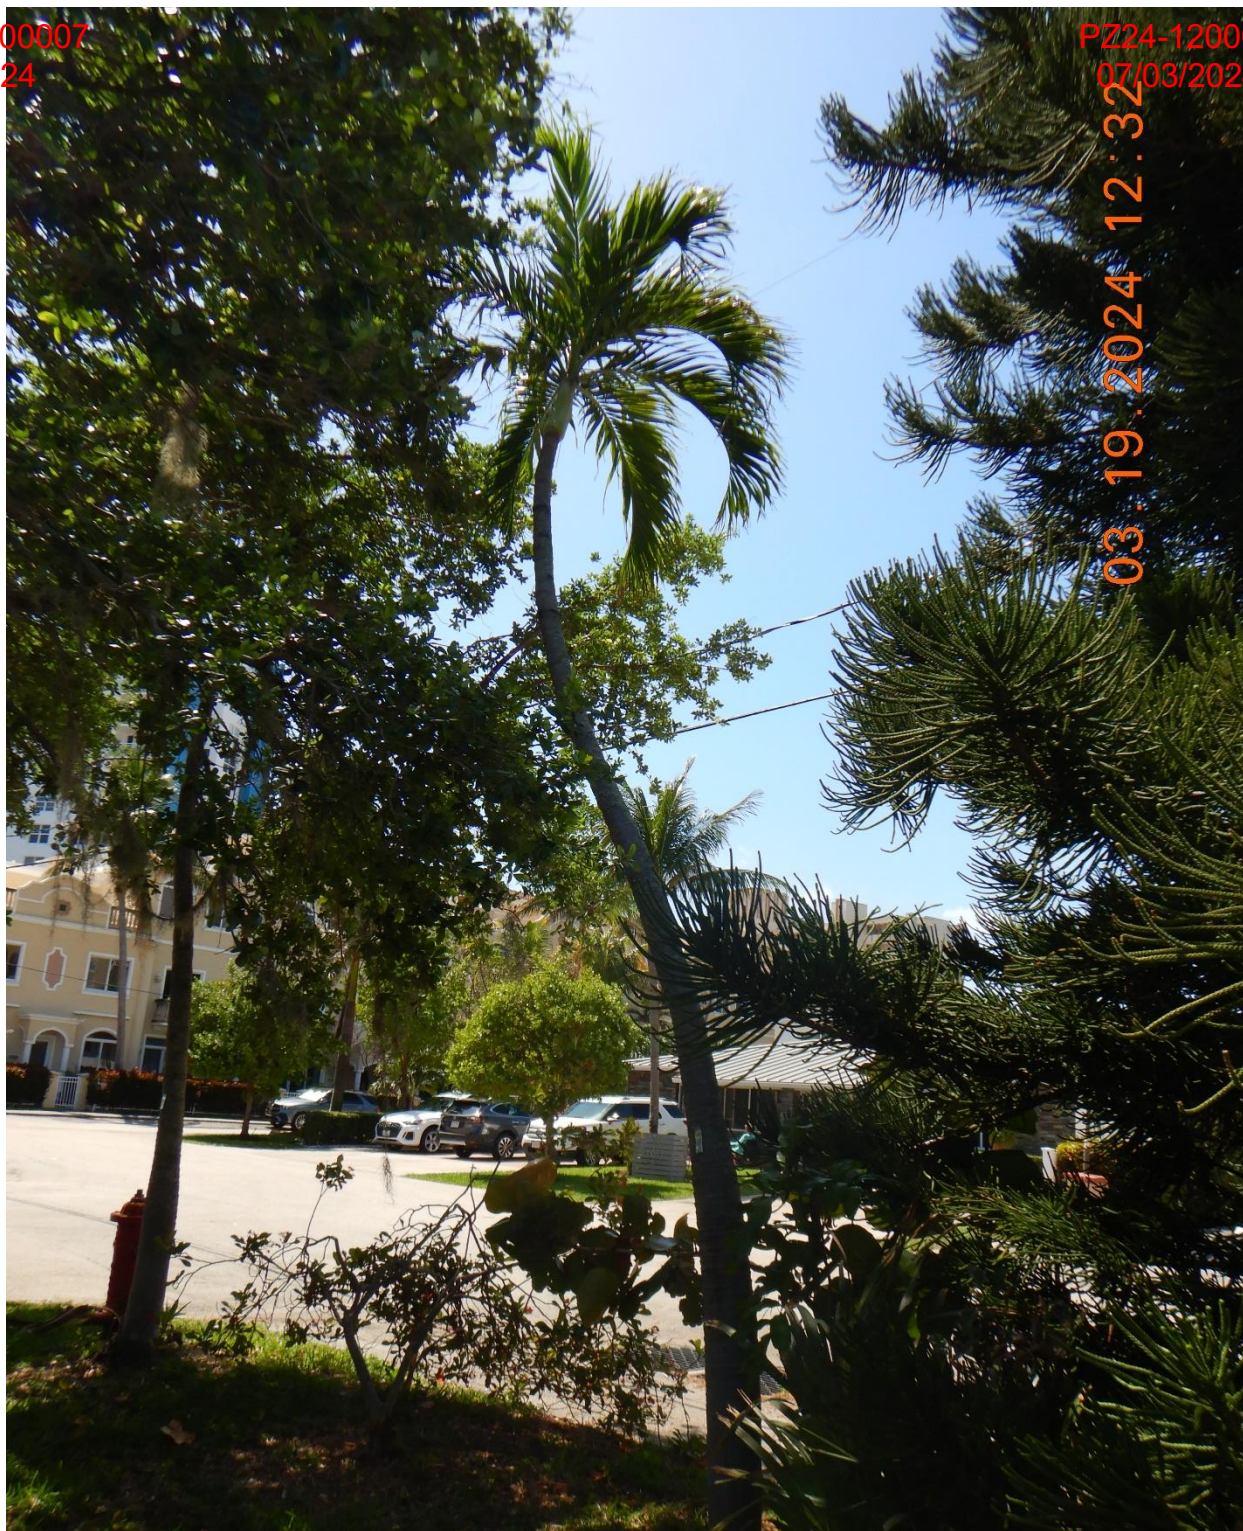
Tree #	Common name	Botanical name	DBH	Height OA	Height c/t	Canopy size	Condition	Price per in / ft	Value before Diminution	Value	Notes
3	Christmas palm	<i>Adonidia merrillii</i>			12	8x8	70%	\$32.74	\$395.00	\$278.02

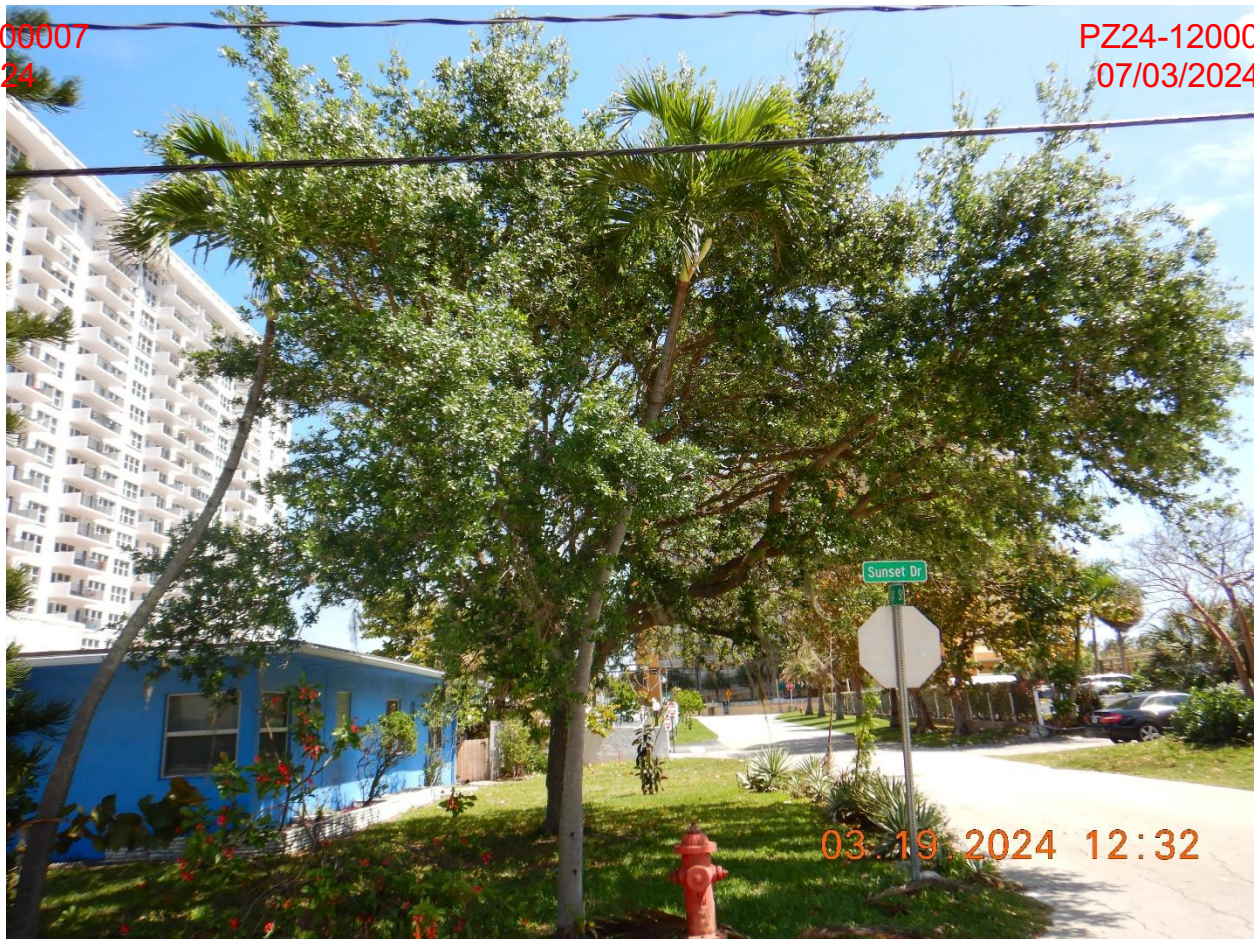
Tree #	Common name	Botanical name	DBH	Height OA	Height c/t	Canopy size	Condition	Price per in / ft	Value before Diminution	Value	Notes
4	Christmas palm	<i>Adonidia merrillii</i>			12	8x8	60%	\$32.74	\$392.88	\$235.73

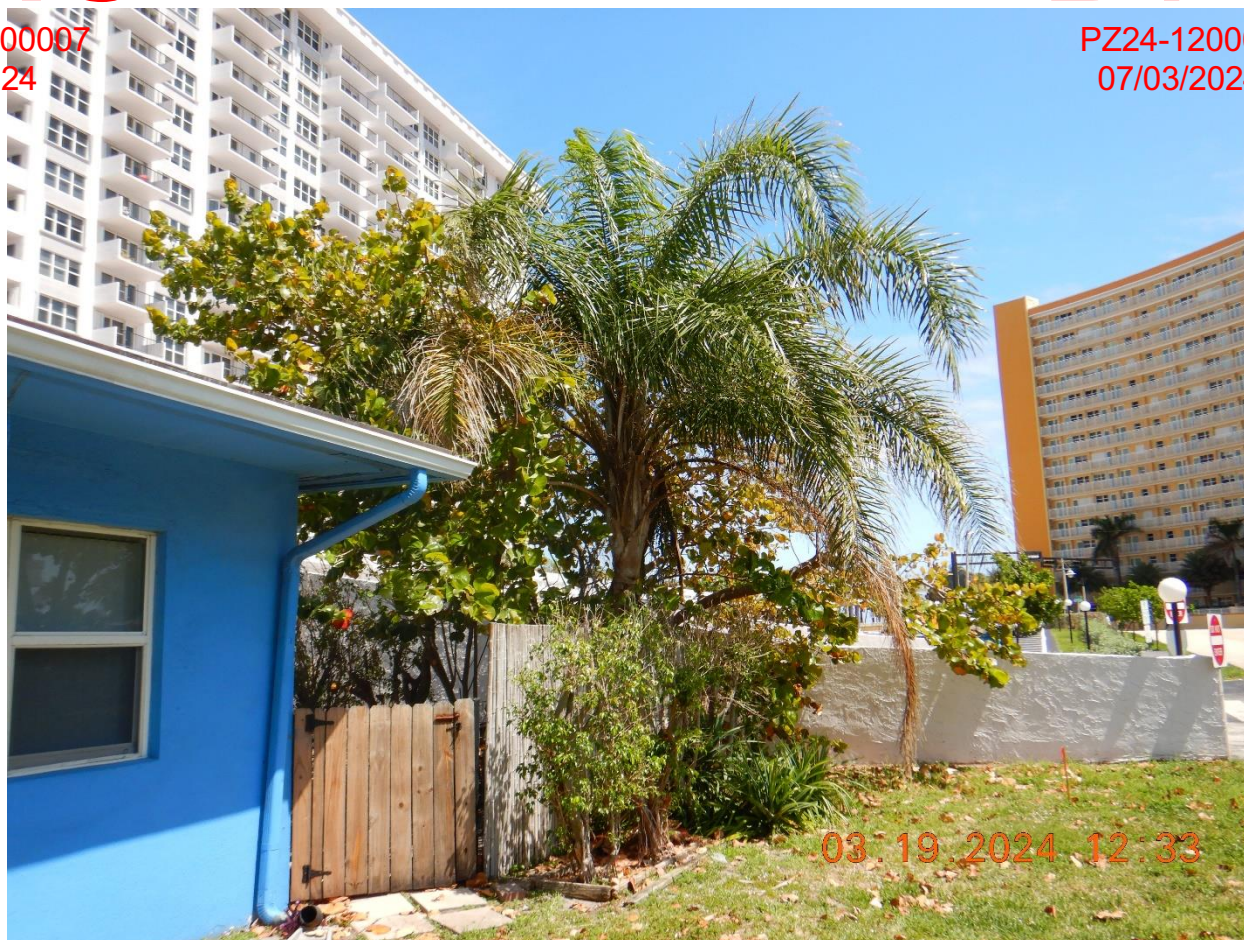
Tree #	Common name	Botanical name	DBH	Height OA	Height c/t	Canopy size	Condition	Price per in / ft	Value before Diminution	Value	Notes
5	Queen palm	<i>Syagrus romanzoffiana</i>			7	24x24	60%	\$25.83	\$180.81	\$108.49

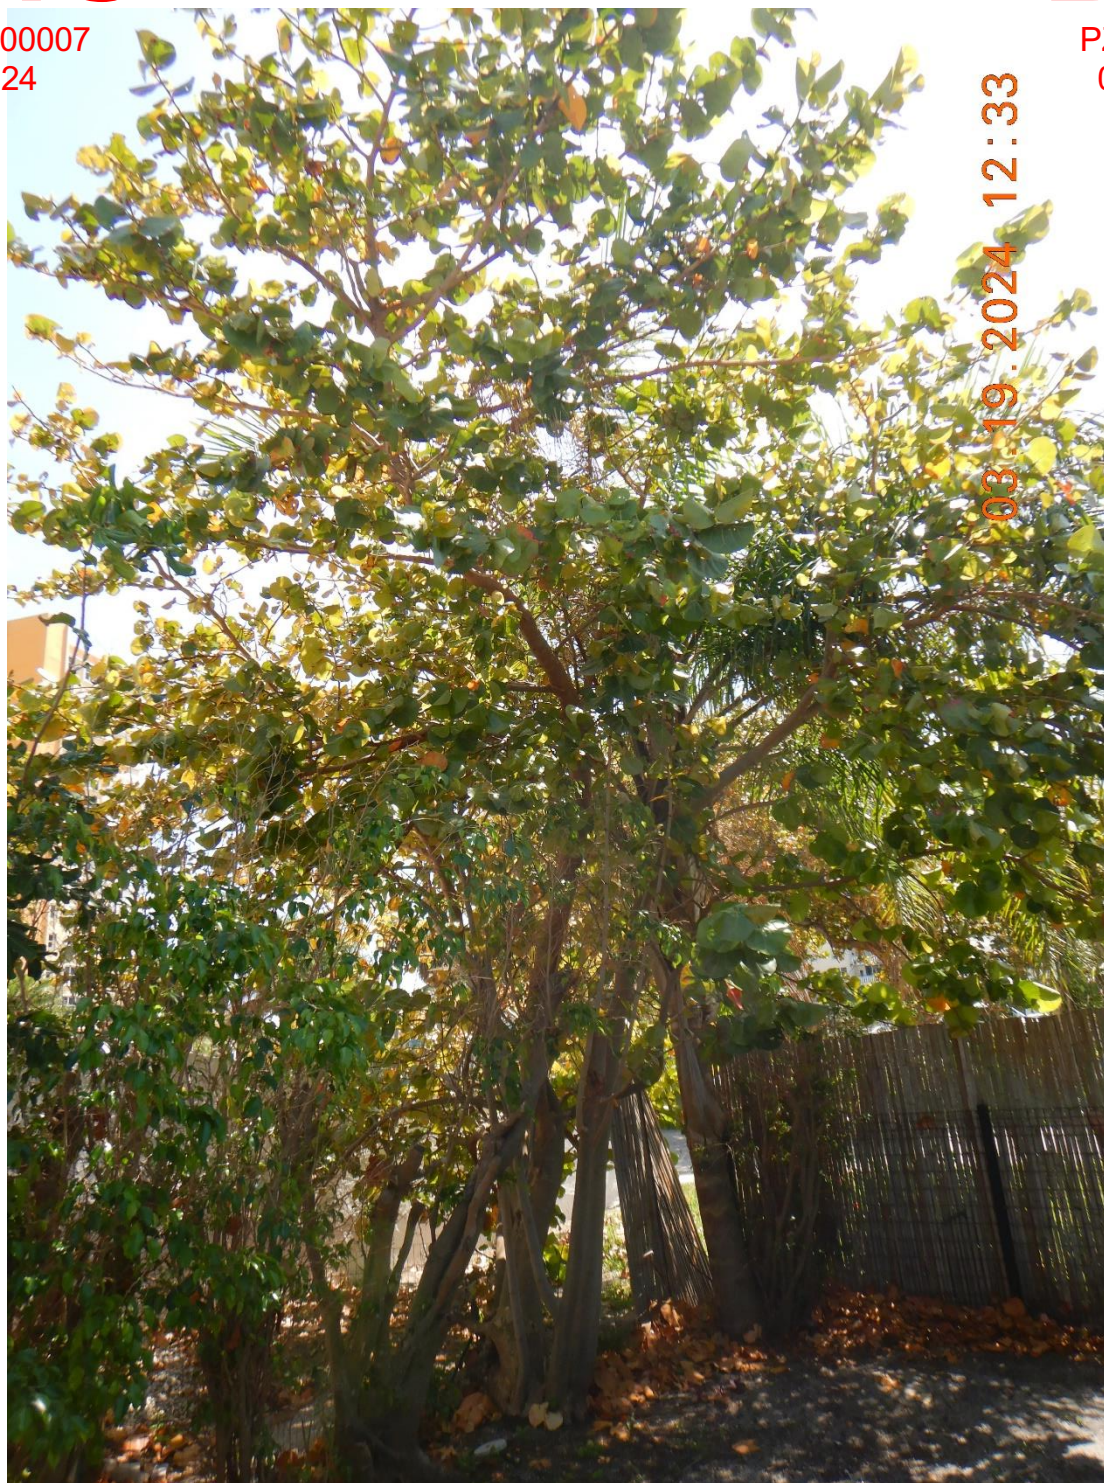
Tree #	Common name	Botanical name	DBH	Height OA	Height c/t	Canopy size	Condition	Price per in / ft	Value before Diminution	Value	Notes
6	Sea grape	<i>Coccoloba uvifera</i>	14	17		25x25	40%	\$229.17	\$3,208.33	\$1,283.35	Very poor structure, co-canopy

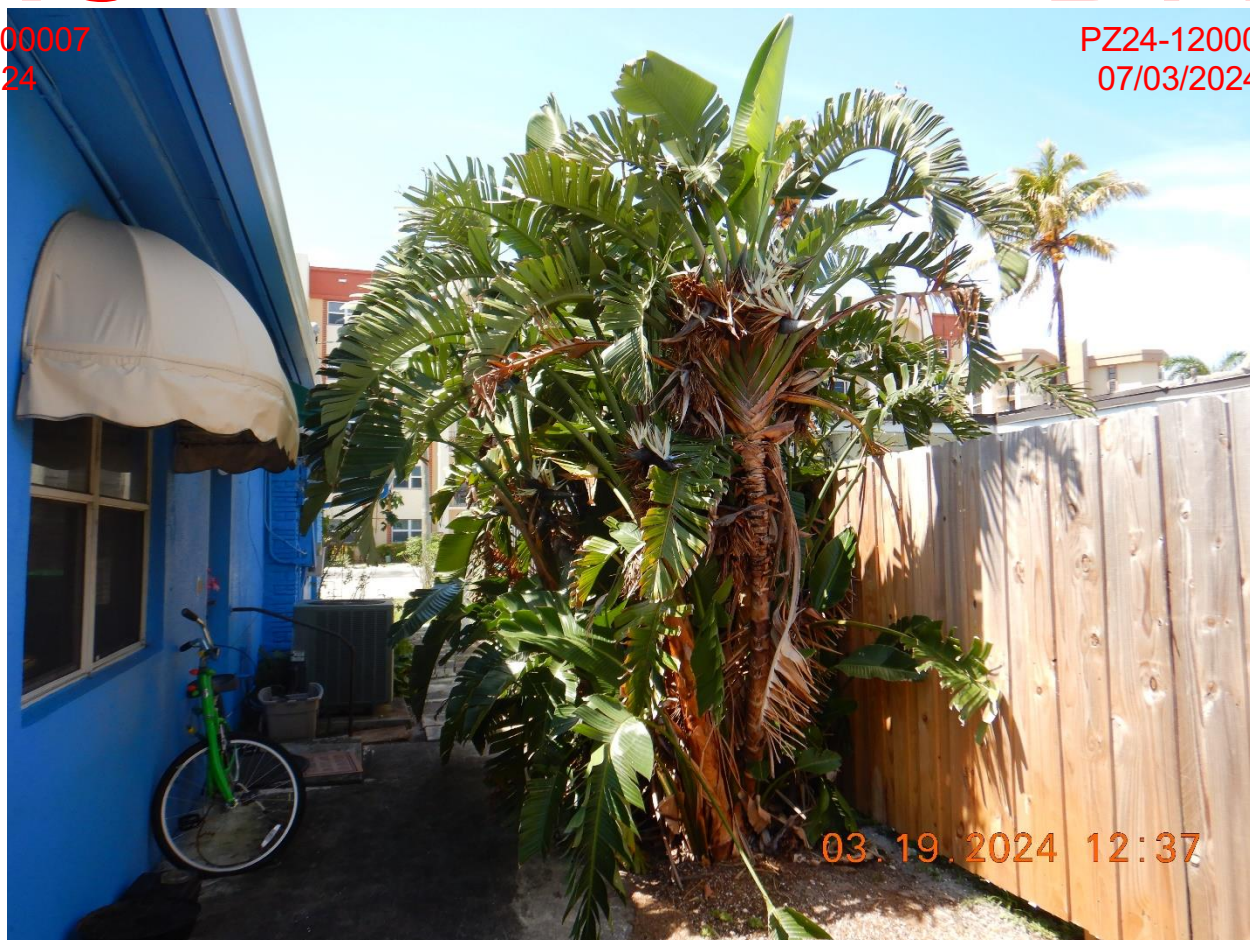
Tree #	Common name	Botanical name	DBH	Height OA	Height c/t	Canopy size	Condition	Price per in / ft	Value before Diminution	Value	Notes
7	White bird of paradise	<i>Strelitzia nicolai</i>			6	12x12	80%	\$30.95	\$185.70	\$148.56	Multi trunk cluster
